ARCHAEOLOGICAL MONITORING AND RECORDING

THE OLD FORGE
7 ERMINE STREET
APPLEBY
NORTH LINCOLNSHIRE

Humber Field Archaeology Report no. 2147

Planning Reference:	PRE/2018/164
National Grid Reference:	SE 9493 1469
HFA Site Code:	WB2019.001
Museum Reference:	APAQ

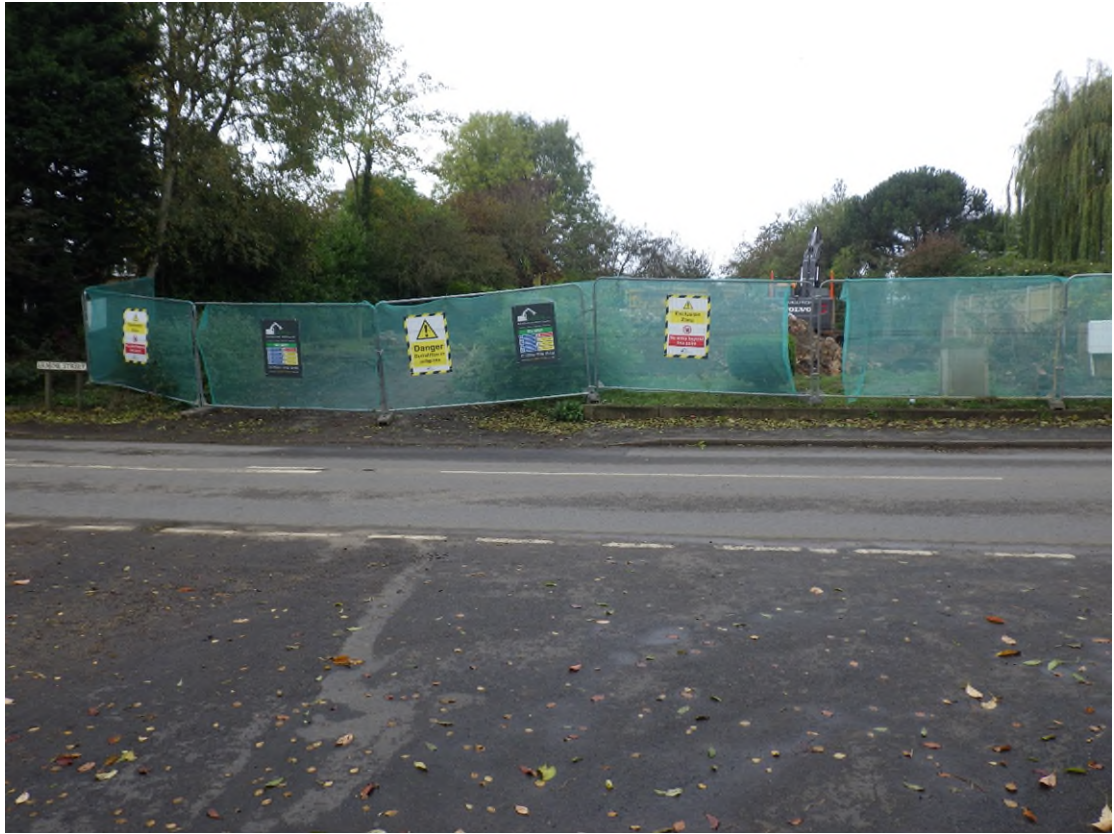
Plate 1 The site of the development's eastern frontage, looking west across Ermine Street.

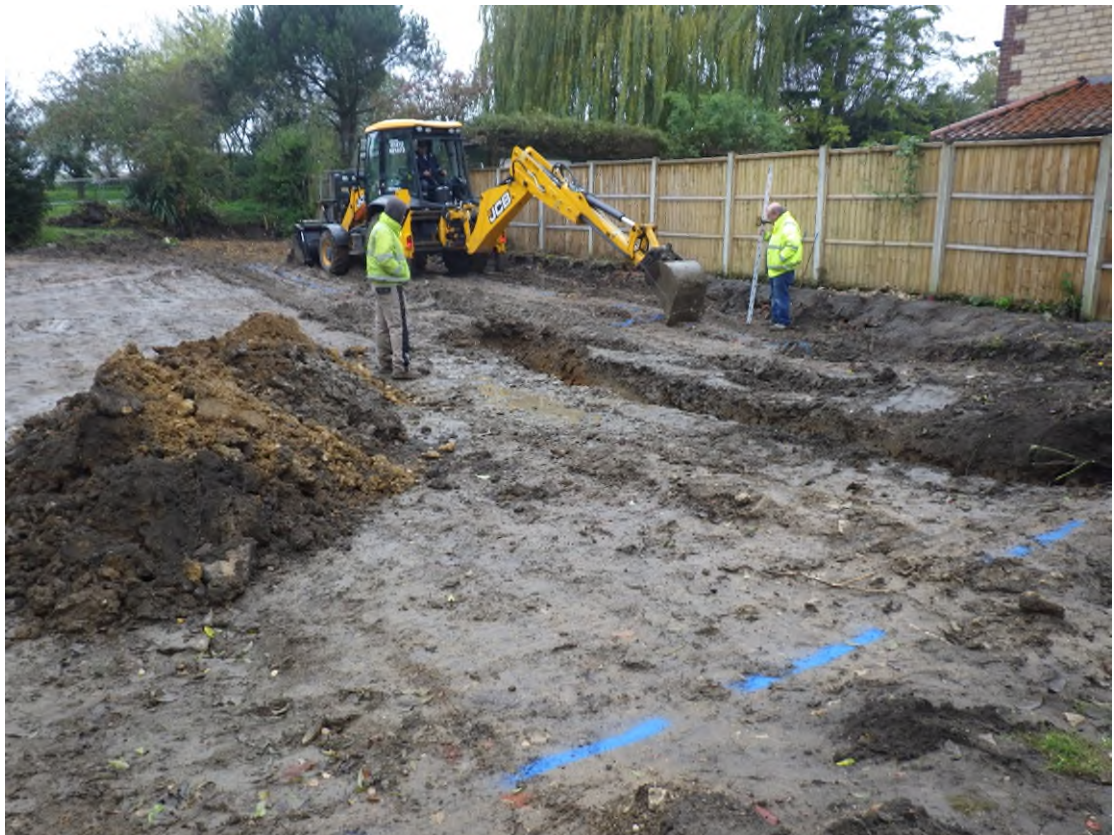
Plate 2 Initial excavation of the house foundation, looking west.

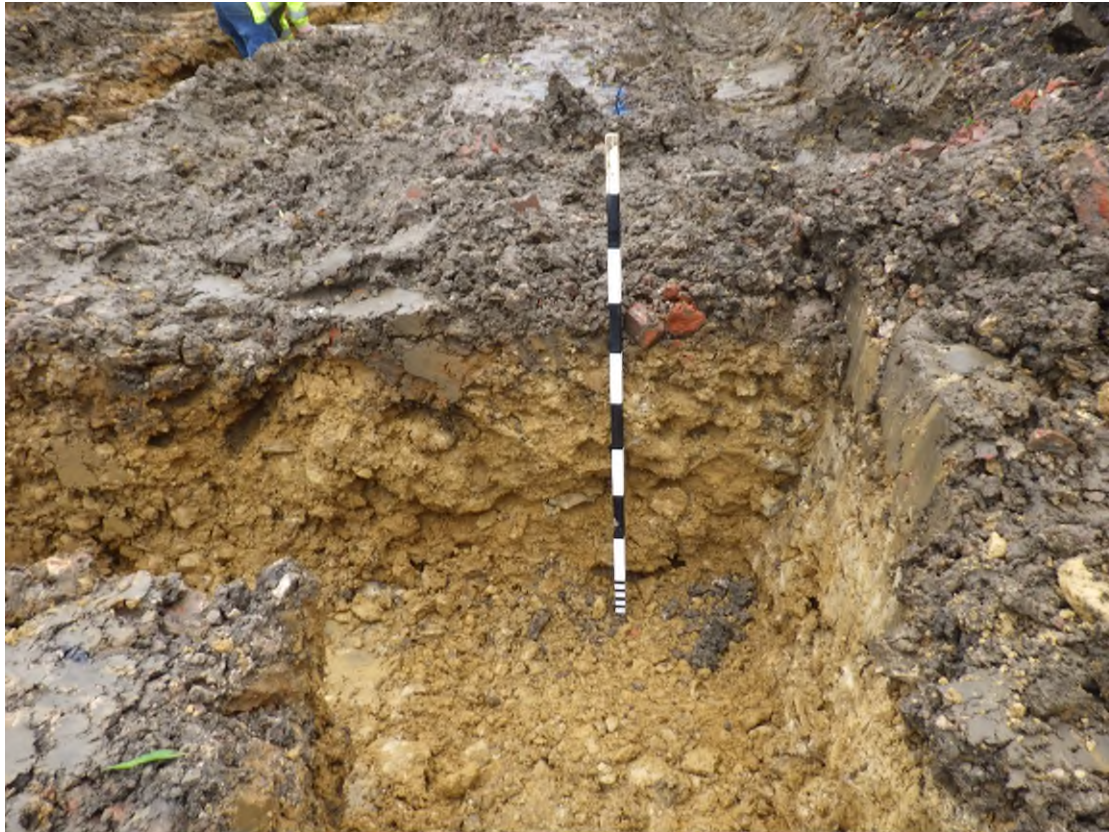
Plate 3 The stratigraphy in the northern part of the house foundation, showing natural stone deposit 2. Looking WSW (1m scale).

The foundation trenches for the new dwelling were 0.70m wide and were between 0.70m and 1m deep. They covered an area measuring 20.70m WSW-ENE and up to 12.60m NNW-SSE. At the northern side of the site, the main east-west foundation trench revealed stratigraphy consisting of between 0.40m and 0.10m of (1) a grey-brown gritty silt clay, which contained broken brick, tile and mortar, presumably residue from the recent programme of demolition and site clearance. This overlay (2), fragmented yellow limestone, or chalk, which was taken to be the underlying natural within this area.

Regarding the house foundation, the shallow depth of the overburden (1) at the north of the site, compared with that in the southern half (5), demonstrates the form of the underlying geology, suggesting the natural stone drops away to the south. The site lies on the northern edge of a small dip between two areas of high ground, with the main village of Appleby occupying the to the north.

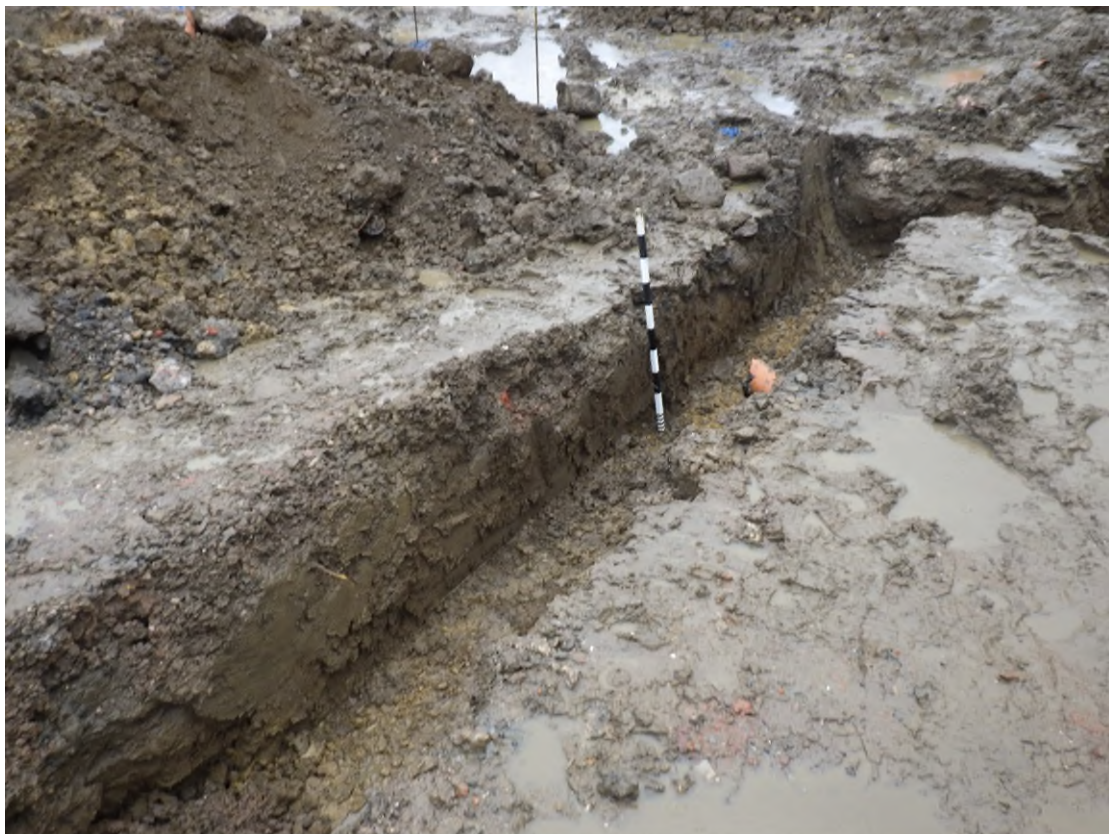
Plate 4 The southern side of the house foundation, showing deposit 5. Looking SW (1m scale).

The excavation of southern foundation trench, which was excavated a week later, again during heavy rain, revealed that the natural was encountered at a depth of around 0.80m, overlain by around 0.70m of yellow-grey brown clay silt (5), which was in turn overlain by between 0.10m and 0.20m of grey gritty silt clay (1). No archaeological features were evident, and there was no archaeological material amongst the spoil generated.

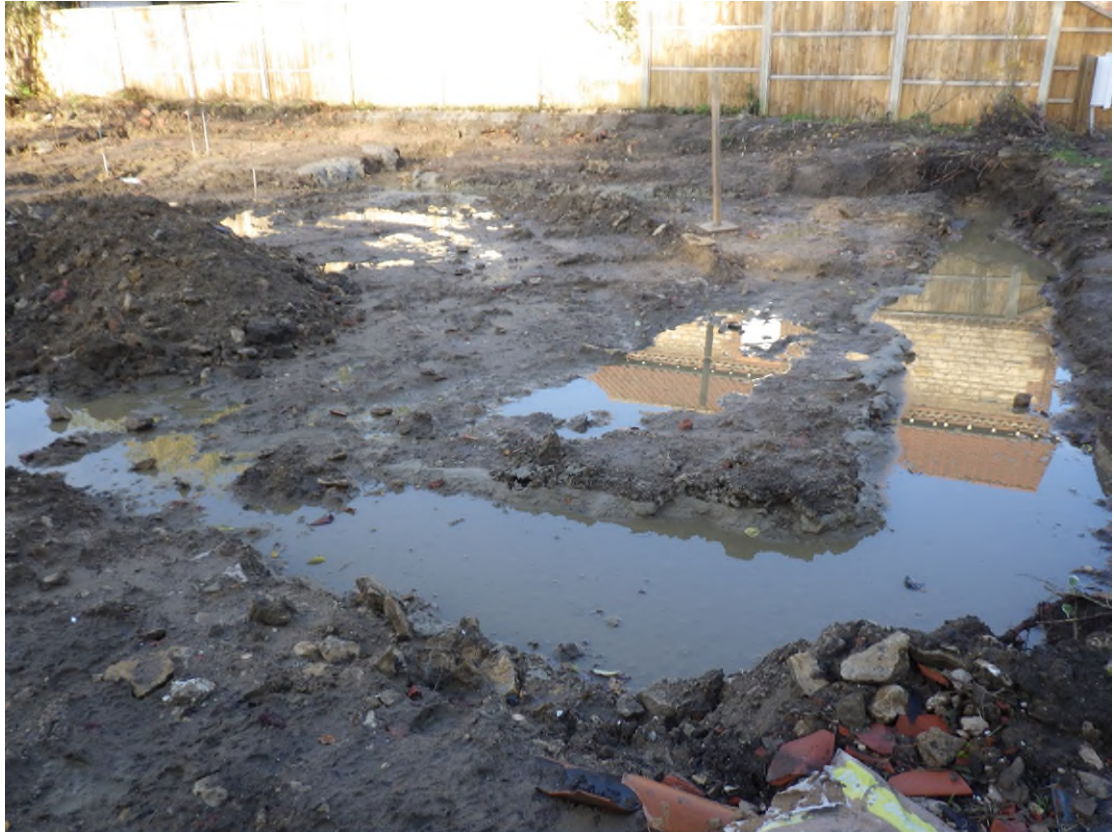
Plate 5 General shot of part of the house foundation at the eastern end, showing poor site conditions.

Work commenced on site on the 5th of November 2019, during a period of very heavy rainfall which had left much of the ground sodden, and which continued through the excavation period. This meant that access to the foundation trenches was poor, with risk of collapse and subsidence. Thus observation of the trenches was limited to top-down views only, with limited instances to access to the bottom of the house foundation.
