## Chalmore Hole Ferry House, Chalmore Gardens, Wallingford, Oxfordshire

**Archaeological Watching Brief**

Site Code: CHW20/211

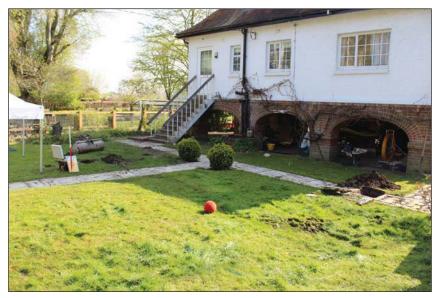
Plate 1. Location of test pits 1 and 2 with Garden, looking North East.

Three small hand-excavated test pits were dug in the garden to locate a number of services, all west of the building (Fig.3; Pl.1). These were at varied depth with a drainage pipe at 0.19m deep (ran W-E) in TP1 and a metal pipe ran N-S) leading to the south at a depth of 0.72m in TP2 and TP3. No natural geology, archaeological deposits nor artefacts were exposed in the test pits..

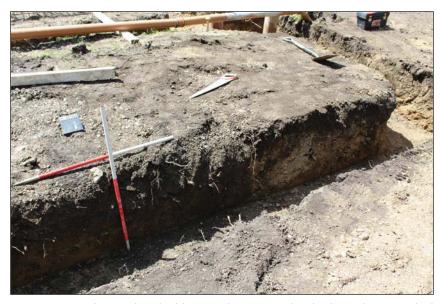
Plate 2. Representative section, looking South West, Scales: horizontal 1m, vertical 1m.

During excavation in the west, sand and gravel was exposed in section from 0.25m deep, though this was clearly redeposited, once at the base of the trench exposed blueish grey clay alluvium underneath from a depth of 0.65m deep. Similar stratigraphy was observed during excavation of the east facing trenches in the north west of the new footings and the north facing footing (Fig.4). None of the modern deposits (three different layered lenses), seen in the middle part of the footings in the western section were seen to be deeper than 0.68m. A brick base within concrete was exposed in the west section of the north east footing. This was a former base for the stairs that, until recently lead to the western façade door.
