**Water pipeline, Stowell Hill Road,  
Tytherington, South Gloucestershire**

**Archaeological Watching Brief**

**Site Code: TSG21/238**

**An Archaeological Watching Brief  
for Wessex Water**

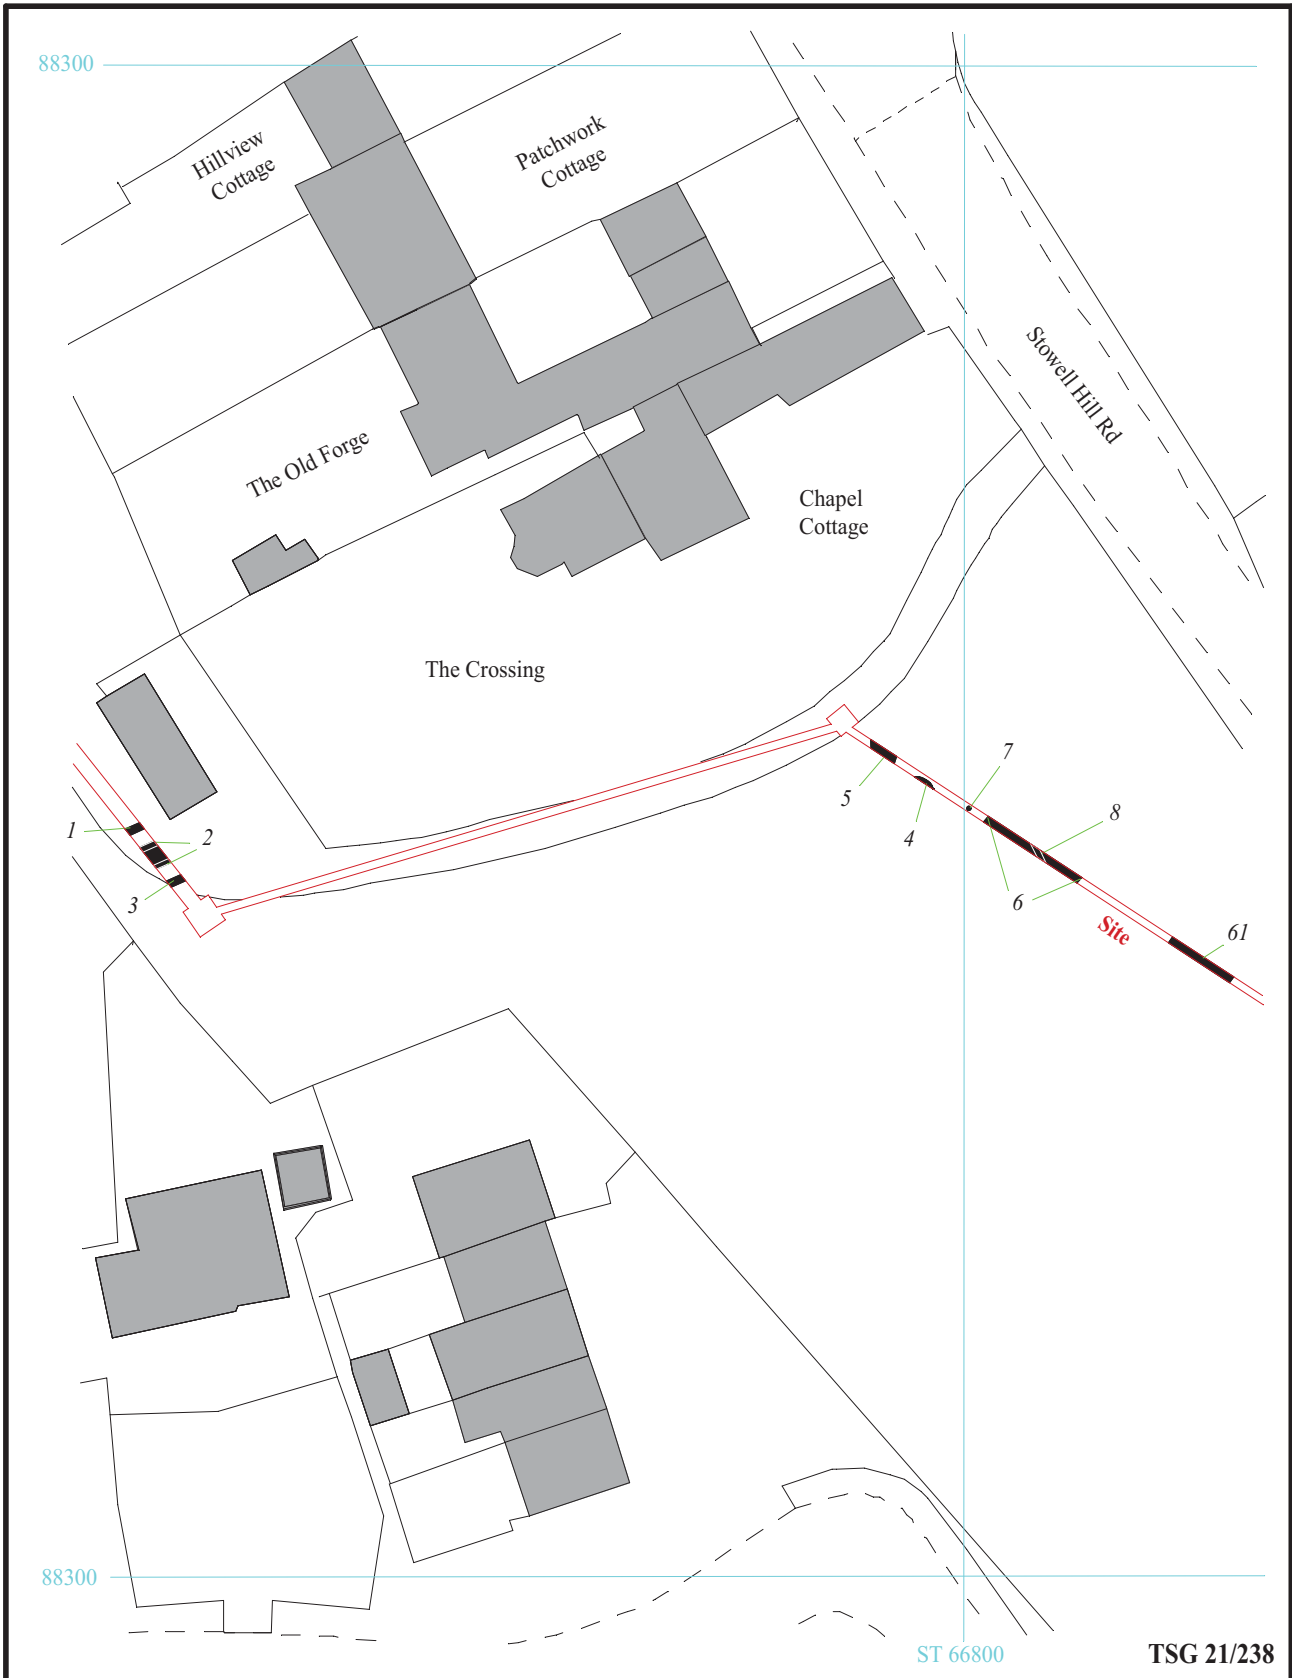
Figure 3. Plan of features.

The features identified in this section of the excavations comprised four parallel walls on a north-east to south-west orientation, located just north of where the track makes a turn to the east (Figs 3 and 4; Pl. 1). The two outer walls (57, 59) remained only as the stone footings some 0.53m wide, 0.4m high and 0.4m below ground surface in cuts 1 and 3 respectively. Their construction is of irregularly sized limestone bonded with a dark grey mortar with frequent white inclusions. Evidence for an upper wall comes from a single course of bricks (66) laid side to side atop footing (53). The remains of this upper wall were 0.1m high and 0.23m wide. Sitting lower in the stratigraphy with their tops at 0.7m below ground level, and at 1m from the outer walls were the two inner walls (54, 56). These were connected from the top of the wall to the outer walls by a gentle slope cut (2) into the natural. The walls themselves consisted of eight courses of bricks with cement bonding to a height of 0.7m, with the width of wall 56 at 0.35m and of wall 54 slightly wider at 0.4m due to a skim of mortar on its northern face. Both walls sat on top of and were connected by a concrete surface (55) some 1.86m wide and 0.3m deep. This surface and the two inner walls formed a rectangular trench some 1.1m wide and 0.7m deep which was subsequently been filled by a dark brown, grey silty clay fill (52) from which several later post-medieval or early modern finds were recovered, recorded but not retained. These included pottery, glass and animal bone fragments, a metal spoon, the head of a metal shovel and track chair with remnant of wood attached to its underside.

Moving south-east along the trench the next feature at 5.5m was a pit (4) 1.2m in diameter and 0.5m deep sitting partially outside of the excavation area (Figs 3 and 4; Pl. 3). Its fill (58) was a slightly reddish-brown silt clay containing several medium-sized chunks of limestone. The only finds recovered consisted of small fragments of unidentifiable animal bone.

The next feature at 9.5m was a post hole (7) 0.35m in diameter and 0.26m deep with a fill (63) of dark grey brown silty clay (Figs 3 and 4; Pl. 4). From this fill three fragments of late post-medieval or early modern pottery and a fragment of clay pipe stem were recovered and recorded but not retained.

Extending from 10.8m to 18.2m the next feature consisted of a shallow depression (6) cut through the subsoil. It was at least 7.4m wide and *c.* 0.6m deep, with a fill (62) of dark brownish grey clay (Figs 3 and 4). From this fill large quantities of late post-medieval to early modern ceramic and glass fragments were recovered. These included several fragments of ceramic building material, amongst which was a fragment of malting tile. Several animal bone fragments were also recovered including the articulated remains of a small canine (Pl. 5) located at the northern edge of the cut. At 15.5m the remains of a wall (64) comprising of a single course of stone with degraded mortar bonding was cut (8) into the top of fill 62 (Figs 3 and 4; Pl. 6). The wall had a width of 0.6m and height of 0.2m.

The last feature to be identified consisted of a concrete surface (61) starting at 30.1m and extended for a further 5m (Fig. 3; Pl. 7). This large slab of concrete sat just 0.1m below current ground surface and was only 0.12m thick. No cut was visible in section and no dating evidence or other finds were identified as being associated with the concrete surface but it is clearly modern.

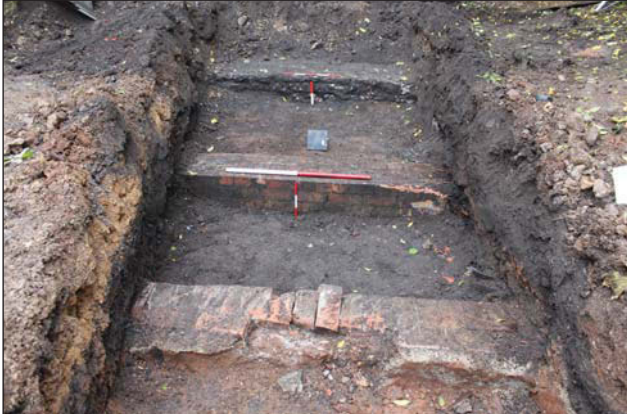
Plate 1. Walls 54, 56, 57 and deposit 52, looking south east, Scales: 1m, 0.5m, 0.3m and 0.2m.

Of the post-medieval and modern features, the four parallel walls (53, 54, 56 and 57) area highly likely to be the remains of an engine shed that is first shown but not labelled on the 1903 OS six-inch map and still appearing and labelled on the 1955 OS national grid map. It sits on an offshoot of the railway from the main line located *c.* 100m to the south-west heading north-east across Stonewell Hill Road to a quarry located just north east of St James' Church. Walls 54 and 56 would have held the track sleepers connected to the walls by track chairs, such as the one recovered from backfill 52. The trench formed by the interior walls and surface 55 would have been the inspection pit and walls 53 and 57 likely formed the footings for the exterior shed walls. The purpose of pit 4 and post hole 7 are unclear as is wall 64 and the concrete surface (61). Shallow cut 6 appears to have been used a rubbish dump including the disposing of a dog's carcass.

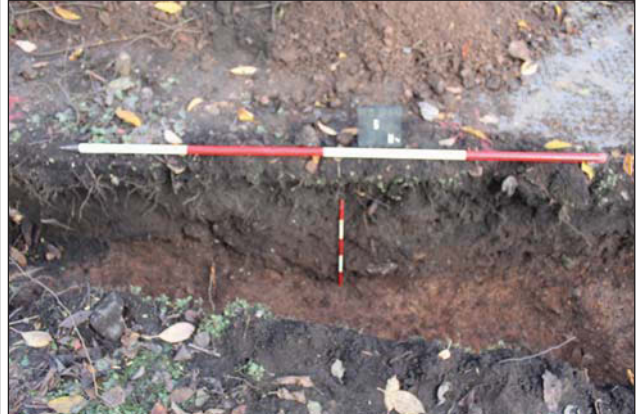
0.18m deep and 1.8m wide (Fig 3 and 4; Pl. 2). Its fill (60) was a mid-brown silt clay and contained two fragments of animal bone and a single fragment of flint.

Plate Ditch 5. looking south west, Scales: 2m and 0.5m.

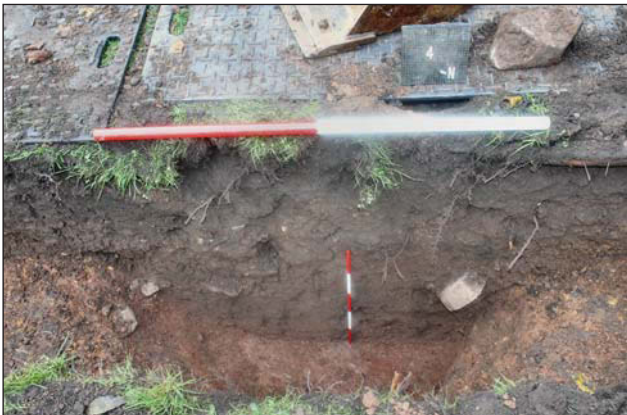
Plate 3. Pit 4, looking south west, Scales: 1m and 0.5m.

A single struck flint ( a flake) was recovered from pit 4 (58). It is not closely datable but is likely to be of neolithic or Bronze Age date.

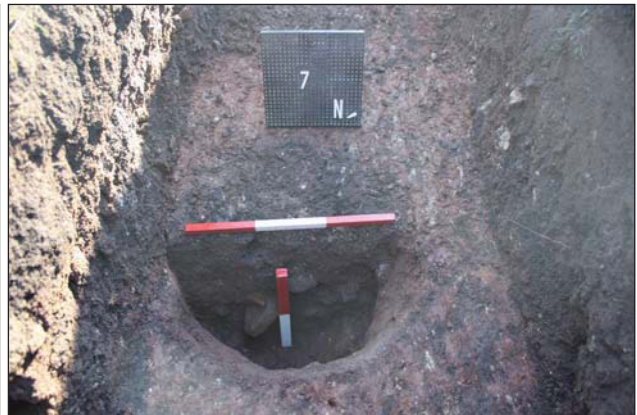
Plate 4. Post hole 7, looking south east, Scales: 0.3m and 0.2m.

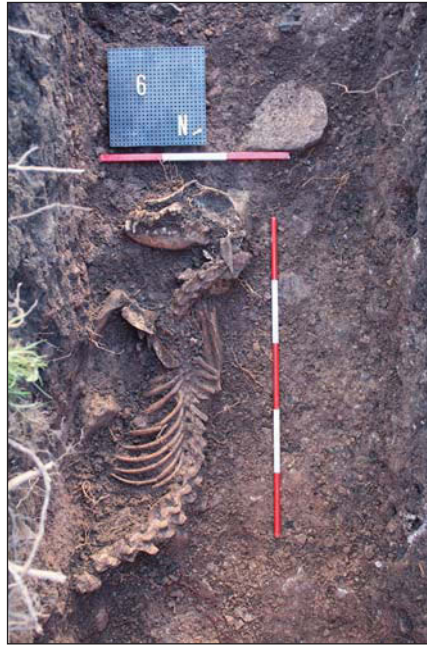
Plate 5. Canine remains in cut 6, looking south east,  
Scales: 0.5m and 0.3m.

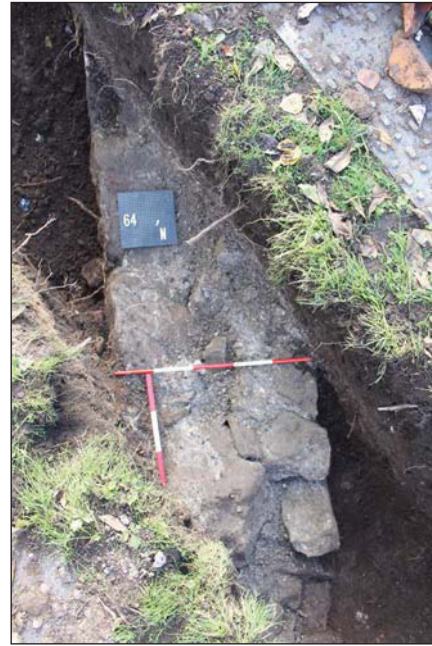
Plate 6. Wall 64, looking south,  
Scales: 0.5m and 0.3m.

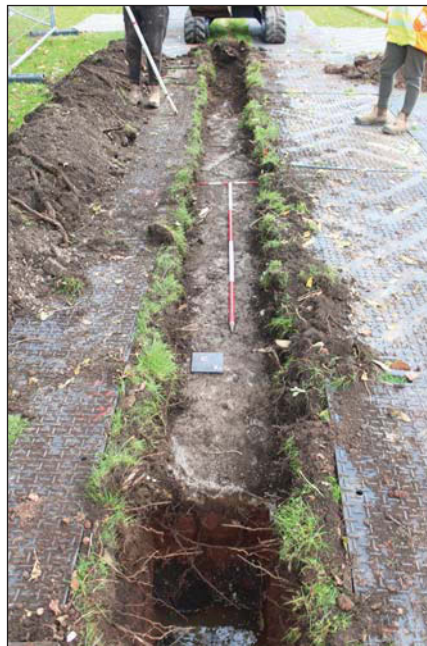
Plate 7. Concrete surface 61, looking south east,  
Scales: 2m and 0.5m.
