**Land at 18 Winterbrook,  
Wallingford, Oxfordshire**

**Archaeological Evaluation**

**Site Code: WWO22/56**

**September 2022**

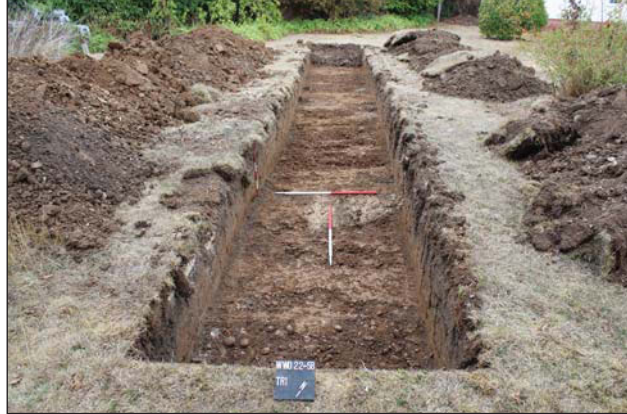
Trench 1 was aligned SE - NW and was 14.50m long and 0.55 to 0.75m deep. The ground level was at 46.3m aOD. The stratigraphy consisted of 0.25m of a made ground layer (dark brown clayey silt with occasional gravels), above 0.25m of a second made ground (dark grey silt with occasional unsorted stones). Both had inclusions such as concrete, plastic, brick fragments, etc. These made ground layers overlie the top geological horizon, orange brown clay, only 0.05m thick at the NW end but 0.25m thick at the SE, with the gravels directly under it. A modern test pit was seen towards the SE end, filled with light yellow sand and gravel. No finds were recovered.

Plate 1. Trench 1, looking North West,  
Scales: horizontal 2m and 1m, vertical 0.5m.

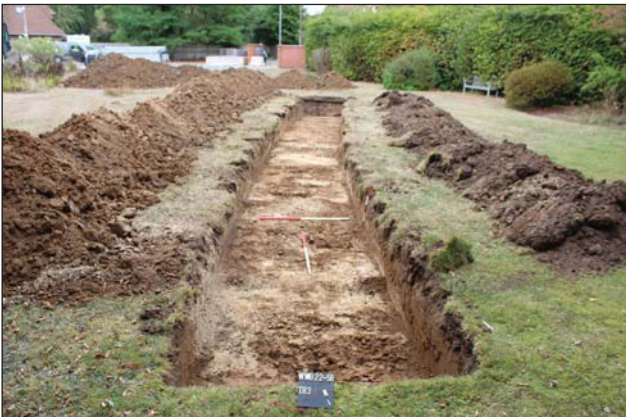
Trench 3 was aligned SW - NE and was 17.20m long and about 0.50m deep. The ground level was 45.9m aOD. The stratigraphy consisted of 0.35m of topsoil grading into made ground towards the NE with flecks of ceramic building material. It directly overlies the natural sterile orange brown clay with lighter patches, 0.42m deep onto the top of the gravels. A modern test slot was seen towards the SW end. No finds were recovered.

Plate 2. Trench 3, looking North East,  
Scales: horizontal 2m and 1m, vertical 0.5m.

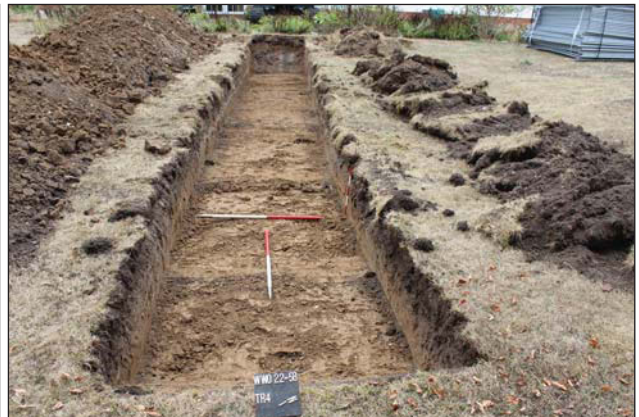
Trench 4 was aligned ESE - WNW and was 14.20m long and 0.55m to 1m deep. The stratigraphy consisted of a number of made ground layers overlying natural geology, increasing in depth from east to west (towards the existing care home). At 10m from ESE end, it showed 0.35m of a brown grey made ground, over 0.20m of a dark grey made ground, overlying 0.15m of a brown made ground with common stone inclusions, brick fragments and charcoal flecks. The layer below, about 0.10m deep, was probably more of a disturbed interface with the natural rather than a made ground. The brown clay geology appeared here at 0.80m below ground level. No finds were recovered.

Plate 3. Trench 4, looking West South West,  
Scales: horizontal 2m and 1m, vertical 0.5m.
