**Stable Block, 145 Main Street, Sutton Bonington,  
Loughborough, Nottinghamshire**

**Building Recording**

**Site Code: 145MSB22/168**

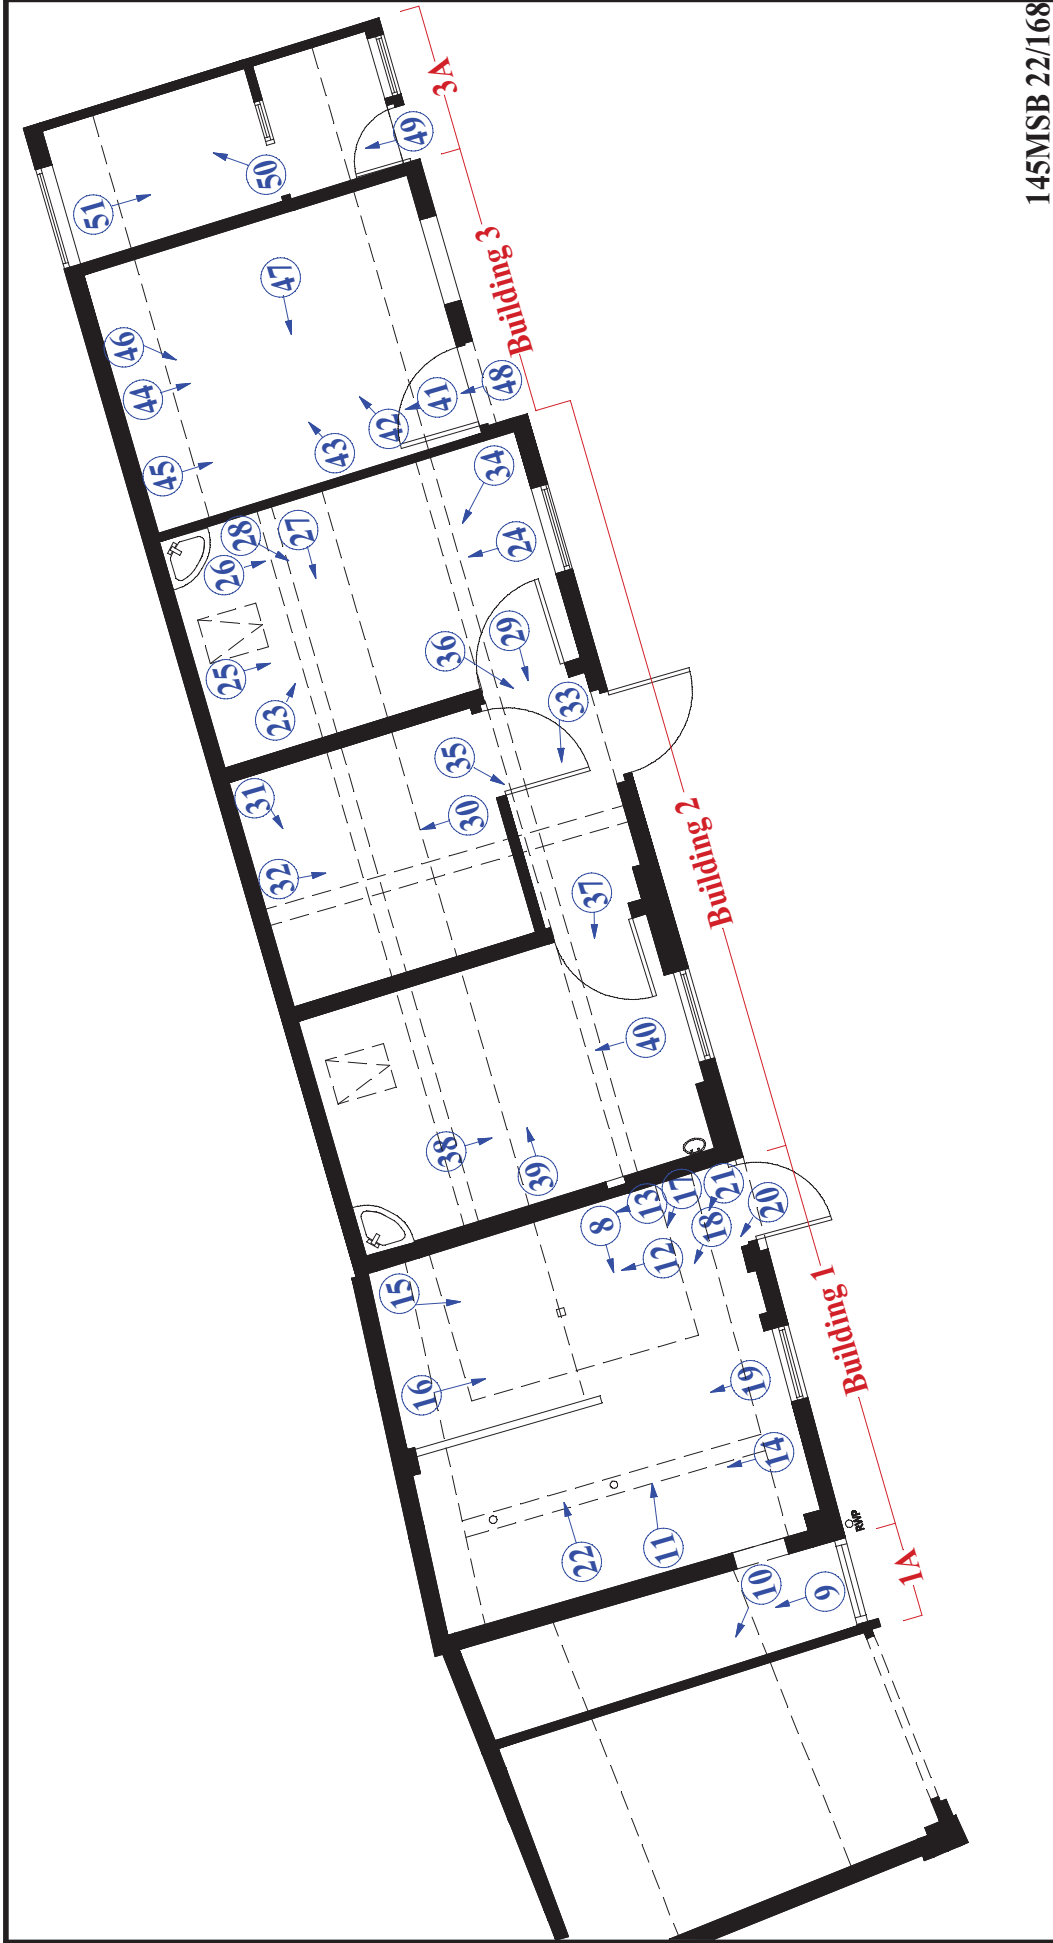
Figure 5. Plan of the buildings

The stable block is located along the northern boundary of the property and consists of the eastern part of a linear arrangement of attached buildings of varying dates with a dovecote forming the western end (Pls 1 and 2). The buildings front onto an access track, opposite which are further outbuildings including a cowhouse and cartshed. The farmstead arrangement in its current form appears to be a variation of a U-shape with a central track leading to the fields and other buildings beyond (Pl. 1). The yard is surfaced in Tarmac at the eastern end and cobbles at the western end.

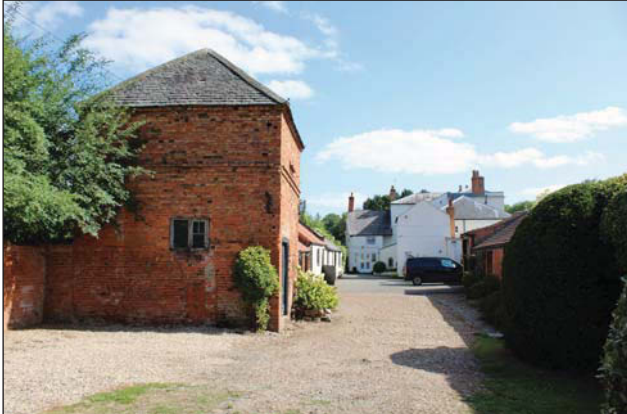
The Stable Block forms part of a complex of buildings (Pl. 1) including the main house (The White House) and associated farm buildings along with a dovecote. Both the house and dovecote are grade II listed with the following descriptions:

Plate 1. House and outbuildings, looking East.

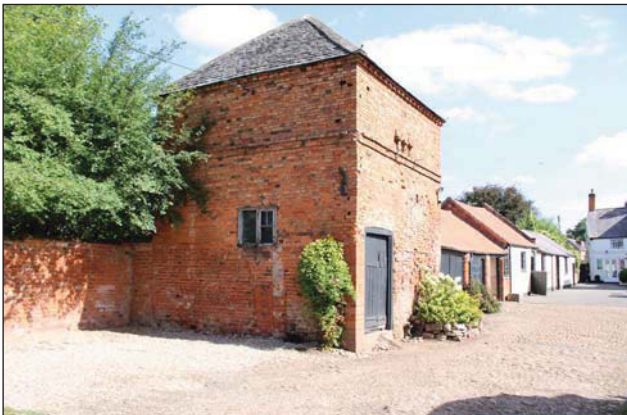
The northern block of buildings consists of the dovecote at the western end, a three-bay building with large doors at the western end and open at the eastern end (Pl. 3), a building with door and window (building 1), the rectangular three-bay current stable (building 2) and a further building at the eastern end containing two doors and windows (building 3) (Pl. 2). All the buildings back onto the property boundary and no access was available to the northern elevation. The two buildings at the western end of the linear arrangement do not form part of this recording.

Plate 3. Dovecote, looking North East.

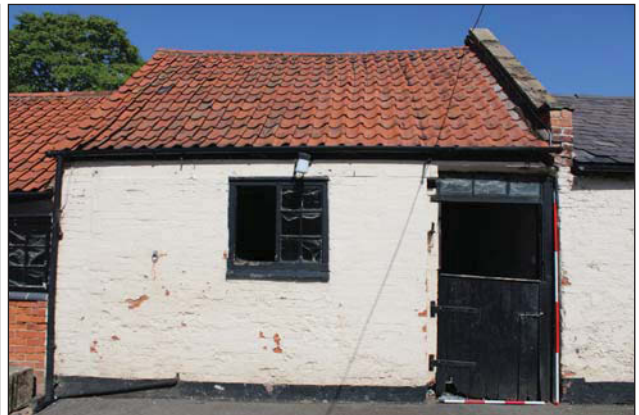
Building 1 (Pl. 4) is sub-rectangular in plan form with a straight frontage and an angled rear wall creating the irregular plan. The building is brick built, predominantly laid in stretcher bond and painted white. The roof is gable end type and covered in pantiles.

The eastern wall is visible above the building to the east and internally. The gable end is capped in a probable stone coping (Pl. 4). Internally the wall is built, predominantly, in Flemish bond, though the upper part of the wall has been rendered. At the level of the wall plate are holes for beam slots within the wall, above which is a blocked pitching eye (Pl. 8).

Plate 4. Building 1, front elevation, looking North,  
Scales: 1x1m and 1x2m.

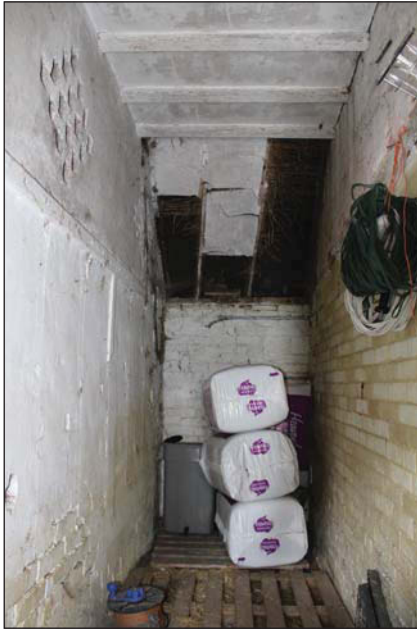
The western elevation is visible above the building to the west and internally (Pls 5 and 6). It appears to consist of bricks laid in stretcher bond, though has been white-washed and plastered over. The wall is not tied into the northern, rear wall. The opening into building 1A is complex consisting of two distinct doorframes; one in each room.

The western wall could be seen internally within the building to the west as well as within building 1A (Pl. 14). It consists of a painted brick wall, predominantly laid in stretcher bond containing three missing brick, diamond-shaped ventilation gaps, which have been blocked up. The rear and eastern walls consist of painted brick in stretcher bond (Pl. 5).

Plate 5. General photo to north wall, looking North.

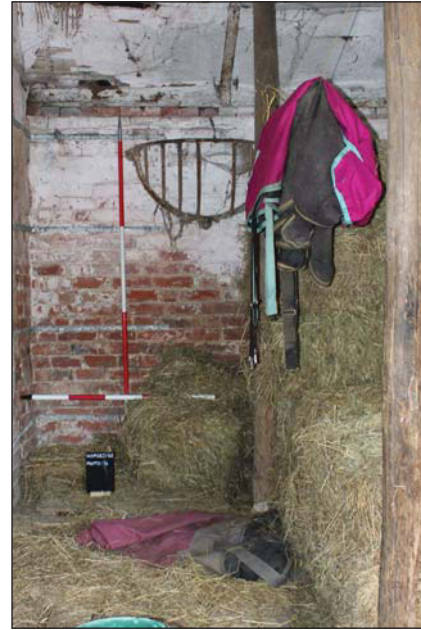
The northern wall is only visible internally and consists of predominantly stretcher bond brickwork, painted white (Pls 6 and 7), though the base of the eastern end contains roughly coursed stonework. A ledge is present internally in the eastern half of the building suggesting the wall has been increased in height. Approximately centrally along the wall is a pillar.

Plate 6. North wall, west end, looking North.  
Scales: 1x1m and 1x2m.

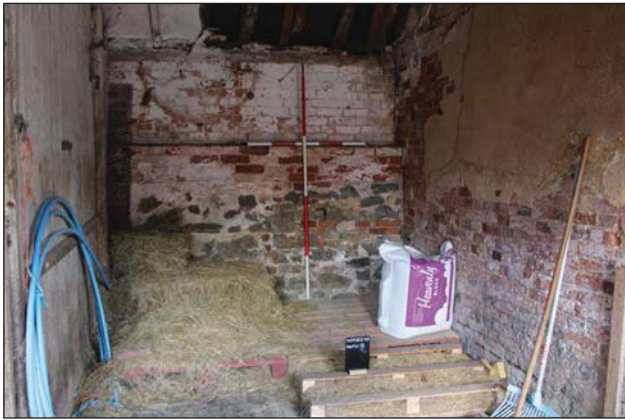
Plate 7. North wall, east end, looking North.  
Scales: 1x1m and 1x2m.

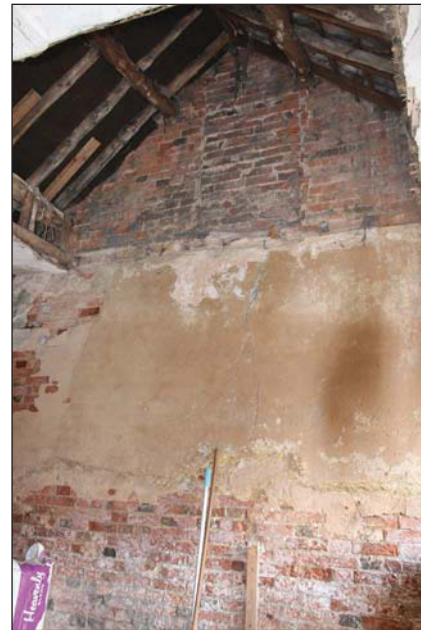
Roof construction is complex with evidence for replacement rafters and a second set of purlins (Pls 8, 11 and 12). In general the roof is of common rafter construction split tree trunk rafters along with modern (pine?) rafters lying across a pair of purlins. The upper purlins consist of whole tree trunks whilst the lower and possibly older purlins are squarer in cross-section. The rafters meet at a ridge plank. The northernmost truss may show reuse; the beam is chamfered and contains an empty mortice (Pl. 12).

Plate 8. East gable end wall showing blocked pitching eye. Looking North East.

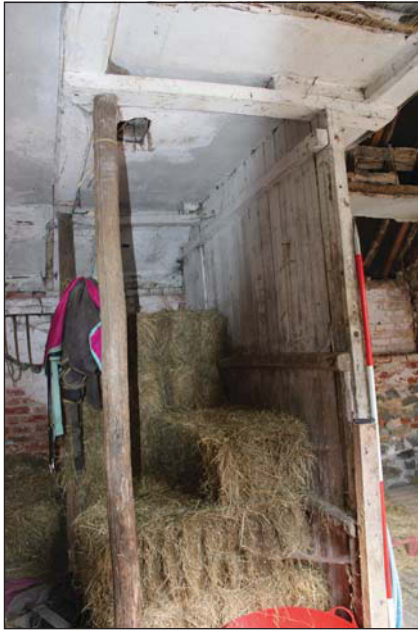
Internally the building is subdivided with a wooden partition (Pl. 9), which along with additional posts supports a first-floor hay loft. The partition is of simple plank and rail construction with additional attachments to the beams on either side, the detail of which is obscured by the ceiling. The western end of the hayloft floor is supported on a beam attached to the western wall. In the southern wall are three brick pillars, suggestive of a former large opening and a smaller one. The floor treatment (Pl. 10) varies, with a brick floor in the eastern half and a stone block floor along the frontage and extending into the western half, where visible. It appears to have been repaired with cobbles at one point. Along the frontage is an east-west aligned drainage channel.

Plate 9. Stud wall and post, looking North East.  
Scale: 1x2m.

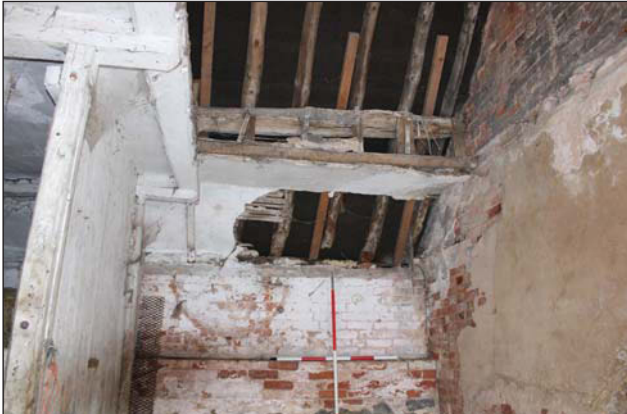
Plate 11. Roof construction, looking North.  
Scales: 1x1m and 1x2m.

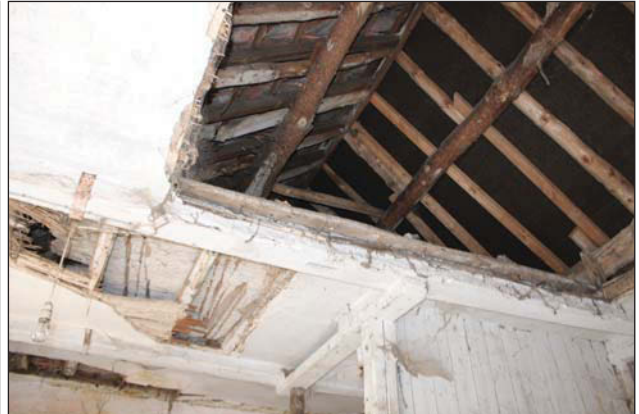
Plate 12. Roof construction, looking West.

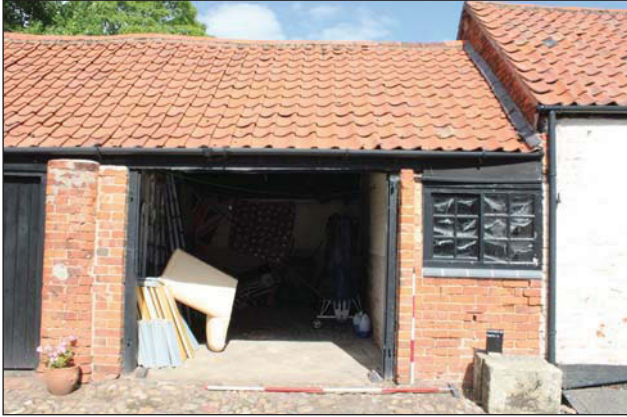
Building 1A consists of a single room to the west of Building 1 (Pl. 13). It appears to be a part of the adjacent building to the west (not part of this survey), with which it shares a roof. Externally it consists of a short section of wall on the southern elevation containing a single window. The bricks within the wall are laid in stretcher bond and measure 230 x 113 x 66mm. The window consists of two casements each containing six panes. The roof extends across from the rest of the building to the west and consists of a gable end type, covered in pantiles.

Plate 13. Building 1A, front elevation, looking North.  
Scales: 1x1m and 1x2m.

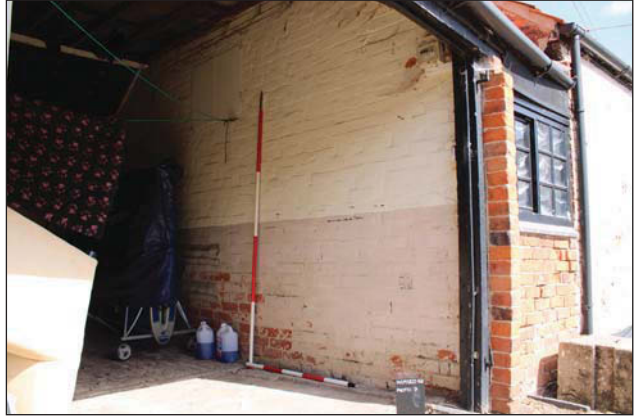
Plate 14. Building 1A, west wall, looking North East.  
Scales: 1x1m and 1x2m.

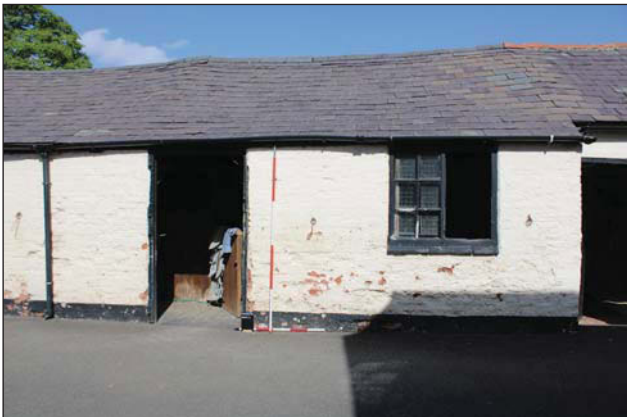
Building 2 is approximately rectangular in plan form with a gable end roof, linked to building 3 at the east end (Pls 15 and 16). The southern side of the roof is covered in slate tiles whilst the northern side is covered in pantiles. The building is brick built, predominantly laid in stretcher bond, though there are some rows of headers within an area of infill, possibly approximating English garden wall bond. As with building 1 the brick sizes vary from 222-236mm x 103-115mm x 60-70mm thick. The brickwork has been painted white with a black base.

Plate 15. Building 2, front elevation, east end, looking North.  
Scales: 1x1m and 1x2m.

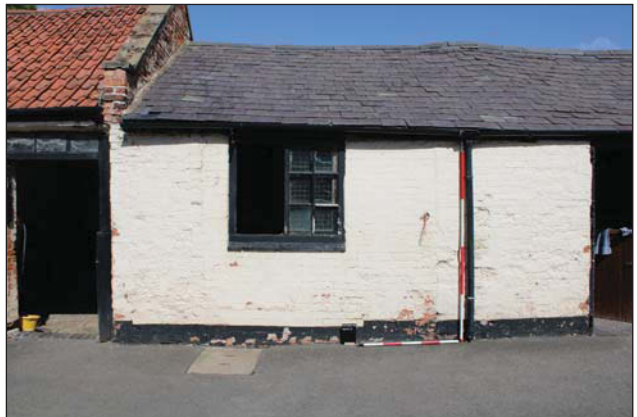
Plate 16. Building 2, front elevation, west end, looking North.  
Scales: 1x1m and 1x2m.

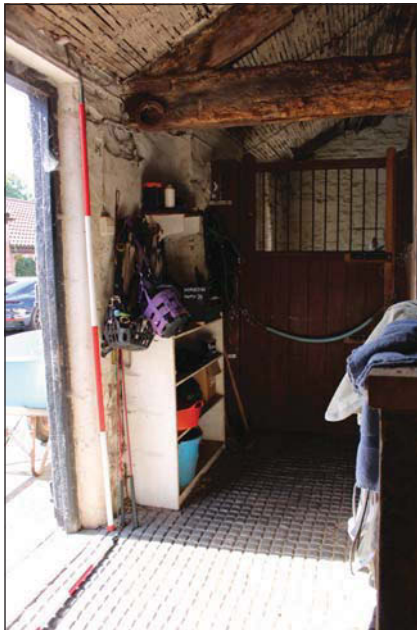
Only the southern elevation is visible externally and consists of a central doorway with a window on either side. The windows consist of a wooden frame containing two casements, each with 6 panes of glass. Within each of the windows a casement is missing. The sill is present of shaped ceramic tiles/bricks. The door is a modern stable-style door. Evidence remains for an earlier stable door hung by pintles. Scars remain in the brickwork at the western end of the building indicating the presence of a larger opening where the window now is, most likely a door. A second scar is present between the door and western window, possibly suggestive of a larger central opening, which would approximately agree with the thinner section of wall seen internally (Pl. 17) which is similarly present on the western window opening (Pl. 18).

Plate 17. South wall, looking West.  
Scales: 1x1m and 1x2m.

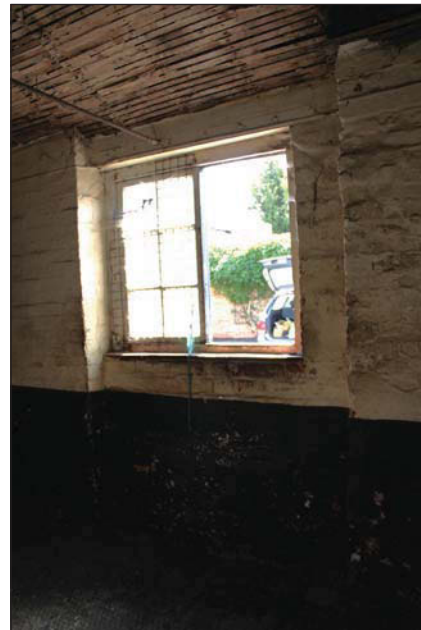
Plate 18. South wall, west end, window, looking West.

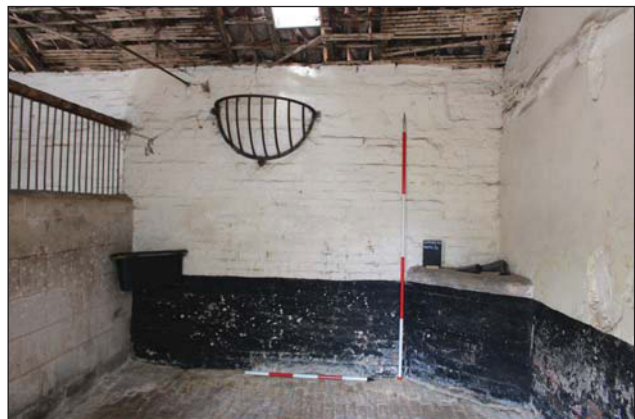
wall is similarly obscured with paint. In general, the wall is built in stretcher bond. Along the base are larger, protruding stones, possibly forming part of a foundation or earlier garden wall (Pl. 20). The east, gable end wall consists of a combination of brick and basic timber framing (Pl. 21). The earliest timber framing consists of a pair of uprights supporting a beam. A further, modern, wooden support has been added at the southern end. The wall has then been infilled with brick laid in stretcher bond, where visible, and subsequently plastered over beneath the beam. Above the beam the bricks are painted white and laid in stretcher bond.

Plate 20. North wall, east end, looking North.  
Scales: 1x1m and 1x2m.

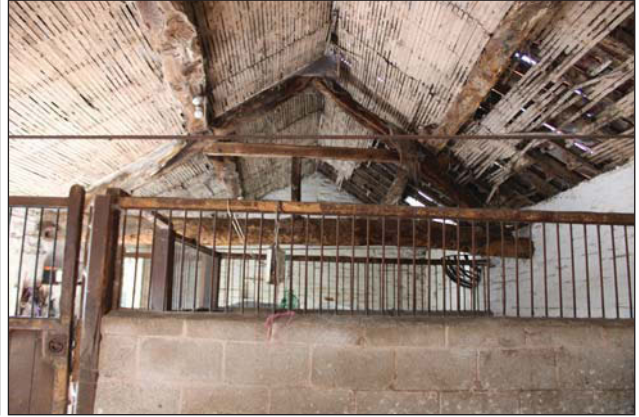
Internally the building is divided into three stables with modern concrete block walls topped with railings (Pl. 22). The eastern end has a small brick trough in the north-east corner (Pl. 20) and a brick floor with a drainage channel running east-west at the southern end (Pl. 23). The central stable is smaller to allow for an access passageway along the southern wall. The passageway is constructed of Staffordshire blue 8-block stable floor bricks (Pl. 17), whilst the stable floor is the same red brick as that present to the east. The western stable is in use and the floor is covered in rubber matting. A matching trough is present in the north-west corner.

Roof construction consists of an approximately central truss with a curved beam, set on the wall at the southern end and embedded into the northern wall (Pl. 22). The same arrangement as seen in the eastern gable wall. The beam and principal rafters show evidence of re-use with a number of empty mortices and peg-holes (Pl. 24). A raised collar sits between the two principal rafters, propped by a small timber post. The collar has a carpenter's mark at the northern end 'VIII' chiselled on the underside, also likely to be reused (Pl. 25). The purlins consist of a pair of trees that have been roughly squared and split in two, with each purlin overlapping on the central truss. The common rafters are mainly obscured by laths, suggesting an earlier plastered ceiling, but where visible are laid on edge over the purlins (Pl. 26).

Plate 22. Roof construction, looking West.

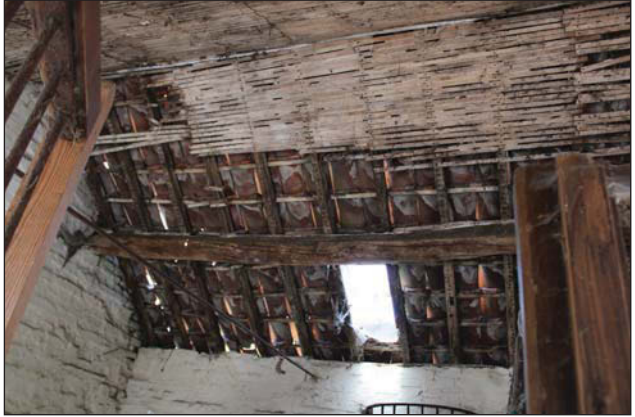
Plate 26. Roof detail, looking North.

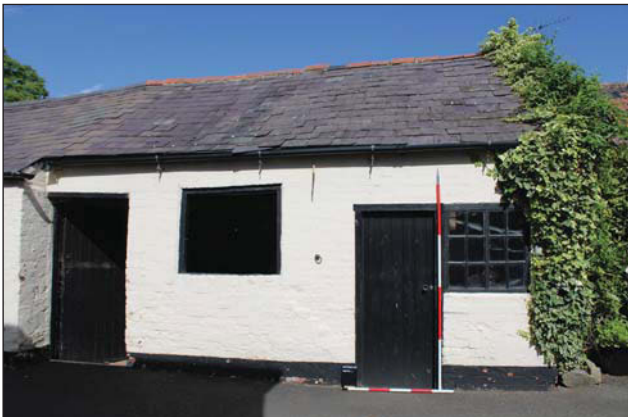
Building 3 is rectangular in plan form and shares a roof with building 2 (Pl. 27). It has a gable end and the south side of the roof is covered in slate while the north side is covered in pantiles. The ridge line is covered in red clay tiles marking it out from building 2. The building is brick built with the bricks laid in stretcher bond measuring 237mm x 110mm x 72mm and painted white with a black base at the bottom of the wall.

Plate 27. Building 3, front elevation, looking North.  
Scales: 1x1m and 1x2m.

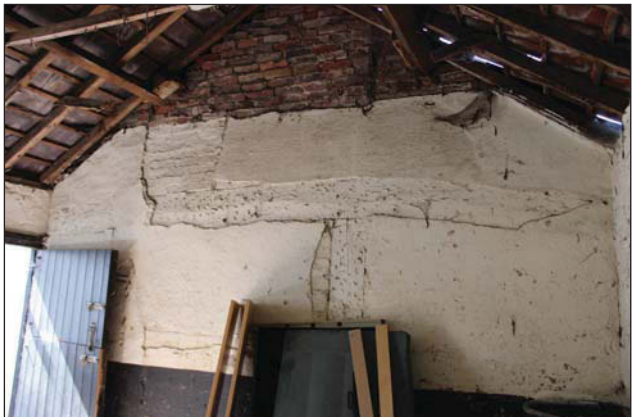
The other walls can be viewed internally. The western wall is the reverse of that seen in building 2 and shows the timbers supporting the beam, infilled with brick (Pl. 28). This has been mainly plastered over but within the apex stretcher bond bricks are visible. Both the northern and eastern walls are plastered, obscuring the brickwork (Pl. 29).

Plate 28. West wall showing timbers, looking West.

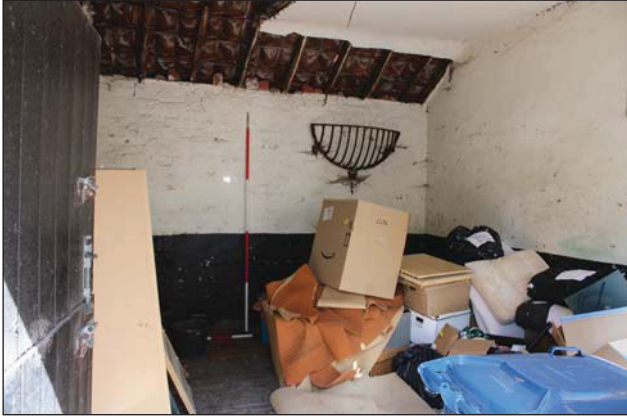
Plate 29. North wall, looking North.  
Scales: 1x1m and 1x2m.

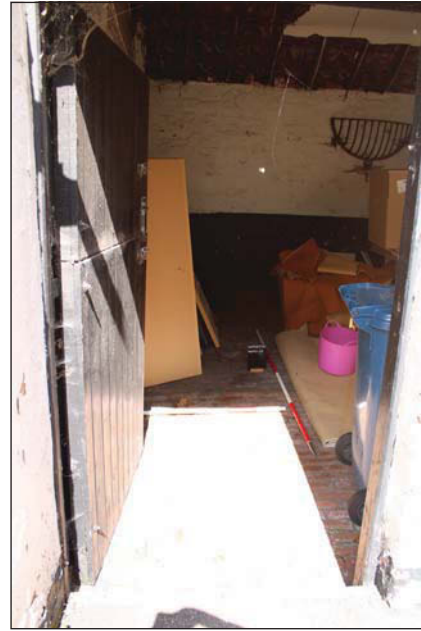
The building has been sub-divided into two, labelled 3 and 3A. The western room (3) is the larger of the two and requires a step down from ground level into the room. The floor, where visible, is brick, but this changes from red brick along the southern wall to grey brick along the northern wall (Pl. 30).

Plate 30. Brick floor, looking North.  
Scales: 1x1m and 1x2m.

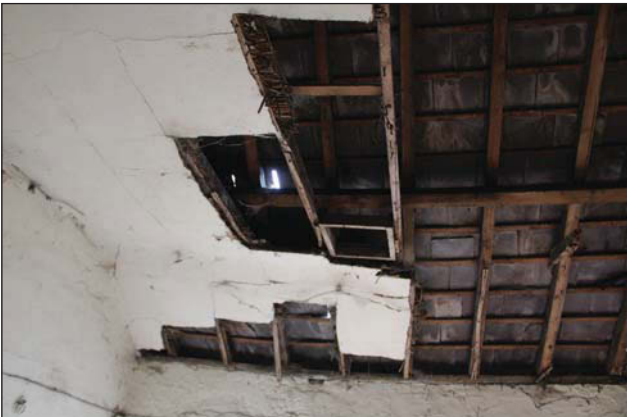
Roof construction consists of common rafters laid across purlins which are built into the gable end walls (Pl. 31).

Plate 31. Roof detail, looking South.
