**6 Market Lane, Lewes,
East Sussex**

Archaeological Watching Brief

Site Code: MLL22/122

December 2022

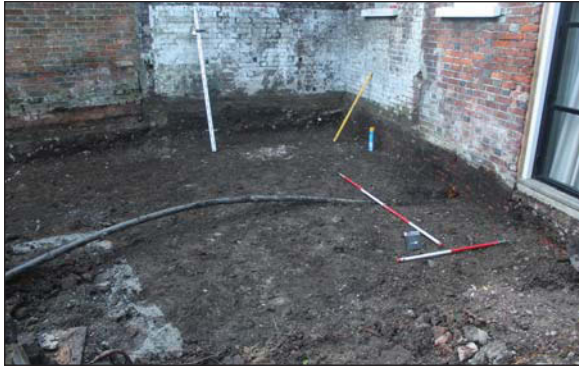
Plate 1. General view of site during initial ground reduction, looking North-west.
Scales: 2m and 1m.

The small outbuilding in the north-west corner of the rear garden had been demolished before the watching brief commenced. The entire footprint of the new extension was then reduced by approximately 0.45m, under constant archaeological supervision (Fig. 3; Pls 1–2 and 4). The ground reduction in the area which had not been affected by the former outbuilding was slightly deeper (*c.* 0.58m). In general, the material removed from within the

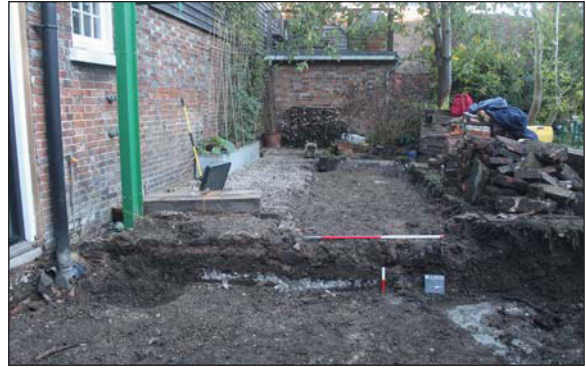
Plate 2. General view of site during initial ground reduction, looking East.
Scales: 1m and 0.20m.

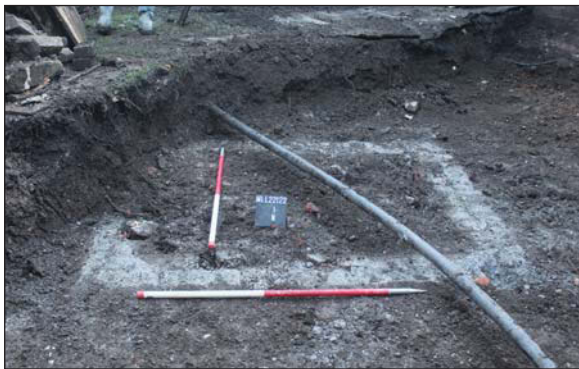
Plate 3. Structure 52, looking South.
Scales: 1m x 2.

The remains of a small rectangular structure (52), measuring 2.05m by 1.75m, was almost fully revealed in the southern part of the stripped area (Fig. 3; Pl. 3). The initial ground reduction stopped at the top of the surviving brickwork, and the feature was cleaned up and photographed. The walls of the building were constructed from brick, although there were a small number of rounded flint pebbles noted. It was two bricks wide (0.24m), and subsequent excavation of the footing trench revealed that it had survived up to 3 courses high. No construction cut for the building was visible, and the feature appears to have been largely demolished before being buried beneath garden soil (50). A sample brick was retained and it appears that the structure was built with re-used bricks, probably in the 19th century. However, no structure is shown in this location on the 1873, 1899, 1910 and 1938 Ordnance Survey maps.

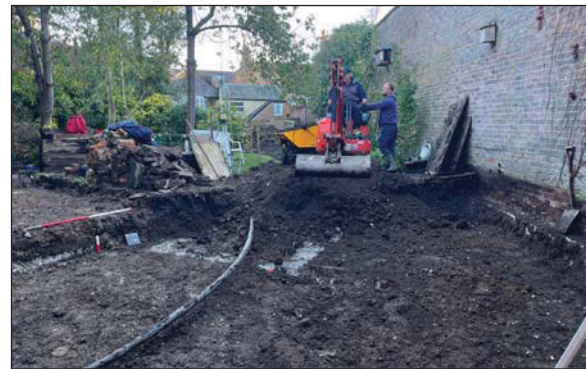
Plate 4. General view of site during initial ground reduction, looking South-east.
Scales: 1m and 0.20m.

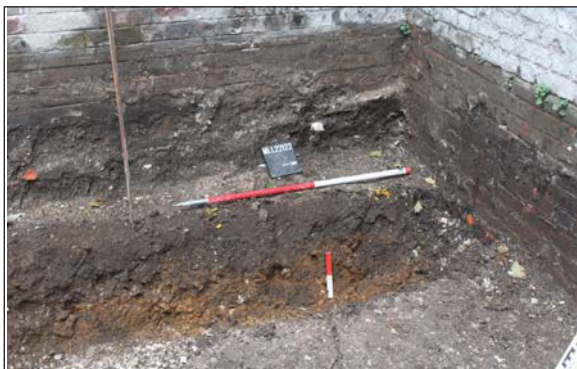
Plate 5. Footing trench in North-west corner of site (following initial ground reduction), looking North-West.
Scales: 1m and 0.20m.

Following the initial ground reduction, a 0.60m wide footing trench was dug around the edge of the stripped area (Pls 5 and 6). This trench varied in depth from about 0.40m close to the house to approximately 0.50m at the southern end. In the north-west corner, the footing trench cut through 0.19m of garden soil (50) and 0.23m of the underlying mid reddish brown sandy clay with flint inclusions (51). This underlying deposit was observed throughout the entire footing trench, and appears to be a surviving subsoil layer. It contained no archaeological finds. Part of the trench was dug through the south-east corner of structure 52, but no trace of an internal floor surface was seen during the removal of the walls.

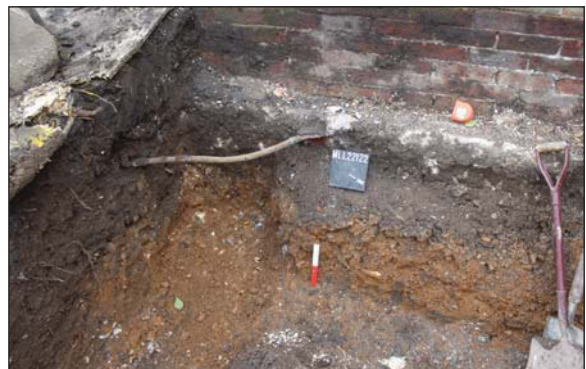
Plate 6. Footing trench in South-west corner of site (following initial ground reduction), looking South-west.
Scale: 0.20m.
