**St Catherine's Church, Burbage,
Hinckley, Leicestershire**

Archaeological Evaluation

Site Code: BBH11/05

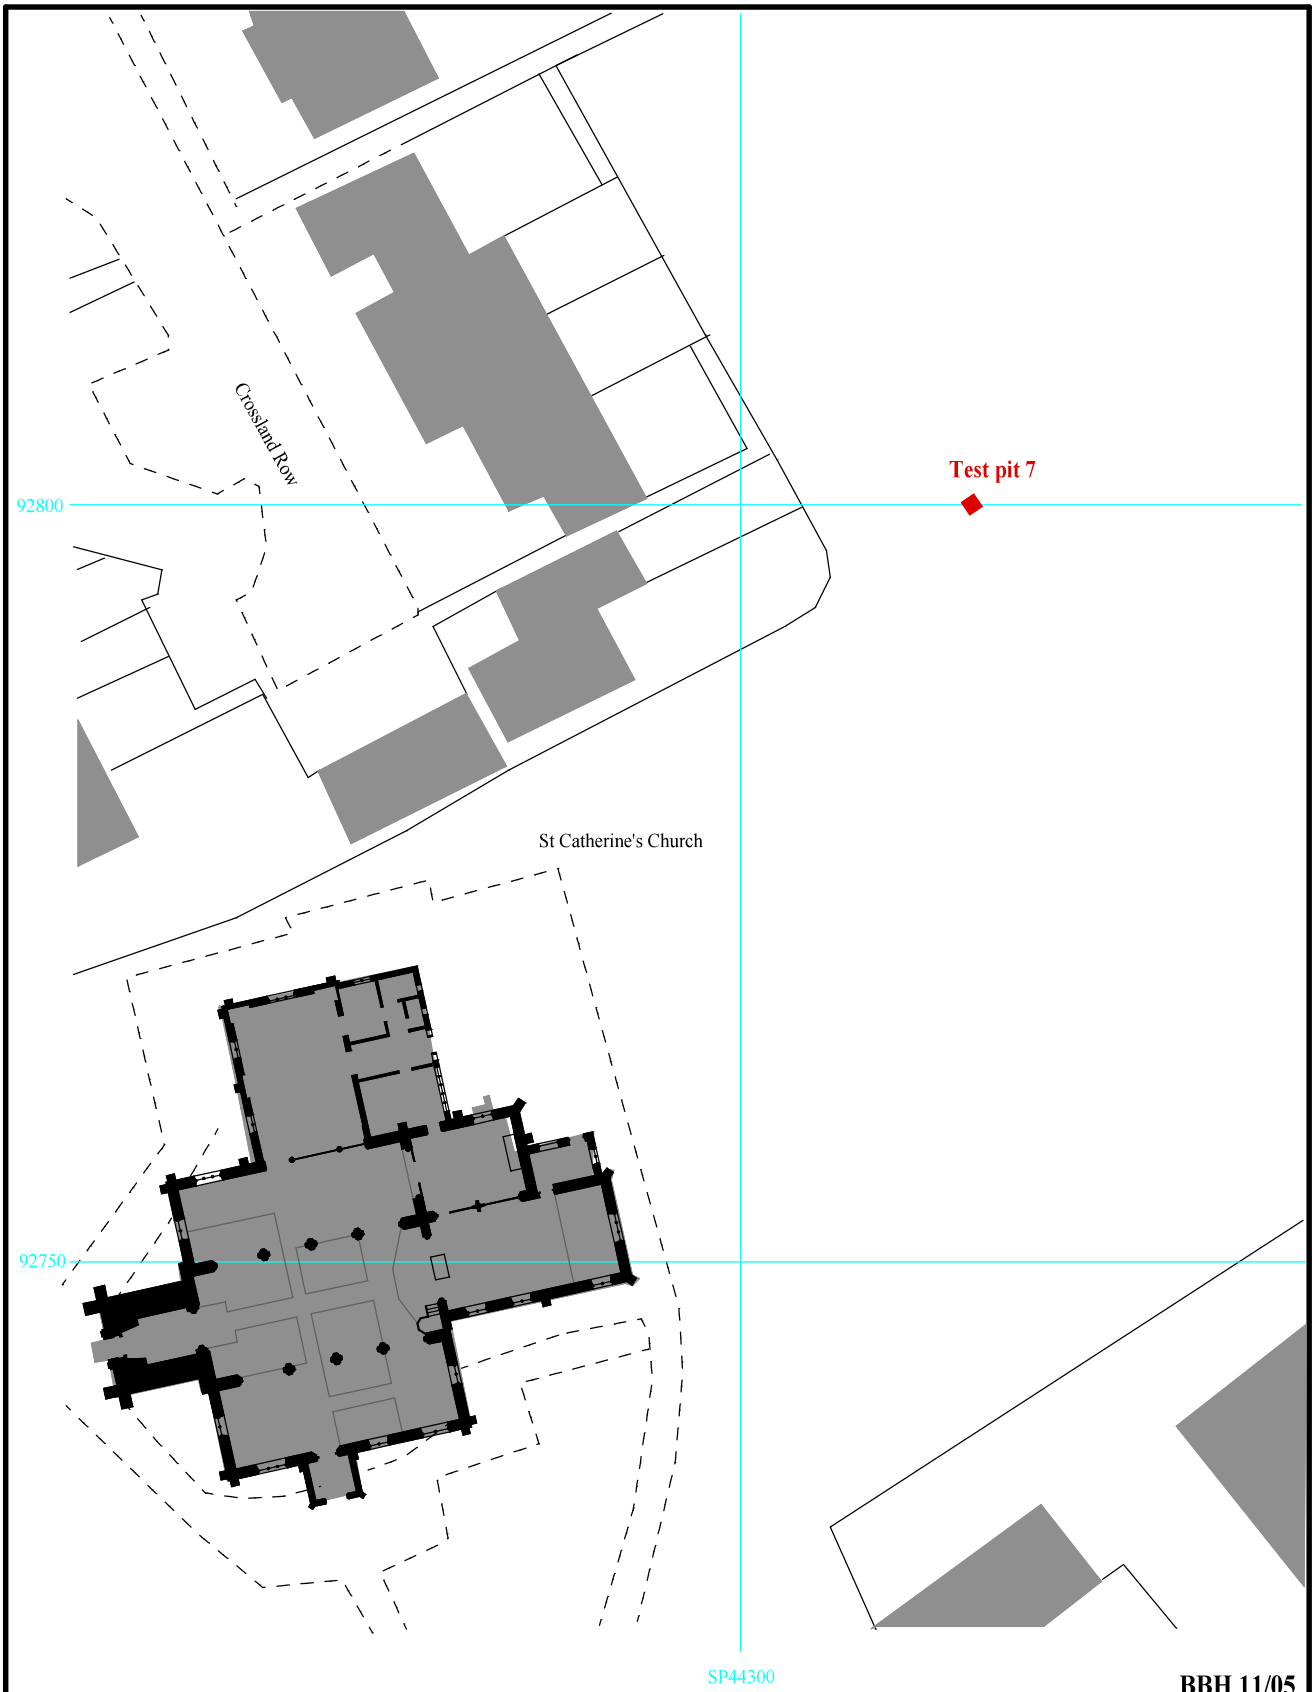
Figure 3. Location of exterior test pit.

External test pit 7 (for the borehole manifold) was 1.00x1.00m and 0.95m deep and was dug into an existing path (Fig. 3). The stratigraphy comprised 0.10m Tarmac and 0.10m grey sand and crush which overlay 0.62m dark brown sand subsoil which in turn overlay orange/brown sandy clay with gravel, interpreted as the natural geology. No archaeological features nor graves were identified.

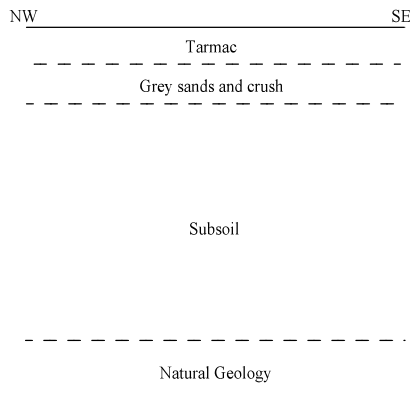
Figure 5. Plans and Representative Sections

Test Pit 2

Test Pit 4

Test Pit 5

Test Pit 7

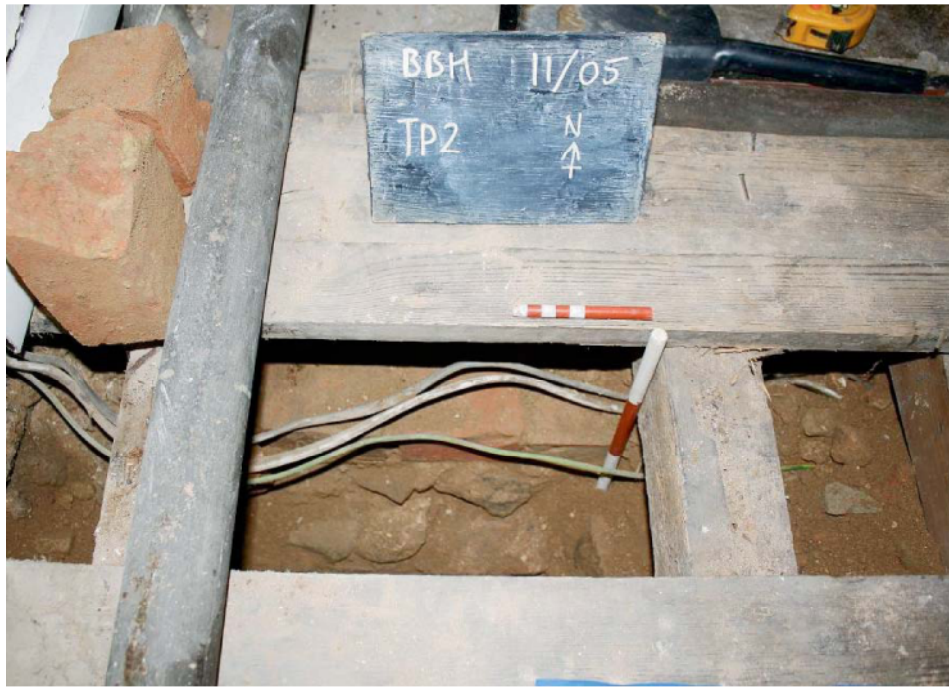
Test pit 2 was dug to a depth of 0.66m and measured 0.80m by 0.42m. The stratigraphy comprised 0.03m wooden floor boards, 0.25m void, 0.38m loose pale grey/brown sand and rubble (50) overlaying a stone built wall (53). Natural geology was not observed. Only the top course of stones was visible in the test pit due to the small area available to dig. Despite this the wall appears to be aligned WSW-ENE and the blocks measured between 144–176mm by 128mm. No bonding material appeared to be present between the rough faced blocks. The alignment of the wall could suggest that it formed part of the north aisle at one time before being demolished to allow the building of a wider aisle. No close date can be offered for either the building or the

demolition of this wall, but the construction would not be out of place in a medieval setting and the demolition seems most likely to have been part of the Victorian rebuilding.

Plate 1. Test Pit 2, looking north, Scales: 0.1m and 0.3m.

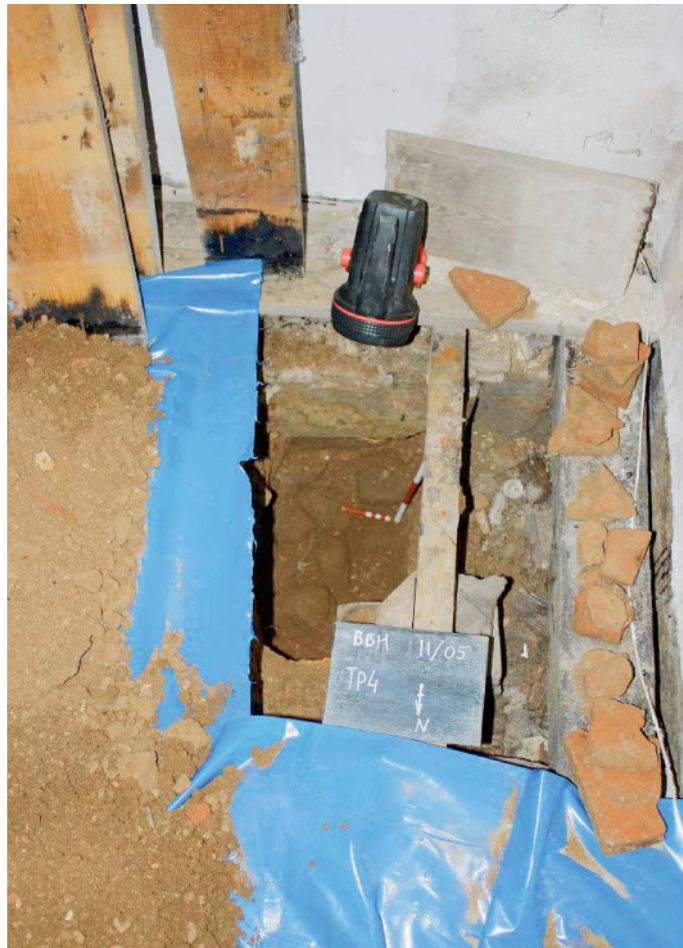
Test pit 4 was dug to a depth of 0.57m and measured 0.32m by 0.40m. The stratigraphy comprised 0.03m wooden floor boards, 0.20m void, 0.22m loose pale grey/brown sand and rubble (50) overlying 0.12m brown sandy clay with stone (54). Natural geology was not observed. The full extent of the test pit could not be dug as intended due to immovable joists under the floor panels.

Plate 2. Test Pit 4, looking south, Scales: 0.1m and 0.3m.

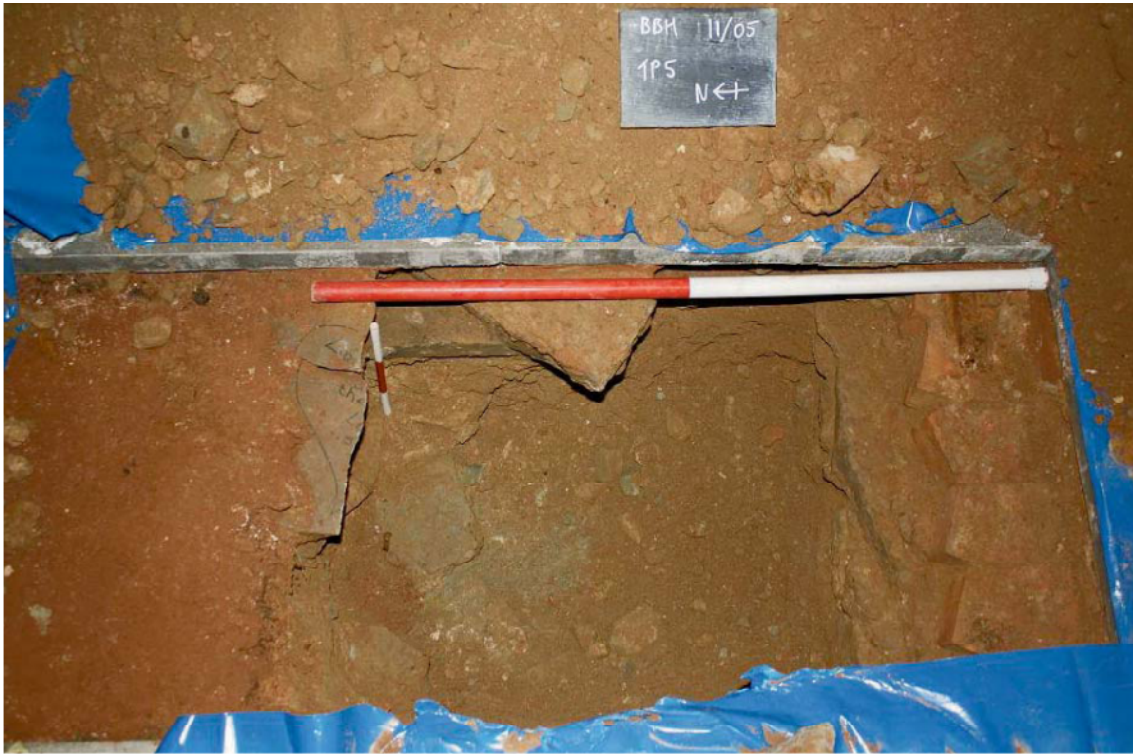
Test pit 5 measured 1.00x1.00m and was 0.55m deep and contained a mixture of loose sand and stone rubble which was probably the remains of previous floors of the church which were replaced in the 19th century. The stratigraphy comprised 0.05m concrete paving slabs, 0.05m builders sand, 0.09m brick floor (51), 0.03m crushed mortar and sand, 0.06m stone slabs, 0.13m stone blocks (52) overlying 0.14m pale grey brown sand with stone rubble (50). Natural geology was not observed in this test pit.

Plate 3. Test Pit 5, looking east, Scales: 1.0m and 0.3m.

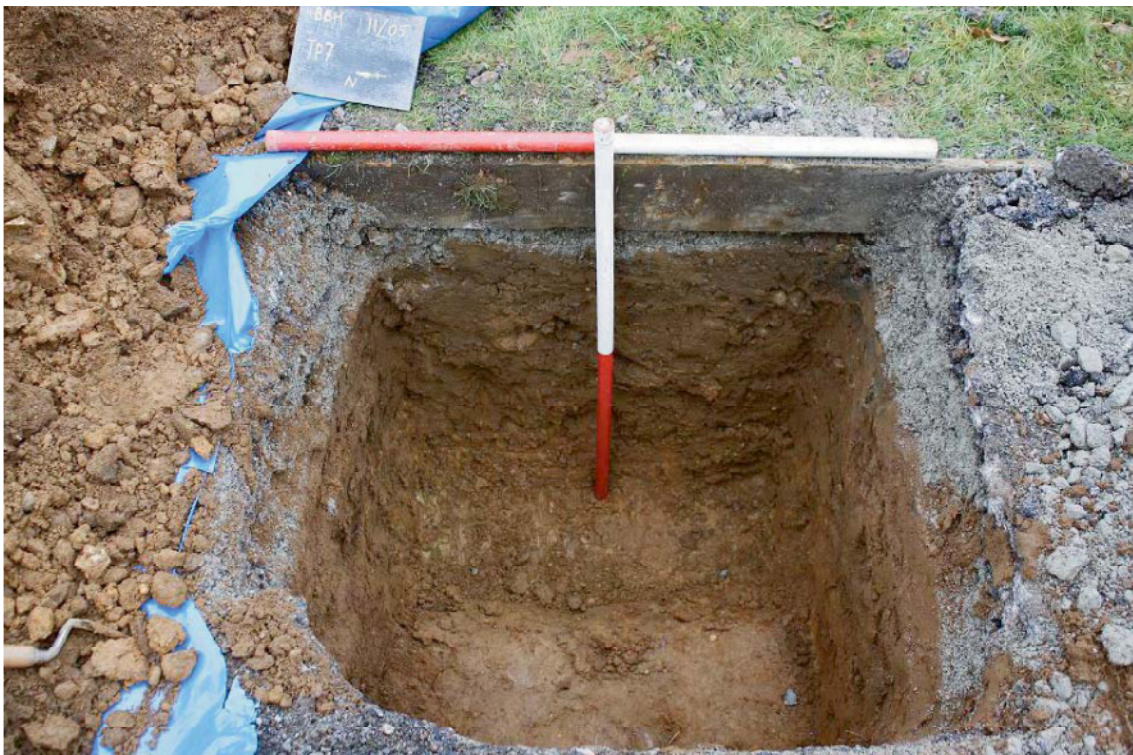
Outside the church it was found that the area of the borehole manifold (along a current path) has not been disturbed as shown by the presence of subsoil in that area overlying the natural geology, and that it was not occupied by any burial deposits.

Plate 4. Test Pit 7, looking north-east, Scales: 1.0m.
