**Lingfield Park Squash Club, Racecourse Road,
Lingfield, Surrey**

**An Archaeological Evaluation
for Thakeham Homes**

SiteCodeRRL11/66

October 2011

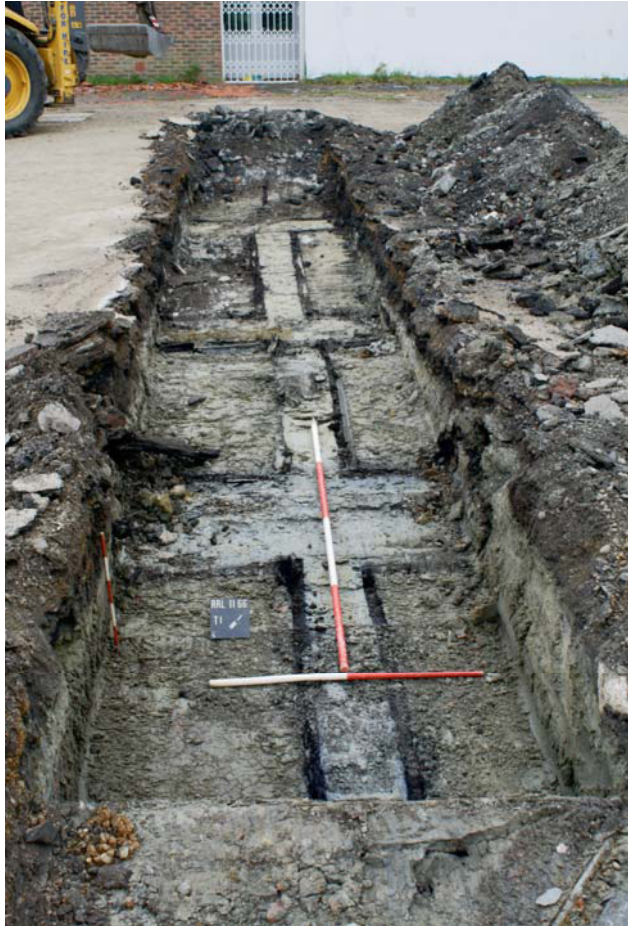
This trench was orientated approximately NW-SE, and was up to 0.73m deep. Tarmac (50) and an associated bedding layer (51) were removed to reveal a made ground deposit (52), which was up to 0.4m thick. The made ground consisted of various dump layers, including some re-deposited natural at the north-western end of the trench. Some demolition rubble was visible within the made ground, along with sherds of modern pottery, and fragments of glass and ceramic building material (not retained). The made ground lay directly above the natural geology, which consisted of light orange blue clay.

Eight pits or tanks (7, 8, 9, 10, 11, 12, 13 and 14) were recorded in the trench, all of which were timber-lined and rectangular in plan. All are presumably tanning tanks. The upper fills of the tanks were sealed by the made ground. Due to the position of the trench, none of the tanks was fully exposed in plan, although it was clear that there was some variation in size, with the smallest being about 1.8m long and the largest being just under 3m long, and they appear to be arranged in matched pairs.

Plate 1. Trench 1, looking south-east. Scales: 2m 1m and 0.5m

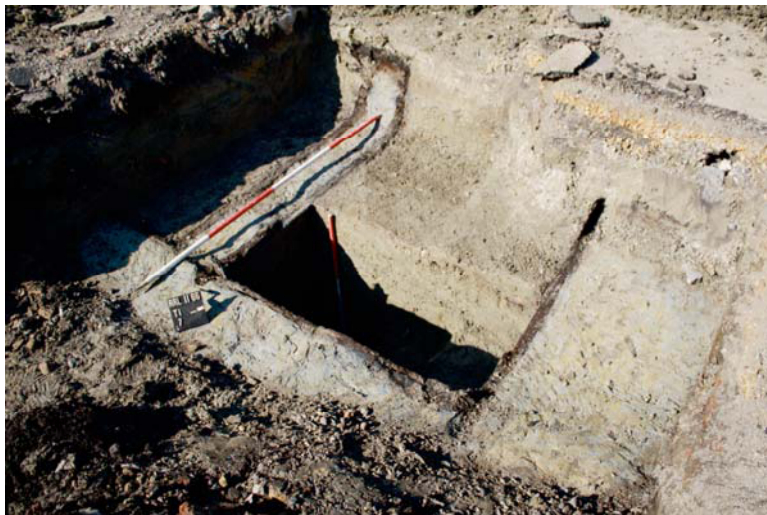
One of the tanks (7) was partially excavated by hand, after the trench had been extended slightly to reveal its complete width. This pit was at least 1.8m long and 1.6m wide, and measured 1.02m from the base of the trench to its timber base (Pl. 2). As the pit was encountered at the far north-western end of the trench it had been

slightly over-machined, and it was seen to have originally been at least 1.3m deep. The pit had been deliberately backfilled with various dump layers of clayey silt (73), which contained several fragments of brick and tile. A lower deposit of backfill material (97) was recorded, which was similar in character to layer 73, but damper. Further pieces of brick and tile were recovered from deposit 73, along with two sherds of pottery dating from the 18th or 19th century. A thin deposit of compact greyish green clayey silt (94) was noted immediately below layer 97: this contained no inclusions or archaeological finds. Layer 94 appeared to seal a primary fill of waterlogged organic material (93), from which two small pieces of leather or felt were retrieved. The timber lining of the pit (65) was constructed from large planks, up to 0.55m wide and 0.1m thick, which were placed on the base and up the sides of the pit. The side timbers were supported by shaped uprights in the corners of the pit, which appeared to be nailed to the side planks, but did not extend as far as the base timbers. The side timbers appeared to have been positioned flush with the edges of the construction cut of the pit, suggesting that there would be no fill material behind the planks to assist in dating. Although they were not excavated, all the other tanks in the trench appeared to have been backfilled in a similar manner, apart from pit 11, the upper fill of which consisted of modern made ground. Two areas of modern disturbance were also noted within the trench.

Plate 2. Pit 7 looking west, Scale: 2m.

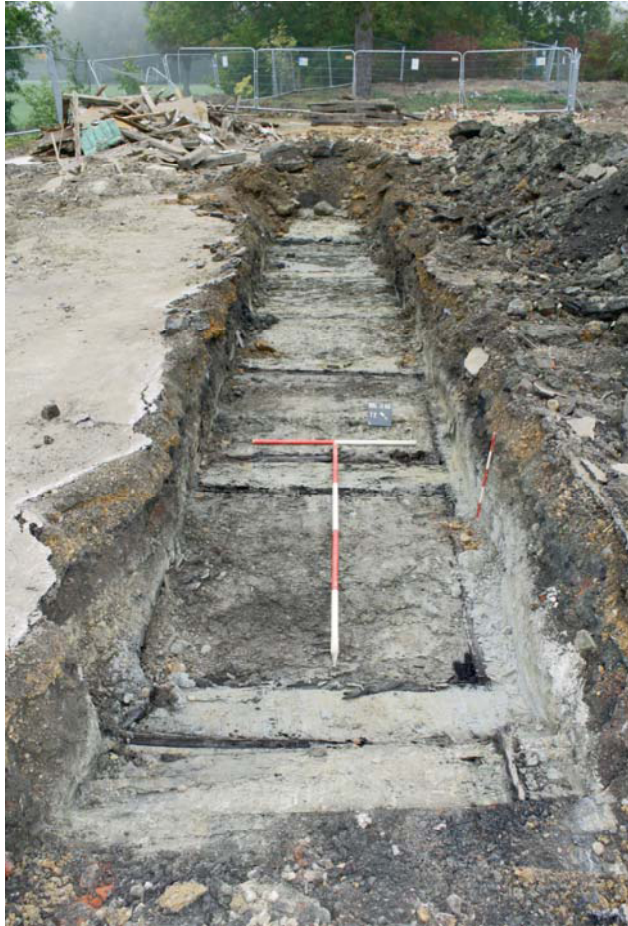
Trench 2 was aligned approximately NE-SW, and was up to 0.66m deep. The stratigraphy was almost identical to that observed in Trench 1, consisting of Tarmac (50) over a bedding layer (51), above made ground (52). The made ground lay directly above the natural geology, which consisted of light greyish blue clay. Six probable tanning tanks (1, 2, 3, 4, 5 and 6) were recorded within this trench. As with trench 1, all the tanks were timber lined and rectangular in plan. The tanks all seemed to be of a similar size, measuring between 1.4m and 1.6m long, and at least 1.6m wide, and were positioned in a row, running along the length of the trench.

Plate 3. Trench 2, looking north-east. Scales: 2m, 1m and 0.5m

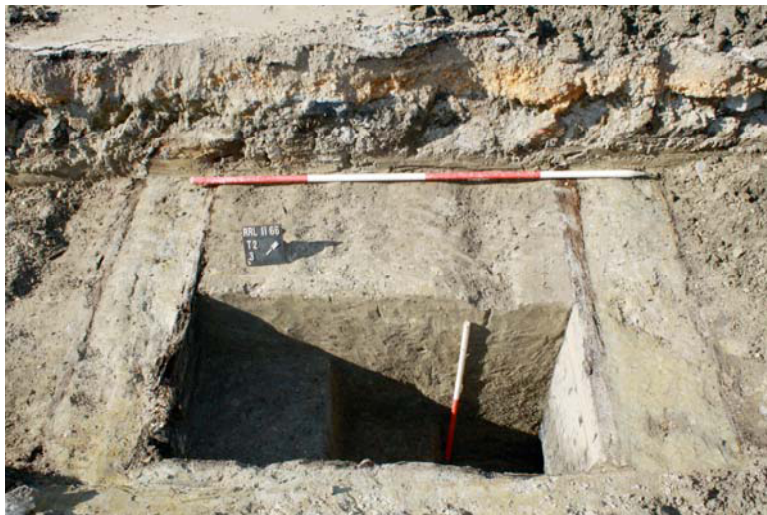
One of the tanks (3) was partially excavated, and its timber lined bottom was recorded 1.12m below the base of the trench (Pl. 4). As well as a small amount of made ground in the top of the pit, two layers representing deliberate backfilling were observed. The uppermost of these (61) consisted of mid greenish grey clayey silt, which contained 19th-century pottery and a few small pieces of brick and tile. This deposit was up to 0.22m thick, and lay above a similar looking deposit (95) which filled the bottom of the timber lined pit. Deposit 95 also contained 19th-century pottery and some fragments of brick and tile, along with a small amount of organic material, which appeared to be straw. The timber frame (55) within the pit was almost identical to that recorded in pit 7, although it seemed possible that the original upright in the southern corner of the pit may have been

replaced by a flat plank. The upper fills of the other tanks in the trench appeared to be similar in nature to deposit 61, suggesting that they were probably all backfilled at the same time.

Plate 4. Pit 3 looking north-west, Scales 2m and 1m.
