**Brent House Farm, Harlow Common,  
North Weald, Essex**

**Archaeological Evaluation**

**Site Code: NWBBHF12**

**Report 12/181**

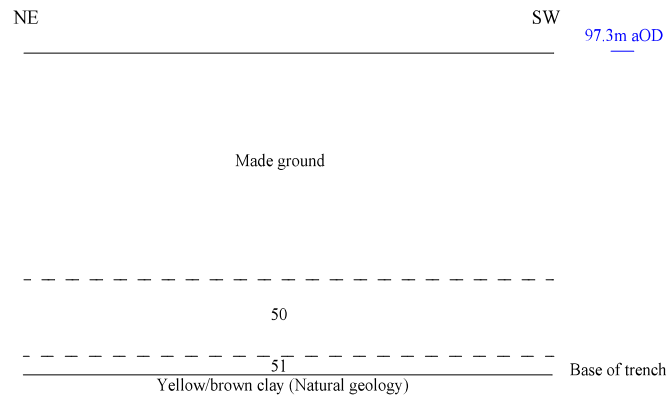
### Trench 3

This trench was 19.70m long and up to 0.85m deep, and was aligned approximately SW–NE. A thick (0.60m) layer of modern made ground lay above the buried topsoil horizon (50), which was 0.2m thick. This lay above 0.05m of subsoil (51), which in turn lay directly above the natural clay geology (Fig. 4). Two areas of modern disturbance were observed, along with four service trenches or land drains. The trench contained no archaeological finds or features.

Figure 4. Representative Sections.

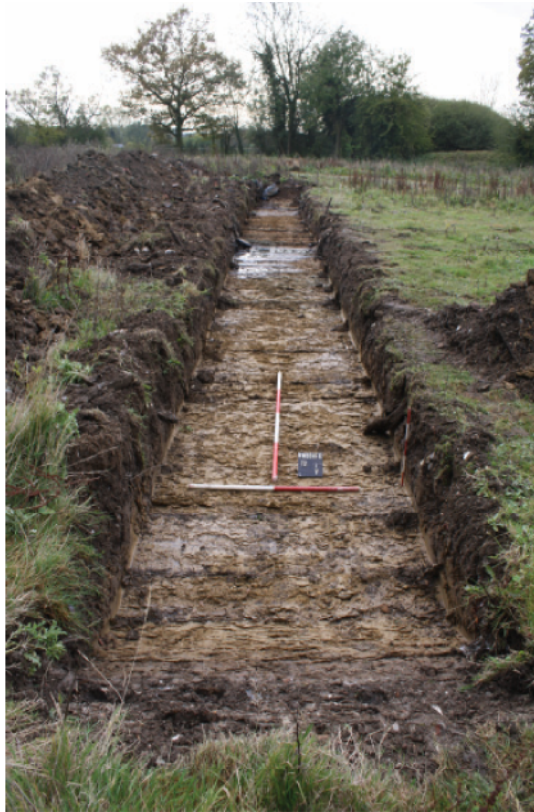
Trench 2 was aligned approximately N–S, and was 20.30m long and up to 0.74m deep. The trench was positioned in an area which appeared to have been previously used as a dump and, as a result, there was up to 0.52m of modern made ground above the buried topsoil horizon (50). The topsoil was only 0.13m thick, and lay above 0.05m of subsoil (51). The natural clay geology was recorded immediately beneath the subsoil. No archaeological finds or features were recorded in the trench which contained a land drain and a small area of modern truncation.

Plate 1. Trench 2, looking south, Scales: horizontal, 2m and 1m, vertical, 0.5m.

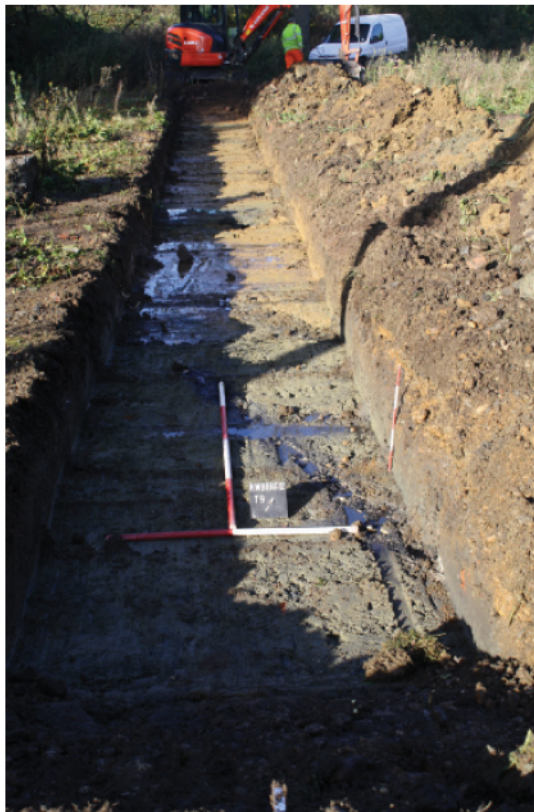
This trench was aligned approximately NW–SE, and was 20.20m long and 0.52m deep. Up to 0.20m of Tarmac and modern made ground lay above a buried topsoil layer (50) which was about 0.17m thick. The topsoil lay above 0.10m of subsoil (51), which in turn lay above the natural clay geology. The natural in the southern part of the trench had been heavily stained by contamination. No archaeological finds or features were recorded.

Plate 2. Trench 9, looking north-west, Scales: horizontal, 2m and 1m, vertical, 0.5m.
