**The Old School, Park Lane, Richmond,  
London Borough of Richmond**

**Building Appraisal**

**Site Code OCS12**

**Report 12/80b**

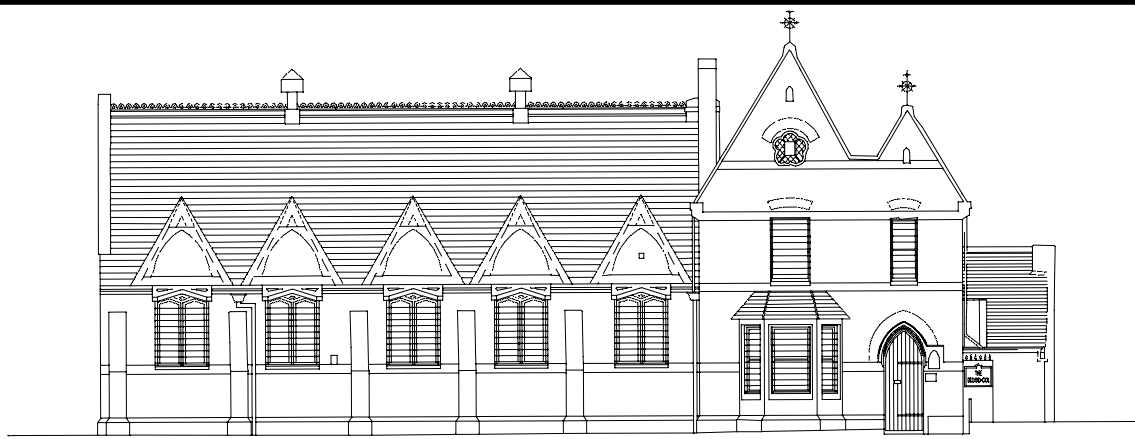
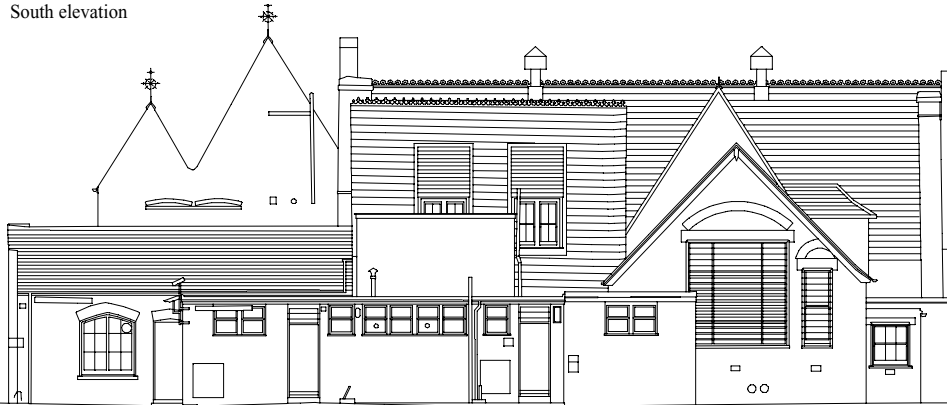
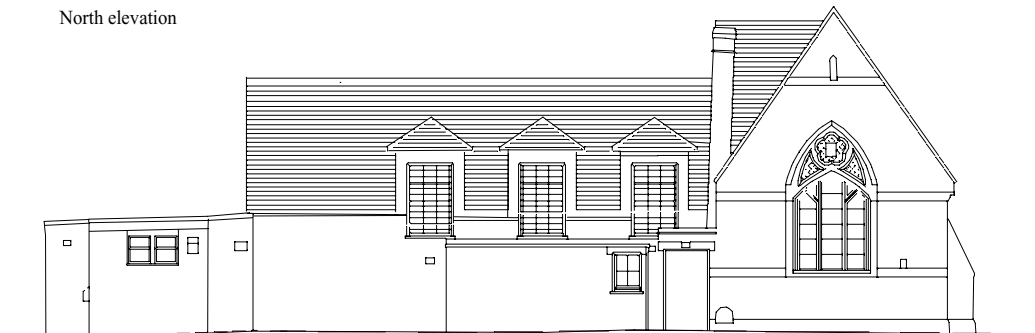
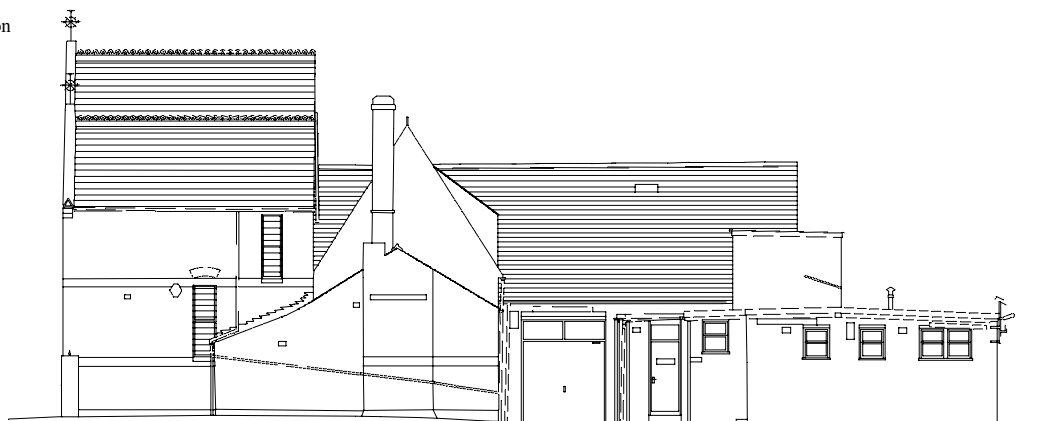
### *Exterior (Fig. 9)*

South elevation

North elevation

West elevation

East elevation

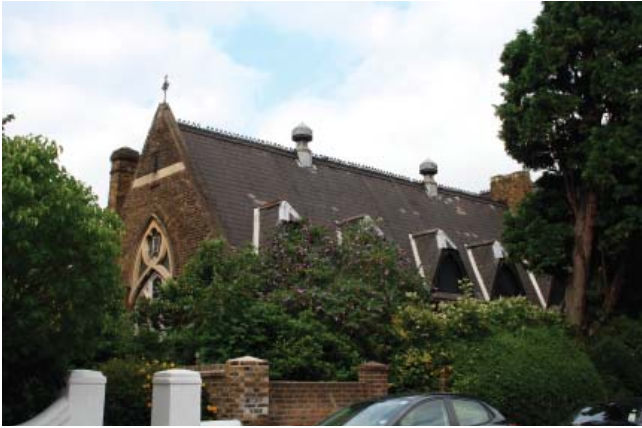
Plate 1. Exterior, elevation of southwest corner of room 11, looking northeast.

The front-facing (south) elevation of the building (Pl. 1) is constructed in yellow London stock bricks, which are typical for the later Victorian period and are laid to a Flemish bond. The roofs of the hall at the west and the three-storey part to the east are tiled with grey slate which appears to be original with the exception of occasional replaced slates. The gabled roof over the main hall has decorative ridge tiles with a trefoil motif, and two leaded air vents which may be modern insertions, though they could not be closely examined. At the east end, there is a rectangular brick built chimney stack with a limestone top and no visible chimney pots. The roof of the three-storey east part is a double gable roof with a larger gable at the west, a flat valley in between and a smaller western gable. These both have the trefoil ridge tiles seen on the main hall roof ridge. At the ends of the gables, there is a moulded pale yellow-grey limestone coping with a cross motif at the apex, with a (presumably wrought iron) decorative cross, with fleur-de-lys elements within a circle, and the ends as a cross 'moline'.

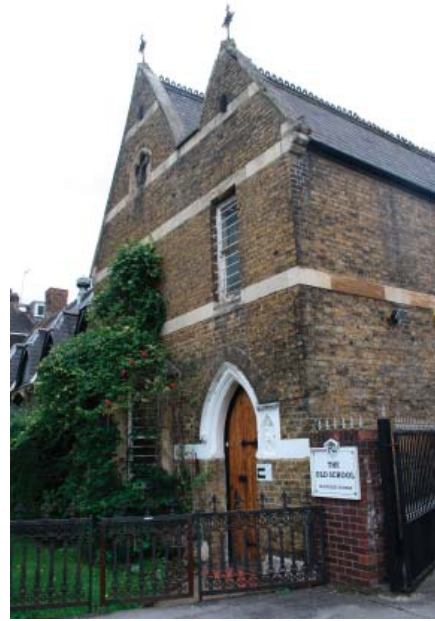
Plate 2. Exterior, elevation of southeast corner, rooms 4 and 5, looking northwest.

At the eaves of the hall roof, there is a simple limestone moulding with a chamfer. There are five large windows on the south elevation of the hall, each of which consists of a pair of painted wooden bargeboards arranged to form a pointed arch within a steeply pitched half-hipped dormer. The upper part of each window has been painted over externally. Below this, at the level of the eaves, the lower part of each window has a deep moulded limestone lintel with sunk spandrels. Below is a low pointed arch with a window beneath, formed of two tall narrow lights, each with a pointed head and vertically-arranged panes (Pl. 2). The frames and glazing

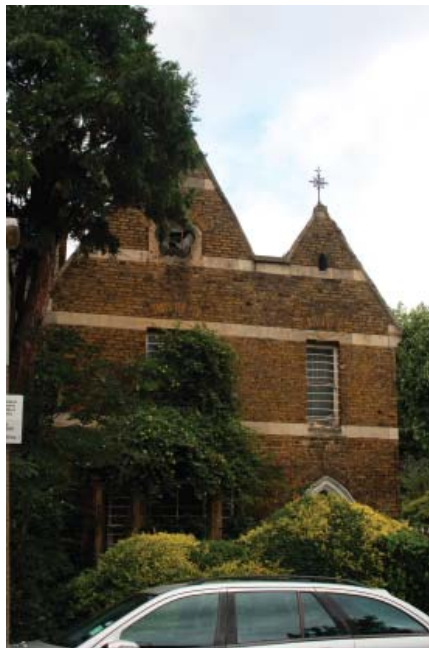
Plate 3. Exterior, south elevation, east end, room 5, looking north.

The east block (Pl. 3) consists of three storeys, with a cinquefoil window set in a limestone moulded frame in the west of the two gables. Here, a small rectangular pane is fixed in the centre and surrounded by leaded diamond lights. The central pane is broken and there is the modern addition of chicken wire. Over the window is a brick arch. In the smaller (east) gable end there is a small aperture (owl hole) with a pointed arch at the top and a chamfer in the limestone course at the base.

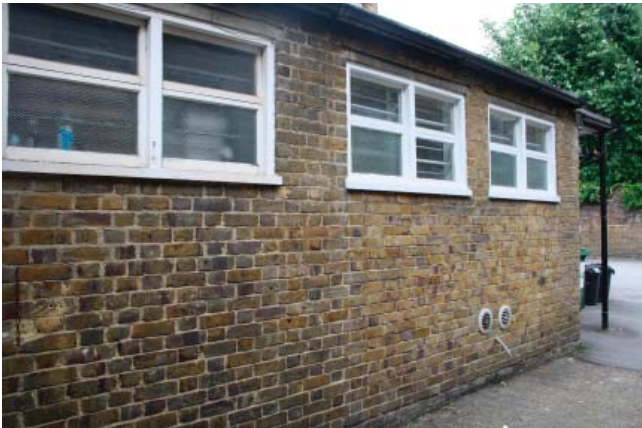
Plate 5. Exterior, south-facing elevation of room 22, looking northeast.

Also facing south is the elevation of the 1950s extension at the rear of the building, which is flat (possibly asbestos) roofed, and which houses rooms 21 and 22 (Pl. 5). It is built of yellow stock bricks in a Flemish bond. There is a subtle discontinuity in the brickwork (in terms of mortar and finish) which suggests that this part was built in two stages, however there is no cartographic evidence to support this and even if so, the two parts are broadly contemporary.

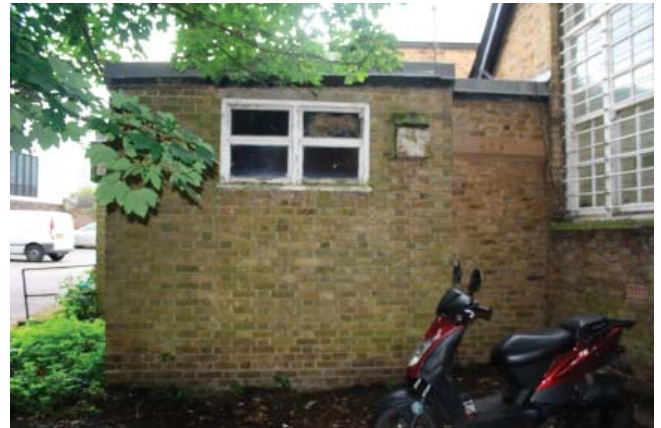
Plate 6. Exterior, west-facing elevation of room 18, looking east.

To the rear of the hall is a blocked doorway into the flat-roofed extension, with a square head and a limestone lintel (Pl. 6). Above the lintel, the brickwork appears to be contemporary with the extension shown on the 1894 architects plan. The brickwork blocking the door is to a stretcher bond and is of likely 1950s date. To the left, the 1950s extension has a flat roof and brickwork laid to a Flemish bond.

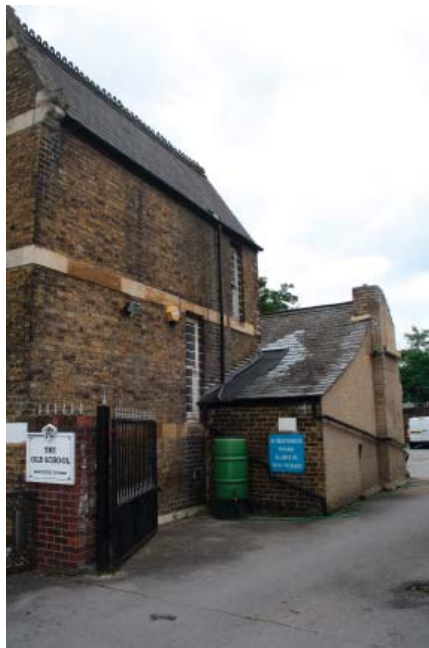
Plate 7. Exterior, east elevation, rooms 4 and 7, looking northwest.

The east elevation at the south comprises the three-storey east block, which is part of the original 1870s building (Pl. 7). The wall is of yellow stock bricks laid to a Flemish bond (as at the south elevation) with two limestone string courses continuing from the south elevations. There are two tall stair windows, each of two rectangular panes, with sash horns and wooden frames, and security bars. The lower of the two has an arch in the brickwork above the string course, which is moulded with simple chamfers to accommodate the window head. Further to the rear is a second chamfer for the base of the upper window and the lower string course has a chamfer for the base of the lower window. The wall behind a modern plastic drainpipe has been repointed, possibly when the original cast iron pipe was replaced. At the rear corner, several red bricks have been incorporated.

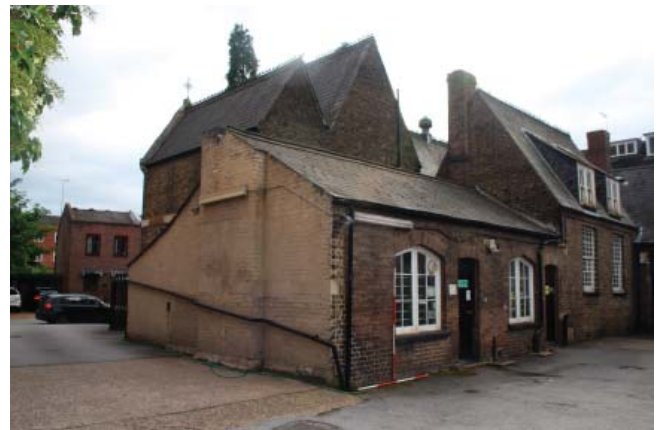
Plate 8. Exterior, elevation of northeast corner, room 7, looking southwest, scales 2.0m.

The slate-tiled roof of a storeroom projects at the ground floor, which is double-pitched (steep from the apex to the south, then shallower). The wall is painted but a discontinuity in the brickwork (in terms of the finish of the mortar) shows that the wall was rebuilt to the south to enlarge the storeroom within room 7. To the right of this is a chimney serving room 7, with a brick chimney stack which is square-topped at the south, and built to an apex to follow the roof ridge (Pl. 8).

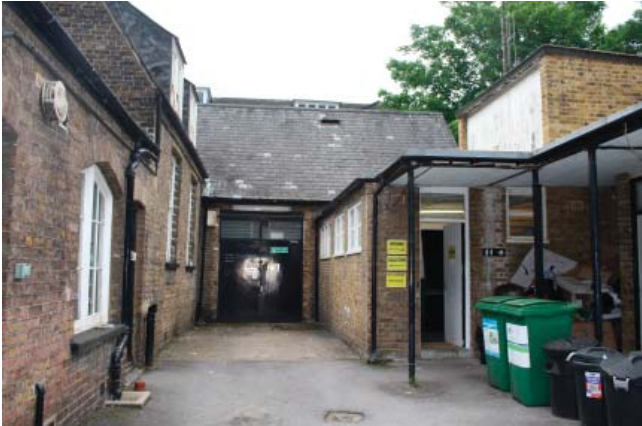
Plate 9. Exterior, east elevation, rooms 23, 10, 15 and 22, looking west.

Further to the rear is the 1950s extension, which is flat roofed, and has a doorway leading into room 22 (Pl. 9), above which is the L-shaped shelter. There is a one-and-a-half-storey section of roof, as described above (see east elevation), with bricks laid to a Flemish bond.

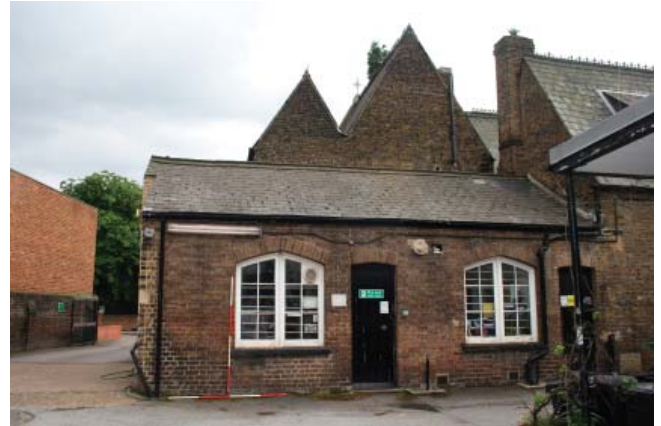
Plate 10. Exterior, north-facing elevation of room 7, looking south, scales 2.0m.

The highest part of this elevation comprises the pair of gable ends of the rear of the three-storey block, at the east of the original 1870s school building (Pl. 10). The walls are of the same brick type, though they differ in pattern, being laid to an English Cross bond. An off-centre stone (or possibly timber) lintel, and the presence of closer bricks suggest the location of a bricked-up window in the larger gable. The locations of two further windows are indicated by low brick arches at first floor level. These are not shown on the 1894 architect's plans and it appears that by that point they had already been bricked up.

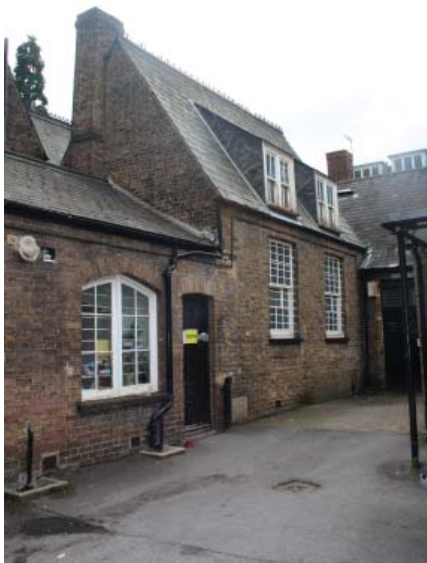
Plate 11. Exterior, north-facing elevation, rooms 2 and 23, looking southwest.

To the right of this is a 1½-storey block (Pl. 11) which has a steeper pitched slate-tiled roof, with trefoil ridge tiles, a few of which are damaged. There are two slate-tiled dormers with lead sides, each with a pair of sash windows of four panes, within white painted wooden frames with fairly thick glazing bars.

Below these is a pair of larger square-headed eight-over-eight sash windows with a very slightly cambered soffit. Both have been modified, with a bottom-hung casement panel replacing two of the panes of the lower sash.

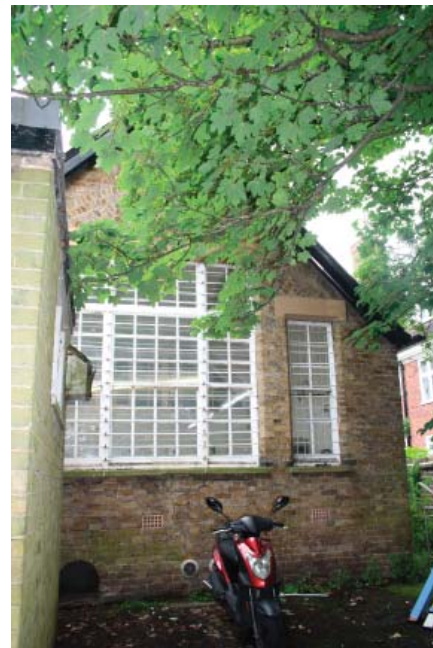
Plate 12. Exterior, north-facing elevation of room 16, looking south.

Also facing north is the rear of the 1950s extension (Pl. 12). This is of the same brick type and construction as found throughout this block, and there are windows as seen on the south elevation (each a lower fixed and a bottom-hung upper casement) with wooden frames. These are arranged with one pair at the left, a single window to the right of the door, four windows together, and a single to the left of the second door. At the far right is a further pair, making this part of the elevation symmetrical. Wooden doors in square frames with a concrete step lead into rooms 20 (at the left) and 19 (at the right), with small rectangular windows over each. There are two areas of square blue-glazed tiles at each side of the block, where drinking fountains were formerly attached.

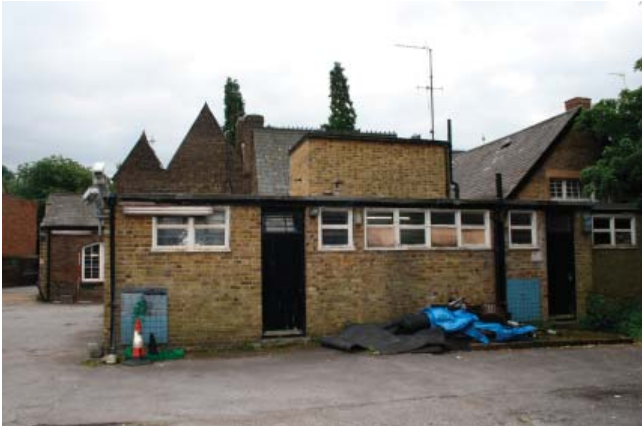
Plate 13. Exterior, north-facing elevation of rooms 20, 19 and 18 looking south.

The north elevation of the second hall (room 14/16) consists of a gable end (Pl. 13), one and a half storeys high, of yellow stock bricks laid to a Flemish bond. There are black-painted wooden bargeboards at the eaves

which appears to be a recent replacement or addition based on the condition of the wood. There is one large central window with a double row pointed brick arch, below which is header brick infill laid to a herringbone pattern over a limestone lintel with a simple chamfer. The window is made up of a central eight-over-eight sash window with small sash horns, flanked by six-over-four sash windows. Above these are four central rectangular fixed panes with a further two either side. To the right of this large window is a tall side window, over which is a smaller pointed brick arch with herringbone brick infill over a stone lintel with a chamfer. At the jambs of both the large and small window, the bricks are chamfered to produce a splay, and the sills are stone. Both the large and smaller window have metal security bars.

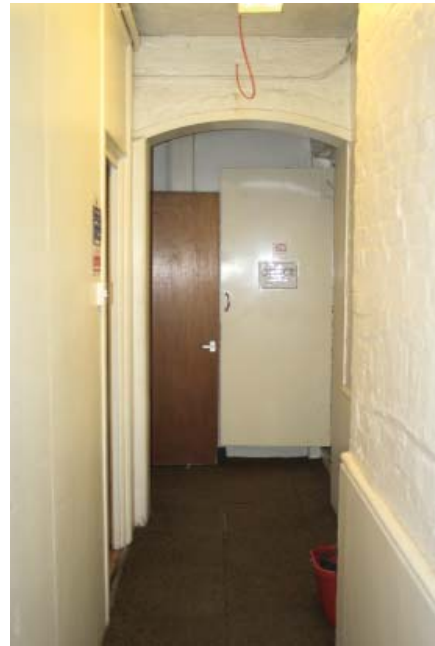
Plate 14. Interior, ground floor, room 1, looking south.

The main access to the building is currently from the north. Room 1 is an entrance hall (Pl. 14) which has a low dado with a round moulding at the top and is plastered and painted. Above this the walls are painted brick. The hall is carpeted and the original floor covering could not be seen. At the west, there is a blocked doorway with a small wooden step, and a blocked up fireplace is evident from a brick arch. The infilling bricks beneath appear to be of Victorian date based on the finish, and it is likely that this was carried out as part of the 1894 remodelling of the school.

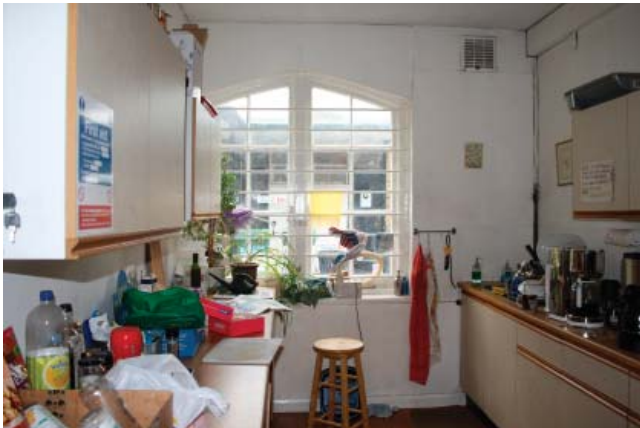
Plate 15. Interior, ground floor, room 2, looking north.

To the east of the hall is a stud wall, with a modern wooden fire door leading into a kitchen (room 2). Room 2 (Pl. 15) has windows as described above, a high ceiling, plastered walls and modern laminate flooring and modern fittings.

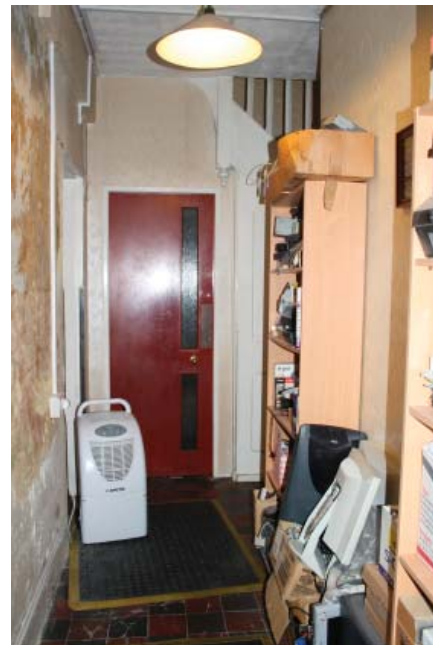
Plate 16. Interior, ground floor, room 3, looking east.

The hall leads into corridor (3), which has the original red and black square tiled floor (Pl. 16). The walls are wallpaper on plaster. To the south, the original entrance hall (4) has a red and black tiled floor, and the gothic-style pointed arch doorway (Pl. 17). This has a painted wooden frame with a simple ovolo moulding, and door appears to be the original heavy wooden plank and batten door with a pointed arched head, of likely 19th-century date. The walls are painted plaster and there is an unusual recessed ovolo moulding in the place of skirting boards.

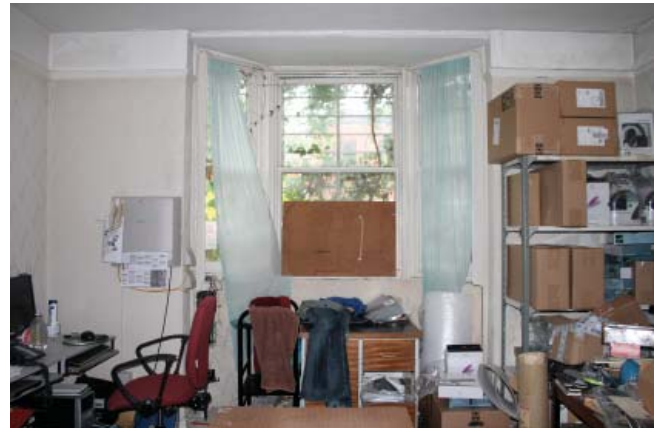
Plate 18. Interior, ground floor, room 5, looking south.

To the south, a modern fire door leads into Room 5 (Pl. 18). Here, wallpaper conceals the original fireplace, and there is an original picture rail. A bay window facing south (described above) is partially boarded up and appears to be original, as do the brass window catches.

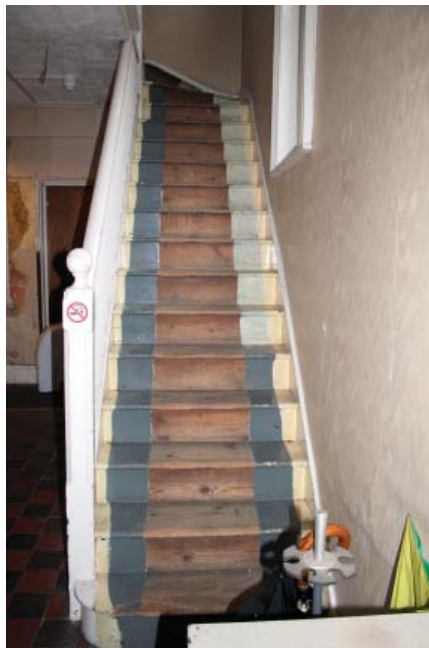
Plate 19. Interior, staircase to first floor, room 4, looking north.

A staircase (6) from the entrance hall leads up to the north (Pl. 19). Two windows with wooden sills light the stairs, which consist of a closed-string wooden staircase, which has been stripped back to bare wood. There is a plain handrail with a ball finial and diamond stick balusters which are likely to be original. Under the staircase is a cupboard with a four-panelled door of likely 19th-century date.

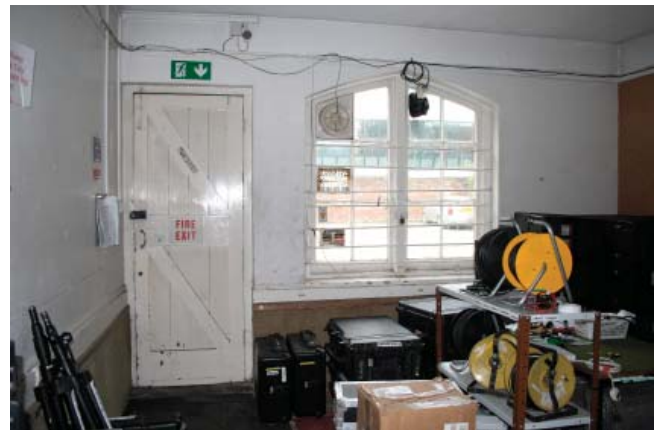
Plate 20. Interior, ground floor, room 7, looking north-northeast.

At the north, room 7 (Pl. 20) has a parquet floor, with an area at the north-west where this has been replaced with poured concrete. The walls are painted plaster and there is a low wooden dado rail at the height of the bottom of the window. The window frame and fittings are painted white, and the fittings appear to be original. A door at the north leads into the yard, and is a wooden plank and batten door in a plain doorframe (both probably original). At the south-east of the room, a door leads into a small storeroom. This has painted brick walls and a poured concrete floor.

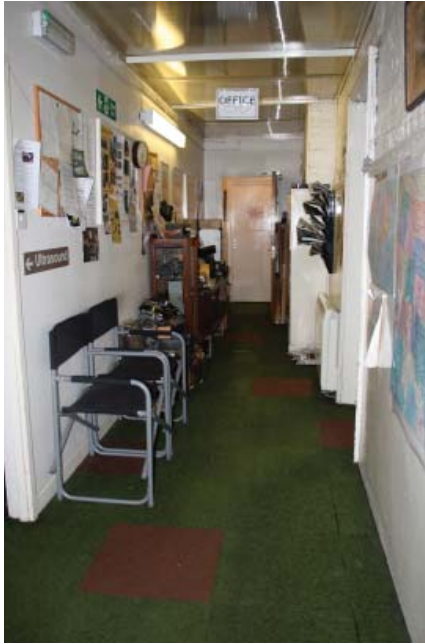
Plate 21. Interior, ground floor, room 8, looking west.

A corridor (8) has a suspended plastic ceiling and the wall at the north is painted brick above a high (1.62m) simple ovolo dado rail (Pl. 21), and below this the wall is painted plaster. At the south is a modern stud wall, and the floor is covered with carpet tiles.

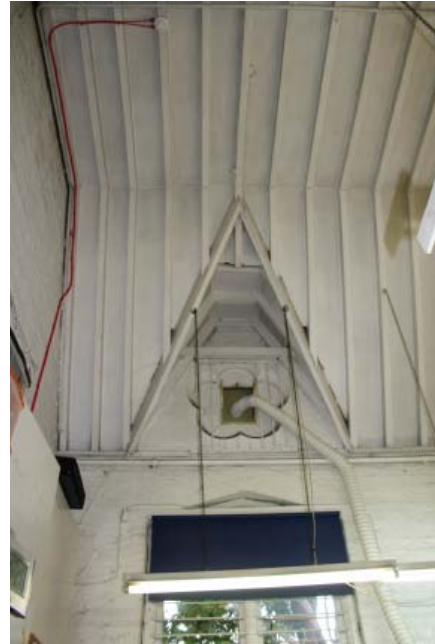
Plate 22. Interior, ground floor, room 9, detail of ceiling, looking south.

Room 9 forms part of the original main school hall (Pl. 22) and has a full-height ceiling with exposed white painted rafters, each with a collar strut fixed in place with large rivets. There is an original metal ventilation grille in the centre of the ceiling. The north and west walls are modern stud wall, while the south and east are painted brick above a dado rail, and painted plaster below.

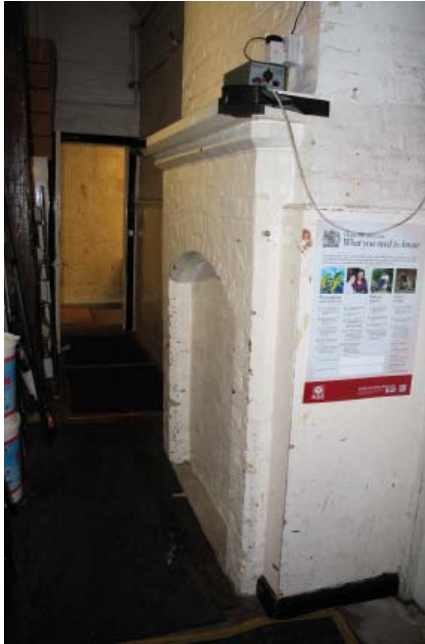
Plate 25. Interior, ground floor, room 15, detail of bricked-up fireplace, looking northeast.

A further part of the corridor (15) has a chimney breast and bricked up fireplace with a plain chamfered stone mantelpiece and a double arch in the brickwork (Pl. 25). Throughout, the walls are painted brick above a dado, and painted plaster below. Adjacent to the chimneybreast, the wall has been remodeled when the double doorway to the yard was inserted.

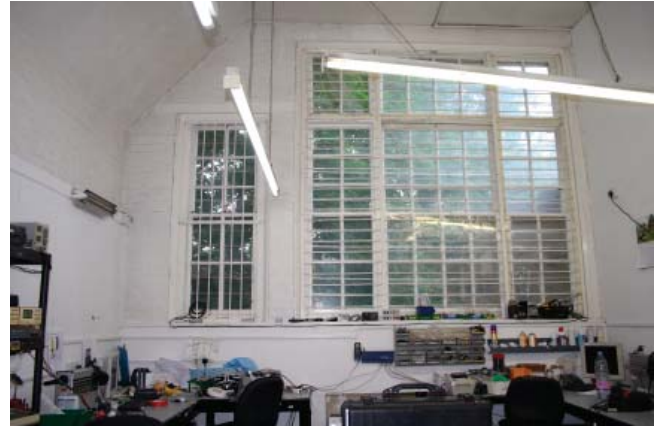
Plate 26. Interior, ground floor, room 16, looking north.

Room 16 is a workshop which is within the northern half of the second school hall. At the north is the large window, with a second tall window (Pl. 26) (described above). Here, the walls are painted brick about the dado, painted plaster below, and at the west painted plaster below a plain wooden picture rail. At the east, the wall is a modern stud wall, as is the south wall. At the top of this wall is a row of windows which are blocked but which presumably helped light room 14 when the hall was divided into two (Pl. 27). These comprise a row of windows divided into four four-pane windows with wooden frames, one of which is a bottom-hung hinged window. There is a further four-pane window, and a single pane, which are sloped at the top to follow the roof pitch, and the west side of the ceiling slopes with the roof above. There are three dormer windows at the west which are described above.

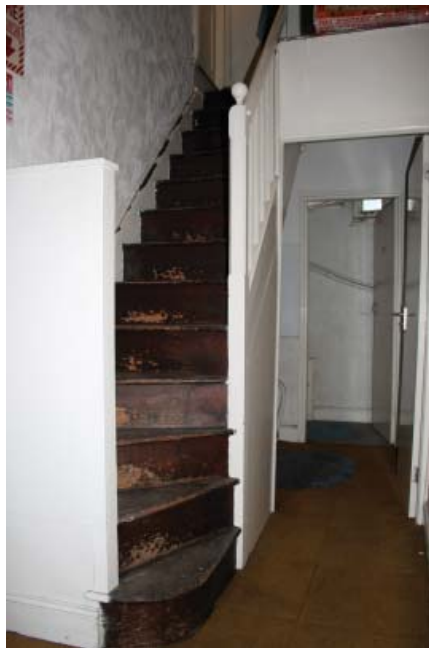
Plate 31. Interior, first floor, staircase to loft floor, looking west.

A stripped wooden staircase (Pl. 31) with matching diamond stick balusters, handrail and ball finial leads from the landing up towards the west, to a small landing (27) and a loft room (28) within the gable (Pl. 32). This has a cinquefoil window and a sloping ceiling to the east and west.
