Friar Street road repair, Reading, Berkshire

Archaeological Watching Brief

Site Code:FSR13/42

For Reading Borough Council

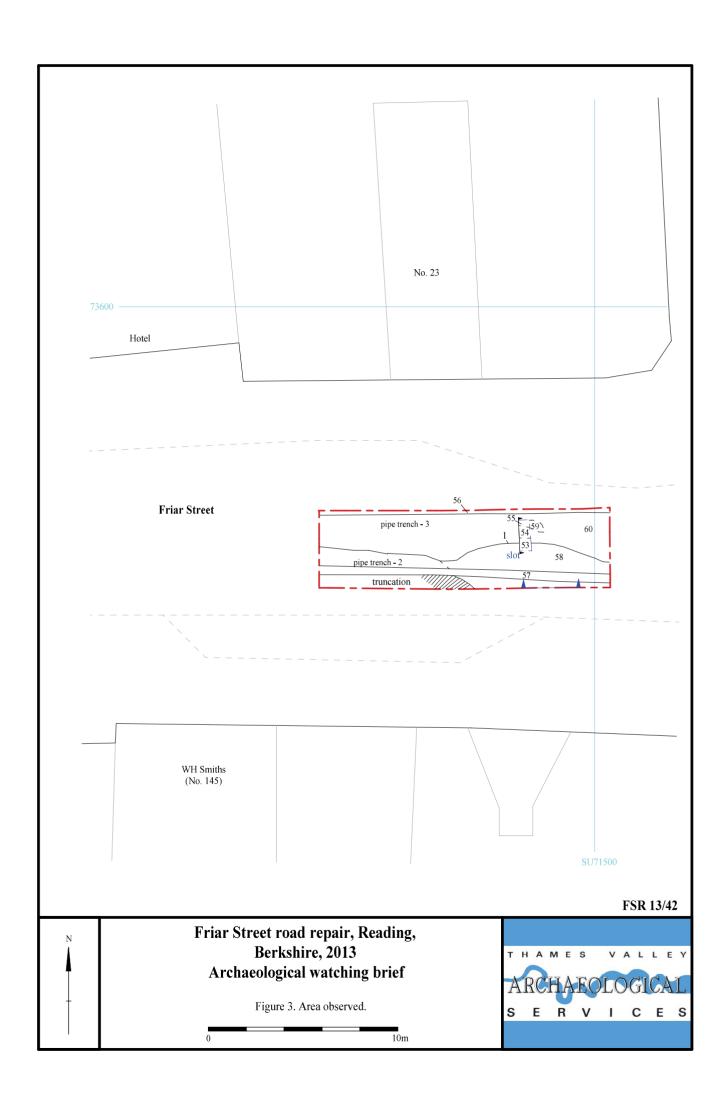
Figure 4. Sections.

Full depth section E W 45.4maOD Concrete 50

Slot through Pit 1 and deposit 60

The trench observed measured 13m in length, 4.20m wide and c.1.40m deep (Pls 1 and 2). It consisted of 0.10m of Tarmac overlying 0.15m of concrete. This overlay 0.44m of mid grey flinty gravel made ground (50) overlying 0.24m of mid grey gravelly clay (51). This overlay 0.20m of a dark grey silty deposit (52) containing material pressed in from the above layer but may in fact be part of the layer below (60). Three (1–3) areas of truncation were evident in the trench aligned east-west. All of these were Victorian or modern, with cuts 2 and 3 containing cast iron pipes. Cut 1 may be associated with pipe 2, although this was unclear. Within layer 60 was another deposit of dark grey flinty silt (59), which may represent another dump layer.

A slot was dug into layer 60 to show the relationship between it and cut 1. This was a dark grey brown silty clay layer with frequent pieces of flint and measured 0.27m deep. It contained 13 sherds of 13th- to 14th-century pottery, 70 pieces of animal bone, 22 pieces of roof tile and 68 pieces of leather, mostly comprising shoe soles. Below this layer a further three layers were also visible (53–55), although these were not investigated further due to the trench having reached its optimum depth for the repairs. Layer 53 was a very pale brown clay fill and may in fact be associated with the truncation of cut 1. Layer 54 was mid grey brown gravelly, flinty silt and layer 55 was a mid grey brown gravelly silt.

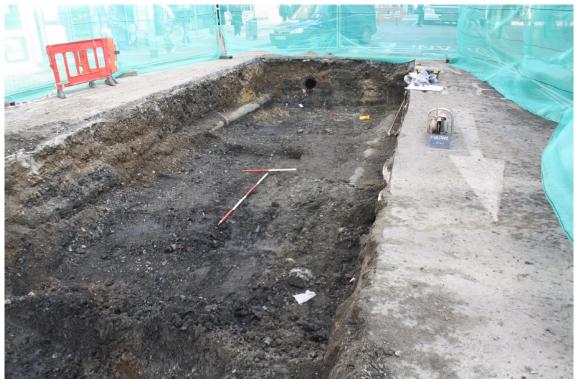
Plate 1. Area of investigation, looking east, Scales: 2m and 1m.

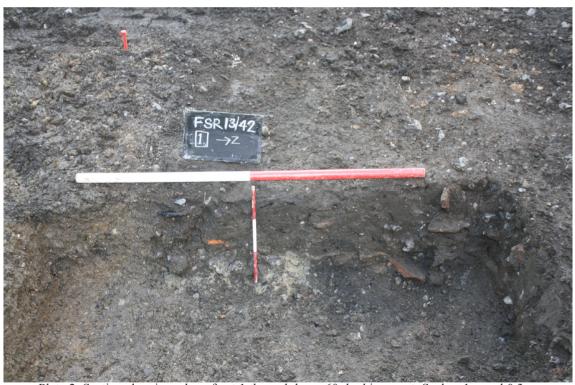
Plate 2. Section showing edge of cut 1 through layer 60, looking west, Scales: 1m and 0.3m.

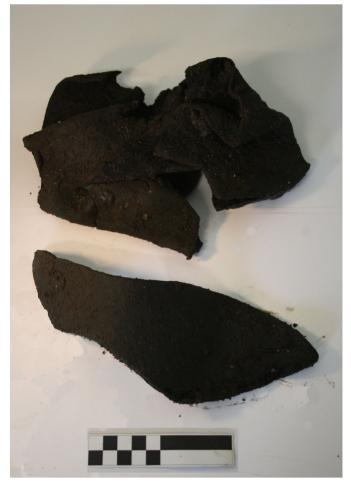
Plate 3. Example of leather shoe recovered from layer 60, Scale: 100mm.

A total of 68 pieces of leather were recovered during the watching brief (Pl. 3). Of these, deposit 60 contained 65 pieces and the remaining pieces were recovered from the spoilheap. They were cleaned and categorized according to type of piece: soles, or partial soles; shaped upper parts (vamps); thin strips (straps, rands or welts); and unidentified pieces (irregular or ragged pieces). These are summarized in Appendix 5. The overall condition was very good, with the pieces fairly soft and not brittle, though some were slightly fragile. The thickness of the leather was typically 2mm, though several slightly thicker (3mm) fragments were present.
