**New Sunday School, St Mary's Church,
White Waltham, Maidenhead, Berkshire**

An Archaeological Evaluation

Site Code SMW06/28

March 2006

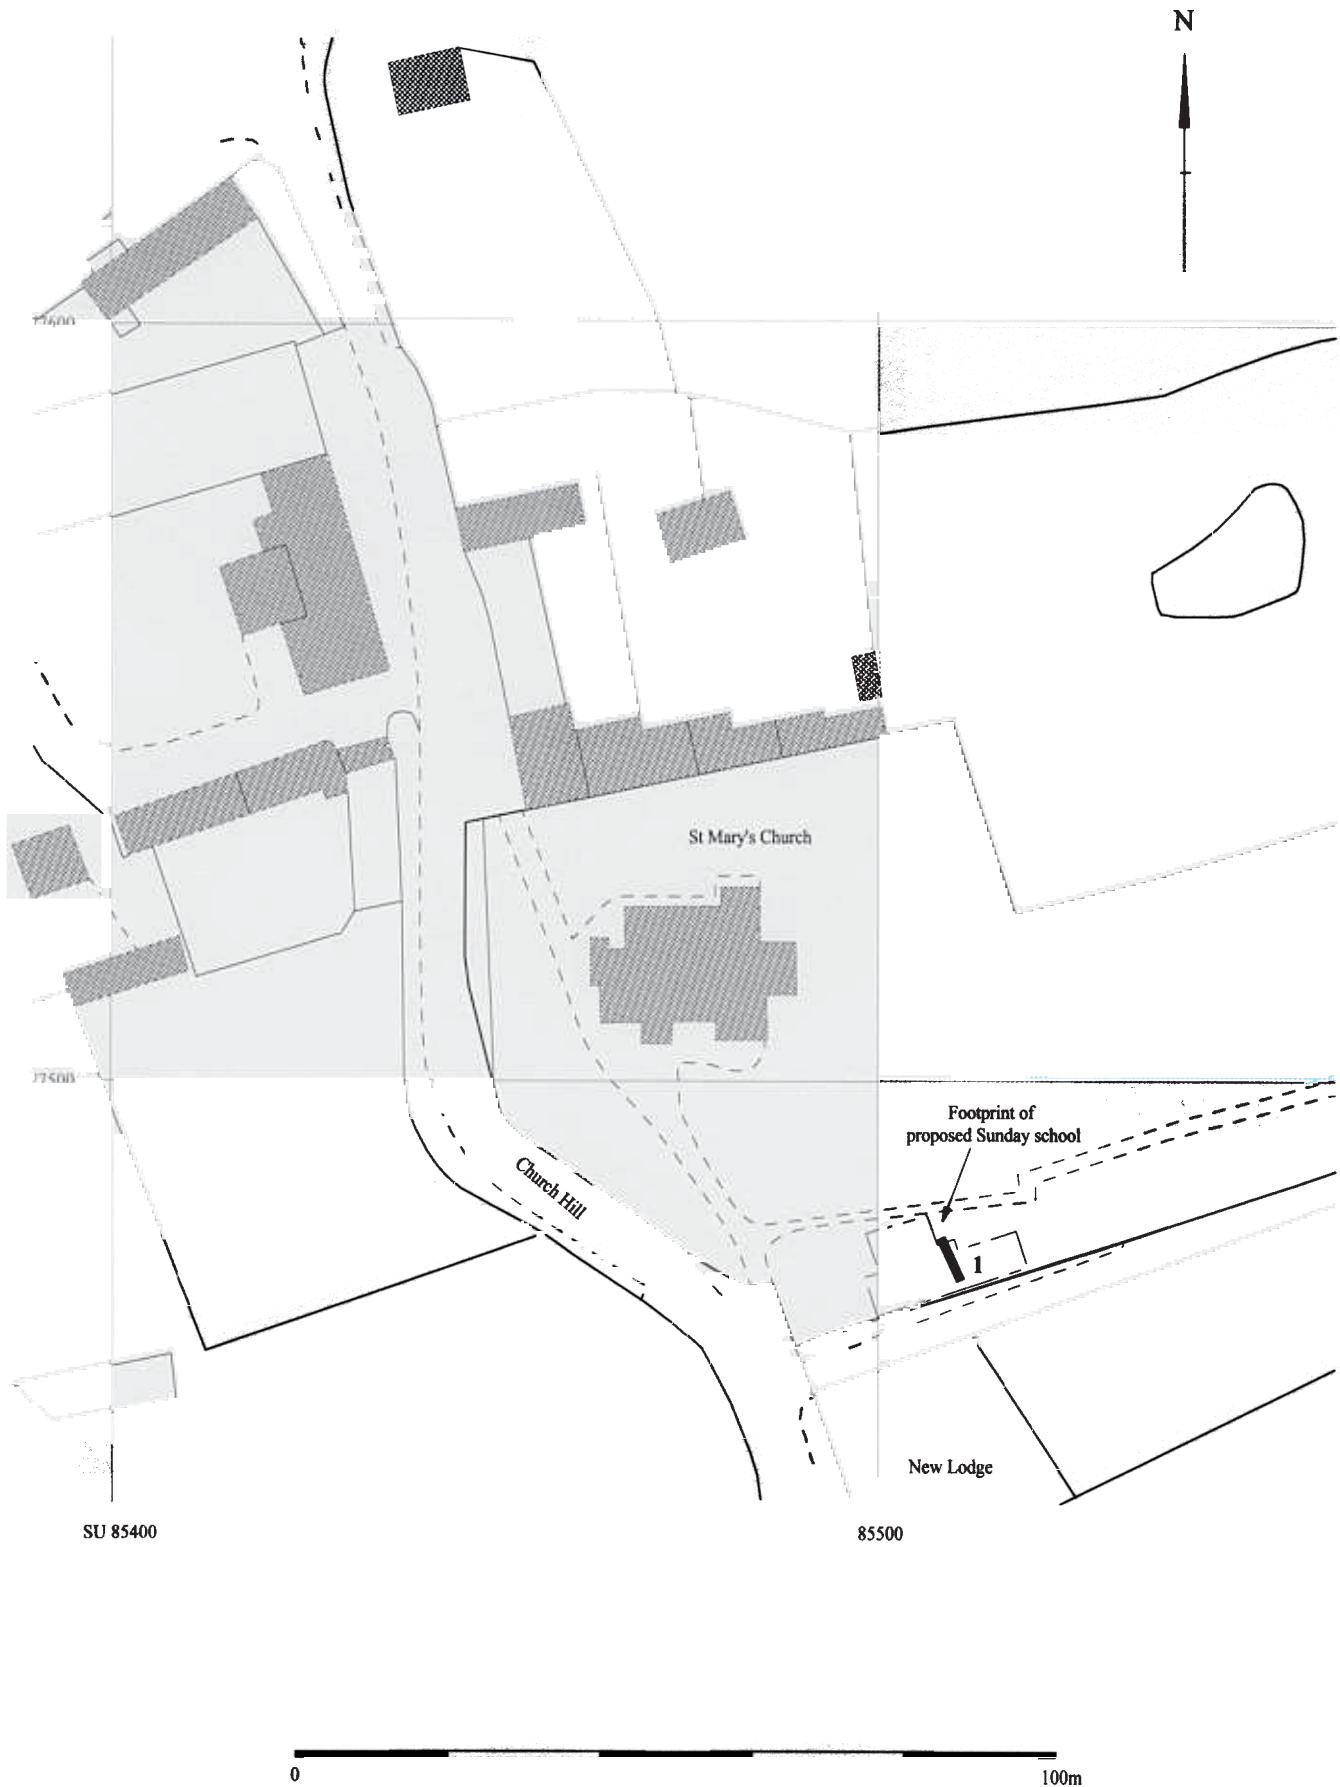
Figure 3: Trench Location

The single trench was dug in the location as shown on Figure 3. The turf was removed as was 0.1m of topsoil to reveal 0.15m of clay subsoil. This overlay a layer of chalk rubble (55) approximately 0.10–0.15m thick. Through this chalk layer, three coffin-shaped pits and at least one other feature were visible (Fig. 4). The coffin-shaped pits were cut through the clayey subsoil overlying the chalk rubble.

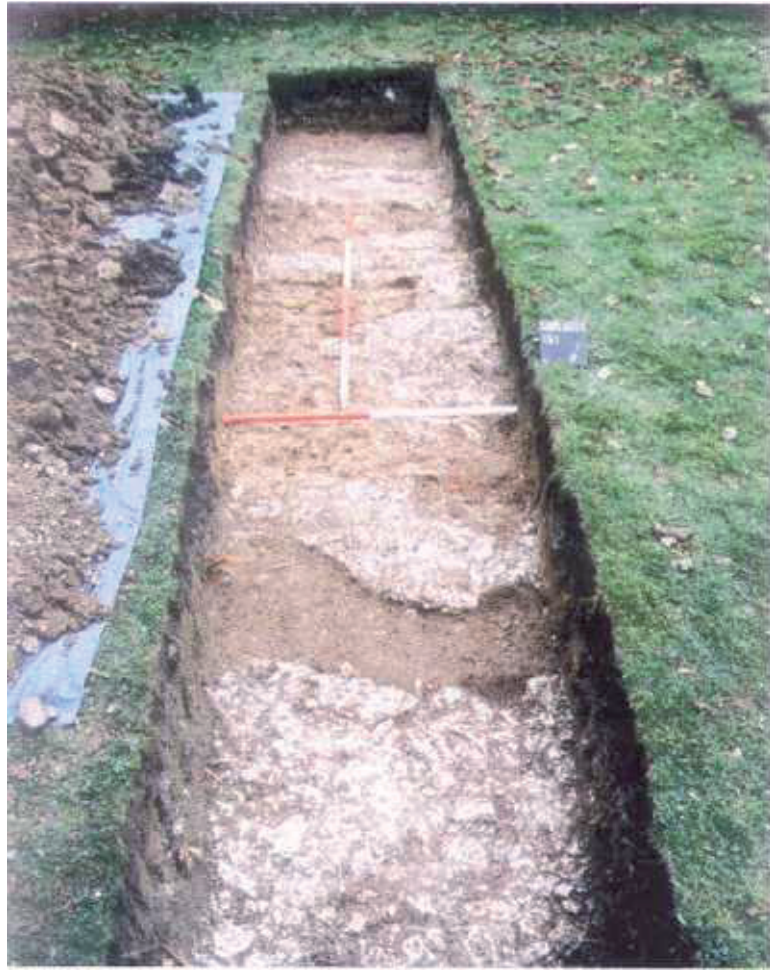
| <i>Trench No.</i> | <i>Length (m)</i> | <i>Breadth (m)</i> | <i>Depth (m)</i> | <i>Comment</i> |
|---|---|---|---|---|
| 1 | 6.1 | 1.0 | 0.45 (N) 0.37 (S) | 0-0.1m turf and topsoil onto 0.15m mid yellow/grey clay subsoil. 4 possible graves, 1 unknown feature, 2 Chalk layers. Brick/Tile recovered. [Plates 1 and 2] |

Plate 1. Trench 1 looking south east. Scales: 1m and 2m.

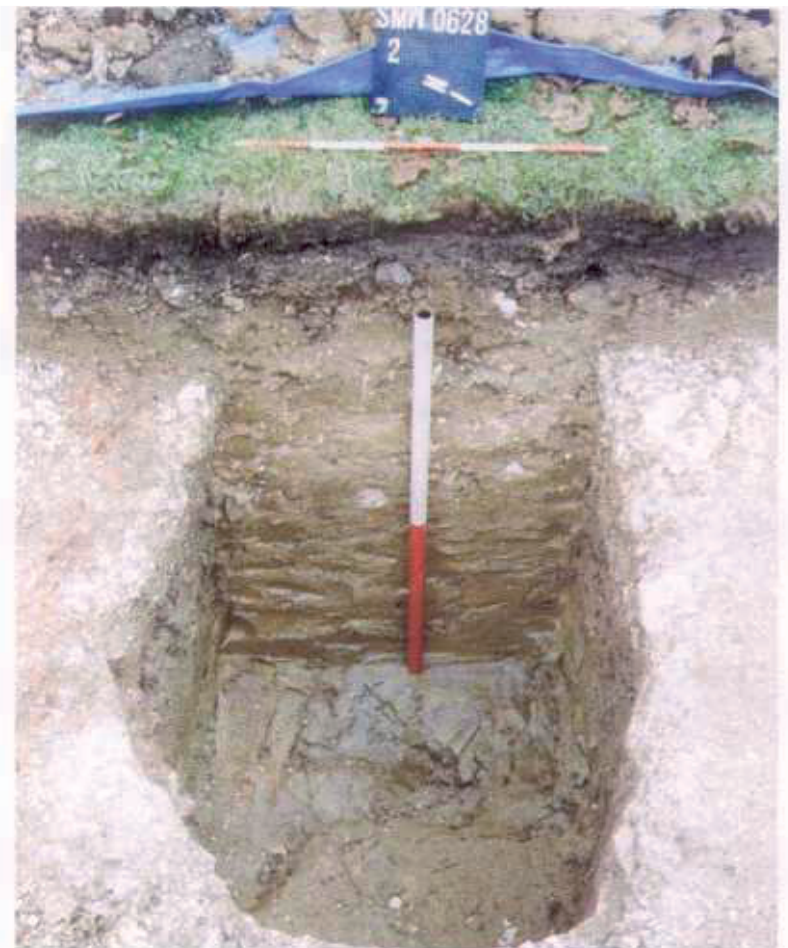
Feature 2 was aligned east–west and was exposed for 0.9m before it exited the trench beneath the baulk. Its maximum width was 0.75m. It was excavated to a depth of .2m and was found to be filled with a mottled yellow/grey clay (53) which had fragments of modern brick and tile within it (Fig. 5). Feature 3 was also aligned east–west, exposed to 0.74m in length and 0.62m in width and found to contain a very similar clay deposit to that in feature 2. Feature 3 was excavated to .35m where ingress of groundwater was encountered. Due to the possible risk of encountering partially preserved organic remains, the decision was taken to cease excavation at that depth rather than continue in an attempt to locate any remains interred.

Plate 2. Cut 2 looking north east. Vertical scale 1m, horizontal scale 0.5m
