**St Margaret's School, Petersfield Road,  
Midhurst, West Sussex**

**Building Recording**

**Site Code: MSM13/95**

Report 13/95b

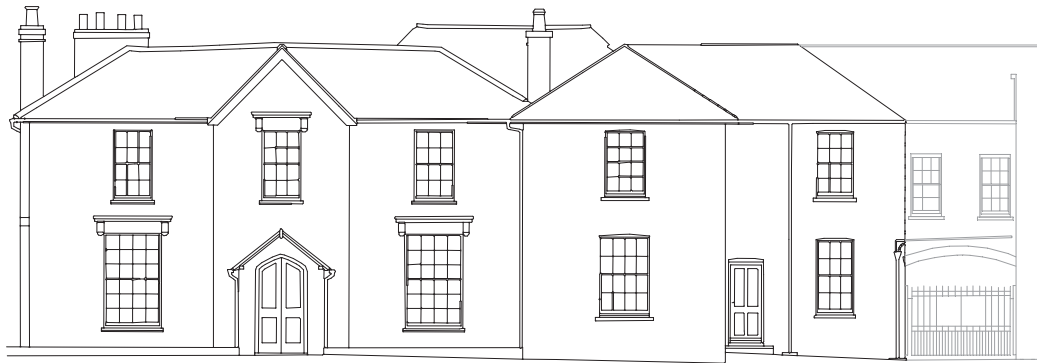
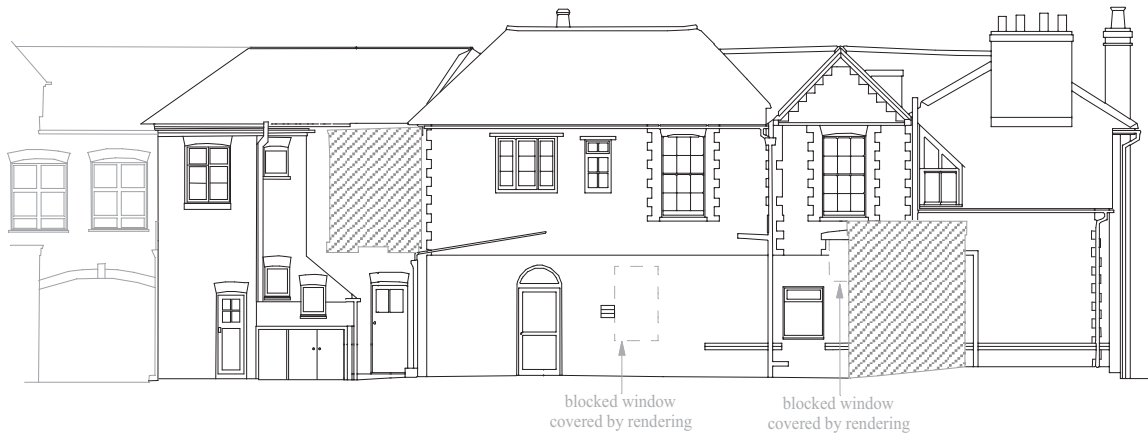
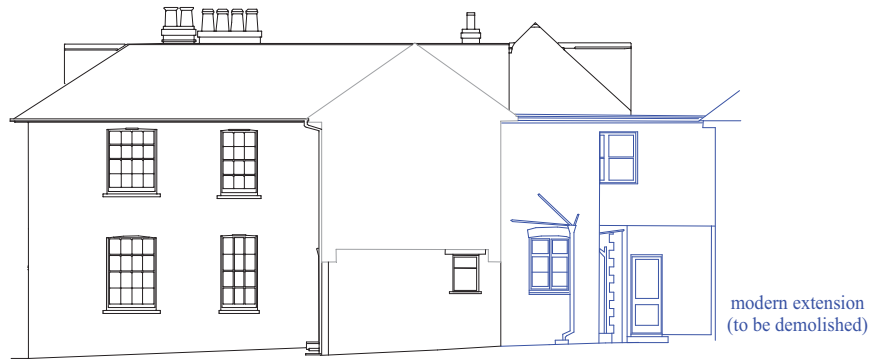
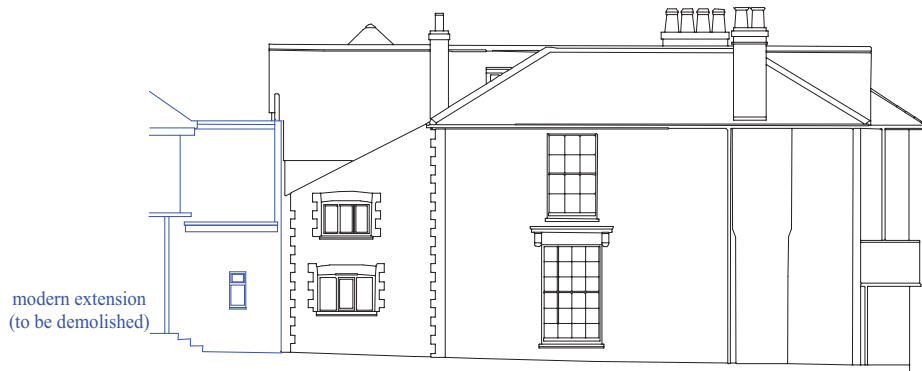
The building is parallel with, but set back from the road and consists of a double fronted villa with a gothic style porch (Pl. 1) and additional later extensions to the east (Pl. 2). A number of later extensions can also be seen at the rear of the property (Pl. 3). The front (south) elevation and the west elevation are rendered in 20mm thick cement which is made to look like ashlar blocks. The lower, ground floor of the rear of the property is also rendered in cement and a stone stringcourse at ground floor level is present over parts of it. A bargeboard decorated with perforated quatre-foils and painted white is present on the façade's gable pediment. The windows either side of the front door, the floor above and one in the west façade were adorned with a stone pediment supported on decorated consols.

The building is mainly constructed of roughly coursed sandstone rubble in a matrix of lime mortar. At the rear of the property where it is not rendered brick quoins are present at the corners of the building and around the windows. The bricks measured 228mm x 105mm x 60mm (9" x 4 1/8" x 2 3/8") and were laid decoratively to display the blue headers resulting from the clamp method of firing (Cunnington 2006, 148). The eastern end of the building was constructed of bricks measuring 215mm x 107mm x 60mm (8 1/2" x 4 1/4" x 2 3/8") in a matrix of gritty lime mortar; the coursing was not seen. The roofs were all covered in slate except one at the rear which was tiled.

Front (north) elevation

Rear (south) elevation

East elevation

West elevation

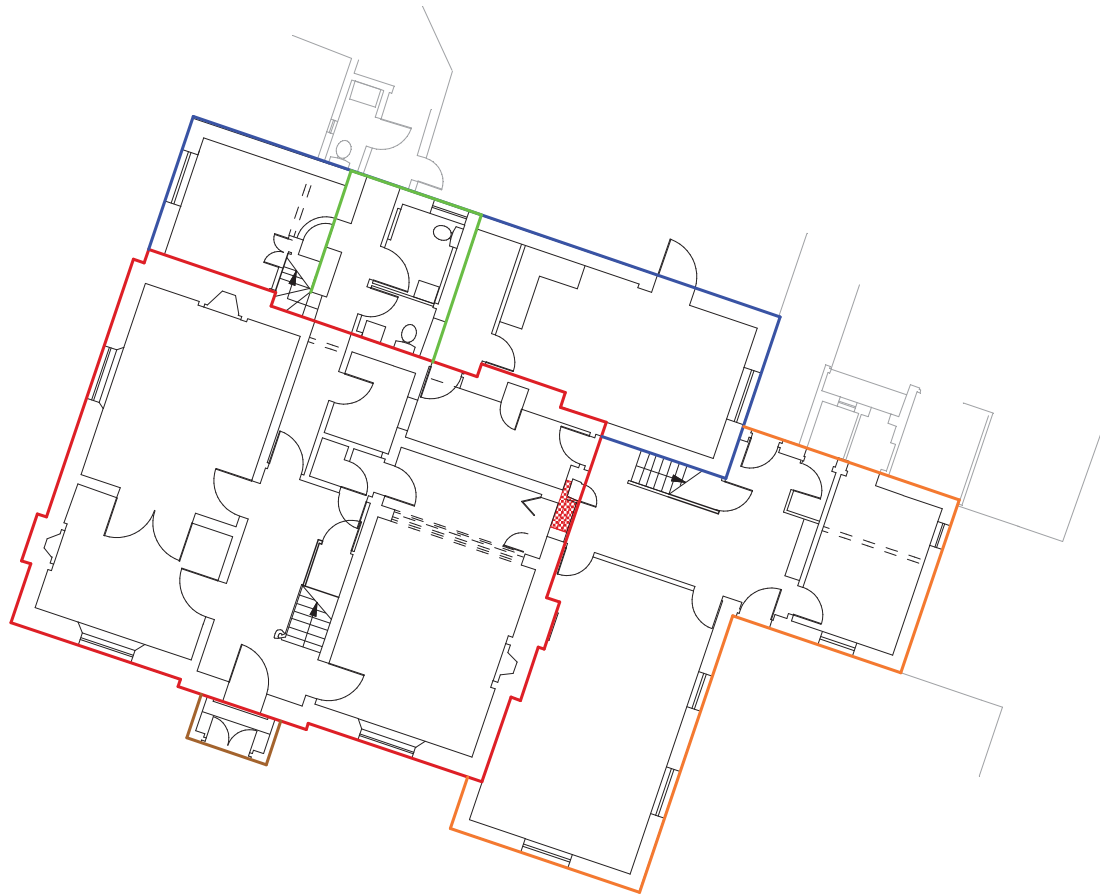
Figure 14. Phase plan of Ground floor.

The house has undergone a number of changes since it was first built, both through extensions and modernization. Map evidence provides some dates for various extensions but several were done prior to the 1840 tithe map, which is the first to show the building, and so can only be dated relative to one another and to that map (Fig. 14).

The house in its earliest form consisted of the south-west corner range without the front gothic style porch. Incidentally this original building respected the land boundary shown on the tithe map. It was constructed of roughly coursed sandstone with brick quoins around the windows (and presumably the doors and corners of the building, not now visible). In plan it was of double-pile type, with probably two rooms either side of the entrance, two rooms deep and two-storied throughout. Little remains of this early house, besides the shell, though key features such as chimneys, windows and door openings are likely to be most unchanged in terms of position. Evidence is also available for an additional two and probably three blocked or removed windows in the walls of rooms 2, 22 and 27. Internally it is not possible to reconstruct the number of rooms or the position of the staircase; the larger chimney stacks at the rear of the property suggest that these may have been service rooms (including a kitchen). The roof has been rebuilt and it is possible that the ceiling heights have been altered and a suspended floor inserted on the ground floor. Old and new timbers are present in the ground floor, first floor and roof spaces.

- Phase 1 c.1700
- Phase 2 pre1840
- Phase 3 pre1840 (on Tithe map)
- Phase 4 1840-1876
- Phase 5 1891-1912

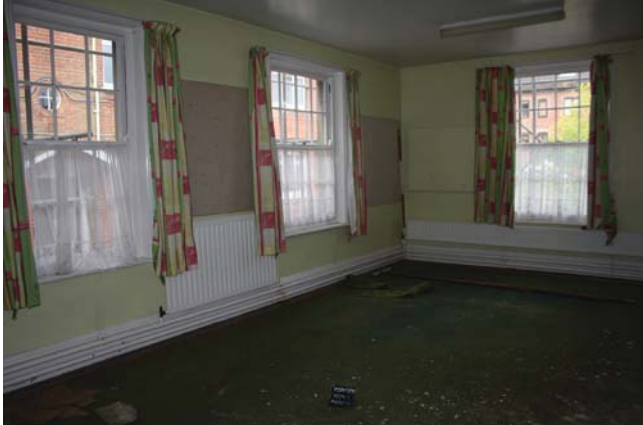
Room 1 was a large room with three windows, one in the front façade and two in the east elevation (Pl. 13). There were two doors in the northern wall, both giving access to hallway 16. The doors had two lower panels with a glass insert above divided into 9 panes of different sizes. A fireplace was located next to the rear of the one from room 2. It was of cast iron with a small flower decoration above the hood (Pl. 14).

Plate 13. Room 1, view to windows, looking south east,  
Scales: 2m and 1m.

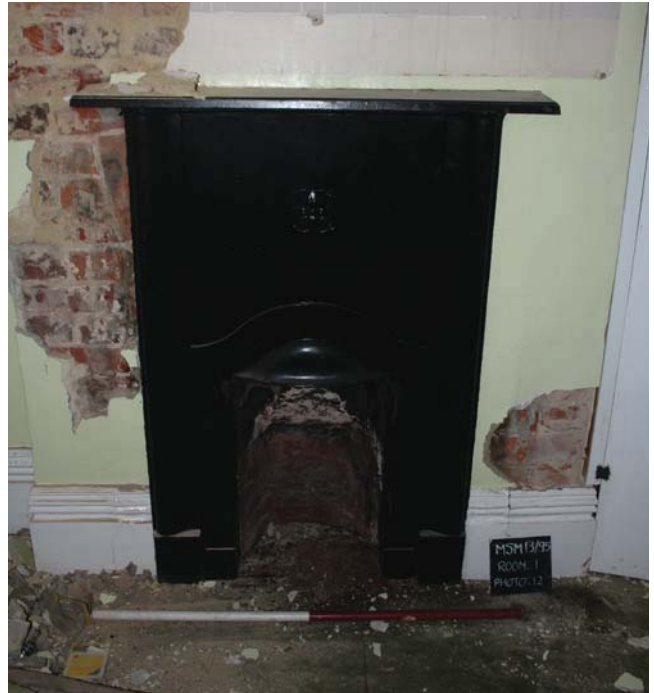
Plate 14. Room 1, detail of fireplace, looking west, Scale:  
1m.

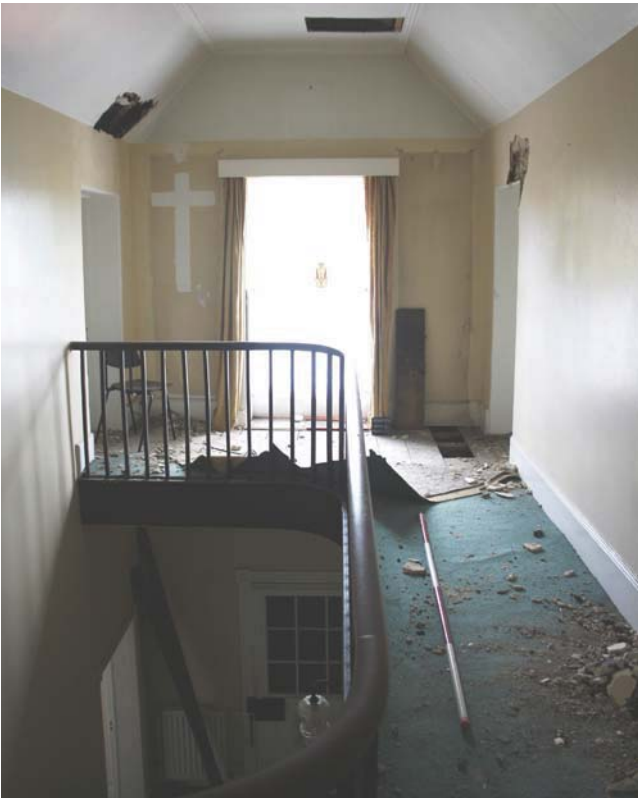
The upstairs landing (room 26) was dominated by the mahogany staircase with the banister rail continuing around the opening (Pl. 15). A sash window was present in the front elevation. The landing gave access to rooms 19, 20, 21 and 28. Where plaster had been removed above the doorways to rooms 20 and 21, the lintels were uncovered which consisted of re-used oak timbers and in both cases it was possible to see mortices (Pl. 16). The lower part of the ceiling followed the rafters before flattening out on the underside of the collar. A cornice was present on the flat part of the ceiling.

Plate 15. Room 26, view to window showing balustrade,  
looking south, Scales: 2m and 1m.

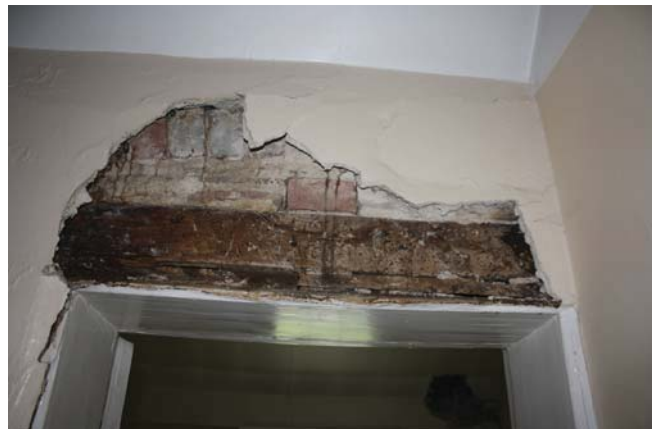
Plate 16. Room 26, oak lintel above doorway to room 21,  
looking west.

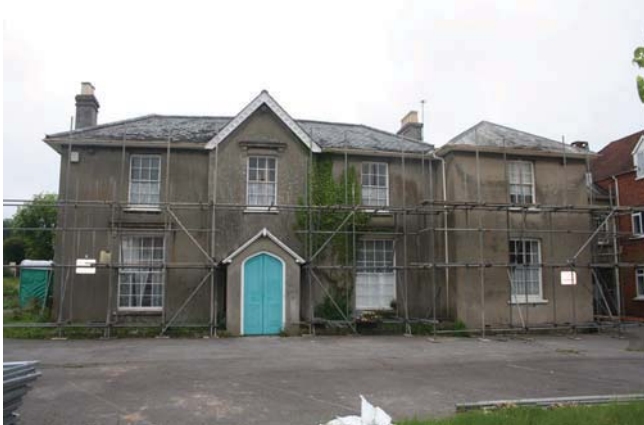
Plate 1. Exterior, front elevation, looking north.

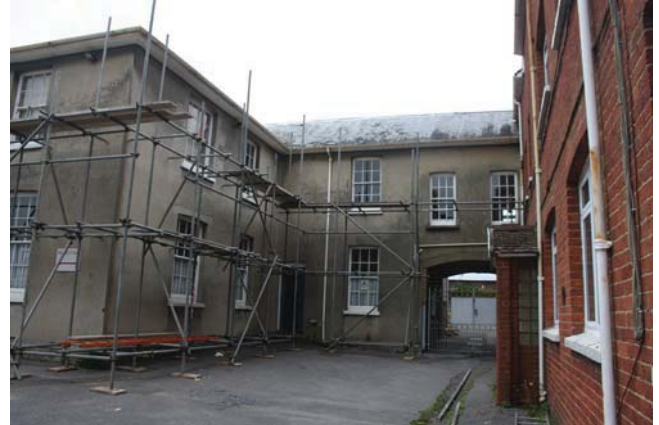
Plate 2. Exterior, front elevation showing arched section on east, looking south west.

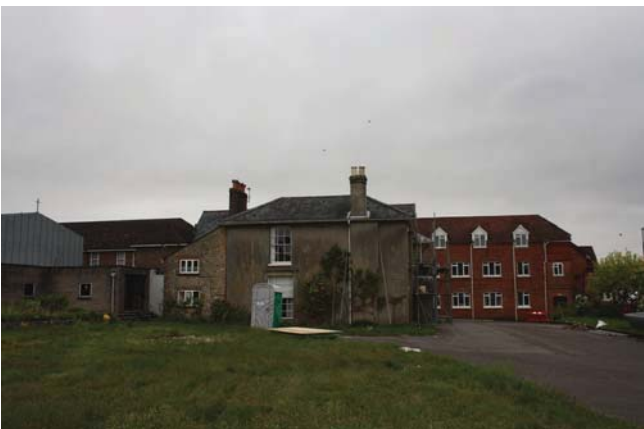
Plate 3. Exterior, side elevation, looking east.

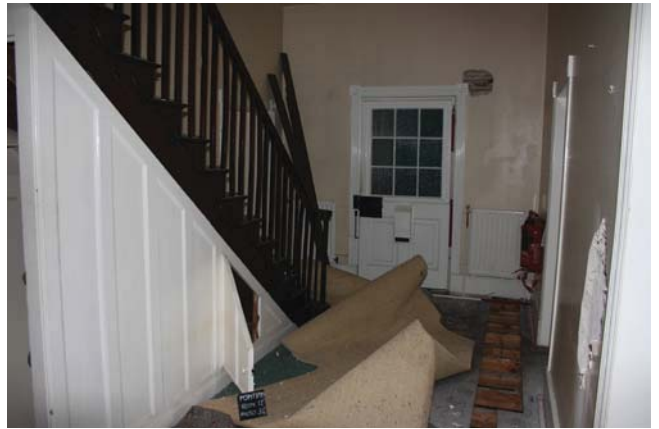
Plate 4. Room 12, view to door, showing stairs looking south east, Scales: 2m and 1m.

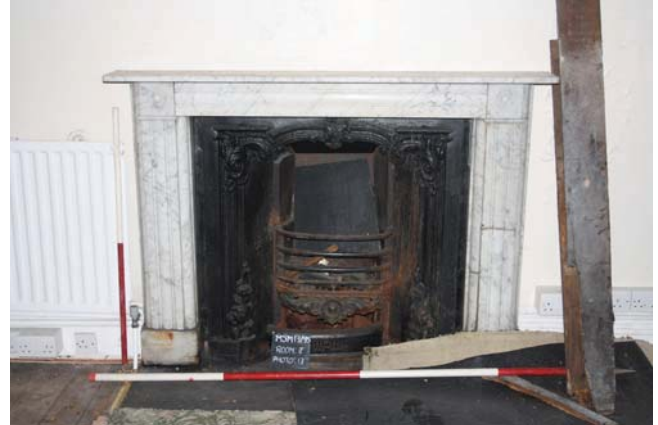
To the right of the entrance was room 2; a large entertaining room that had been increased in size by the opening up of what was originally a separate room beyond (Pl. 5). The window was in the front (south) elevation. A cast iron fireplace with marble surround was located in the original centre of the eastern wall (Pl. 6). The iron grate had floral decoration and a marble surround that matched the door mouldings. A supporting beam on square pillars provided access into a small room beyond which had a separate entrance and a cupboard in the recess formed by the supporting walls of the arch. The square pillars were decoratively fairly simple with raised panels and a slightly splayed capital. The ceiling height within this area was 3.21m rather than 3.05m as found in the rest of the room and the cornice was of a reeded style, slightly different from that found in the rest of the room.

Plate 6. Room 2, detail of fireplace, looking east, Scales: 2m and 1m.

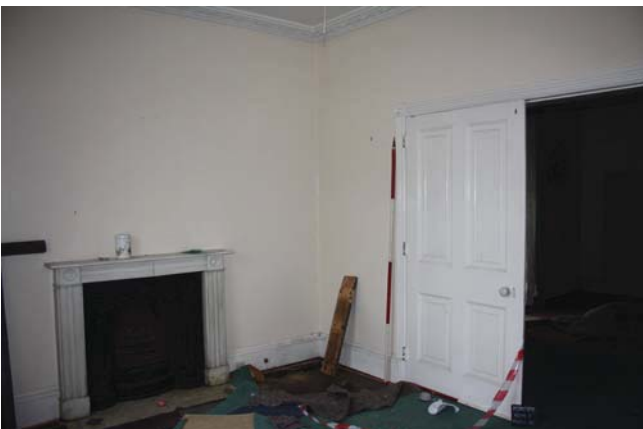
To the left of the entrance was room 3, with a window in the front elevation of the house, a fireplace on the west (external) wall and a pair of double doors separating it from room 4 (Pl. 7). The fireplace was of the same design as that found in room 2, but of a whiter marble. The hearth was of cream, rectangular tiles, fitted into the floorboards. The double doors were of the same four-panelled design found elsewhere in the house. The cornicing was of a leaf design.

Plate 7. Room 3, view to double doors and fireplace, looking north west, Scales: 2m and 1m.

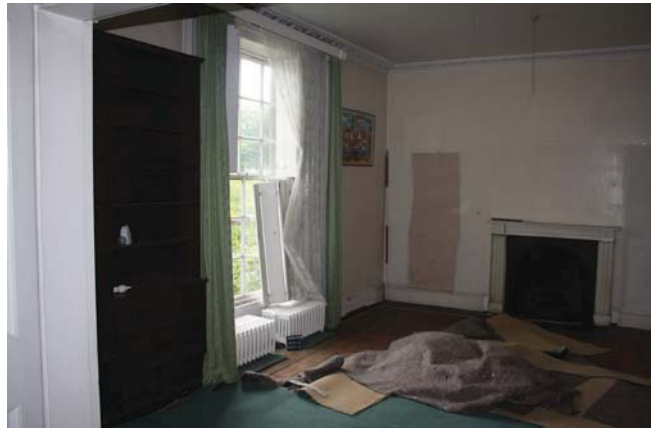
Further along hallway 12 on the left side of the entrance was room 4 (Pl. 8); accessed from both the hallway and via room 3. The window was in the western wall and the fireplace was located in the rear (northern) wall. The fireplace surround was of the same design as that found in room 2 but a different marble; the iron grate however was plainer with a curved opening. The hearth was of square, brown tiles. The cornicing was the same as that found in room 3.

Plate 8. Room 4, view to window and fireplace, looking north west, Scales: 2m and 1m.

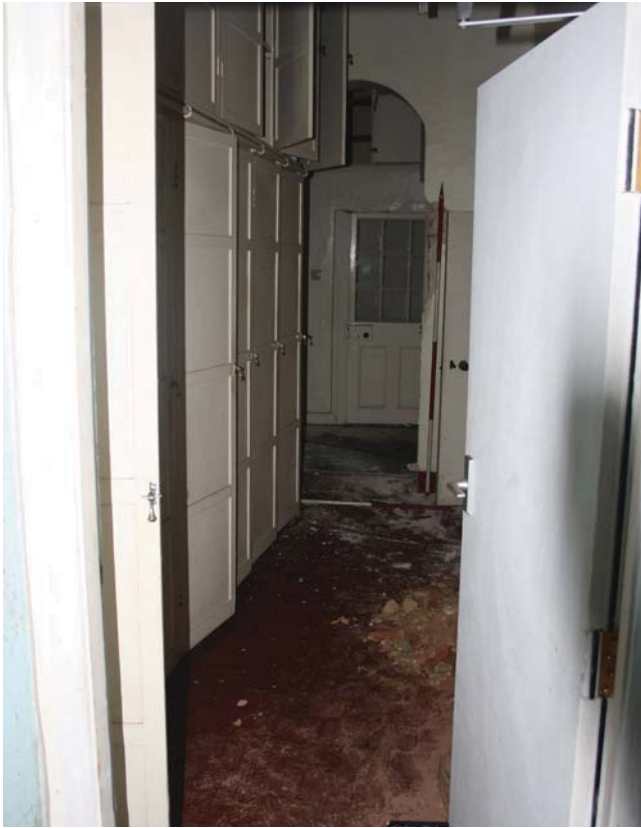
providing light into what would otherwise be a dark corridor. Room 10 was accessed from room 11 or from corridor 9 and consisted of a passageway lined with floor to ceiling cupboards. A later style door separates rooms 9 and 10. Room 11 provides a further storage cupboard and gives access to the rear of room 2. Room 13 was a corridor running behind room 2 between rooms 10 and 16 (Pl. 9). A plain door divided rooms 13 and 16 and a large archway divided it from room 10. The corridor was lined with cupboards on the south side and a blocked fireplace was on the north wall. The floor was of quarry tiles, presumably laid over timber as there was a slight ramp between rooms 10 and 13.

Plate 9. Room 13, view to room 10, looking west, Scales: 2m and 1m.

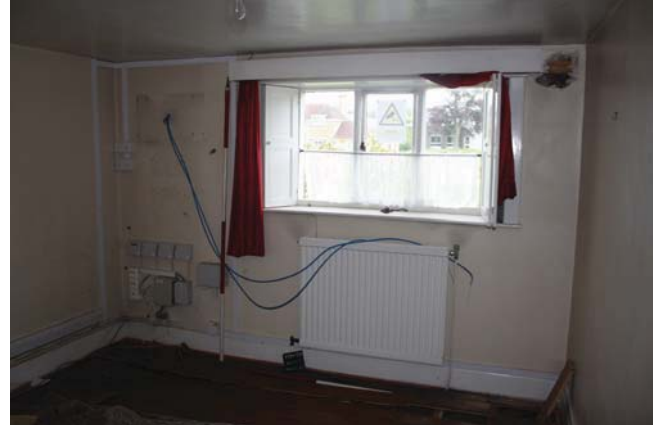
Plate 10. Room 5, view to window, looking south west, Scales: 2m and 1m.

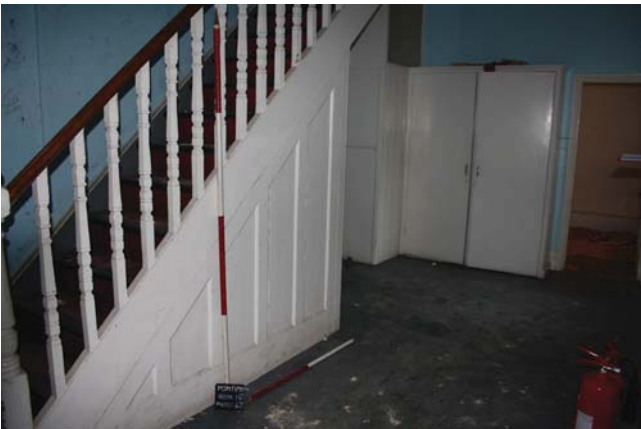
An external door was present in the south façade entering into room 16. The door was of four panels with glass inserts. Room 16 was a large hallway (Pl. 11) giving access to rooms 1 (two doors), 13, 17, the first floor and to a later extension at the rear. Access to a toilet extension had been partitioned off in the north-west corner. The staircase ran along the north wall and was a straight flight with carved balustrades and a newel post. A

Plate 11. Room 16, view to stairs and room 17, looking north east, Scales: 2m and 1m.

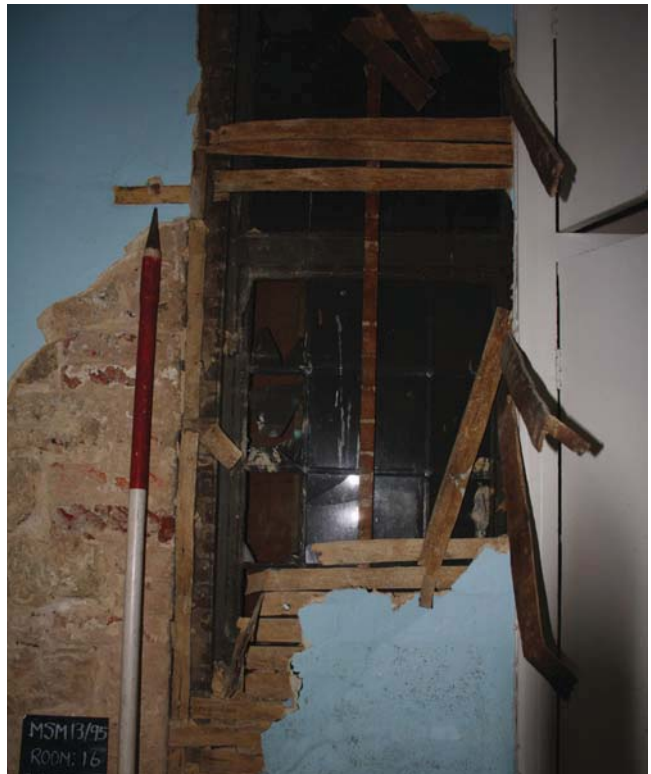
cupboard was present under the stairs. In the eastern wall was a cupboard recessed into the wall. Removal of plaster next to this cupboard revealed half of a wooden cross-style casement window with leaded panes and iron bars behind the lower opening (Pl. 12). The window measured more than 1.54m tall by more than 0.565m wide and around the edges of the window were brick quoins. The bricks were handmade and measured 220mm x 102mm x 48mm (8 7/8" x 4" x 1 7/8"). Above the window was a more recent brick arch, presumably put in at the same time as the cupboard to support the stone wall above.

Plate 12. Room 16, view of blocked window, looking west, Scale: 2m.

In terms of dating the original house construction, the double pile layout dates from the late 17th century (Brunskill 1997, 48). The blocked window is of cross-window type with a square cut transom, a type which was commonly found in houses dating from 1680 and into the 18th century (Hall 2005, 85). The bricks around the

edge of the window were handmade with dimensions suggesting a date of around the Restoration (*c.*1660–1685) after which bricks generally became thicker to 2 ½” or a little more (Harley 1974, 75). Whilst it is not certain if the suspended ground floor is original, such a concept dates from the beginning of the 18th century (EH 2006b, 6). Of possible note are the dates of the hearth tax which was repealed in 1685 and the window tax which was introduced in 1695; the house has a chimney in each room, which for the period is substantial, but it would appear that there was no more than one window per room. Therefore a date from sometime around 1685 to the very early 18th century would seem appropriate. This house would therefore appear to have been built by a wealthy yeoman or gentleman in the latest fashions of the period on the outskirts of Midhurst.

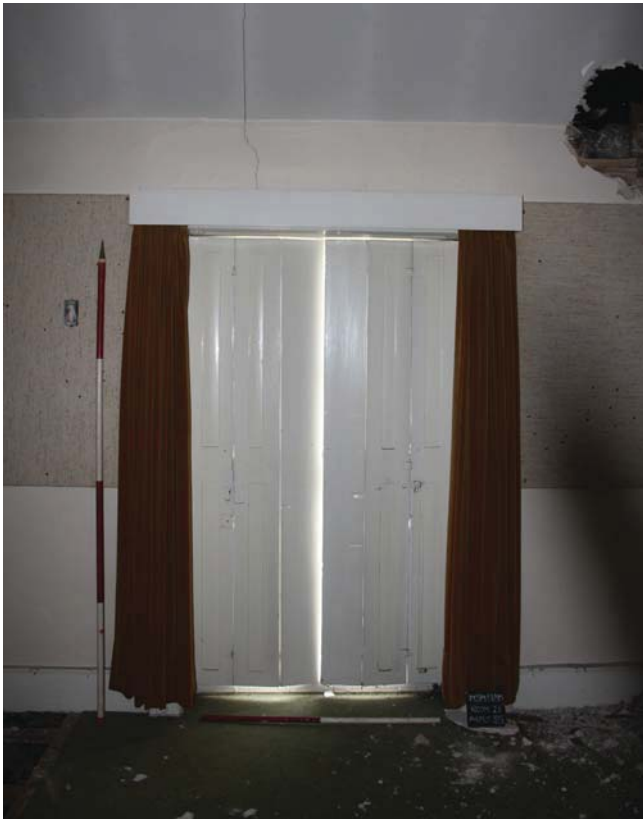
Behind room 20 was room 21 which was accessed from landing 26 and gave access to room 22. It had a sash window in the west façade which reached the floor; the shutters also reached the floor and were of the same design as others found throughout the house (Pl. 17). It is likely that there would originally have been a small wrought iron balcony protecting the window. A tall, narrow cupboard was present in each of the four corners of the room. The chimney breast was blocked, but would have been in the north wall. Room 22 was located in between room 21 and corridor 28 (Pl. 62). It had a dormer window to provide light and a cupboard recessed into the back wall. The cupboard was probably once the location of a window and or doorway to room 23.

Plate 17. Room 21, view to shuttered window, looking west, Scales: 2m and 1m.

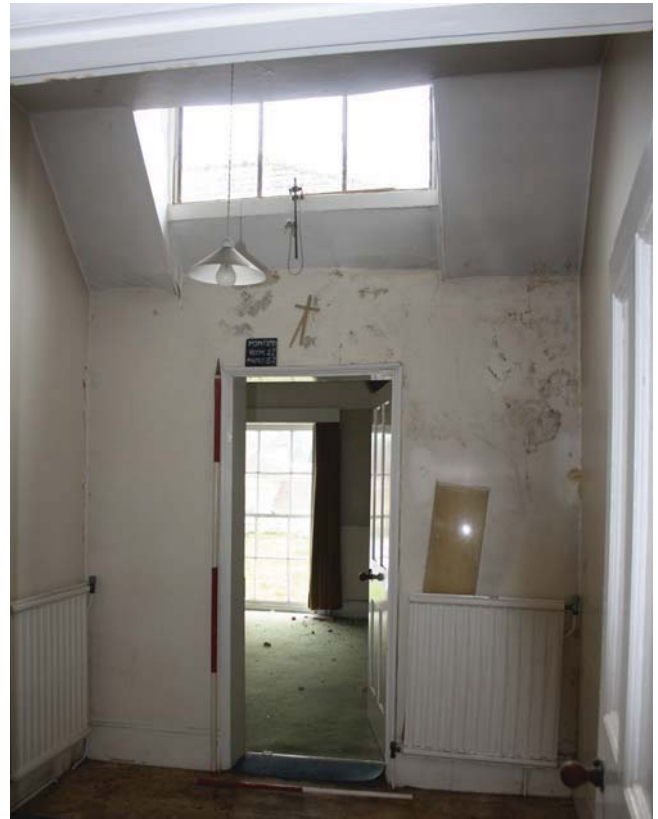
Plate 18. Room 22, general view to room 21, looking west, Scales: 2m and 1m.

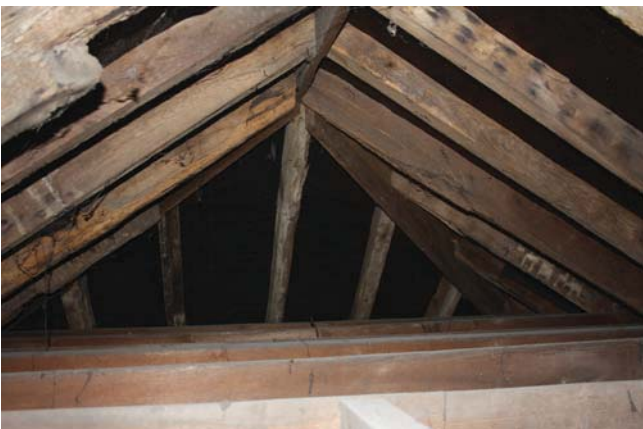
The roof space above rooms 19/27–28 was constructed using both new and reused timbers laid on edge to form trusses. The trusses had a raised collar and were joined using a ridge plank (Pl. 19). The roof space above rooms 29–32 was of a different construction with the purlins supported on trusses with raking struts, though the

Plate 19. Roof above room 19, looking north.

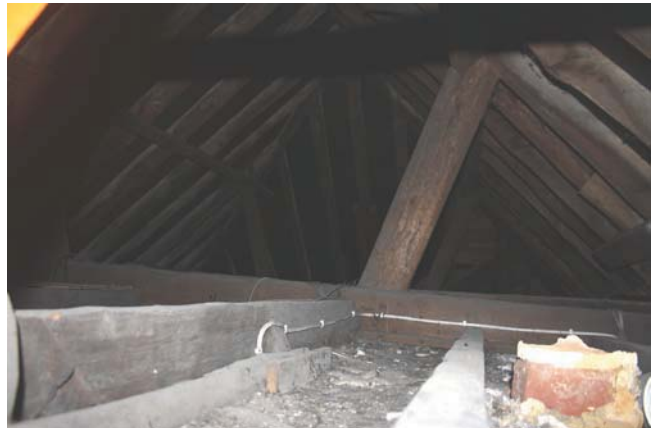
timbers were still laid on edge (Pl. 20). From photographs in the structural report the roof space above rooms 18/34 was similar to that above 19–32 but narrow, vertical supporting timbers were present either side of the collar. The roof above room 25 consisted of timbers laid on edge continuing down from the roof over rooms 20/21 and presumably resting on the rear wall of room 21. A mixture of new and reused timber was used, including one cut with a circular saw (invented 1777).

Plate 20. Roof above room 29, looking east.
