**Letchworth Golf Club,
Letchworth, Hertfordshire**

Archaeological Evaluation

Site Code: LGC12/128

**An Archaeological Evaluation
for Woodland Environmental**

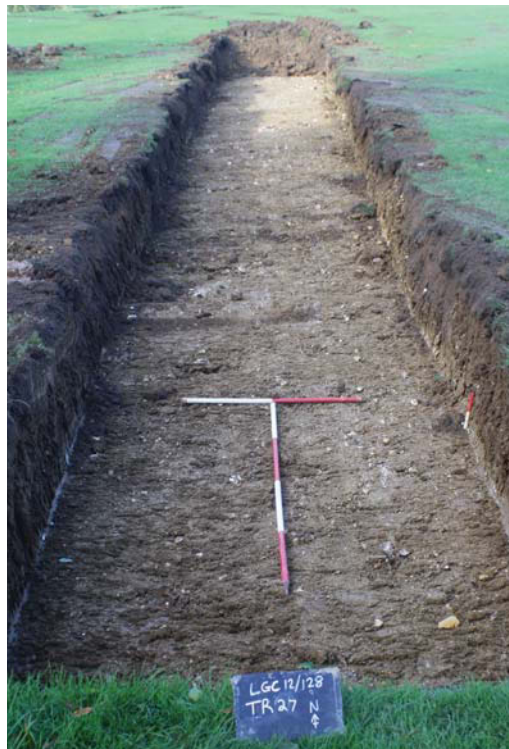
Plate 1. Trench 3, looking north, Scales: 2m, 1m and 0.1m.

Trench 3 was aligned SE-NW and measured 25.2m long and was 0.42m deep. The stratigraphy comprised 0.19m topsoil and 0.21m subsoil overlying natural chalky clay. Two ditches (1 and 2) aligned E-W were identified corresponding with geophysical anomalies that resembled a trackway. Ditch 1 measured 1.16m in width and was 0.5m deep. It contained two deposits of grey brown silty clay (52) and a brown silty clay (53), a single sherd of Roman pottery was recovered from each deposit, along with tiny chips of brick or tile from 53. Ditch 2 was 0.96m wide and 0.48m deep and contained a single grey brown silty clay deposit (54) from which 100g of animal bone were recovered. A third linear feature (3) aligned NE-SW was recorded towards the NW end of the trench. It measured 0.72m wide and was 0.18m deep, it contained a brown grey silty clay deposit (55) but no finds were recovered. This linear feature did not correspond with anything from the geophysical survey.

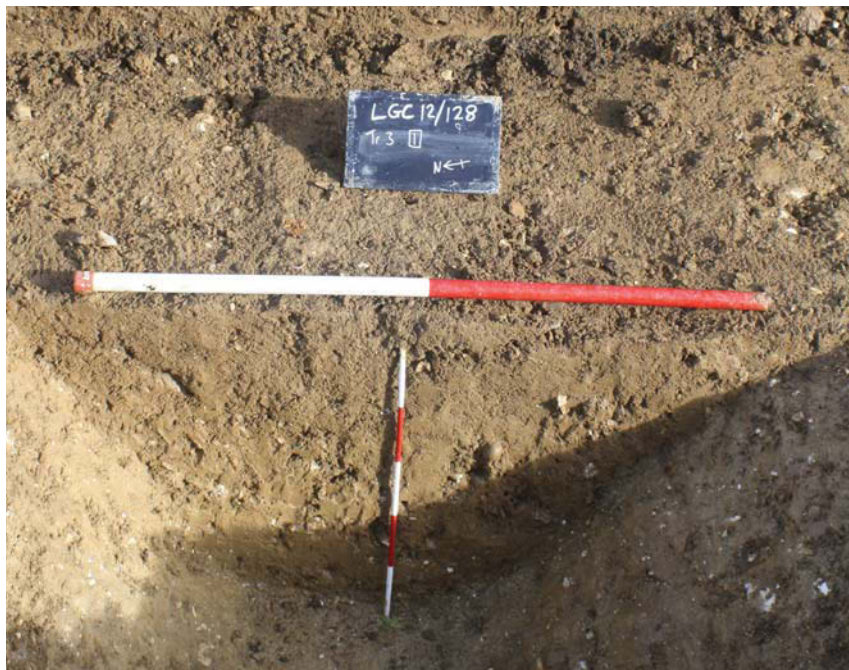
Plate 2. Trench 3, ditch 1, looking south east, Scales: 1m and 0.5m.

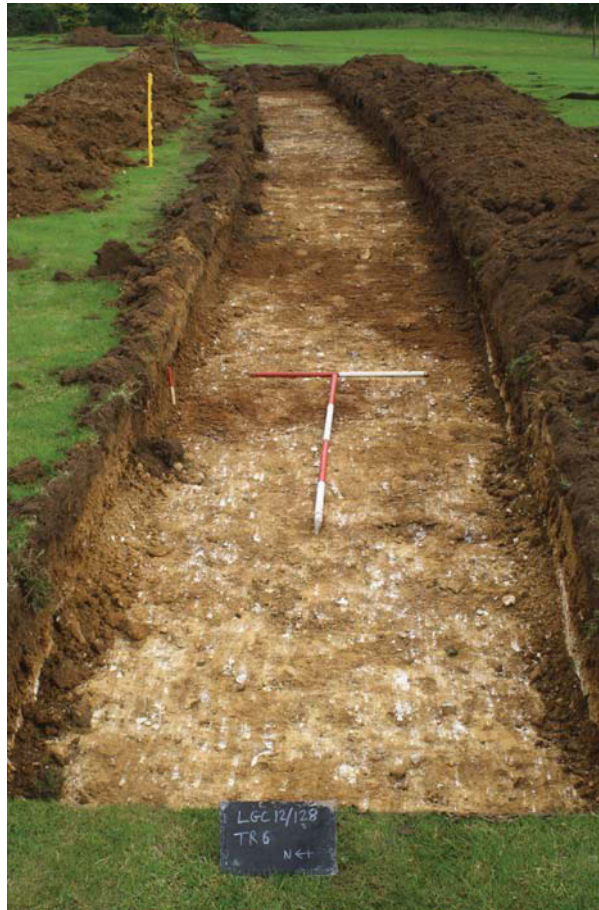
Plate 3. Trench 6, looking east, Scales: 2m, 1m and 0.1m.

Trench 6 was aligned W-E and measured 25.2m long and 0.53m deep. The stratigraphy comprised 0.3m topsoil and 0.18m subsoil overlying natural geology. A ditch (6) was aligned NE-SW and measured 1.4m wide and 0.33m deep. It was filled with a brown silty clay (58) from which no finds were recovered. The ditch was not previously identified in the geophysical survey but roughly parallels those to the north.

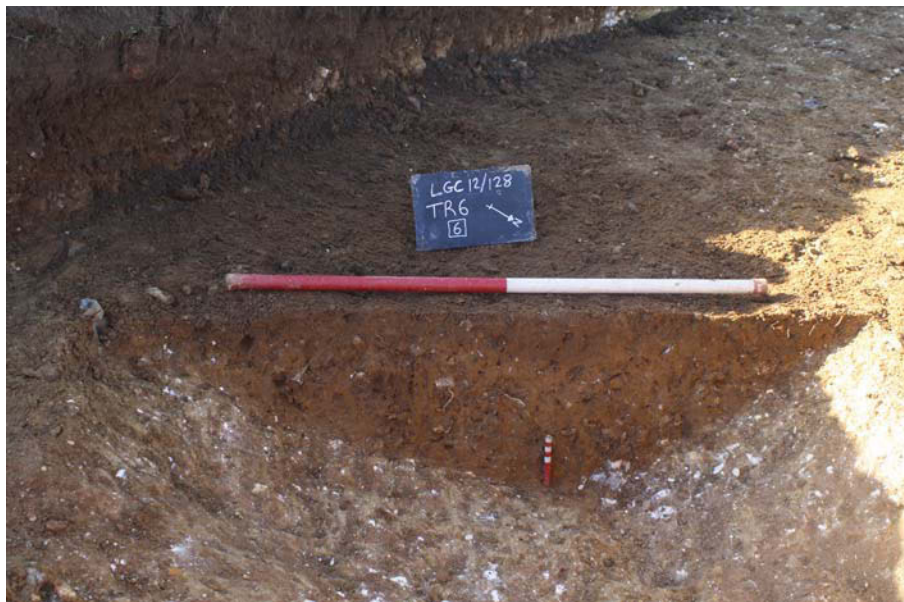
Plate 4. Trench 6, ditch 6, looking south west, Scales: 1m and 0.1m.

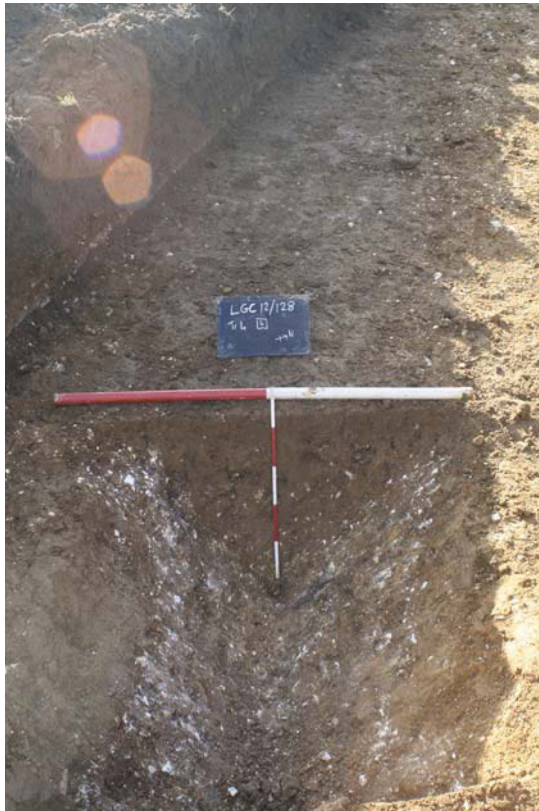
Plate 5. Trench 4, ditch 4, looking west, Scales: 1m and 0.5m.

Trench 4 was aligned E-W and measured 25.2m in length and was 0.42m deep. The stratigraphy comprised 0.2m topsoil and 0.2m subsoil overlying natural chalky clay. Linear feature 4, aligned NE-SW and measuring 0.97m wide and 0.44m deep, was recorded (Pl. 3). It contained a single deposit of grey brown silty clay (56) from which a single horse bone was recovered. Ditch 4 corresponds with a geophysical anomaly and with ditch 2 in Trench 3.

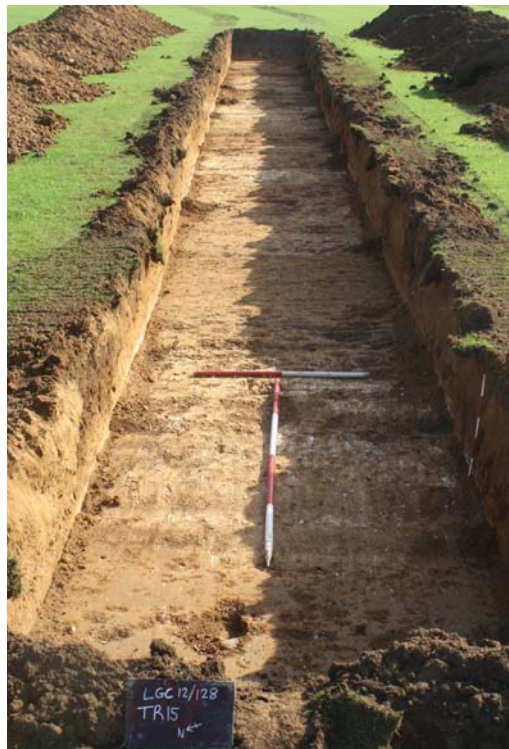
Plate 7. Trench 15, looking south east, Scales: 2m, 1m and 0.1m.

Trench 15 was aligned SE-NW and measured 25.0m long and 0.64m deep. The stratigraphy comprised 0.21m topsoil and 0.39m subsoil overlying natural geology. A ditch at the south end of the trench (9) was aligned NE-SW and measured 1.92m wide and 0.78m deep was recorded (Pl. 4). It contained deposits of dark brown sandy silt with flints (61), light brown sandy silt (62) and dark brown sandy silt (63); 28 sherds from the lower half of a single Roman pot were recovered from deposit 61. Ditch 9 matches a geophysical anomaly, part of the same trackway noted to the north-east. A second ditch marking the other side of the same trackway (17) was 3.86m wide, 0.55m deep and contained three deposits of dark brown sandy silt (71), light brown sandy silt (72) and sandy gravel (73). No finds were recovered from this feature.

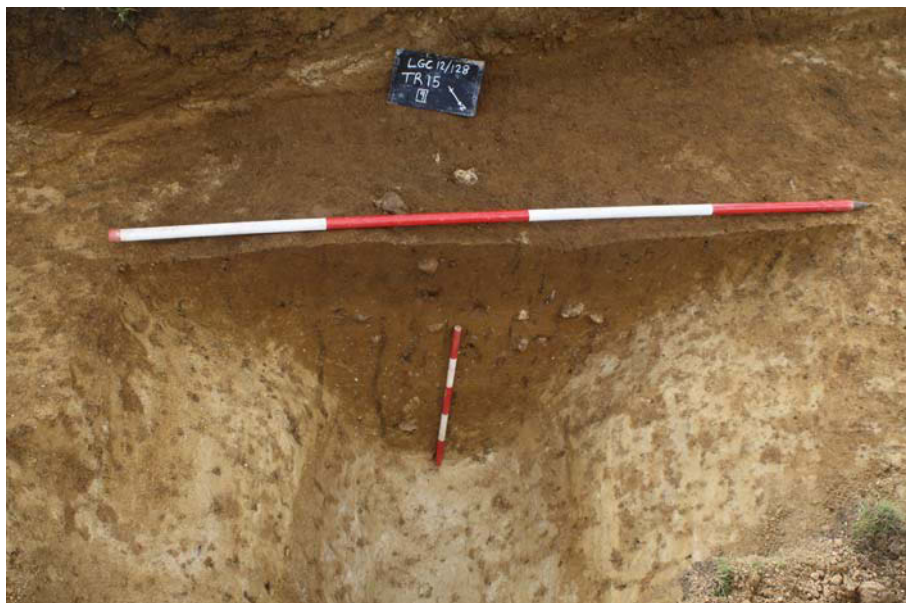
Plate 8. Trench 15, ditch 9, looking south west, Scales: 2m and 0.5m.

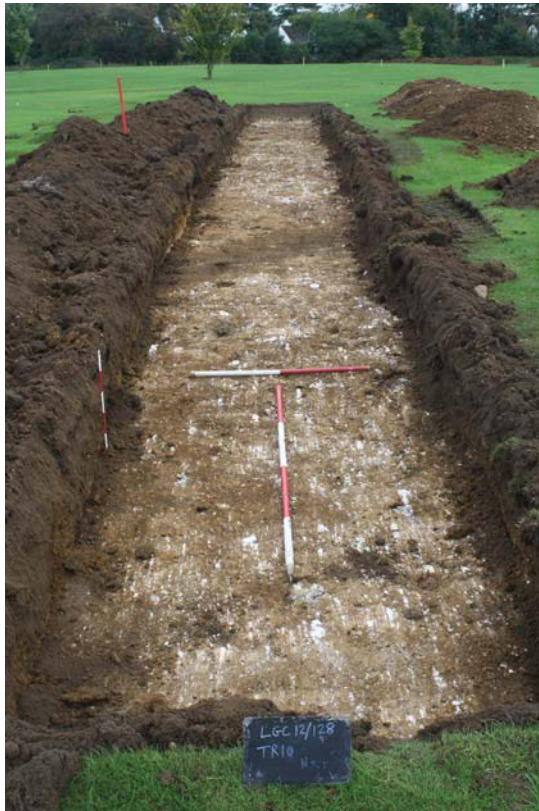
Plate 9. Trench 10, looking east, Scales: 2m, 1m and 0.5m.

Trench 10 was aligned W-E and measured 24.95m long and 0.42m deep. The stratigraphy comprised 0.2m topsoil and 0.16m subsoil overlying natural geology. A ditch (7) aligned NE-SW was recorded that measured 0.36m wide and 0.26m deep and was filled with a grey brown silty clay (59) from which no finds were recovered. The ditch was truncated by a modern boundary ditch (8; probably the same as ditch 5 observed in Trench 9) which was filled with a soft dark brown deposit of silty sand (60).

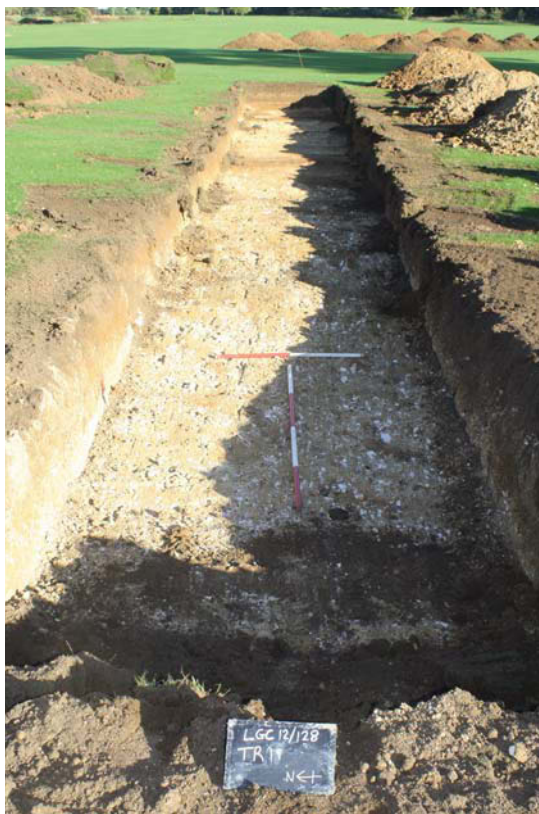
Plate 10. Trench 19, looking east, Scales: 2m, 1m and 0.1m.

Trench 19 was aligned W-E and measured 25.0m long and 0.70m deep. The stratigraphy comprised 0.3m topsoil and 0.18m subsoil overlying natural geology. A ditch (14) aligned roughly N-S was recorded that measured 1.4m wide and 0.39m deep and was filled with a grey brown sandy clay (68) from which no finds were recovered. Ditch 15 lay parallel to ditch 14 and measured 1.46m wide and 0.40m deep and was filled with grey brown sandy clay (69) and no finds were recovered.. Both match geophysical anomalies that continue north.

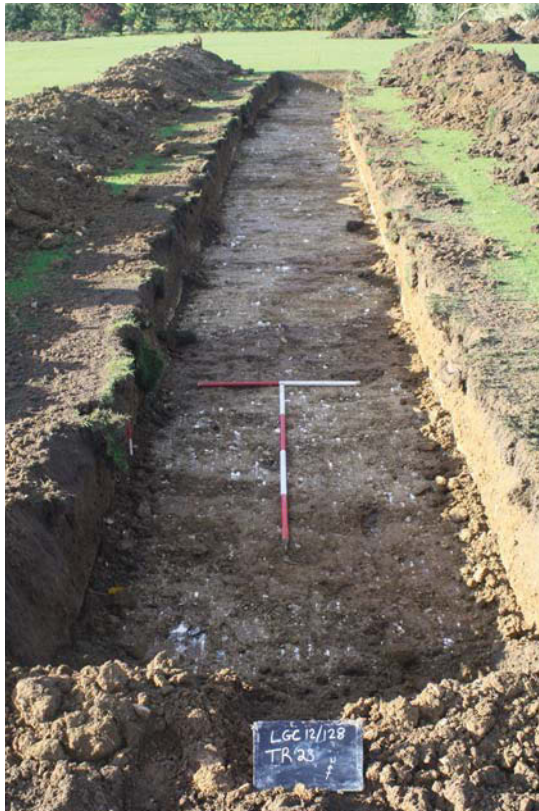
Plate 11. Trench 23, looking north west, Scales: 2m, 1m and 0.1m.

Trench 23 was aligned SE-NE and measured 28.1m long and 0.62m deep. The stratigraphy consisted of 0.30m topsoil and 0.3m subsoil overlying natural geology. Three linear features aligned SW-NE (11, 22 and 23) were recorded and measured 0.8m wide and up to 0.3m deep, all were filled with a brown silty clay deposit and no finds were recovered, their spatial pattern suggests that they are the remains of furrows. A N-S aligned ditch (12) was 1.0m wide and 0.4m deep. It contained a grey silty clay deposit (66) but no finds were recovered, the ditch was not identified during the geophysical survey and nor did it appear in nearby trenches.

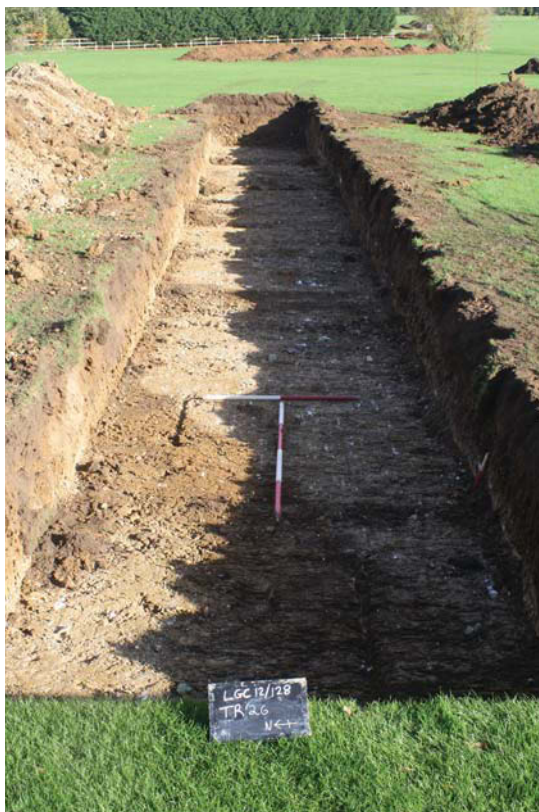
Plate 12. Trench 26, looking east, Scales: 2m, 1m and 0.1m.

Trench 26 was aligned E-W and measured 25.1m long and 0.64m deep. The stratigraphy consisted of 0.30m topsoil and 0.3m subsoil overlying natural geology. A ditch (10) aligned NW-SE and measured 0.8m wide and 0.27m deep was recorded. It was filled with a brown silty clay (64) from which no finds were recovered. The alignment of the ditch suggests a relationship with the linear features recorded in Trenches 23 and 24.
