# Land at Mill House, 17 Mill Road, Denmead, Hampshire

An Archaeological Evaluation

Site Code AY285

**Report 06/21**

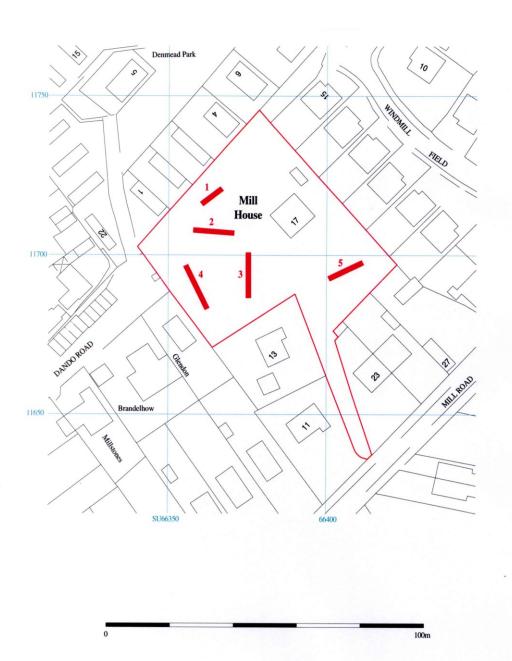
Figure 3. Location of Trenches

A number of trenches had to be shifted slightly from their original intended positions, due to the presence of trees, a pond, and areas of the garden which could possibly contain reptiles (Fig. 3). As a result, it was not possible to excavate all the trenches to their full intended length of 15m. Ms Matthews approved these slight variations from the intended scheme of investigation.

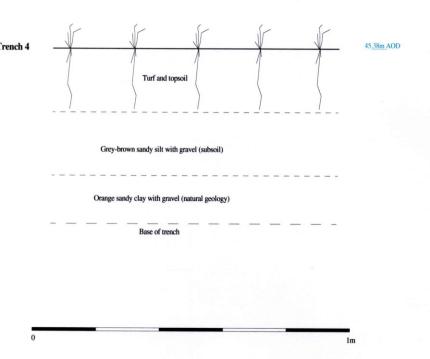
Figure 4. Representative section

This trench was moved slightly from its original intended position, due to the presence of trees. The trench was aligned approximately NW–SE, and was 16m long. Up to 0.2m of turf and topsoil were removed to reveal a layer of subsoil, about 0.2m thick. This lay directly above the natural clay with flints, although a small patch of clean yellow clay was observed at the southern end of the trench (Fig. 4). Apart from a modern field drain, no archaeological finds or features were present.

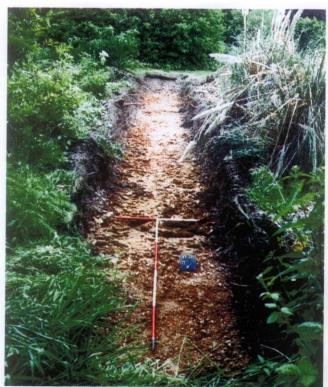
Plate 1. Trench 2 looking east, scales 1m and 2m.

Trench 2 was aligned approximately east—west, and was 13.5m long. Topsoil, up to 0.2m thick, overlay about 0.2m of subsoil, which lay directly above the natural clay with flints. There were no archaeological finds or features observed.

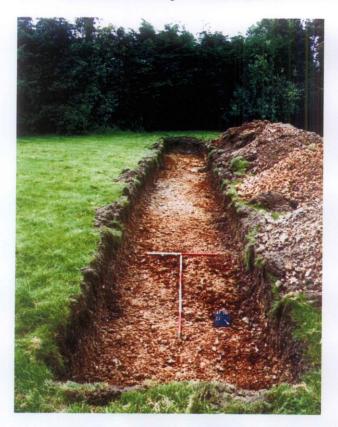
Plate 2. Trench 3 looking south, scales 1m and 2m.

Trench 3 was 14.7m long and aligned north—south. Turf and topsoil, up to 0.25m thick, overlay about 0.25m of subsoil, which lay directly above the natural geology. This generally consisted of clay with flints, although a patch of clean yellow clay was observed at the southern end of the trench. No archaeological finds or features were recorded in this trench.
