**The White House, St Mary's College, Bitterne Park,  
Southampton, Hampshire**

**Building Recording**

**Site Code: SOU1635**

Report 13/184

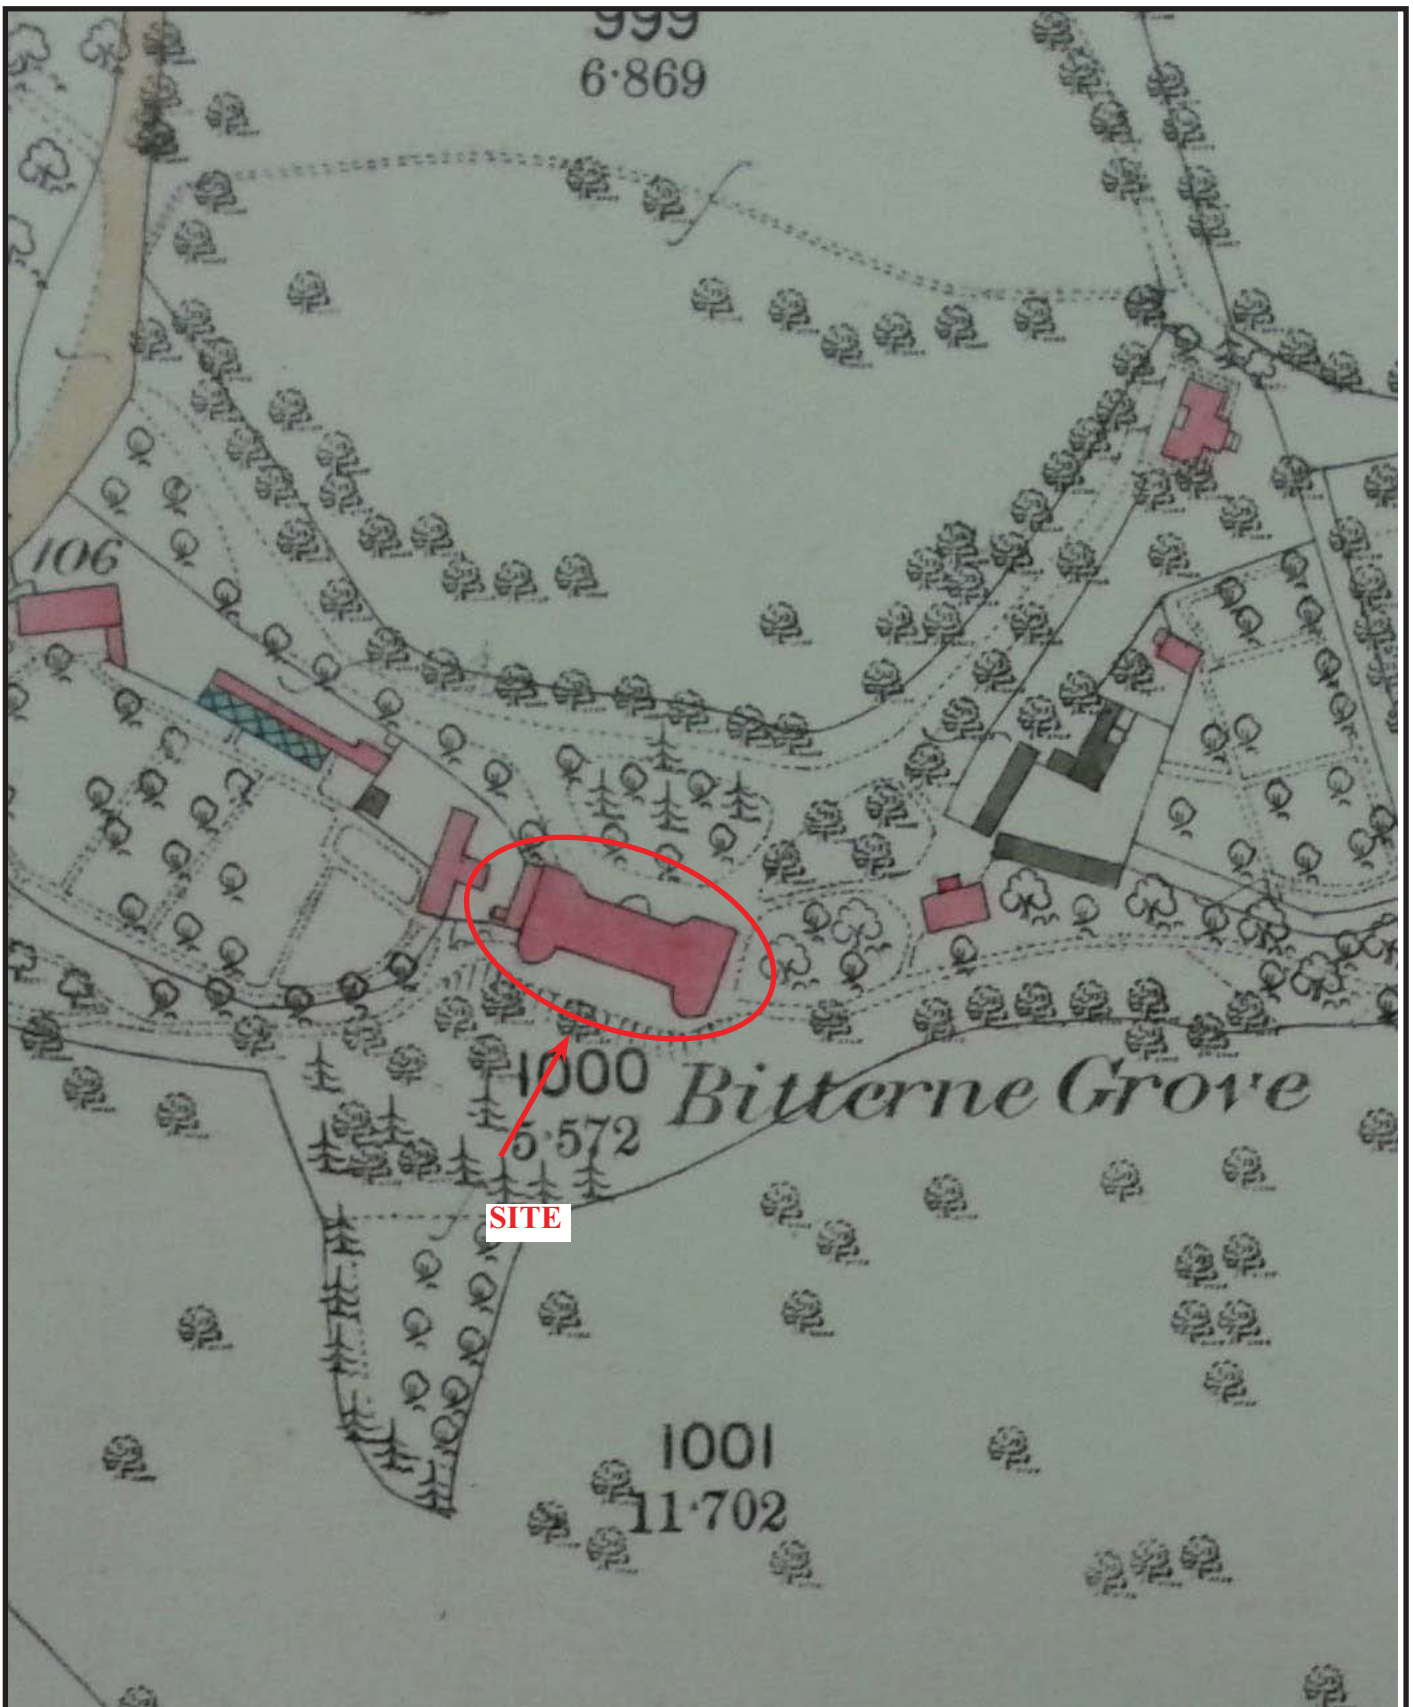
Figure 4. First Edition Ordnance Survey, 1885.

The first edition Ordnance Survey map of 1885 (Fig. 4) shows a bit more detail. The shape of the wings at either end of the house can be seen to be curved on the southern side of the building. The porch on the north side of the building is also curved and there is a further small extension on the western side of the building. The only change by 1897 (Fig. 5) appears to be the demolition of the small extension on the western side of the building that had appeared on the earlier 1885 map. No further changes have occurred by 1910 (Fig. 6). However by 1933 (Fig. 7) significant changes have taken place. A large, L-shaped extension has been added to the eastern end of the building, though no changes have been made to existing building. It is at this point that the building becomes known as St Mary's Roman Catholic College, rather than Bitterne Grove. No further changes can be seen on the 1941 and 1947 maps. By 1960 (Fig. 8) a building has been built to the east and connected to the existing building via a corridor. On the 1973 map the building is at the junction of two map sheets and consequently the exact nature of the extensions to the east are unclear, however a further extension has been added to the west.

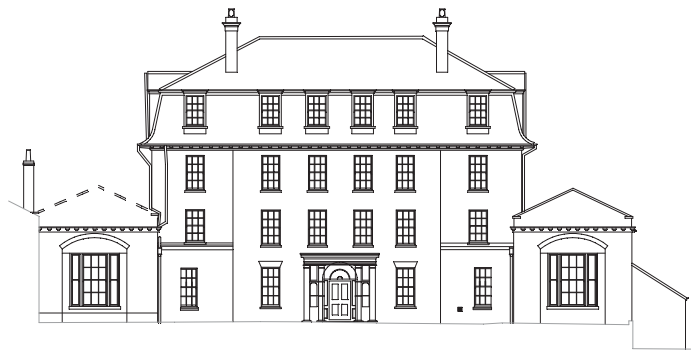
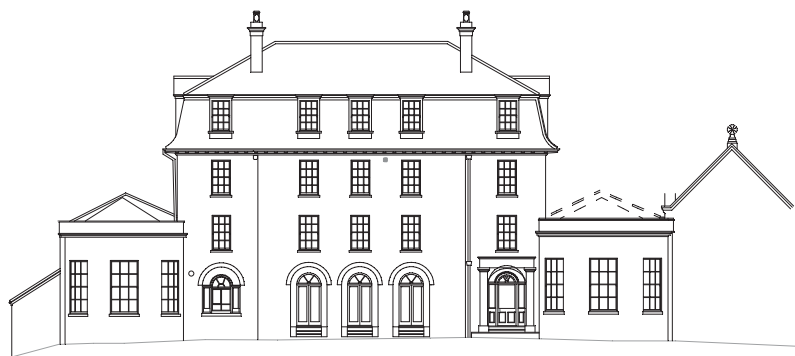
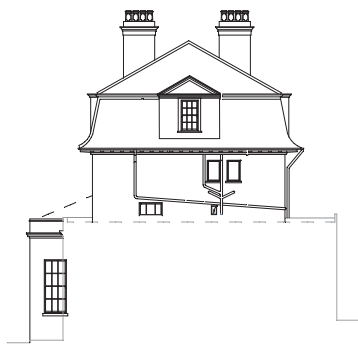
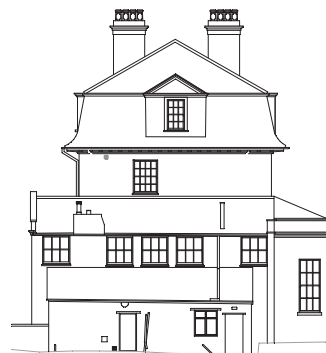
Figure 9. Elevations.

Bitterne Grove stands on a terrace of land with its main entrance on the northeast east side (Pl. 1) with a patio area at the rear before the land slopes away to the south (Pl. 2). It is a three-storey building, six windows wide with a slate mansard roof covering the main central area. The two wings either side have a pitched slate roof. The building can be sub-divided into four distinct parts; the central area, the southeast wing, the northwest wing and the lean-to extension.

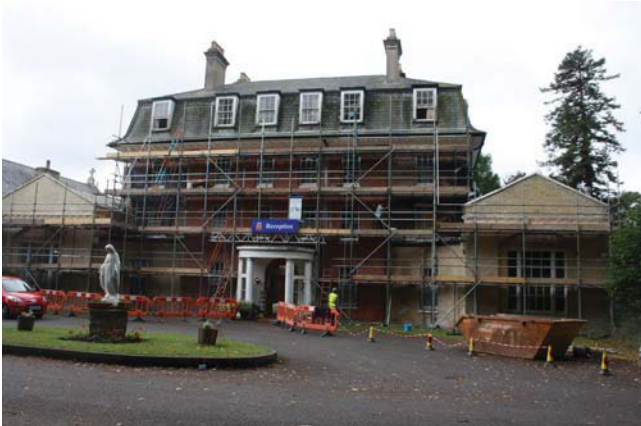
Plate 1. Front of building, looking south west.

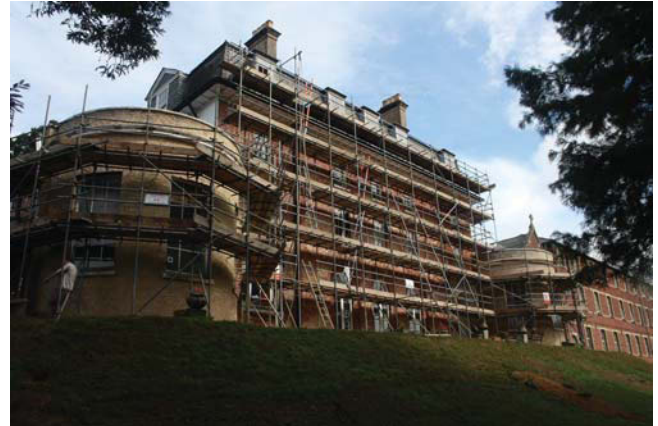
Plate 2. Rear of building, looking east.

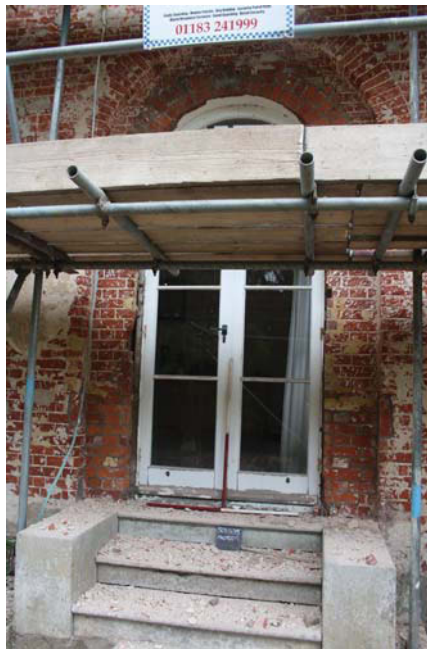
The rear, southwest elevation contained only three windows across its width on the first floor. These were the same as the ones round the front. On the ground floor were three French windows with fan lights set back in arches. Each had three steps up to it. Repair work has been carried out around all of the doors which may suggest that the original may have been a different size or could have been windows (Pl. 3).

Plate 3. Brickwork around door, looking north east,  
Scales: 1m.

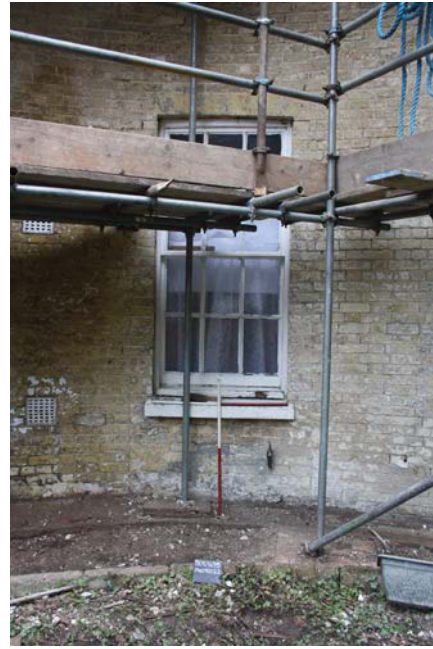
window and joining the original building with the two wings at either end. In the northwest wall it would appear that there was once a doorway that has subsequently been blocked up beneath the window (Pl. 4).

Plate 4. Brickwork under window, N wing, looking west,  
Scales: 1m.

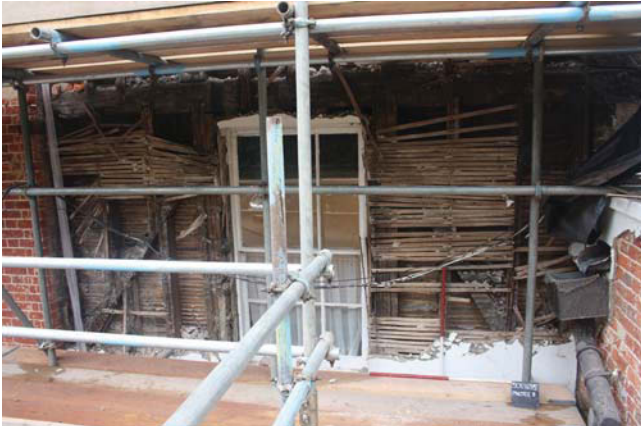
Above this was a timber frame construction, containing a window at each storey. The timber frame consisted of re-used oak timbers containing peg holes and mortices. The construction consisted of a timber joist supporting two upright posts each side of the window, tied together with a brace (Pl. 5). Supported on this was a second joist, window and timber frame. Smaller uprights were then added to hold laths for plaster. At the northwest end it was possible to see chiselled carpenters marks on some of the timbers (Pl. 6). Part of the southeast end had been rebuilt in brick, presumably when the roof was raised, c. 1912.

Plate 5. North wing bottom, looking south west,  
Scales: 1m.

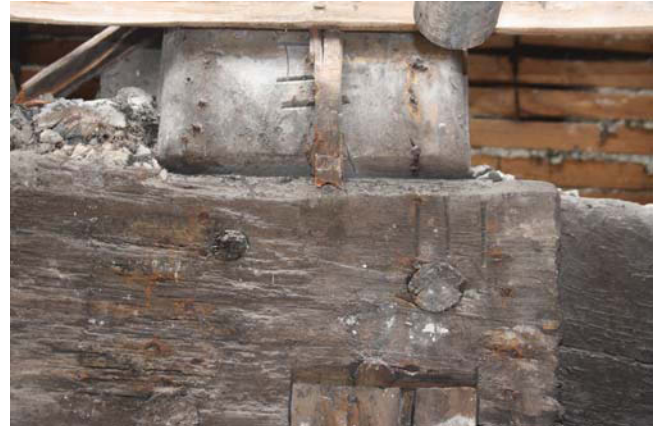
Plate 6. North wing bottom carpenters mark III,  
looking south west.

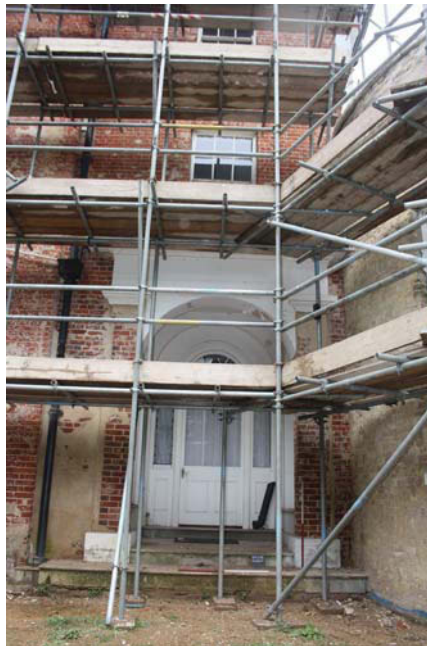
The rear elevation was entirely brick built with a window on both the first and second storeys. The construction was of red brick with slightly blue headers measuring 212mm x 102mm x 60mm (8 3/8" x 4" x 2 3/8") laid in English bond with lime mortar. On the ground floor the northwest end contained a Venetian style window, similar in size to the French doors of the original building. The southeast end contained a door, set back in an arched porch with a pilaster on either side (Pl. 7). Alcoves were present either side of the door.

Plate 7. Large rear door, looking north,  
Scales: 1m.

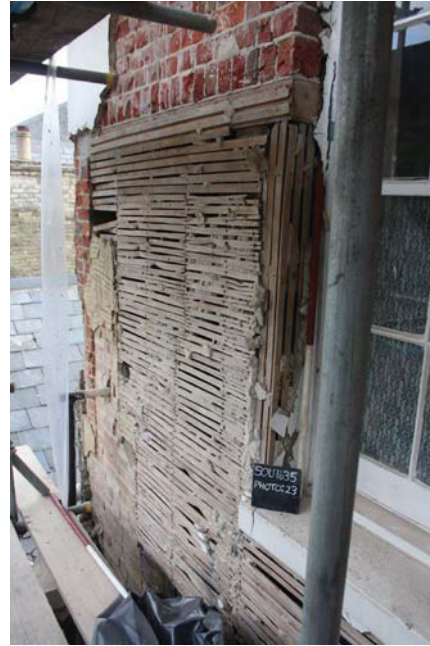
Plate 8. Laths top, South wing, South side, looking south,  
Scales: 1m.

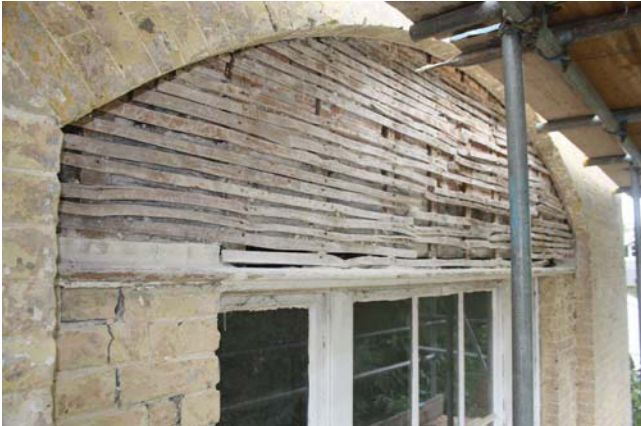
design, was located centrally within the frontage, recessed into an archway. The curve of the archway, above the window, was bricked up and covered in laths to enable plastering (Pl. 9).

Plate 9. North wing above window, looking west.

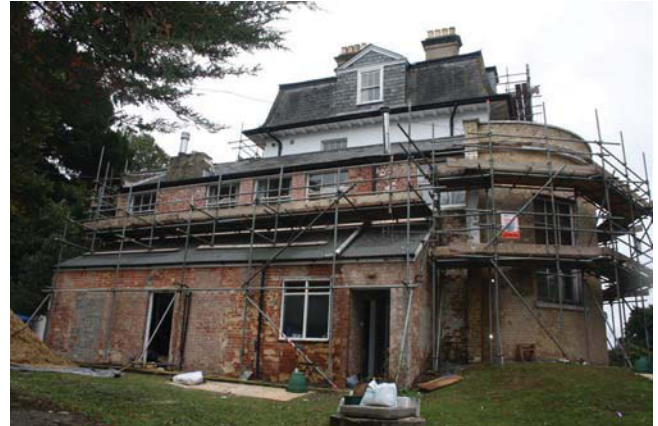
Where visible, the northwest face was constructed of red bricks bonded in lime mortar, measuring 220mm x 110mm x 62mm (7 7/8" x 4 3/8" x 2 7/16"). The lower part was obscured by a lean-to extension but the upper part of the wall contained five half-sized sash windows of three over three panes. Originally two chimneys would have been visible, but one had been removed (Pl. 10).

The lean-to extension on the northwest side of the building shows evidence for much alteration with blocked doors and windows, areas of rebuilding and an extension to the southwest. The bricks are primarily of red bricks measuring 216mm x 110mm x 62mm (8 1/2" x 4 3/8" x 2 7/16") bonded in lime mortar and laid three stretchers to one header in Flemish garden wall bond. The roof was covered in felt (Pl. 10).

Plate 10. General view lean to, looking north east.

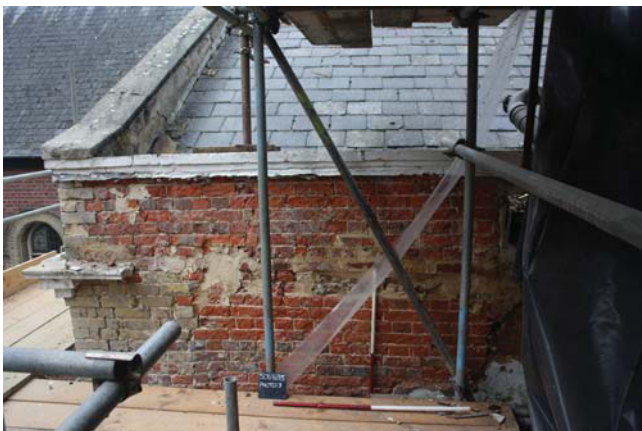
Plate 11. Jointing South wing to main building, looking south east, Scales: 1m.

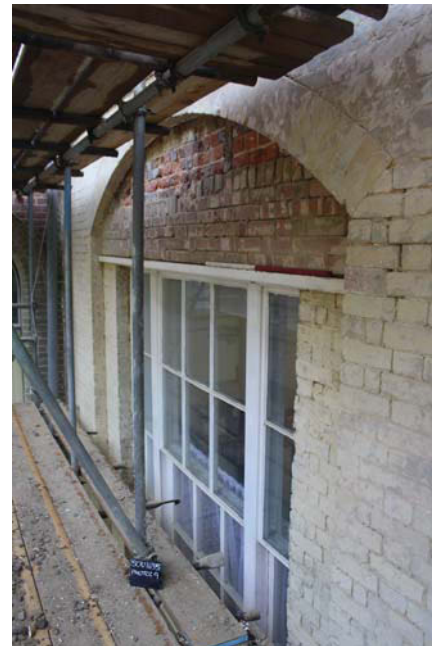
The southeast wing is similar in construction to the northwest wing and consists of a single storey structure with a curved wall at the rear. The northeast face consists of a facing of yellow bricks measuring 218mm x 103mm x 61mm (8 5/8" x 4 1/8" x 2 3/8") laid in Flemish bond with lime mortar. Behind this facing, the walls are of red brick laid in English bond (Pl. 11). The roof is pitched and covered in slates, hidden behind a parapet. A large sash window with side lights, of six over six design, was located centrally within the frontage, recessed into an archway. The curve of the archway, above the window, was bricked up. Two different types of brick can be seen in this archway and probably represent repair work. Lath grooves in the uppermost brickwork suggest that it was originally the same as the northwest wing (Pl. 12).

Plate 12. South wing above window, looking south, Scale: 1m.
