**St Michael The Archangel, Warfield,
Bracknell, Berkshire**

Building Recording and Archaeological Watching Brief

Site Code: WCB13/105

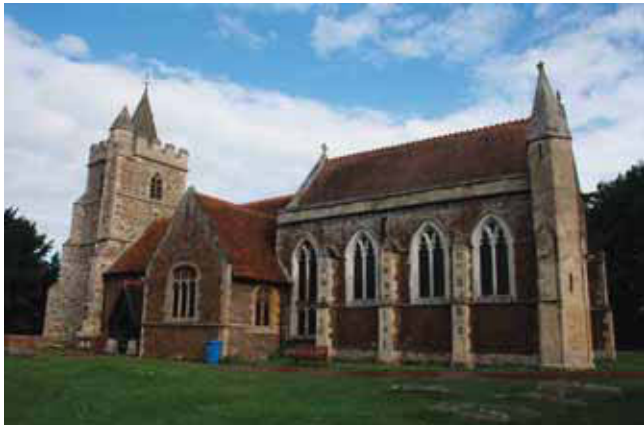
Plate 1. South elevation of the Church, looking North West.

The church is built of a gravel conglomerate with stone quoins at the corners and a red tile roof (Pls. 1-2). The main entrance to the church is through the West Tower, which is a single square room with a spiral staircase giving access to the roof built into the south-east corner of the wall. Beyond the West Tower is the Nave which has a door in the south wall. The font is located to the west of the south door and the pulpit in the south-east corner. The South Transept is located off of the south-east corner of the Nave and access to the Chancel is up a step at the east end. A row of octagonal columns separates the Nave from the North Aisle, which also has a door in the north wall. At the east end and up a step is access to the North Chapel. The North Chapel and Chancel are divided by a stone screen.

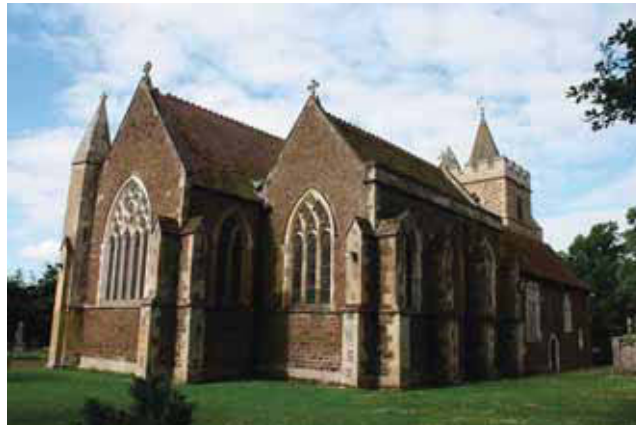
Plate 2. North and East elevations of the Church, looking South West.

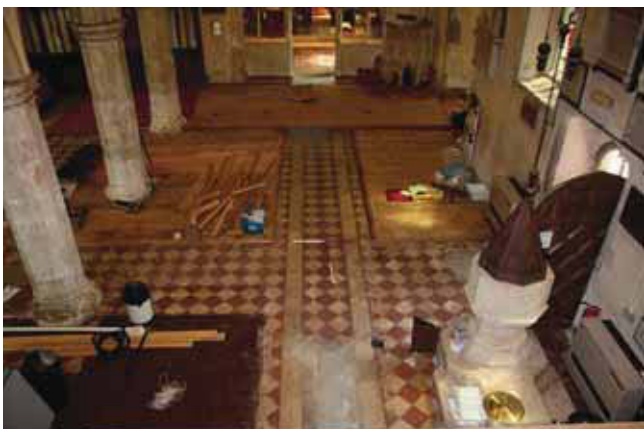
Plate 3. Flooring in the Nave, looking East, Scales: 2x 1m.

The more public area consisted of a combination of solid flooring and slightly raised suspended timber flooring (Pl. 3) which had been re-laid recently (2006) and extended to obstruct the north door. The timber flooring was arranged in three rows (Fig. 7); along the whole of the north wall, at the east end of the central area and along the south wall which extended into the South Transept (Pl. 4). The flooring around the timber was a combination of red ceramic and buff limestone tiles arranged in a diamond checkerboard pattern. Four red ceramic floor tiles measuring 101mm x 101mm were used to create one larger diamond, for every one limestone tile, which measured 220mm x 220mm. A linear walkway was denoted by the use of rectangular limestone blocks measuring 697mm by 225mm running from the West Tower to the Chancel (Pl. 3). Three gravestones were incorporated into the solid flooring in the north aisle (Pl. 5); two laid east-west and one laid north-south. A further gravestone was located at the north entrance (Pl. 6), also laid north-south. The font was located just to the west of the south doorway raised up on two steps.

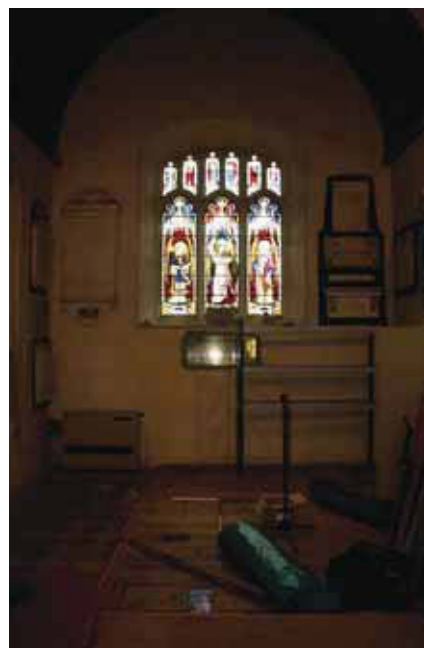
Plate 4. South Transept, looking South, Scales: 2x 1m.

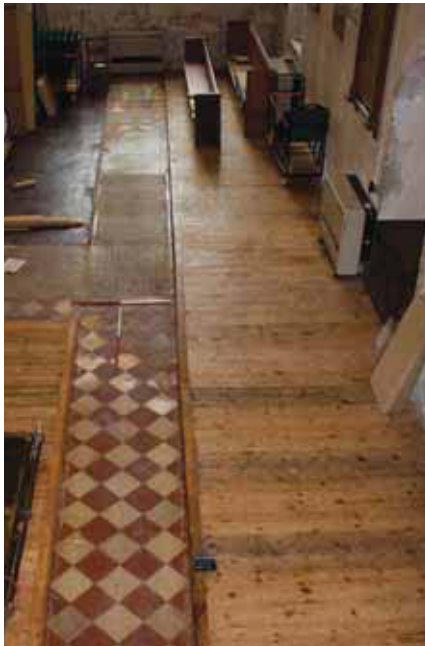
Plate 5. Flooring in the North Aisle, looking West,
Scales: 2x 1m.

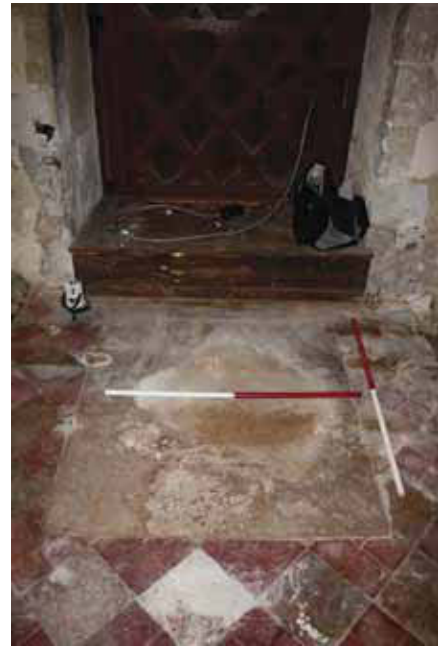
Plate 6. Grave stone at the North door, looking North,
Scales: 2x 1m.

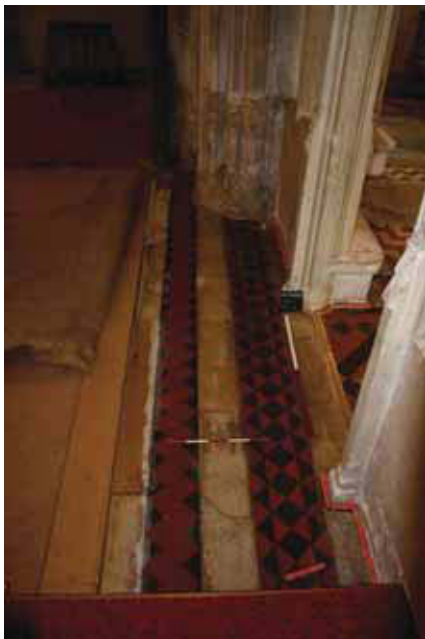
Between the Nave and the Chancel is a single step up which incorporates the thickness of the former east wall of the Nave. This step denotes the change between the flooring of the more public area and the flooring of the Chancel and North Chapel. A wooden rood screen and step denote the boundary between the North Aisle and North Chapel. The step was constructed of five rows of limestone and ceramic tiles laid in the following arrangement from west to east (Pl. 7):

- a row of limestone blocks with a chamfered edge (one of which was found to be replaced by an imitation concrete scree over bricks), presumably indicative of the location of the lectern seen on the original plan
- red and black ceramic tiles laid in a geometric pattern
- a row of limestone blocks
- red and black ceramic tiles laid in a different geometric pattern
- a row of limestone blocks

Upon demolition the limestone blocks were found to have a rebate for the ceramic tiles to be laid onto.

Plate 7. Detail of step, looking North,
Scales: 1m and 0.5m.

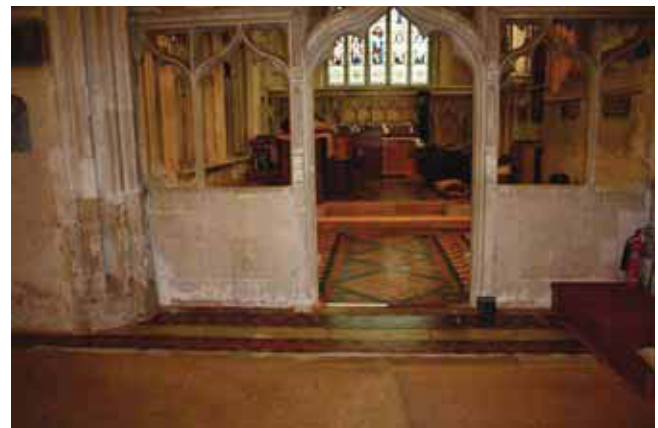
A stone screen dividing the Nave and Chancel was built on the last row of limestone blocks (Pl. 8). Beyond the screen the flooring became more ornate with ceramic floor tiles of red, black, cream and green laid out in various geometric patterns with a further step up within the Chancel focusing the eye on the altar (Pl. 9). Central within the larger geometric squares were decorated floor tiles – copies of medieval encaustic floor tiles including

Plate 8. View to Chancel, looking East,
Scales: 1m and 0.5m.

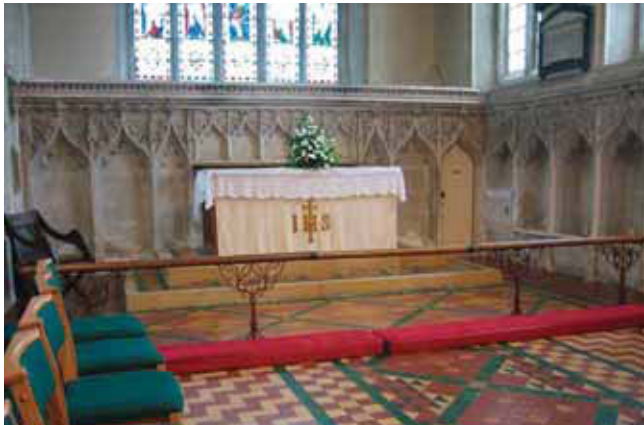
Plate 9. Chancel floor, looking South East.

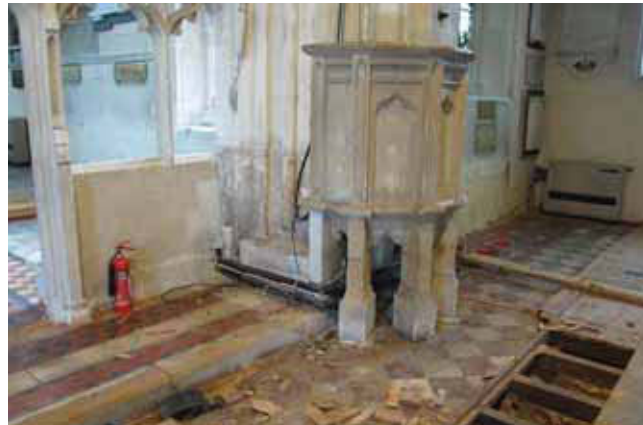
The pulpit is located at the south end of the step, at the junction of the Nave and South Transept and accessed via a small spiral staircase (Pl. 10).

Plate 10. Pulpit, looking South East.

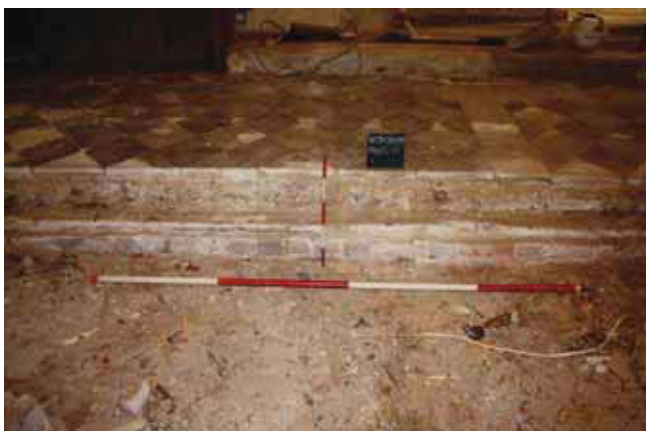
Removal of the flooring within the Nave, North Aisle and South Transept enabled the construction of the flooring to be seen. The suspended timber floors were laid over small brick walls constructed using frogged bricks measuring 220mm x 105mm x 68mm bonded in lime mortar (Pl. 11). A mixture of rubble and concrete scree was beneath these floors. Each of the central line of pillars stood on a square limestone block, 0.22m thick. Beneath this it appeared that the pillars had been underpinned with a mixture of concrete scree and post-medieval ceramic peg tile (Pl. 12). Above the brick walling, the solid floors were laid on a bed of scree, 0.14m thick which in turn was above a layer of lime mortar, 0.12m thick (Pl. 11). Beneath the south doorway was a circular brick drain for the font (Pl. 13; Fig. 7).

Plate 11. Floor make-up, looking East,
Scales: 2m and 0.5m.

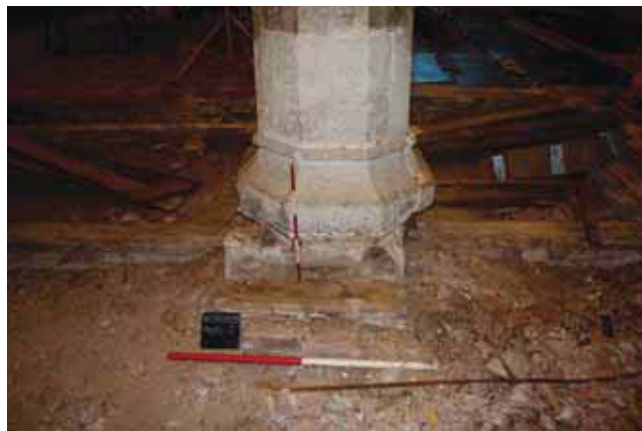
Plate 12. Detail of column base, looking West,
Scales: 1m and 0.5m.

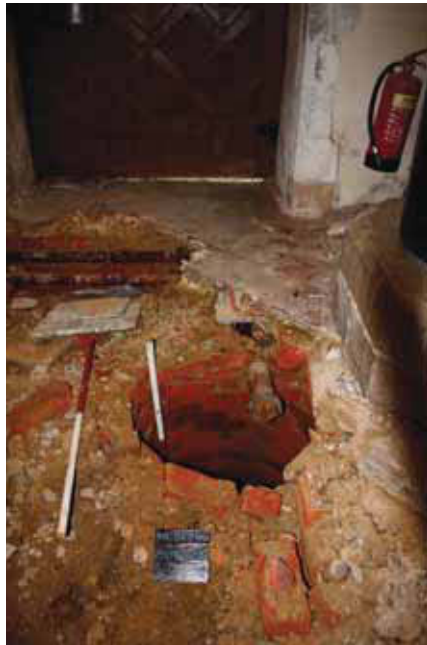
Plate 13. Drain for the font, looking South, Scales: 2x 1m.

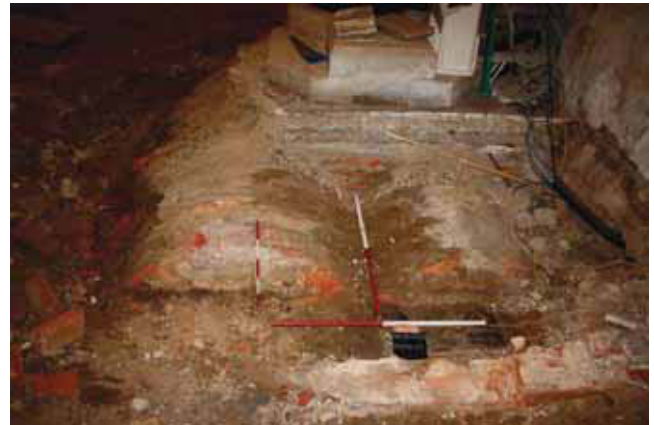
With the removal of the flooring constructed by Street a number of crypts were found (Fig. 8), each constructed of red brick in lime mortar with a vaulted roof. These were all dug into a brown, sandy silt buried soil layer and found:

- A pair of crypts in the southwest corner of the Nave (Pl. 14)
- A single crypt in the northwest corner of the North Aisle
- A single crypt at the south central side of the North Aisle
- A single crypt in the centre of the Nave
- A single crypt beneath the former step between the Nave and Chancel (Pl. 15)
- A large crypt in the South Transept

Plate 14. Two crypts, looking East,
Scales: 2x 1m and 0.5m.

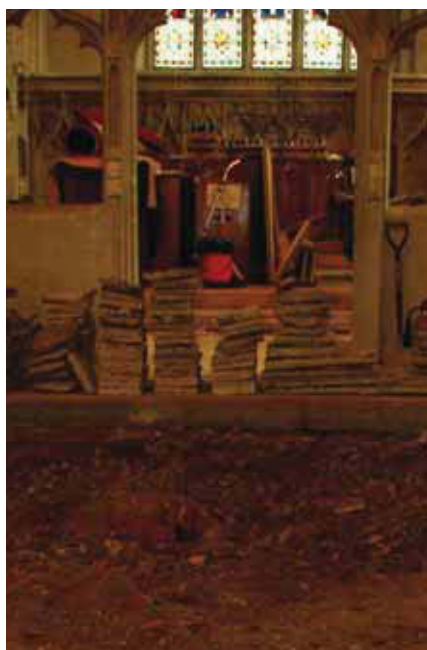
Plate 15. Crypt, looking East.

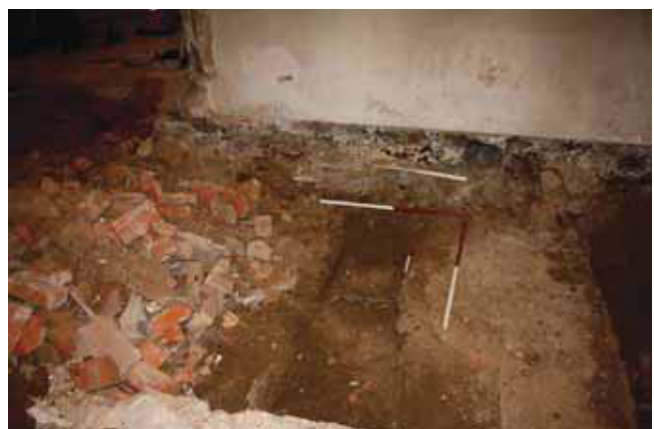
A sondage into a loose area of buried soil on the south side of the Nave between the south door and the South Transept revealed two east-west aligned coffins – one child-sized lead coffin (Pl. 16) and the west end of a

wooden coffin. Immediately to the west of the wooden coffin were five curved layers of clay and lime mortar. These were not further investigated as they were not going to be disturbed by renovations to the church.

Plate 16. Lead coffin, looking South,
Scales: 2x 1m and 0.5m.
