**Chapel Royal, North Street,
Brighton, East Sussex**

Building Recording

Site Code: CRB13/08

January 2013

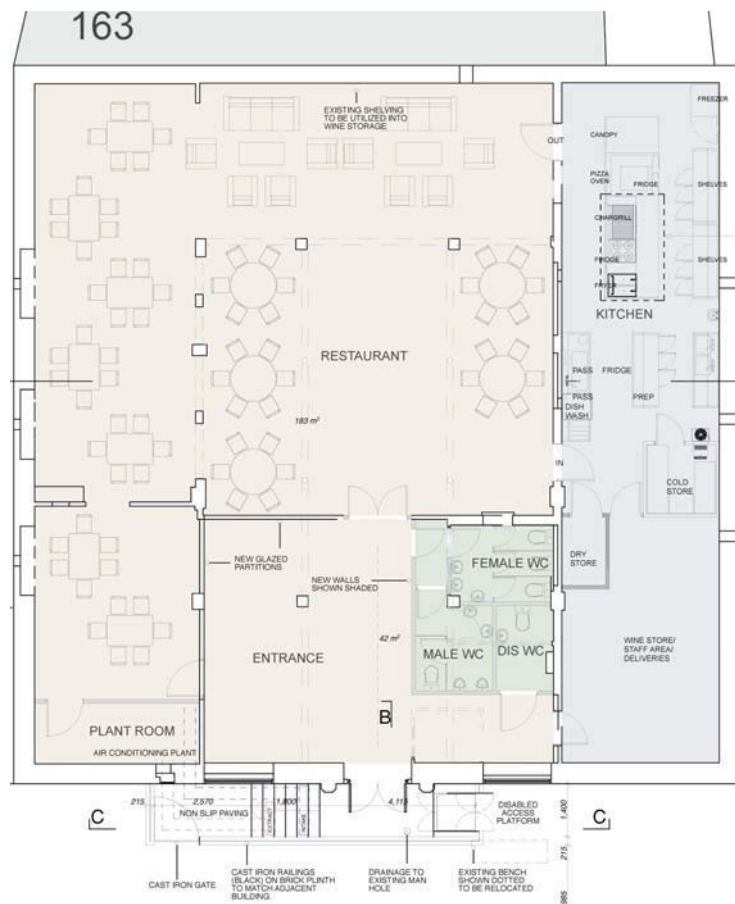
The proposed re-development will necessitate reducing the ground level of cellar area by approximately 1m, in order to provide more head room, and to allow a new damp proof floor to be installed. As part of this building work, the existing roof supports will be underpinned, and various internal features will be removed. An area immediately outside the entrance will also be reduced by approximately 1m to allow a taller entrance to be constructed, along with steps leading down from the pavement (Fig. 9).

Figure 9. Plan showing the proposed re-development at 1:200.

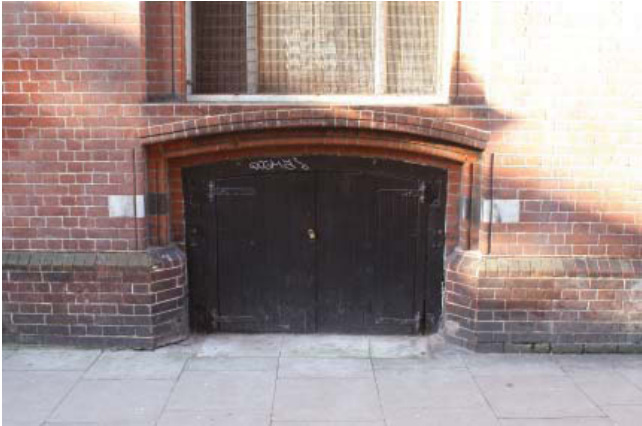
The only entrance into the vaults is via a low doorway in the east elevation of the chapel [Pl. 1], which dates from the late 19th century. This entrance has a decorative brick surround, and wooden doors which open outwards and appear to be fairly modern replacements. The door posts however are clearly older, and are best viewed from inside the vaults [Pl. 13]. The doorway is flanked by two windows, of which only the upper portions are visible at street level. On entering the vaults there is a significant gap between the external ground surface and the first of a series of four stone steps which lead down to the floor. This gap, along with the fact that the doorway appears to have possibly been taller in the past, suggests that the ground level outside the chapel has been raised since it was built. However, a drawing of the original chapel made before the significant rebuilding work in the late 19th century indicates that the door may always have been this small size (Fig. 5). It is proposed to reduce an area of ground immediately outside the entrance, to enable a taller doorway to be constructed along with a new set of steps leading down from the pavement level. The 1788 map suggests that this area may have been open ground before the chapel was built, and it is likely that it was significantly disturbed during the construction of the original building, and the subsequent rebuilding in the late 19th century. The ground would also have been truncated by the original colonnade of Doric columns and their removal in the second half of the 19th century.

Plate 1. Exterior, entrance leading to vaults, looking north west.

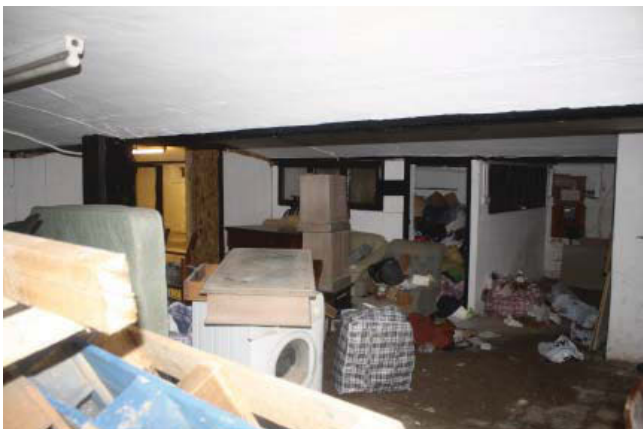
The entrance steps of the vaults lead into room A [Pls 3–5], which measures 9.20m by 6.35m. There are a few stone floor slabs immediately adjacent to the bottom step [Pl. 16], and then a slightly raised floor area, bounded by red brick, which extends into the room. The rest of the floor is concrete. A small amount of light is provided by the two windows in the east elevation, but the sunken nature of these means that the level of illumination is minimal. The entire cellar is therefore lit by modern fluorescent lighting. The wall between room A and room E, to the west, is constructed from timber planks, whilst the north and south walls of room A are brick. The east wall of room A was largely obscured by numerous layers of paint, but is clearly a combination of brick and beach pebbles.

Plate 3. Interior, general view of room A, looking north.

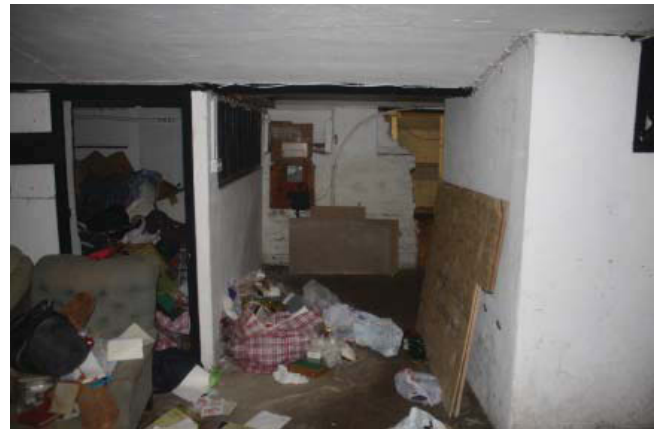
Plate 4. Interior, general view of room A, looking north east.

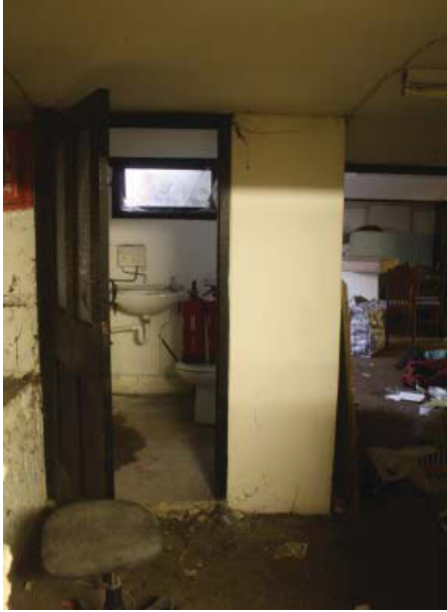
Plate 5. Interior, room A, looking south west towards room C.

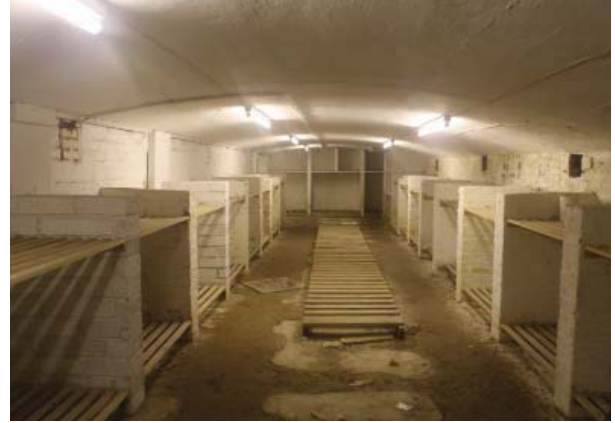
The entranceway between rooms A and D is clearly a later addition, and consists of a very crudely made opening through the brick wall. Room D runs the entire length of the building, and measures 17.80m by 4.15m [Pls 6, 7]. The west, north and east walls of the building are constructed from a combination of brick and beach pebbles, largely obscured by thick layers of paint. The north wall has three small vents. The south wall is of brick and is clearly a later addition to the building as it incorporates some of the timber posts and iron pillars which support the ceiling above via an iron girder [Pl. 14]. The wall has two small openings which look into room E, and these appear to have been created when some larger openings were bricked up. A large opening at the western end of this wall provides access to room E.

Plate 6. Interior, general view of room D, looking north west.

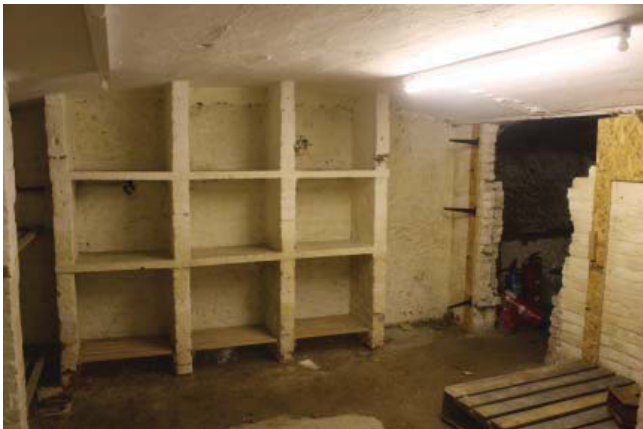
There are shelves along all of the walls of room D, the uprights of which are of either brick or breeze block construction. These are not keyed into the walls and are clearly later additions. The timber shelves themselves appear to be very recent, as are the timber pallets which run along the centre of the room's western end. The floor of the room is entirely concrete, and there are numerous areas where this has been repaired in the recent past. The fact that most of these repairs run along the centre of the room suggests that they may be associated with additional shelving in this area which has been removed.

Plate 7. Interior, general view of room D, looking south.

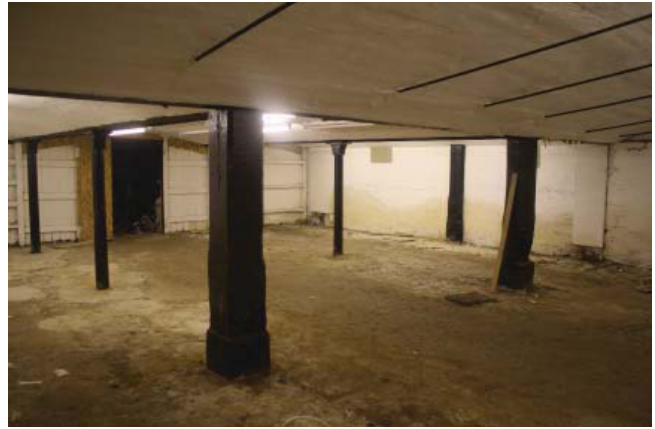
Room E measures 11.35m by 9.25m, and can be accessed from rooms A, D and F. The iron girders which carry the vaulted roof are clearly visible within this room, along with their supports [Pls 8, 9]. The latter are a

combination of timber posts with brick or stone bases, and iron pillars. Two timber posts and four iron pillars can be seen within the room, while others have been incorporated into the later north and south brick walls of the room. As with the post in room A, the upper sections of the timber posts are chamfered. The one in the south-west corner of the room appears to have been affected by rot at some point in the distant past. It is likely that the iron pillars are later replacements for earlier timber posts which may have been similarly affected by rot. The west wall of the room is mostly constructed from beach pebbles, with occasional brickwork for support. As with the most of the perimeter walls of the vaults it is covered with numerous layers of paint. A series of brick built shelves abuts the west wall. As mentioned above, the brick wall between rooms D and E is clearly a later addition, and the same is true of that between rooms E and F, which has two small window openings and an entrance through to room F at its western end. The floor of room E is entirely concrete, with isolated areas of repair [Pls 10, 11]. As part of the proposed redevelopment, much of the wall between rooms E and F will be removed, although the timber posts and iron pillars which are currently incorporated into it will be retained. It is also proposed to retain some of the shelving along the west wall for wine storage.

Plate 8. Interior, general view of room E, looking south.

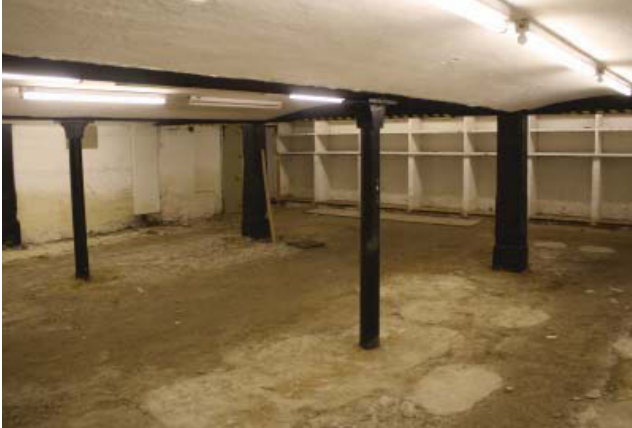
Plate 9. Interior, general view of room E, looking west.

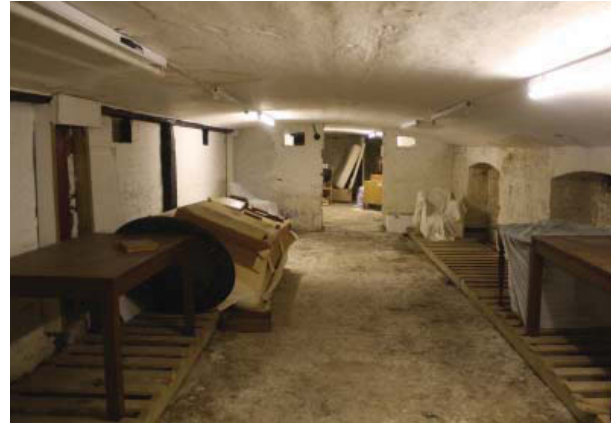
Room F is situated in the south-west corner of the building, and measures 10.95m by 4.20m. It is separated from room G, to the east, by a brick wall which has two small windows and a doorway connecting the two rooms. The west and south walls of room F are constructed from beach pebbles and brickwork, and are largely obscured by thick layers of paint [Pl. 15]. There are two alcoves in the south wall with brick arches, which contain small vents. There is a small brick built plinth in the south-east corner of the room, the original function of which is unknown. As part of the proposed re-development most of the north wall of the room will be removed, exposing the timber and iron roof supports.

Plate 10. Interior, general view of room F, looking south east.

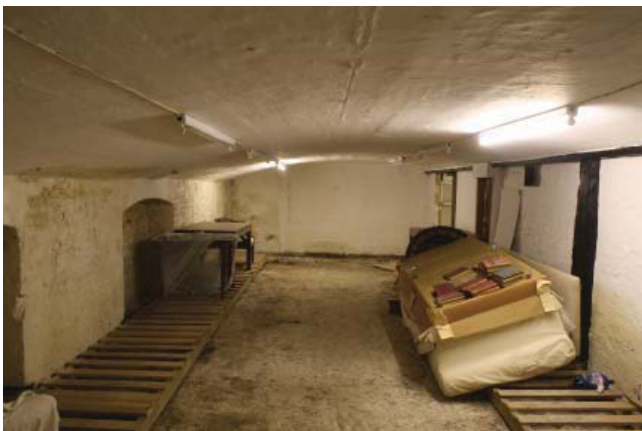
Plate 11. Interior, general view of room F, looking north west.

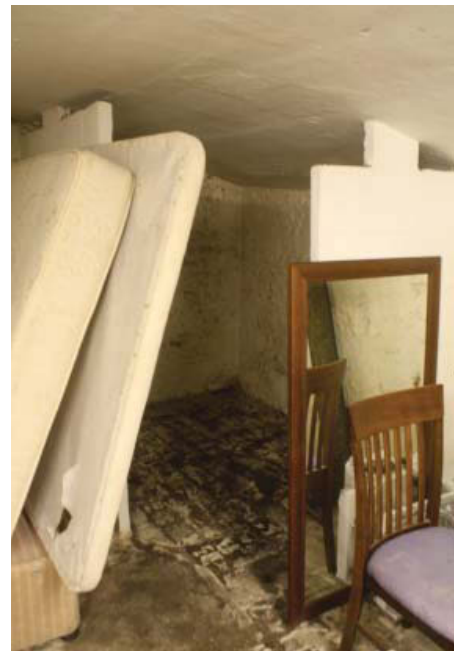
Room G measures 6.75m by 4.25m, and occupies the south-east corner of the building. It can be accessed from rooms A and F [Pl. 12]. It is very similar to room F and the two were obviously one room before the dividing brick wall was built. There is one alcove in the south wall, with a brick arch and a small vent. This wall and the east wall are largely constructed from beach pebbles, with some brickwork. As noted elsewhere, the details of the walls are largely obscured by thick layers of paint. There are breeze block partitions along the south, east and north walls, which were presumably used for storage purposes. The floor is mostly concrete, although there are small areas of brick paving in the south-east corner of the room and immediately east of the dividing wall with room F. As part of the proposed development, all the breeze block partitions will be removed, and part of the north brick wall will be replaced by a new glazed partition wall. A new wall will be built at the eastern end of the room to create a plant room.

Plate 12. Interior, general view of room G, looking south.

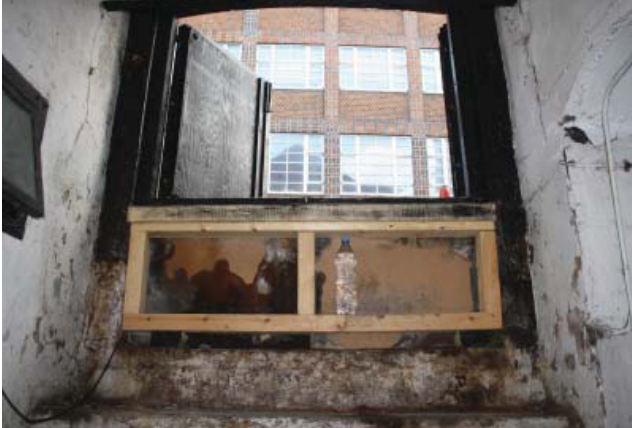
Plate 13. Interior, room A, close-up of entrance into vaults, looking south east.

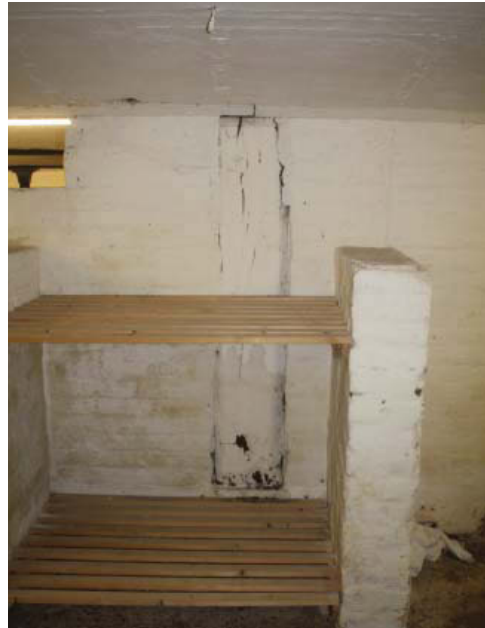
Plate 14. Interior, room D, timber post in dividing wall, looking north west.

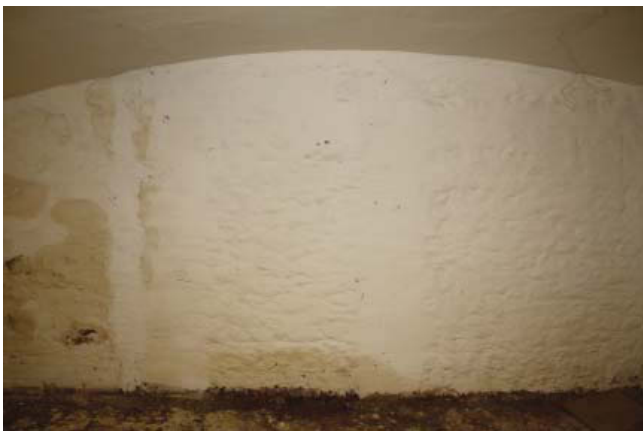
Plate 15. Interior, room F, close-up of west wall, looking north west.

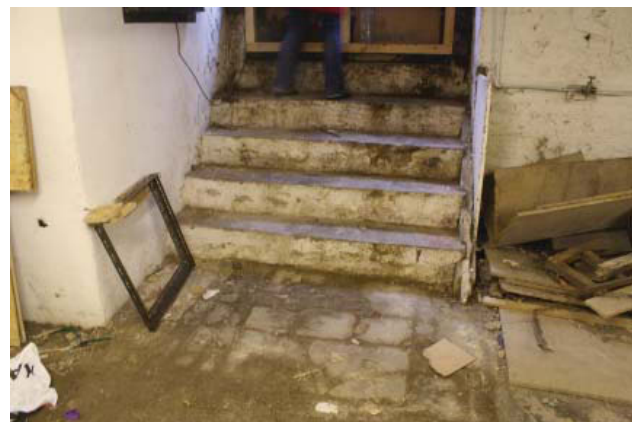
Plate 16. Interior, room A, stone slabs next to entrance steps, looking south east.
