**Bath Road Reservoirs,
Reading, Berkshire**

Building Recording

**Building Recording
For Bewley Homes Plc**

February 2014

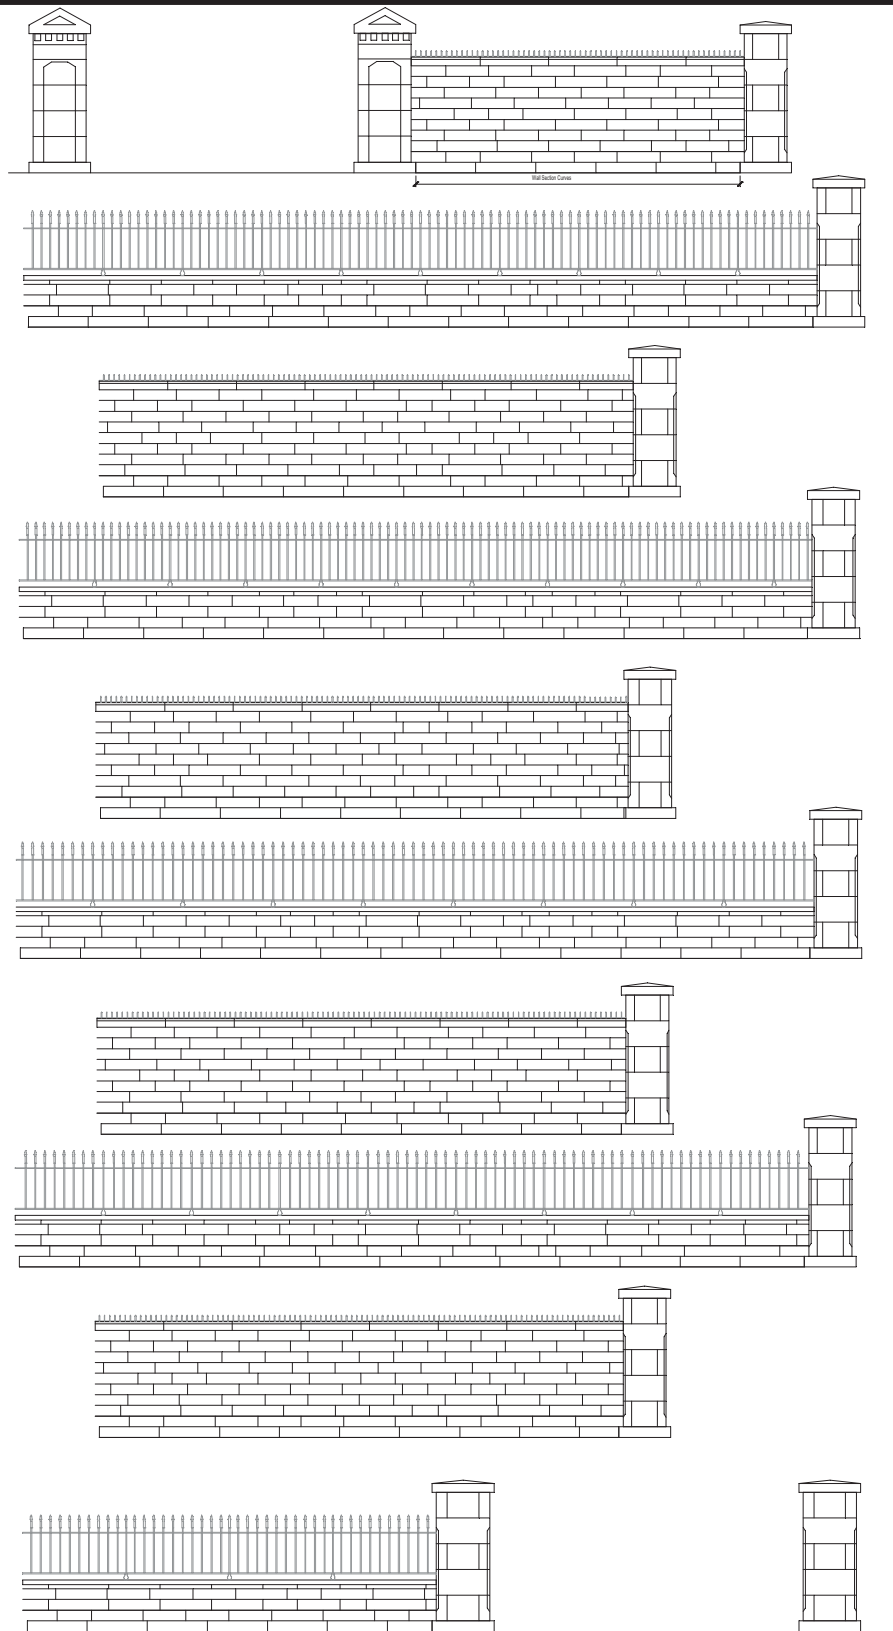
Figure 11. Boundary wall along Bath Road.

Along the street frontage the boundary is marked by a limestone block wall (Fig. 11), divided into alternating panels of full-height stone wall and lower stone wall surmounted by iron railings, separated by square stone pillars each topped with a concrete capstone. The railings were of wrought iron painted black and surmounted by finials in the shape of a foliate bud. Supporting the railings were scroll shaped backstays (Pl. 1). The entrance, at the western end of the site was marked by a curved section of limestone wall and a pair of pillars built in ashlar style and surmounted by a pediment with dentile decoration on the underside. There was a slightly recessed panel on the pillar (Pl. 2).

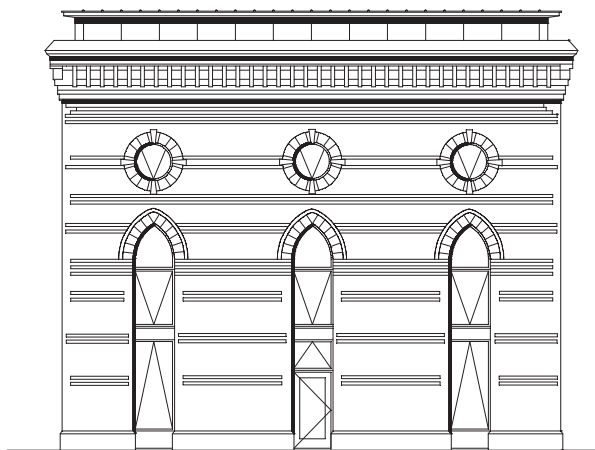
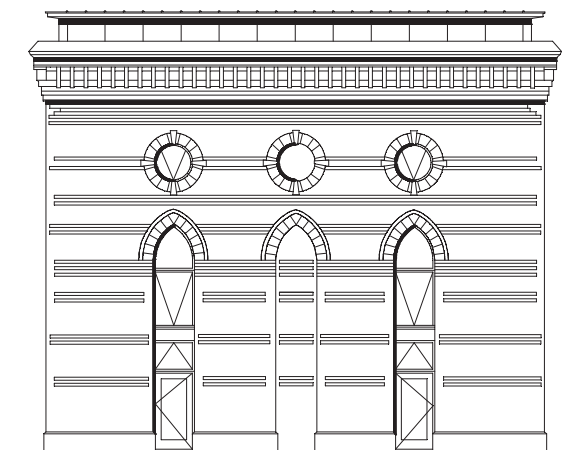
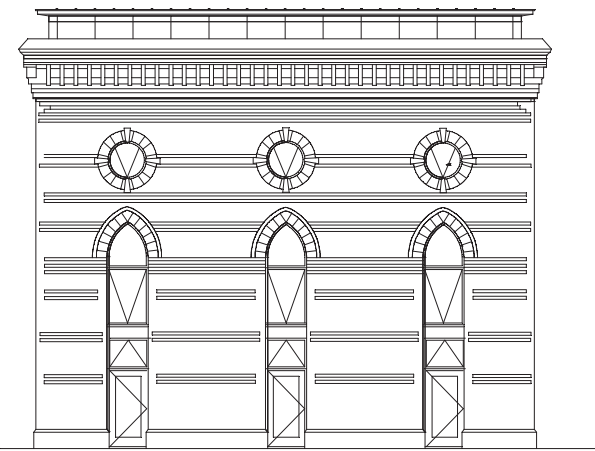
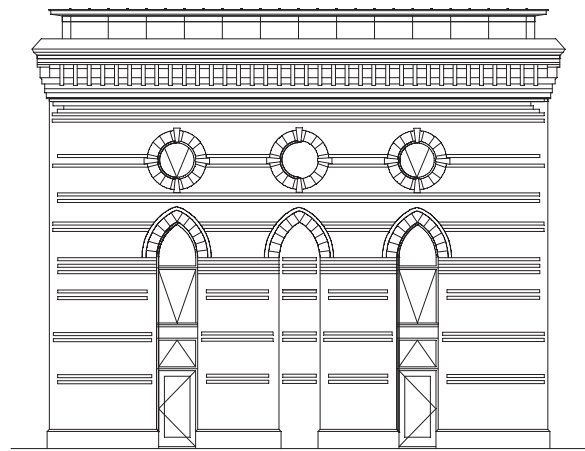
Figure 12. Water Tower Elevations.

The water tower was located in the south-east corner of the site and was square in plan with four near-identical elevations (Pl. 3). The tower was of brick construction, predominantly laid in English bond in a mixture of red and blue bricks (probably Staffordshire blue bricks), set in cement mortar though this is presumably later pointing of original lime mortar. The red bricks measured 220mm x 106mm x 73mm ($8\frac{5}{8}$ " x $4\frac{9}{16}$ " x $2\frac{7}{8}$ "") and the blue bricks measured 228mm long x 76mm thick (9" x 3"). The blue bricks were laid to create pairs of horizontal bands across the elevations with a central pair set slightly further apart and in-filled with a cross decoration. Within each elevation were three tall lancet openings above which were three oculi with a white stone keystone at each quarter of the circle. The oculi (Pl. 4) and top of the lancets (Pl. 5) were also decorated with blue and red bricks. Within the bottom of the lancets were located doors to access each room, above which was cladding painted brown. Two doorways in the north face had been blocked up. The oculi were filled with brown louvers. On the east and west elevations the central lancet and oculus were built blind (bricked to match the elevation). The entablature of the building (Pl. 6) consisted of rows of projecting and moulded brickwork in red brick with a single band of blue bricks running through it. Above the entablature was the cast iron water tank (Pl. 7).

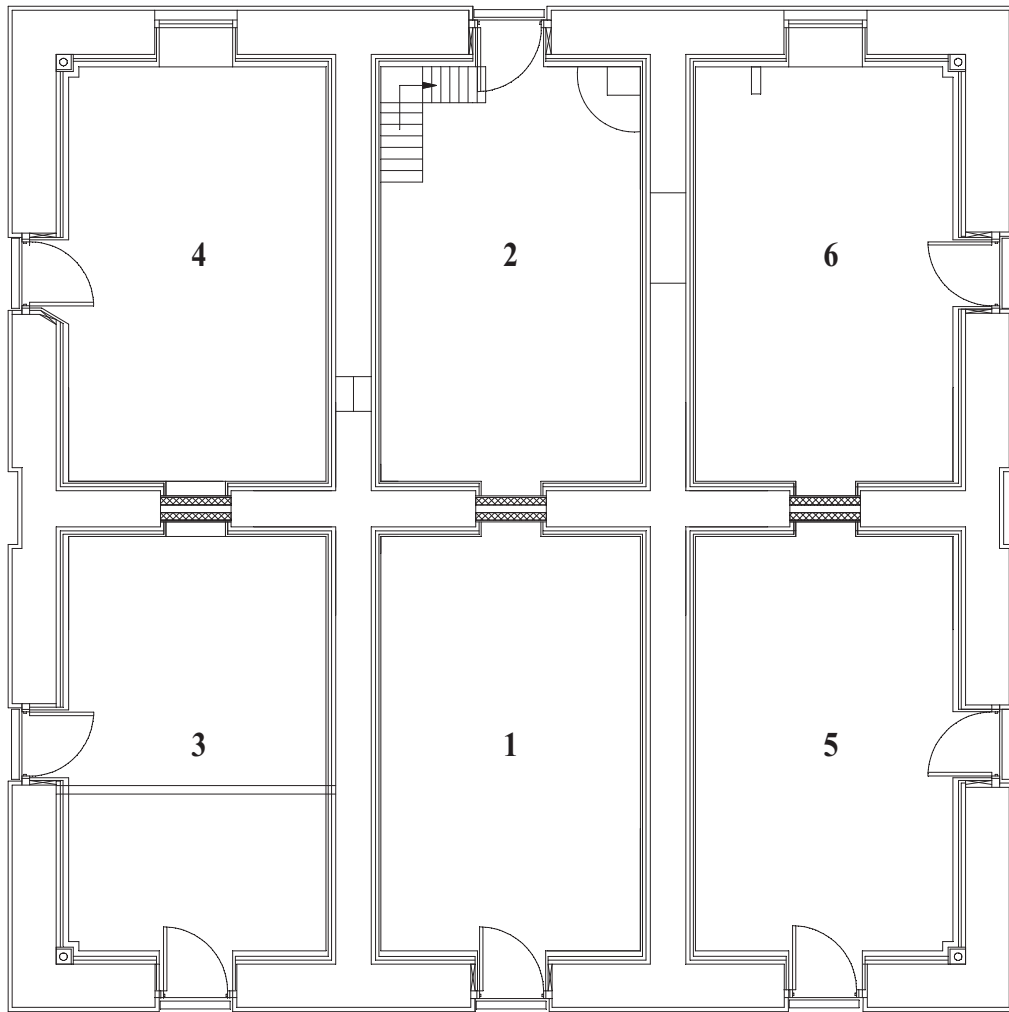
Figure 13. Water Tower Plans.

Internally the building was divided into six equal sized rooms (Fig. 13). Each room originally had individual access from the north or south sides and four of the rooms had further access from the east and west sides. Internally the design of tall lancet openings with oculi above continued on the east-west aligned central wall, linking two rooms together. The pattern created by the use of blue bricks was not continued inside, nor were the stone keystones within the oculi on the internal walls (Pl. 8). The walls were of plain brick; however a horizontal line of stone blocks were used to sit the water tank onto. The floor treatment varied from room to room with concrete floors found in rooms 1, 4 and 5, flagstone floors found in rooms 3 and 6 and a wooden floor in room 2.

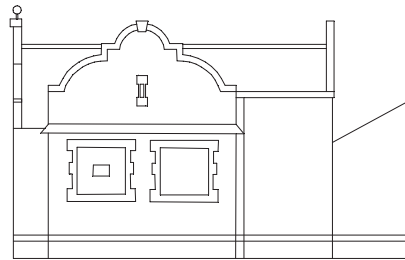
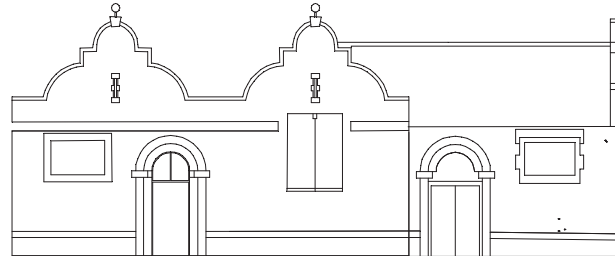
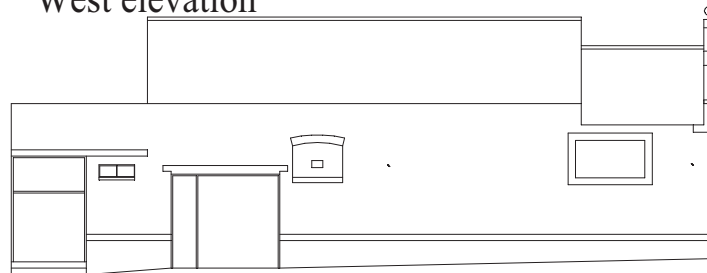
Figure 14. Pump house elevations.

The pump house was located in the south-west corner of the site and was roughly square in plan, but with varying roof lines and a small extension to the north. The building was brick built of red brick measuring 230mm x 112mm x 75mm ($9\frac{1}{16}$ " x $4\frac{11}{16}$ " x $2\frac{15}{16}$ ") and laid in Flemish bond. A plinth course was present around the building topped with stone. The roof was covered in slate and the gable ends were in the Dutch style surmounted by stone with a spiked ball at the top.

Within the south façade (Pl. 12) were two Dutch gable ends at the western end. Within each of the gables was an arrow slit type window picked out in stone. A stone string course was also present across the gable ends at the height of the roof line. At both ends of the façade was a rectangular window with a stone block surround and infilled with white glazed bricks. The windows may have been built blind originally. Beside each of the windows was a door with a double curved brick arch above it, supported on a pair of brick pilasters with stone capitals. The western door had a stone keystone and glass above the door. To the east of it was a scar in the brickwork showing where the two walls butted each other. The centre of the façade had a pair of double loading doors raised up above the ground, with a hoist.

The east façade (Pl. 13) was predominantly obscured by the bund and vegetation. Removal of this revealed the Dutch gable end with the parapet extending to cover the valley between the two roofs. A small lean-to extension was present in the centre of the façade. The northernmost block was of plain brick laid in English bond.

The west façade (Pl. 14) contained two blocked up/blind windows and two pairs of double doors, along with a small window towards the north end.

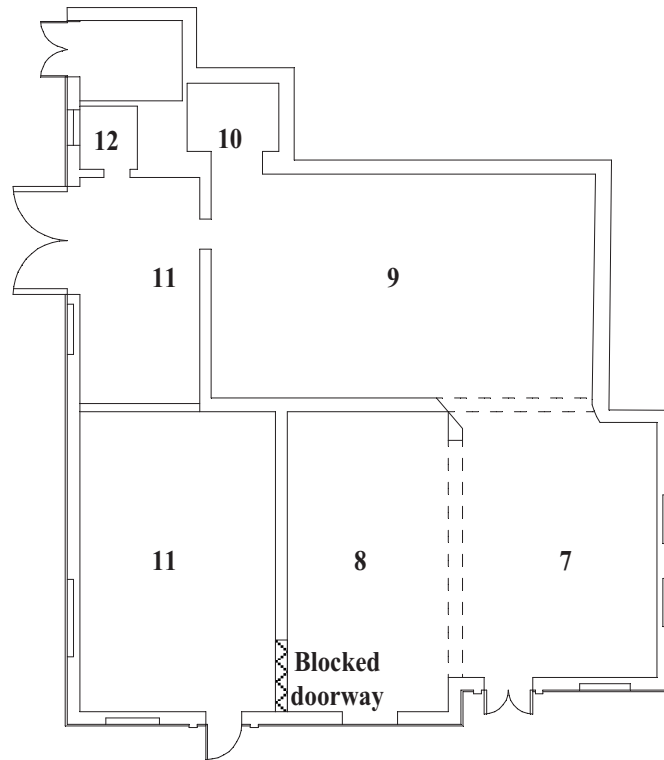
Figure 15. Pumphouse Plan.

Internally the building could be sub-divided into seven rooms (Fig. 15). Entrance was gained through a pair of double doors in the south façade into room 7. The floor was of concrete and the ceiling was timber clad. A small area had been separated off in the north-east corner with a stud partition wall. Machinery was also present within the room. To the east was room 8, accessed via a set of steps up to the raised metal floor. Within room 8 was housed more machinery (Pl. 15). In the south-west corner was a blocked doorway (Pl. 16). To the north of room 7 was room 9, a large double height room with two rows of skylights in the roof, which was supported by metal trusses (Pl. 17). The floor was covered in red quarry tiles and the walls were a combination of painted brickwork on the upper half and tiled on the lower half with white glazed tiles. A line of brown tiles decorated it with a line of moulded brown tiles along the top. The room housed more machinery, including a hoist mechanism that could track along the length of the building, built by Appleby Frodingham steel company (Pl. 18). The I-beam across the room was built by Herbert Morris of Loughborough, crane manufacturers. In the north-west corner was a small store cupboard (room 10). Room 11 was located to the west of room 10. It was sub-divided by a low wall, with the southernmost part having no access on the day. The roofline at the southern end was lower than the majority of it (Pl. 19). A pair of double doors was present in the western façade and a blind window. To the north was a toilet (room 12). To the north of room 12 was a further room which had no internal access and was the former sub-station (Pl. 20).

Aspects of the original building are still present. Room 8 forms part of the pump house that was on the original designs (Fig. 3). It is possible that the westernmost block is contained within part of room 11, but it is not possible to see any evidence of this in the brickwork. It is likely that the north-east corner of room 9 is the same as that seen on the 1853 plans (Fig. 4). Room 7 forms the extension seen on the 1879 Ordnance Survey map (Fig. 5). By 1910 (Fig. 6), the western block, incorporating room 11 had been extended. This may have occurred in more than one stage based on the change of height within the roof line, although it may have been to tie in with the existing gable end.

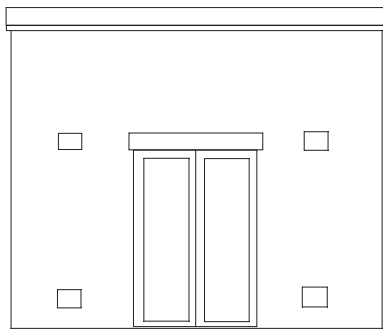
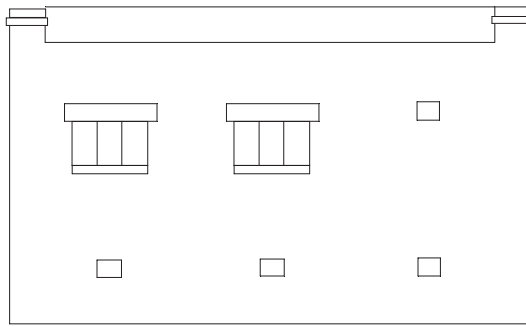
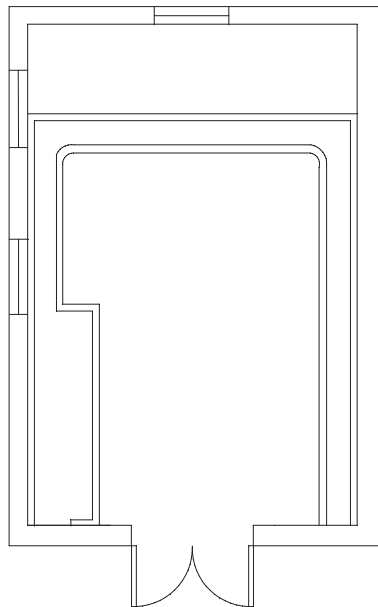
Figure 16. Substation Plan and Elevations

To the rear (north-west) of the pumping station were two ancillary buildings. The larger building was a substation (Fig. 16) with a smaller building tacked onto the rear. The substation was of red brick construction

bonded in (pointed) cement mortar (Pl. 21). The bonding was a variation of garden wall bond, where there were several stretchers between each of the headers and the bricks measured 230mm x 106mm x 68mm ($9\frac{1}{16}$ " x $4\frac{3}{16}$ " x $2\frac{11}{16}$ "). Above the windows and doors were concrete lintels. The roof was flat and constructed of concrete lintels. A small parapet was present on the north and south walls constructed of line of proud stretchers above which was a soldier course. Internally (Pl. 22) the building was a simple rectangle with access in the south face via a pair of double iron doors, and two windows in the west wall and one in the north wall. The floor was concrete, with a gully running round the edge, presumably for pipes and cables.

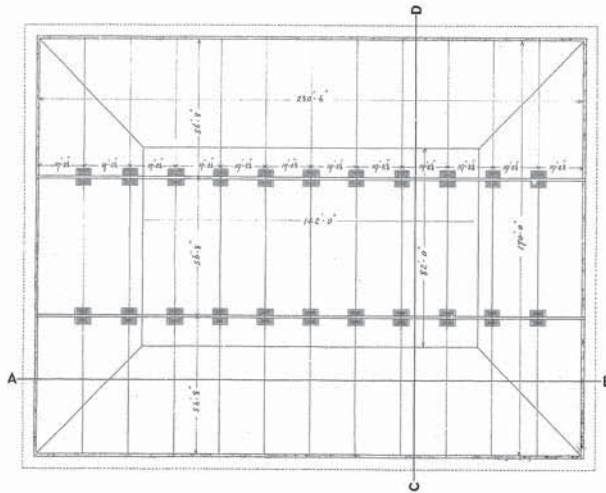
Figure 17. Proposed Covered Reservoir Roof.

Behind the filtration beds was the rectangular, covered reservoir (Fig. 17, Pl. 27). This was completely grassed over and no detail of the actual reservoir could be seen. Around the edges were brick built box structures. Architectural plans suggest that the reservoir had approximately 45° sloping sides and a flat base. The proposed cover was constructed of iron, supported on columns and girders. The signature and date suggest that the cover was constructed around 1933.

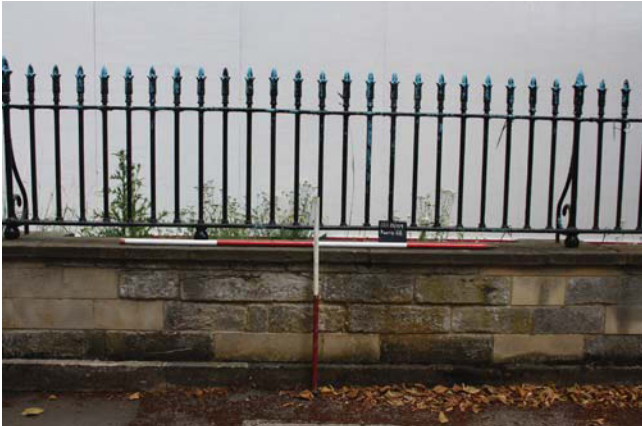
Plate 1. Boundary wall, looking North, Scales: 2m and 1m.

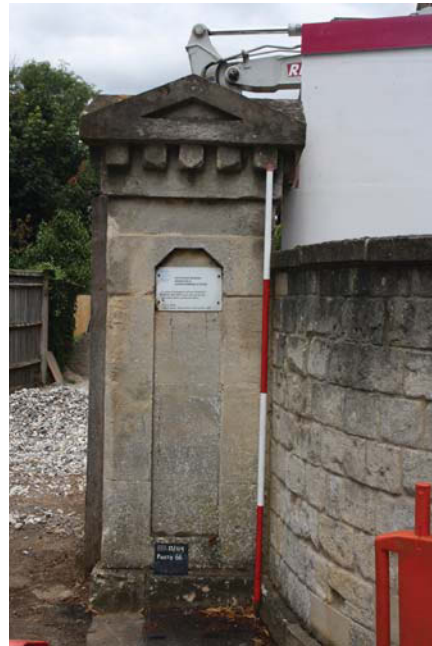
Plate 2. Pillar, looking North, Scale: 2m.

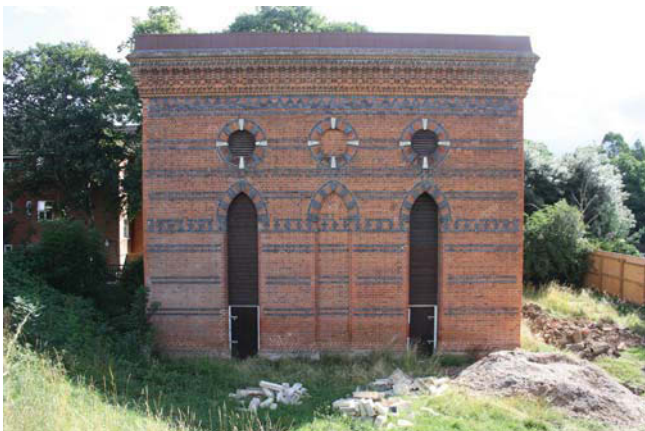
Plate 3. Water tower, looking East.

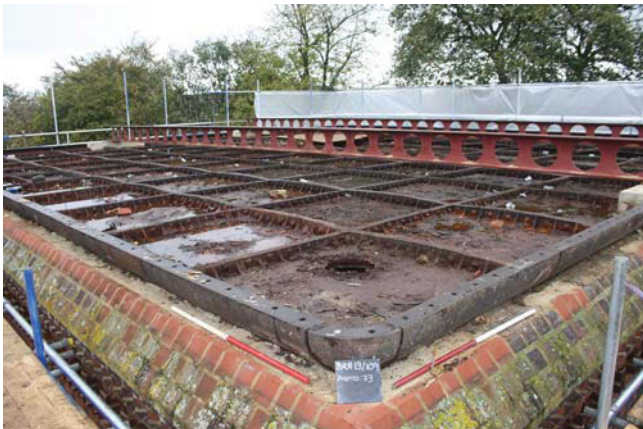
Plate 7. The roof, looking Northeast, Scales: 1m.

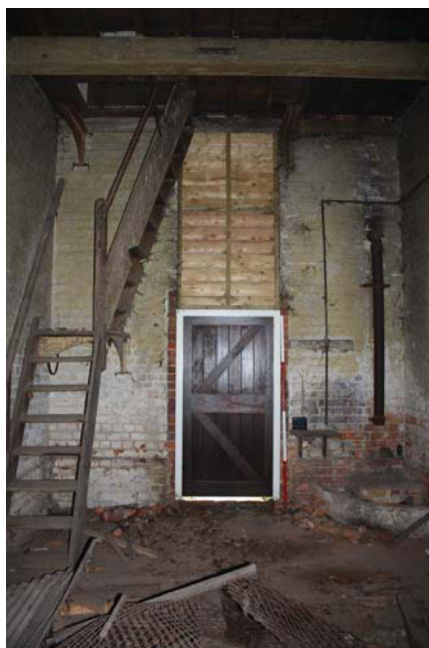
Within room 2 were the stairs leading up to the tank at the top of the tower (Pl. 9). These steps were steep and narrow, and of a simple wooden construction supported on cast iron brackets. A number of wooden landing stages were present up the height of the tower, but these were not safe to access.

Plate 9. Stairs in room 2, looking North, Scale: 2m.

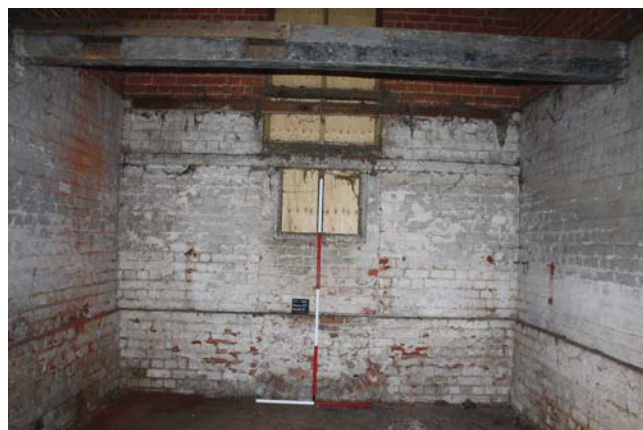
Within room 4 the ground level was lower than the outside resulting in a step down into the room from the entrance in the west wall. The step was formed from an inverted arch and then infilled with bricks. The same step arrangement could be seen in the blocked opening in the north wall (Pl. 10).

Plate 10. Blocked door in room 4, looking north,
Scales: 2m and 1m.

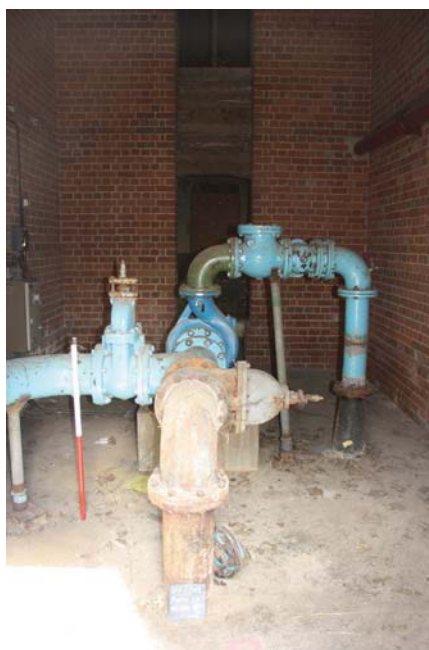
Within room 5 was housed part of the machinery (Pl. 11) for the tower and throughout the other rooms were various pipes and meters.

Plate 11. Pumping equipment in room 5, looking North,
Scale: 1m.

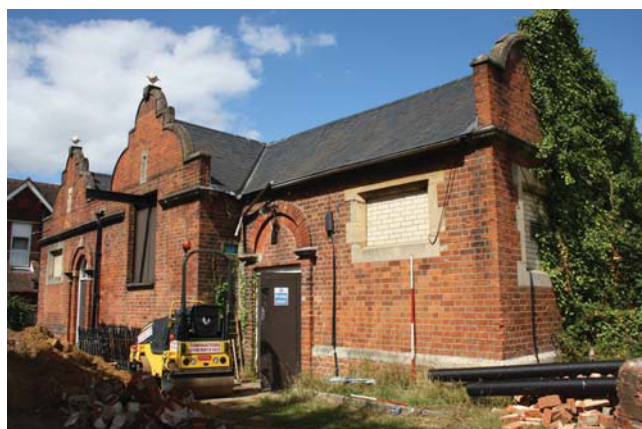
Plate 12. Pump house, looking Northwest,
Scales: 2m and 1m.

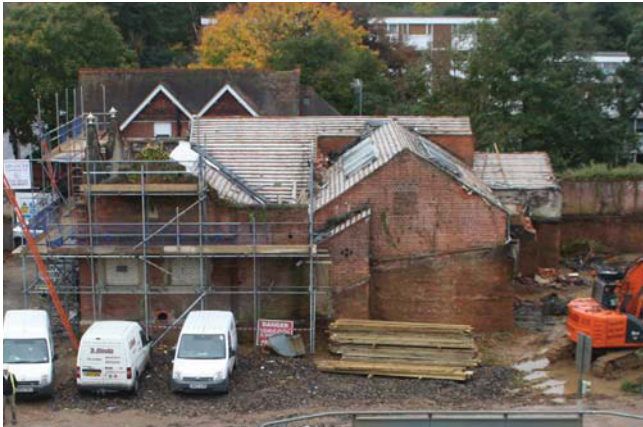
Plate 13. Pump house (East elevation), looking West.

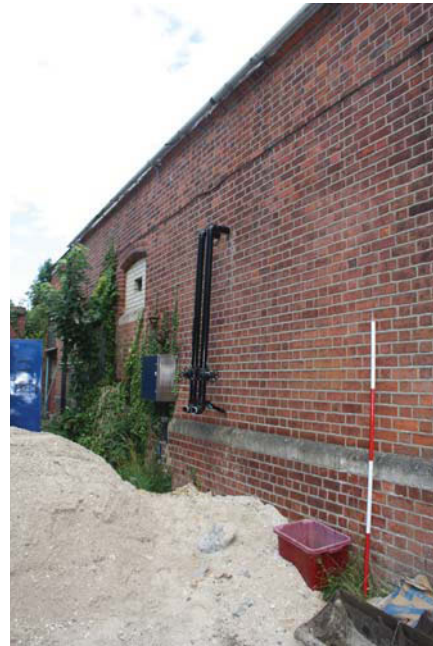
Plate 14. Pump house (West elevation), looking Northeast, Scale: 2m.

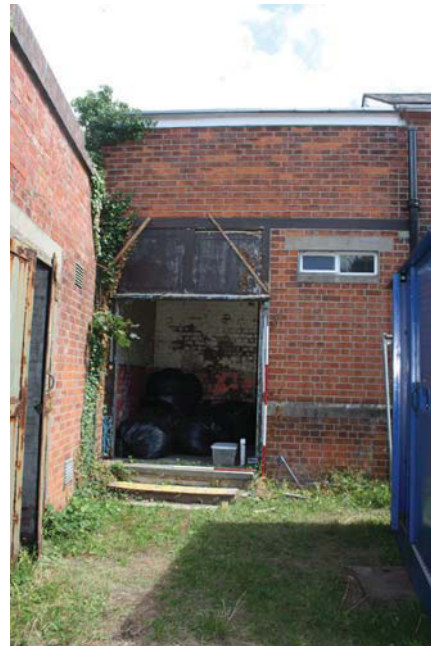
Plate 20. Former substation, looking East, Scales: 2m and 1m.

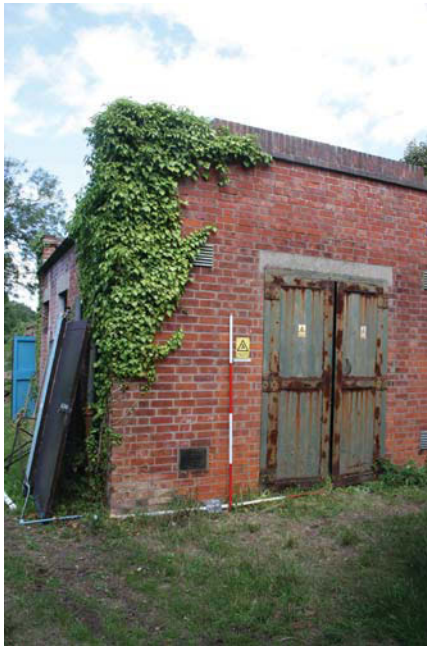
Plate 21. Substation, looking Northeast,
Scales: 2m and 1m.

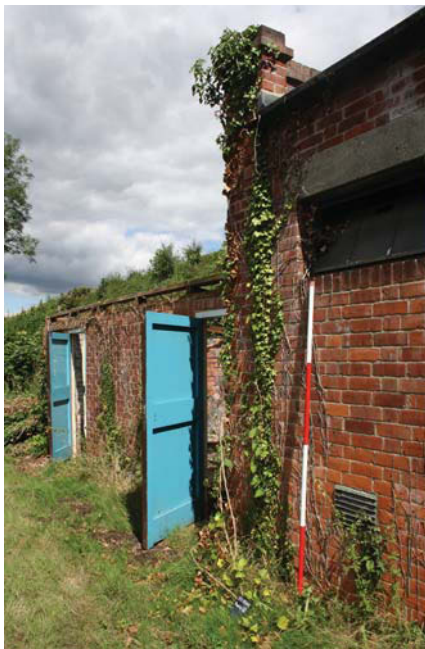
To the rear of the building was a low, single-storey building in a dilapidated state (Pl. 23). It was subdivided into two rooms, each with its own access. The bricks were laid in stretcher bond.

Plate 23. Lean to, looking Northeast, Scale: 2m.

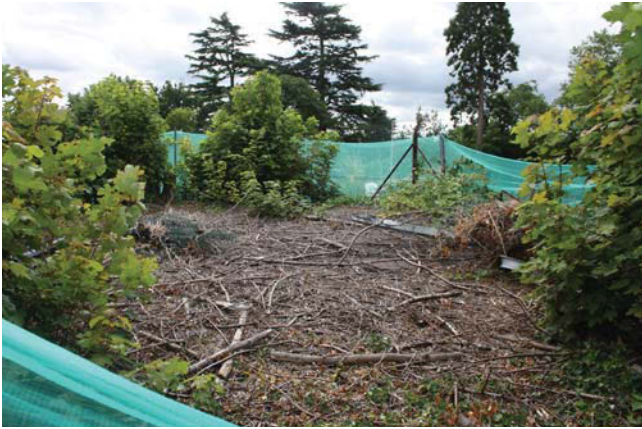
The filtration beds were at the southernmost end of the bund and consisted of a covered circular tank which was covered in scrub and inaccessible (Pl. 25). Further to the north was a larger circular tank of brick construction and whitewashed (Pl. 26). No access was possible, thus the type of brick bonding was not discernible. Within the centre of the tank was a brick pillar. Around the edges were various cast iron inlet and outlet pipes. A set of iron ladder rungs were laid into the wall on the southern side for access. To the north of the main tank was a further small, brick built, covered tank.

Plate 25. Covered filtration bed, looking South.

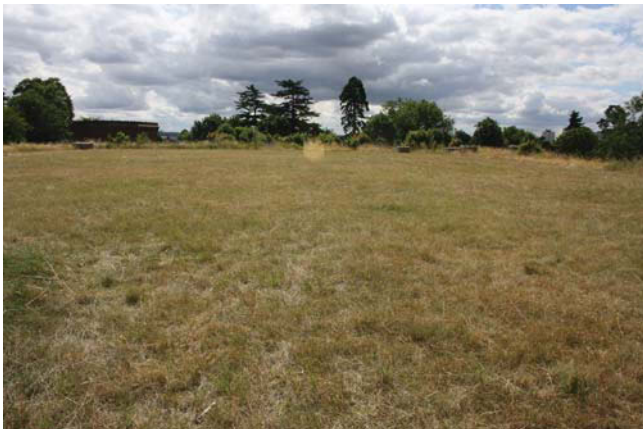
Plate 27. Covered reservoir, looking South.

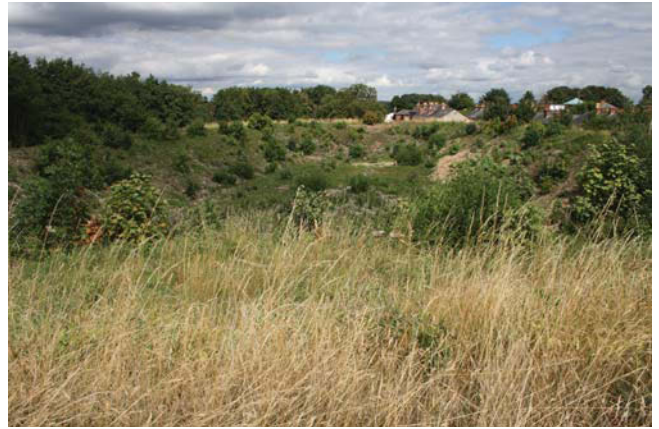
At the rear of the site (northern end) was the disused reservoir (Pl. 28). It was rectangular in shape, except for the north-west corner where it followed the line of the site boundary and railway line. It consisted of sloped sides at approximately a 45° angle and a flat base. The entire reservoir was overgrown with scrub.

Plate 28. Disused reservoir, looking North.
