Bury Knowle Barn and Stables, North Place, Old Headington, Oxford

Building Recording

Site Code: BKO13/233

February 2014

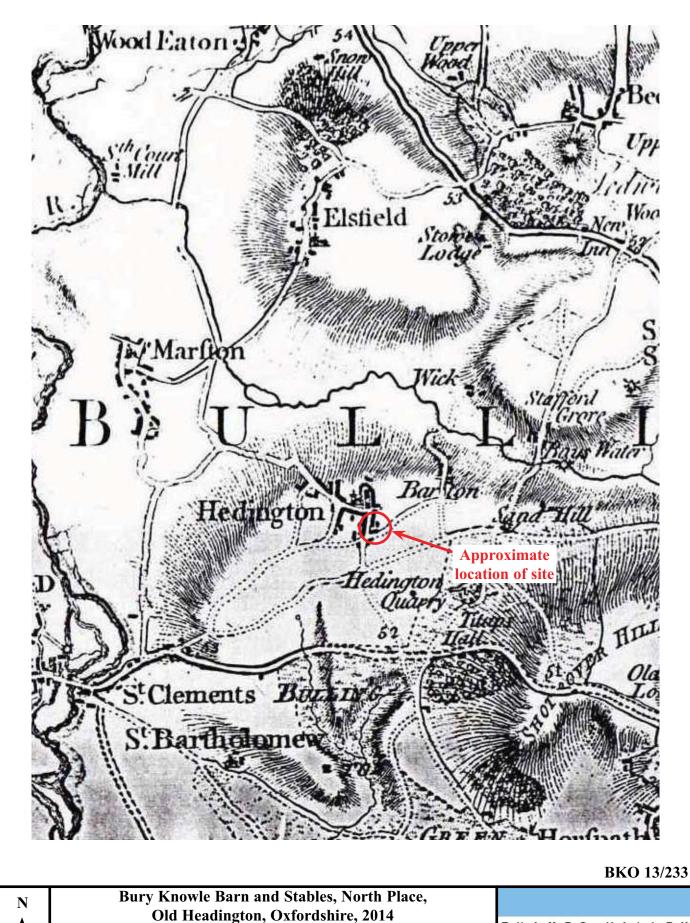
Figure 3. Jefferies' map of Oxfordshire, 1769.

A range of Ordnance Survey and other historical maps of the area were consulted at Oxfordshire Record Office and online in order to show the development of the site. Jeffries' map of Oxfordshire dated 1769 (Fig. 3) shows a group of buildings alongside Old High Street with a block set further back which may represent the barn and stable, but the scale is too small to be certain. The earliest map to show the site in sufficient detail is the Headington enclosure map of 1802 (Fig. 4) which shows the barn but not the stable block, located within a rectangular plot. The barn is part of a complex of buildings with another barn like structure attached to the west side of the barn and a smaller building to the south. None of the land plots occupied by buildings are numbered, as they would not be enclosed, so no occupant details are given: most of the surrounding land is assigned to Jos[ep]h Lock Esq (he was allocated some 17 acres in all).
