**Underwoods Farm Cottage, Borders Lane,
Etchingam, East Sussex**

Building Recording

Site Code: UFC13/168

February 2014

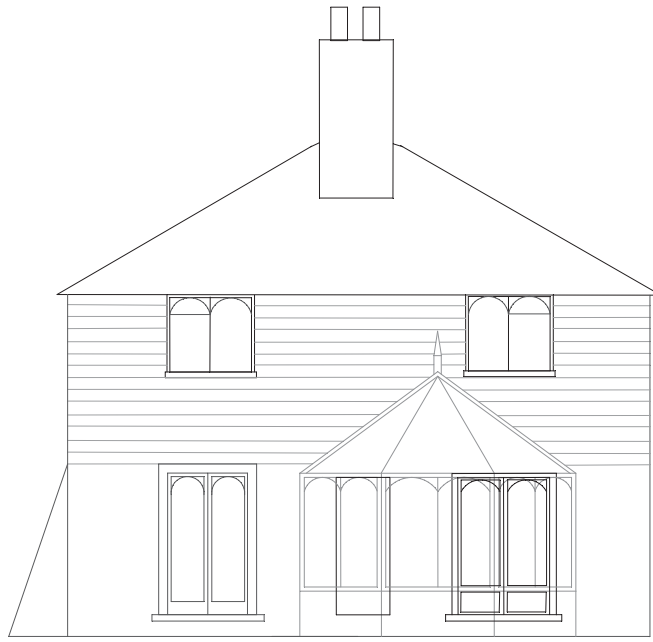
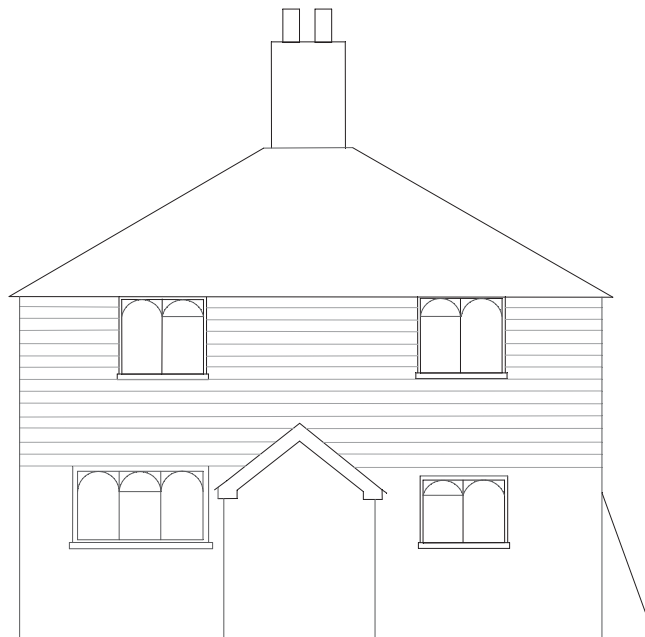
Figure 7. North and South Elevations.

The building was set back from the road and consisted of a rectangular building with a later extension to the north and a conservatory added to the south. The building was constructed of a brick ground floor and a timber first floor covered in wooden cladding painted white. The bricks, measuring 220mm x 106mm x 59mm (8⁵/₈" x 4³/₁₆" x 1¹⁵/₁₆") were predominantly laid in Flemish Garden Wall (Sussex) bond; the pointing had been redone

with cement mortar. The roof was an east–west aligned hip with slate tiles; these were of recent date. The windows were all of casement style with wooden frames with a wooden strip overlying the glass to form a decorative arch. To the rear were two French doors with matching decoration on the glass. The main entrance was on the east face of the north extension. Three later brick buttresses were present; two on the west elevation and one on the south elevation.

Externally it was harder to see what changes had occurred, as any changes to the brickwork had been bonded in. It is reasonable to assume that the two houses were a mirror image of each other externally as well as internally and that each room only had one window, in line with a low construction cost.

The north face of the eastern house was probably the original with a three pane window on the ground floor and a two pane window on the first floor. On the east face it is likely that the first floor window was a later addition that is not found in the western house. The ground floor window denotes where the original entrance to the house was and within the brick work it was possible to see a line of queen closers on either side of the window from the ground up to the cladding. The south face also probably reflects the original design with a two pane window on the first floor and a pair of French doors on the ground floor. The French doors were slightly wider in the eastern house compared to the western house and probably reflect a replacement set of doors, as they are the same as those found on the conservatory.

The north face of the western house had a two pane window on both the ground and first floor. It is likely that the ground floor window had been altered as a line of brickwork was present above the window which only appears to be present on openings that have been altered, the original height being to the level of the cladding. On the western face the original entrance to the house had been blocked up and a three-pane window inserted, again with a line of brickwork between it and the cladding. The south elevation was probably the original design with the window in the first floor and French doors on the ground floor.

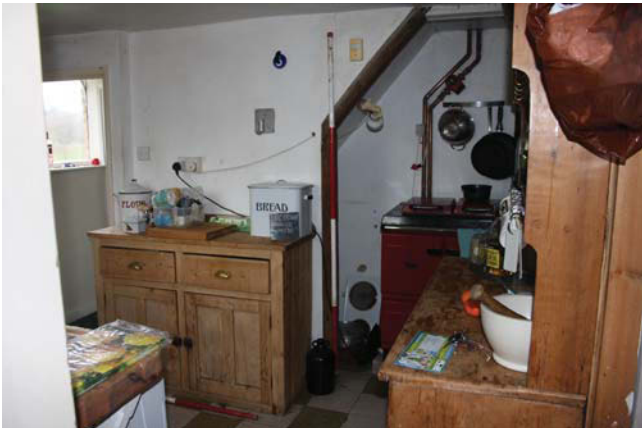
Room 10 (Pl. 5) was used as a kitchen. In the north wall was a three-paned window and in the south wall was access to the rest of the house and an area under the stairs. Woodwork framing the area under the stairs consisted of two reused oak timbers, one of which had the carpenters mark 'XX IIII' or '24' (Pl. 6). Room 9 was a narrow corridor between rooms 10 and 8 which contained the stairs to the first floor on the west side and a single window in the east wall. The staircase was relatively narrow and steep.

Plate 5. Kitchen (room 10), looking South east,
Scales: 2m and 1m.

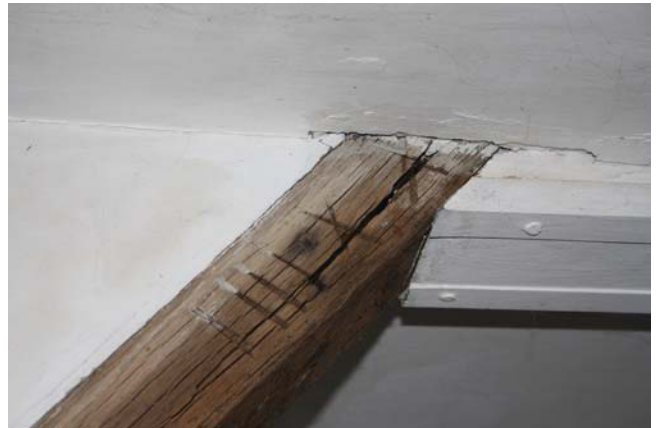
Plate 6. Carpenters mark in room 10, looking South.

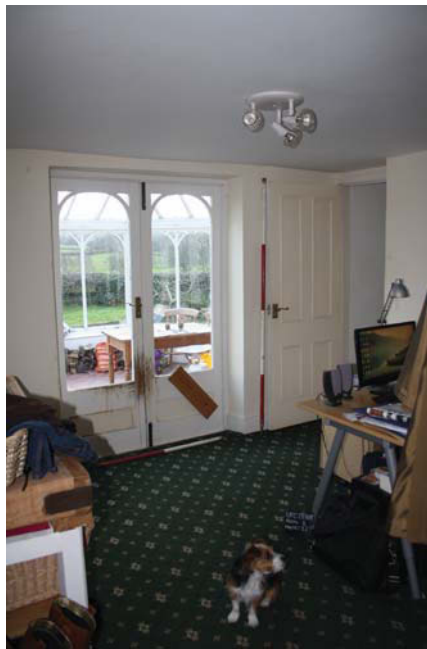
Room 8 (Pl. 7) was beyond corridor 9 and was at the rear of the house. A pair of French doors in the south wall gave access to the conservatory. In the west wall was a blocked fireplace and access to room 7 which formed the entire west side of the original cottage. The floor between rooms 8 and 7 sloped upwards slightly to room 7. Room 7 (Pl. 8) also had a pair of French doors in the southern wall, though of a slightly different design from those in room 8 and slightly narrower. In the north and west walls were windows of two and three pane design respectively. The fireplace in the east wall (Pl. 9) was still functional and consisted of a red brick chimney breast and flagstone hearth. The bricks were predominantly laid in stretcher bond in a matrix of lime mortar but a number of headers and queen closers were also present in no set pattern. Above the opening was a flat arch with two partial bricks forming the keystone. The cast iron grate was completely separate from the fireplace and had a hood.

Plate 7. Room 8, looking South west, Scales: 2m and 1m.

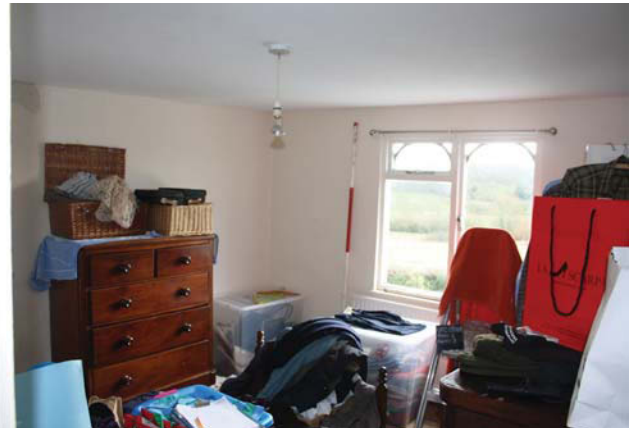
A small first floor landing (room 4) gave access to all the rooms on the first floor (Fig. 10). Immediately to the south was room 3 (Pl. 10) which had a chimney breast in the west wall and a two pane window in the south wall. Room 2 (Pl. 11), the next room along the corridor overlooking the rear of the property, was a mirror image of room 3. Opposite the stairs was a small cupboard (Pl. 12). In the northwest corner of the house was room 1 (Pl. 13) which was L-shaped and had a window overlooking the road. On the south wall was a cupboard. Corridor 4 continued through a doorway to the north, giving access to rooms 5 and 6. Room 5 was a narrow room, used as a bathroom (Pl. 14), across the north side of the house. It had a sliding door and a single window in the north-east corner. Room 6 (Pl. 15) was a long narrow room with a window in the east wall and a second, single window in the north-west corner of the room. Above the stairs to the south was a cupboard.

Plate 10. Room 3, looking Southeast, Scales: 2m and 1m.

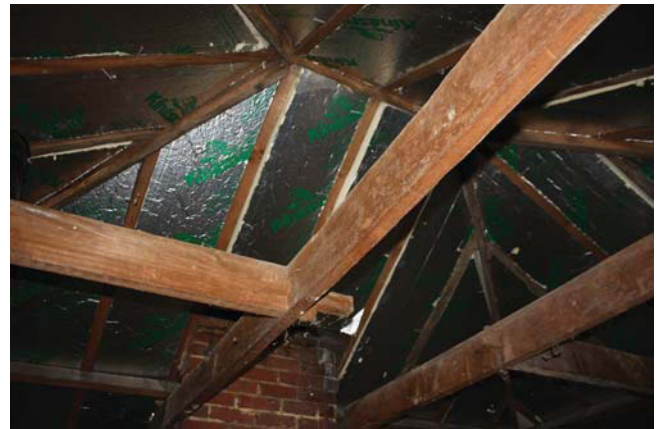
The roof structure (Pl. 16) consisted of wooden rafters laid on edge, overlying a purlin with a central plank ridge. Two T-shaped tie beams were present either side of the chimney stack.

Plate 16. Roof structure, looking North west.
