Cleave Farm, Weare Giffard, Bideford, Devon

**Archaeological Watching Brief**

Site Code: CFWG14/52

An Archaeological Watching Brief

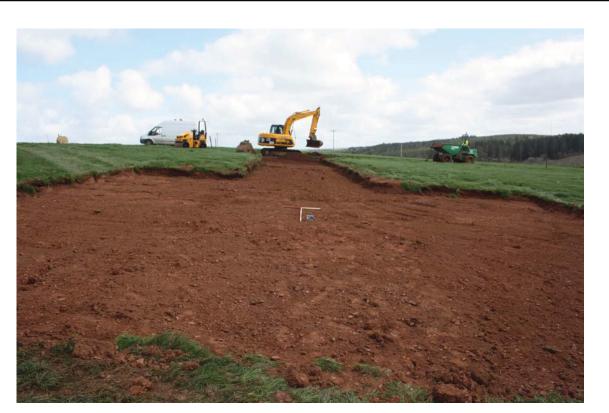
Plate 1.Strip for turbine base, looking north east, Scales: 2m and 1m.

The cable run from the fence line northwards to the base of the turbine was excavated with a width of 0.70m and varied in depth from 1.00m to 1.30m (Pl. 1). At point C (Pl. 7) the topsoil was 0.30m thick, subsoil 0.20m thick with a red clay with sandstone fragments to 1.0m+. No archaeological features or artefacts were observed.

The access road from the current farm track at the north end of the site to the turbine area, and the turbine area itself, were stripped using a toothless bucket to a maximum depth of 0.35m. In this area topsoil was 0.18m thick but the base of the subsoil was not reached (Pls 1 and 3). No archaeological features or artefacts were observed.

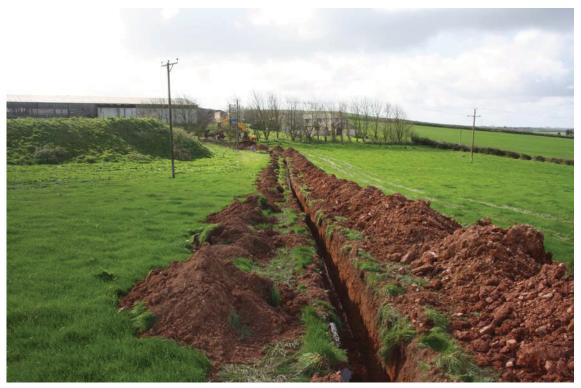
Plate 2. Pipe trench, looking south towards Cleave Farm.

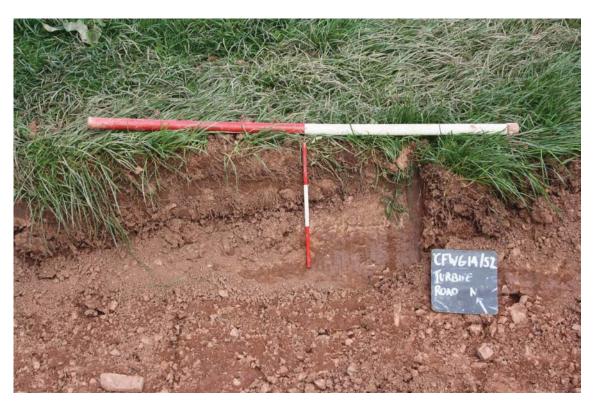
Plate 3. Turbine base section, looking north-east, Scales: 1m and 0.3m.

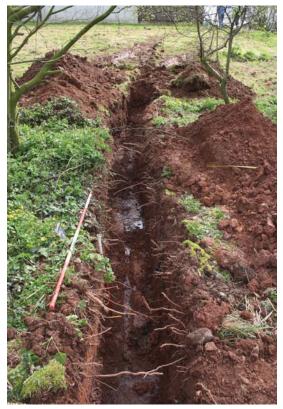
Plate 4. Pipe trench, looking south within northern part of Cleave Farm. Scales: 2m, 1m.

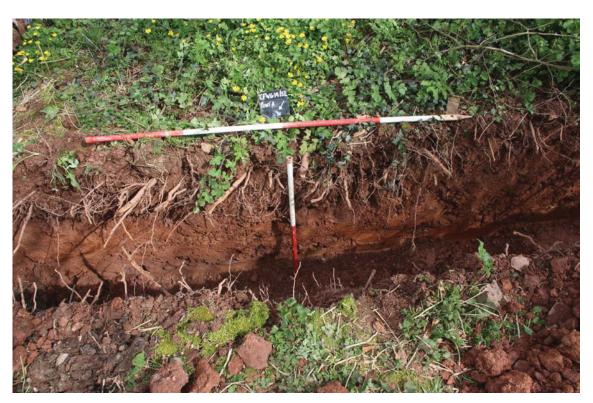
The first part of the cable trench to be excavated was a section from a fence line at the rear (north) of the farm complex, southwards towards the farm buildings and was dug using a toothed bucket which remain the case throughout the cable trench. Topsoil was stored on one side of the trench and subsoils/natural bedrock was stored on the other. The trench was 0.70m wide and 1.00m deep at point A (Fig. 2, Pls 4 and 5) with topsoil 0.20m thick and subsoil 0.40m thick overlying a red brown clay with sandstone fragments. No archaeological features or artefacts were observed.

Plate 5. Representative section of cable trench (A), looking south-east, Scales: 2m, 1m.

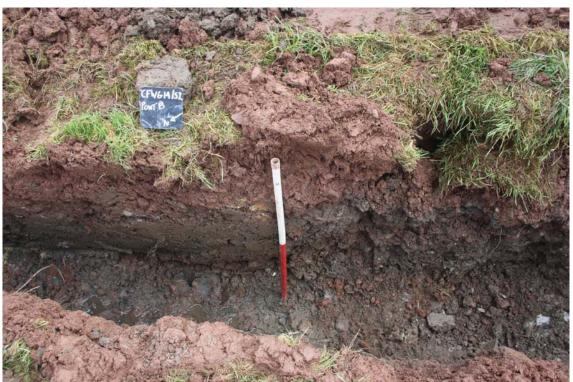
At a point 5m south of the fence line, the trench was reduced to 0.50m wide and was cut though an area of landscaping which appeared to be associated with the construction of the farm building to the south. Here (point B) there was a maximum of 0.30m of topsoil and 0.70m+ of a grey silty clay made ground which contained

modern plastic, oil filters and ceramic building material (Pl. 6). The level of the natural geology was not reached. No archaeological features or pre-modern artefacts were observed.

Plate 6. Southern representative cable trench section close to Cleave Farm (B), looking south-east, Scale: 1m.

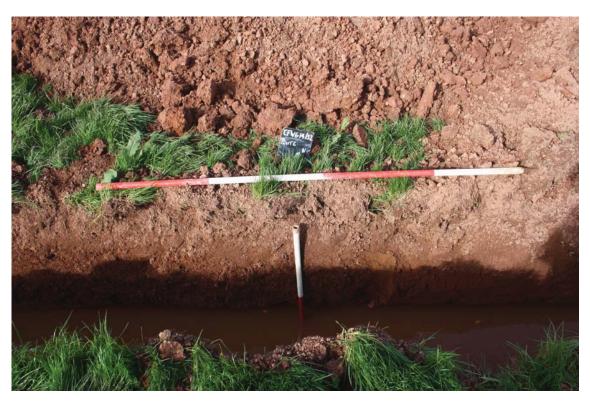
Plate 7. Representative section of cable trench (C), looking north-west, Scales: 2m and 1m.

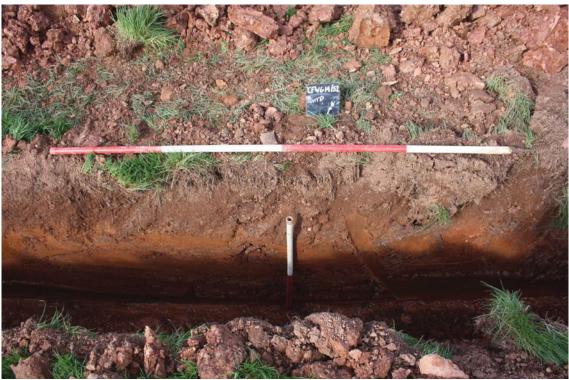
Further north at point D the topsoil was 0.40m thick, over subsoil 0.10m thick beneath which a red clay with sandstone fragments to 1.10m. Beneath this was crushed sandstone natural to a depth of 1.30m (Pl. 8). No archaeological features or artefacts were observed.

Plate 8. Northern representative cable trench section close to new turbine base (D), looking north-east, Scales: 2m and 1m.
