**22a East Street, Brighton,  
East Sussex**

**Historic Building Recording**

**Site Code: ESB14/36**

**Historic Building Recording  
For Baron Homes Corporation Ltd**

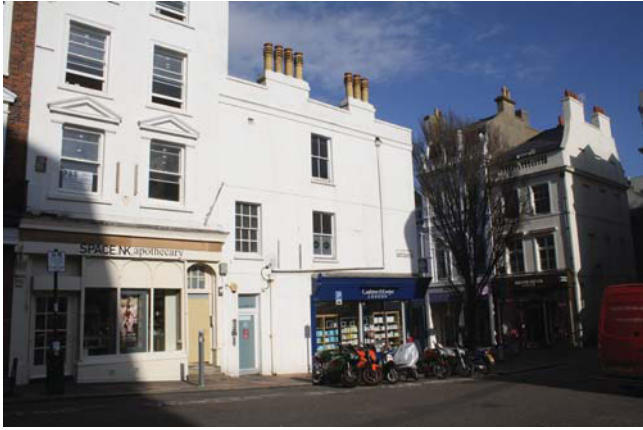
Plate 1. Exterior view of south frontage from Bartholomews.

The north, east and south elevations of the building are visible from East Street Arcade, East Street and Bartholomews (Pl. 1) respectively, whilst the west end of the building is largely obscured by neighbouring properties, save for the small rear lightwell which is accessed via the ground floor shop premises. Apart from the shop fronts, the whole building is covered with stucco and painted white, which means that very little can be gleaned about the materials used in its construction (Pl. 2). The main entrance (22a) to the upper floors is on the south side of the building, via a modern glass door. This elevation has two wooden framed sash windows at first floor level, and a further sash window on the second floor. The first floor window above the entrance may be an original feature, whilst the other two appear to be later replacements. Two chimney stacks are visible.

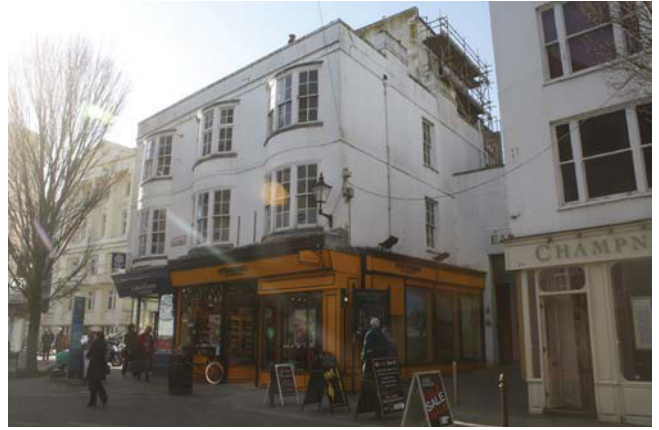
Plate 2. Exterior, general view looking south-west.

Excluding the ground floor shop facade, there are two wooden framed sash windows visible in the north facing elevation (one on the first floor and one on the second floor), along with two chimney stacks. The small window which serves the WC between the first and second floors (room S9) is not visible from ground level, due to the high facade at the entrance to East Street Arcade (Pl. 2).

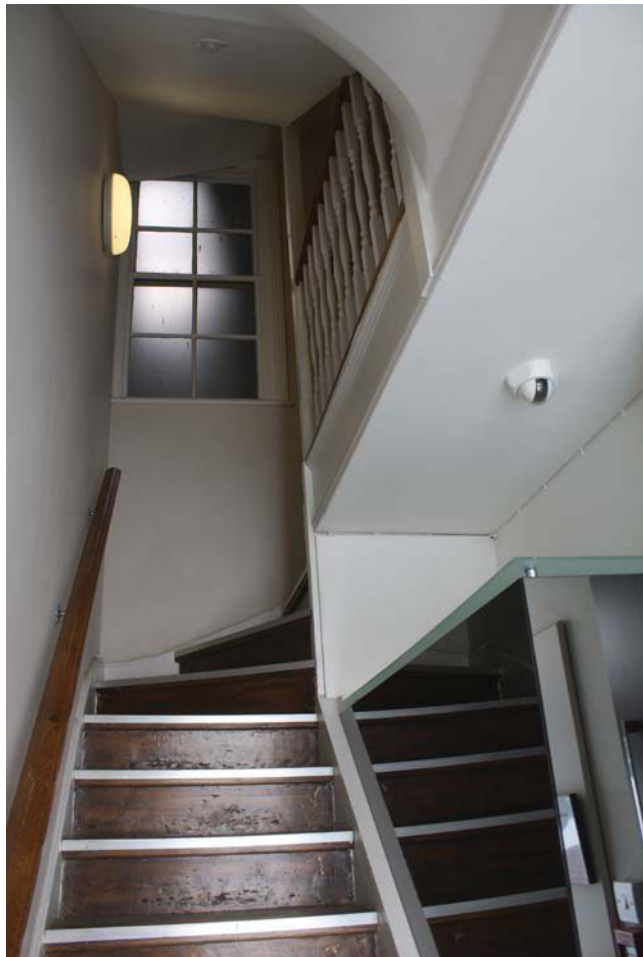
Plate 3. Staircase in Room G1, looking north

There are two entrances to the upper floors of the building. The main entrance from Bartholomews leads into a small lobby (G1) with a staircase leading to the upper floors (Pl. 3). The wooden stairs appear to have been

renovated, and the handrail along the western wall appears to be a recent addition. There is a small sash window at the top of the first flight of stairs which overlooks the rear lightwell. The secondary entrance from East Street Arcade (Pl. 4) is fairly anonymous from the exterior of the building, as it is largely used as a fire escape. The small lobby (G2) contains a staircase to the upper floors. The staircase leading to the first floor has 20th-century square balusters and is clearly a later addition as it partially obscures a boarded up window above what is presumably the original doorway (Pl. 5). The presence of this earlier doorway (which now has no door) indicates that this part of the building has been significantly modified in the past, possibly when the present entrance to East Street Arcade was built.

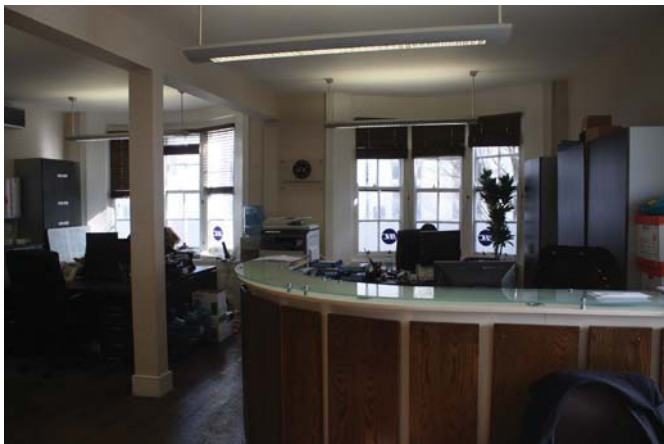
Plate 7. Room F2 looking north-east

Room F2 may originally have been at least two rooms, although any earlier partition walls were removed prior to 2002. The top section of a central wall can be seen, supported by two pillars (Pl. 7); this would probably correspond with the division shown on the map of 1875 (Fig. 5). There are two large bow windows in the east wall, overlooking East Street, which are probably original features. Each of these is split into three sash windows, which are in good condition. There is another sash window in the south wall, overlooking Bartholomews, and a further one overlooking the rear lightwell (Pl. 8). A partition wall in the south-west corner of the room contains a WC (F3) which is fully tiled with modern fittings (Pl. 9). Whilst there was a WC here prior to 2002, a comparison of the plans suggests the area has been altered in the last twenty years, and the present partition wall is probably a recent feature (Pl. 10). There are two narrow doorways in the north wall of room F2 (Pl. 11), which lead into rooms F4 and F5. The 2002 plans indicate that these doorways are relatively recent in date, and were built to replace an earlier, wider, doorway. The 2002 plans also seem to depict a possible cupboard to the east of the doorways, along the north wall of room F1. Interestingly this 'cupboard' is positioned immediately below a fireplace on the second floor (in room S5), so it is possible a fireplace was removed some time before 2002. In any event, no such a feature exists anymore. It is highly likely that the north wall of room

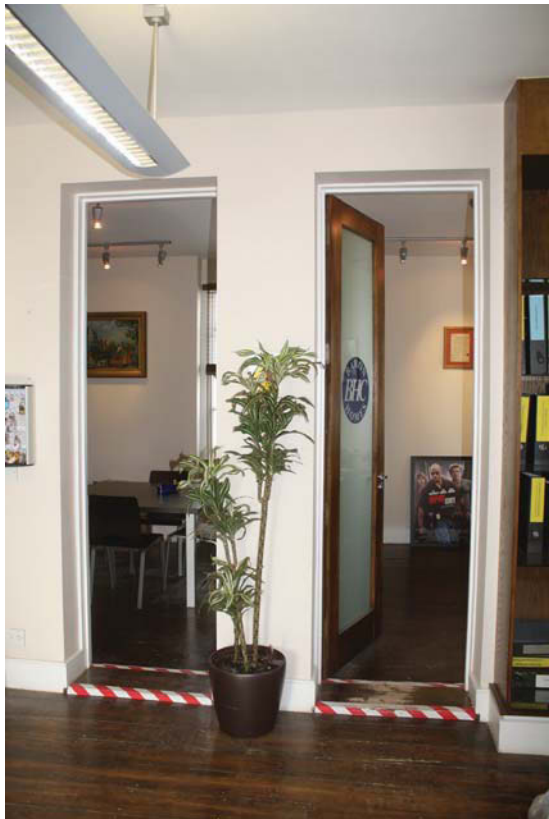
Plate 11. Doorways in Room F2 looking north

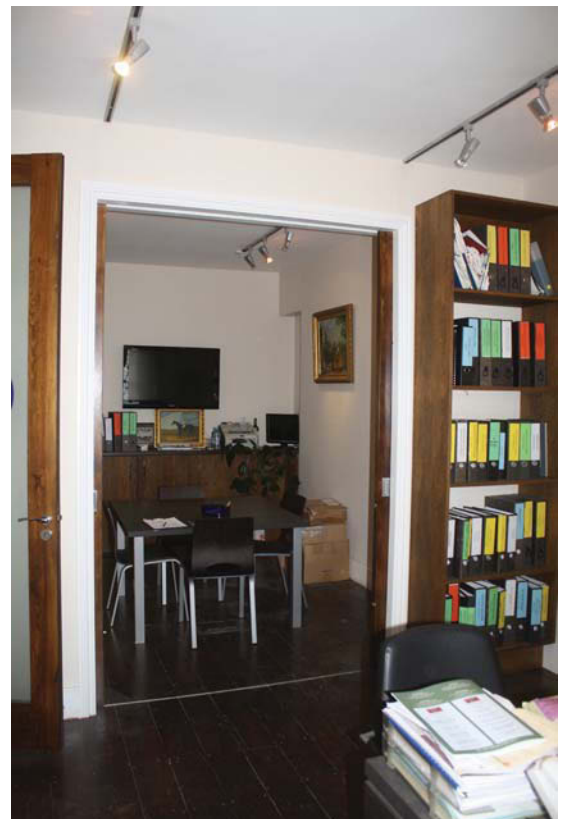
Plate 12. Room F4 looking north-west

The partition wall between rooms F4 and F5 is clearly a modern addition, as this area was one room in 2002 (Pl. 12). Room F4 has one large bow window in its east wall, overlooking East Street (Pl. 13). It is almost identical to the two in room F1, which indicates that they are all contemporary. The 2002 plan shows a further window in the north wall, along with a fireplace / chimney breast. However, these features are no longer visible within the room, and there is no indication of the presence of a blocked window on the exterior of the building but there is a corresponding chimney stack. Room F5 has a sash window in its north wall, overlooking East Street Arcade, along with a blocked up fireplace (Pl. 14). The partition wall between room F5 and the first floor landing (F6) is shown on the 2002 plan.

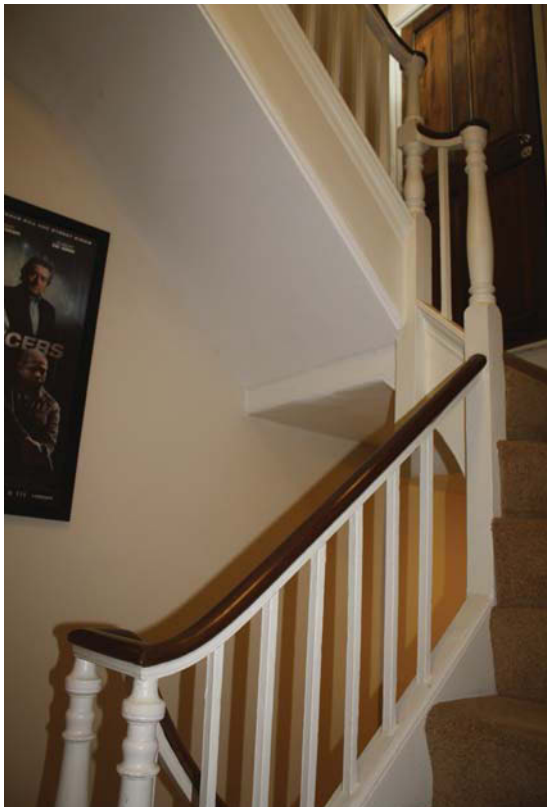
Plate 15. Northern staircase looking north-west from F6

Landing F6 contains a staircase linking all three floors of the building (Pl. 15). The lower section staircase has plain square balusters and turned newel posts, which suggests that it may be a later replacement, as the upper sections have turned balusters, similar to those observed in the southern staircase.

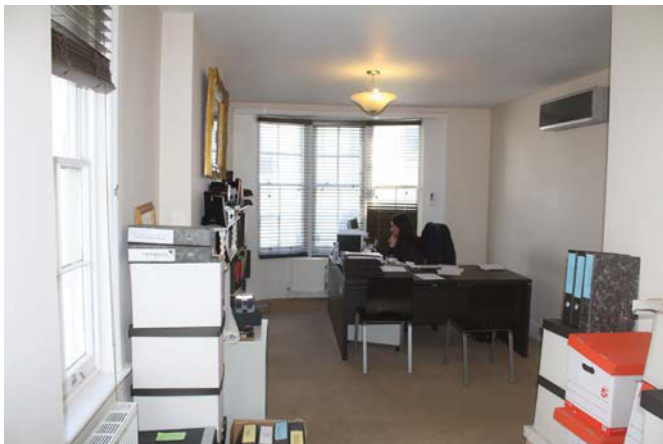
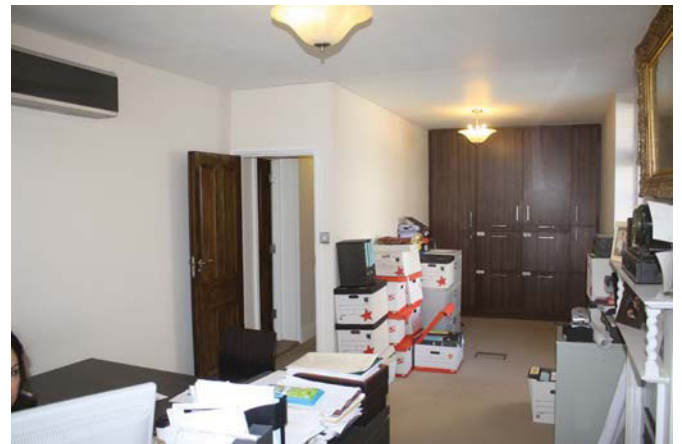
Room S6 is now a large office (Pls 19 and 20), but it is clear from the 2002 plans that it was originally two rooms. The partition wall has clearly been removed since 2002. There is a large bow window at the east end of the room, overlooking East Street, and a smaller sash window in the north wall overlooking East Street Arcade. The room originally had two fireplaces along its north wall, but the western one has been completely blocked up. The eastern fireplace has been substantially renovated to give it a modern appearance (Pl. 21).

Plate 19. Room S6 looking south-east

Plate 20. Room S6 looking west

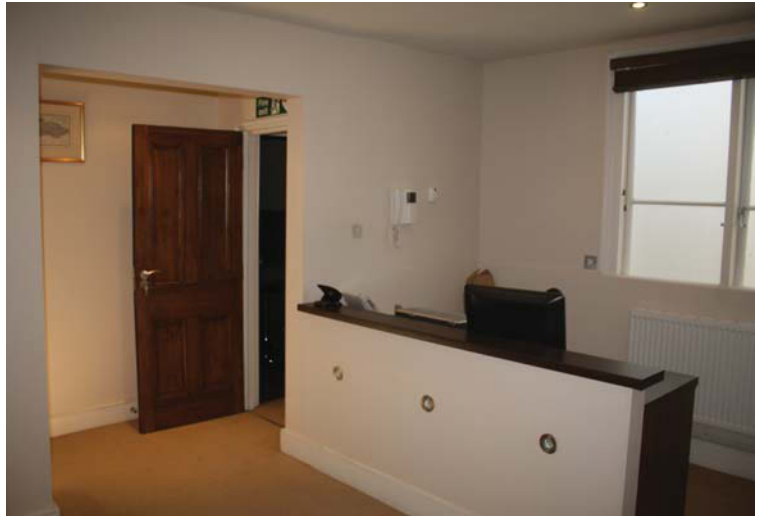
Plate 22. Room S3 looking south-west

Room S3 is currently a small reception area, with the desk positioned behind a low partition wall (Pl. 22). There is a modern looking window overlooking the rear lightwell (Pl. 23). There are doorways leading to corridor S7, room S5 and corridor S1. The fireplace along the north wall of the room has been completely obscured, and the 2002 plans suggest that a feature in the north-west corner of the room has been removed recently. The plans also show a window in the south wall, which would have overlooked what is now landing S1 but was then part of room S4. This wall has been radically altered, with the window being replaced by a wide entranceway into landing S1. Room S5 functions as a meeting room at present, and has a large bow window in its east wall overlooking East Street (Pl. 24). The fireplace along its north wall has been completely blocked up.

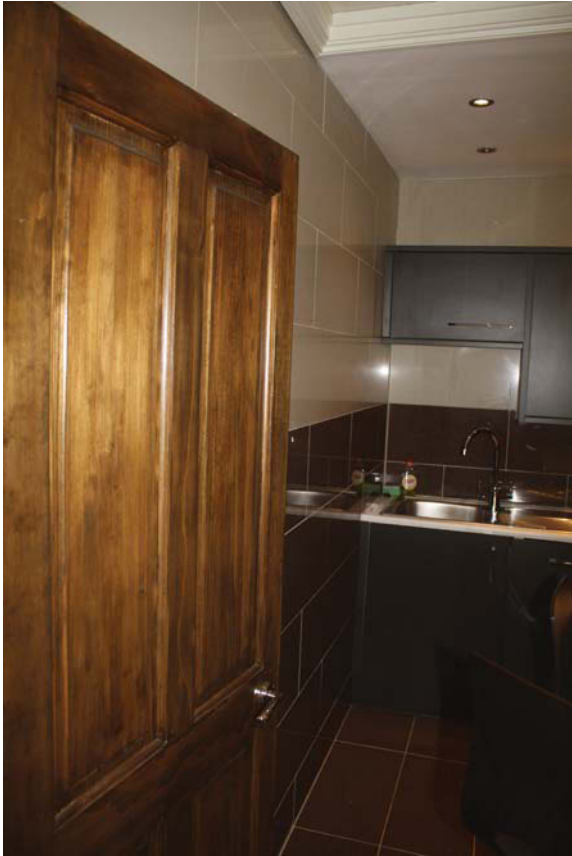
Plate 25. Kitchen S2, looking south

Landing S1 can be accessed from the southern staircase and from room S3. The 2002 plans indicate that this area of the building has been significantly modified since then. As mentioned above, the present entranceway through to room S3 was created to replace an earlier window. The partition walls to the south of landing S1 are mostly recent additions and, as a result, kitchen S2 (Pl. 25) is clearly a relatively new feature within the building.

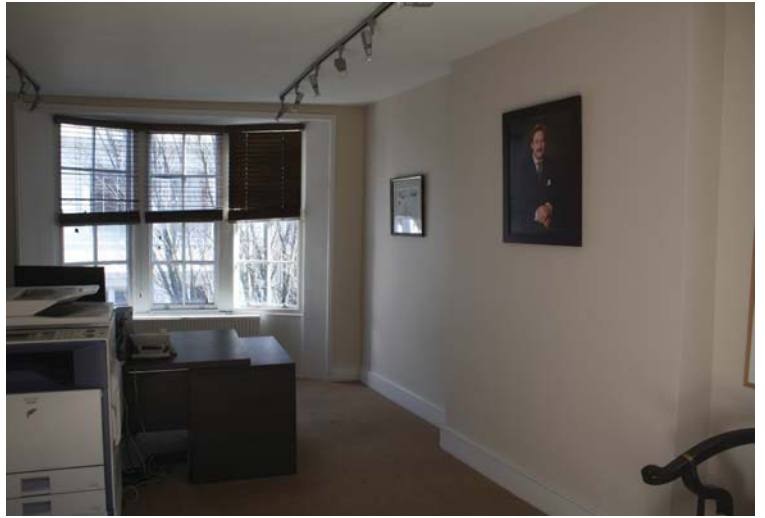
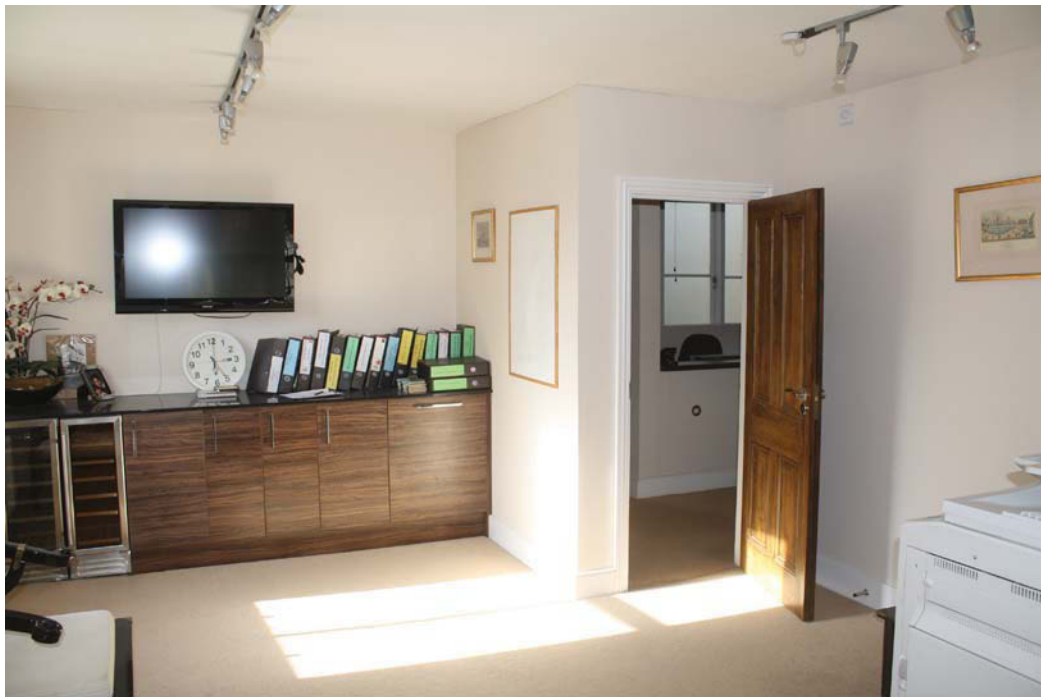
Room S4 is now quite a large office (Pls 26 and 27), but the 2002 plans indicate that this room was previously much smaller as there was an earlier L-shaped partition wall in the western half of the room, which has now been removed. The room has one large bow window overlooking East Street, and a smaller sash window overlooking Bartholomews. Two fireplaces in the southern wall have been completely blocked up.

Plate 26. Room S4 looking south-east

Plate 27. Room S4 looking north-west
