**The Falmouth Arms, Bath Road,  
Woolhampton, West Berkshire**

**Building Recording**

**Site Code: FAW14/47**

**March 2014**

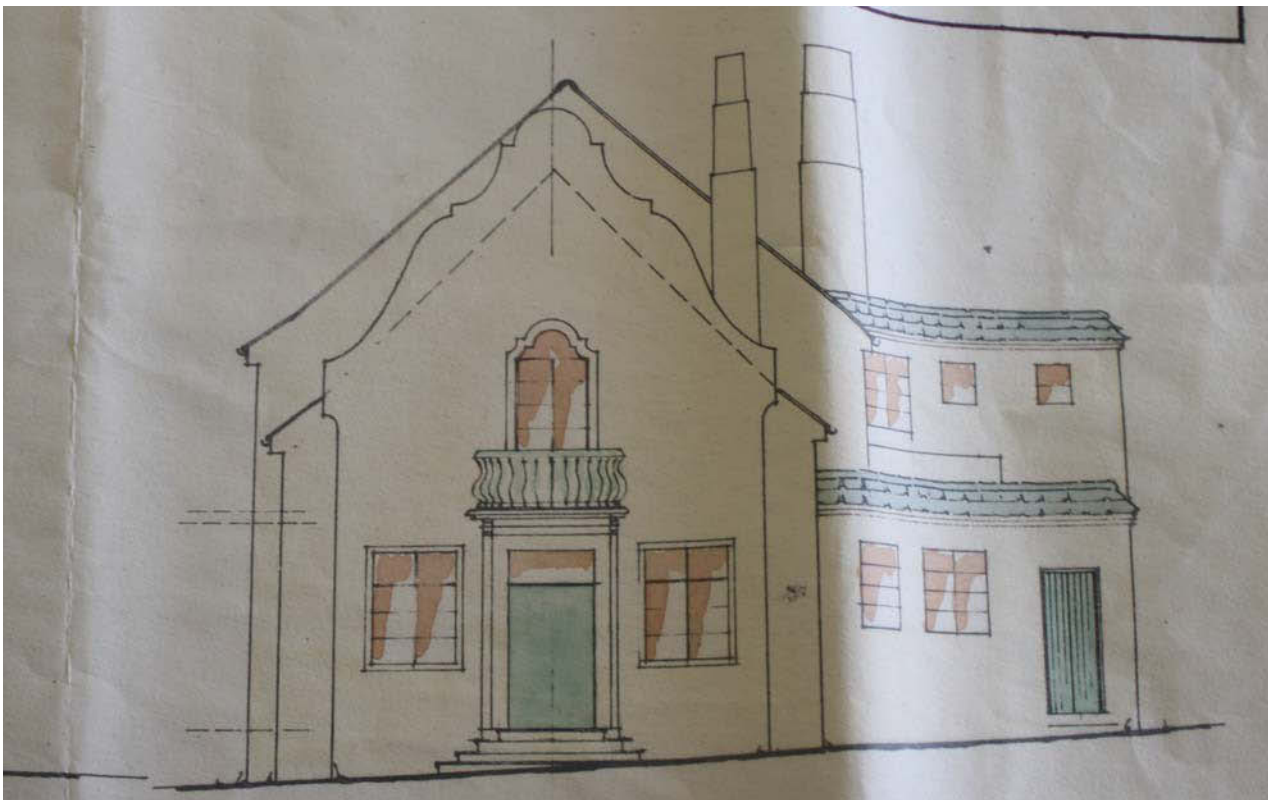
Figure 11. New Elevations, 1936.  
Front (top), Gable end (bottom)

The redevelopment plans of the 1930s changed the frontage of the building, a gable end (Fig. 11) and the internal layout with the addition of new extensions (Fig. 12). Pevsner’s reviser described the inn as dating from the 1930’s heyday of motoring and “in the Portmeirion style of play-Baroque, rendered, with shutters, curvy gables, an eared surround to the main doorway and blue-green pantiles,” (Tyack, 2010, 737). Earlier editions of this work (i.e. Pevsner himself) did not mention the Falmouth Arms.

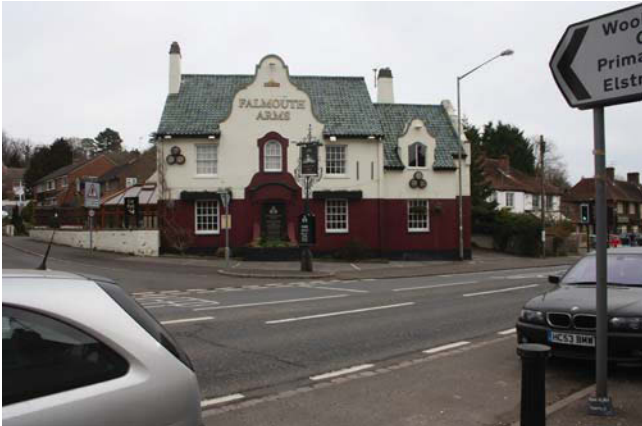
Plate 1. Exterior, front elevation, looking north east.

The front (south-western) façade contained both the original building and the eastern extension (Fig. 14, Pl. 1); the modern conservatory was present to the west. The original building was double fronted with a central doorway. The door was accessed via a small, curved flight of steps with low curved walls on either side. The door had been blocked and a plaque detailing the (inaccurate, see *historical background*) history of the inn erected.

The central part of the original building was surmounted with a Dutch-style pediment consisting of a combination of concave and convex curves. This was mirrored by curved mouldings above the door and central window, which was itself a round headed sash window. The remaining four windows were recessed, eight over eight-paned sash windows with their boxes exposed and 24mm thick glazing bars.

The eastern extension was set slightly back from the original building and had a staggered frontage. A single window was present on the ground floor, of the same style as those on the original building. A second, dormer, casement style, window was present above it, surmounted with a small Dutch-style pediment.

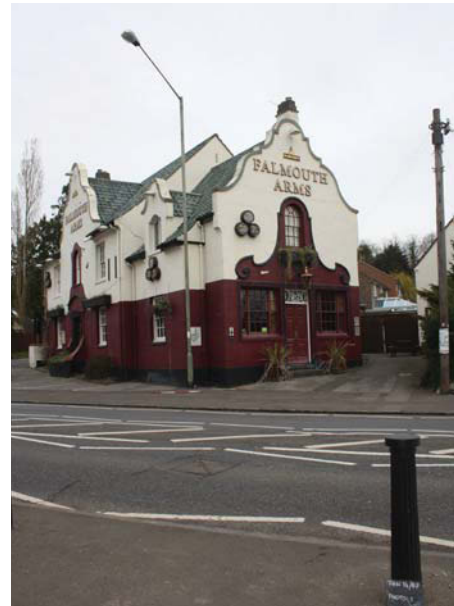
Plate 2. Exterior, south elevation with street entrance, looking north.

The south-east elevation (Fig. 15, Pl. 2) consisted of the eastern extension, the ground floor infill and the first floor of the rear extension. The ground floor consisted of a central, double doorway, reached via two steps

with a set of windows either side. The windows were tri-partite sash windows, consisting of a central six-over-six panes with a one-over-one pane on either side. Above the door was a decorative glass and metal panel with the date 1936 and the initials UWB (Ushers Wiltshire Brewery). The first floor contained a single central, round-headed sash window. The gable end was surmounted by a Dutch-style pediment, matching the one on the front. This was mirrored with mouldings above the ground floor door and windows, including the first-floor window.

The ground floor infill consisted of a pair of doors at the north end, with two sets of windows at the south end. The windows were small, horizontal opening metal windows with the northern one containing three panes and the southern one two panes. Both had a plain concrete sill with a decorative hood above, surmounted by a line of tiles; there was also a decorative hood and line of tiles above the door. Beneath the parapet were three courses of projecting bricks, into which a water drainage hole had been inserted to drain the flat roof. The water was collected in a cast iron hopper which had a diamond motif in relief on it.

The first-floor rear extension contained two windows; a taller one to the south and a smaller one to the north. Both had horizontal openings, with the tall window being of metal (Crittall-type) construction. Each window had a decorative hood above it and a row of tiles; the same as the ground-floor infill. The projecting brickwork beneath the parapet was also the same.

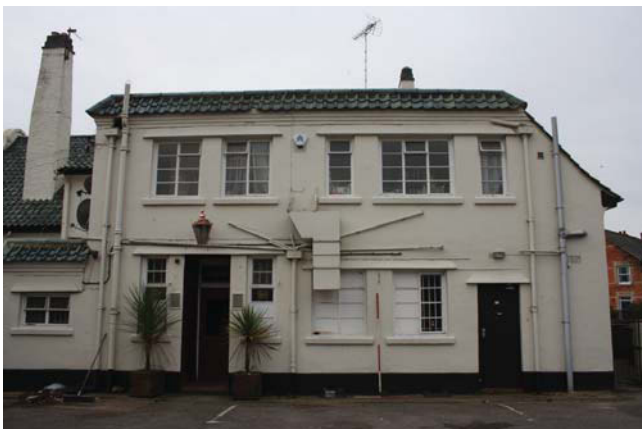
Plate 3. Exterior, rear elevation, looking south west,  
Scale: 2m.

The rear (north-east) elevation (Fig. 14, Pl.3) consisted of the rear extension, part of the ground-floor infill and a single window of the original building. The rear extension was in the same style as that seen on the south-east façade with projecting brickwork, decorative hoods over the windows and two cast-iron down pipes with decorated hoppers; a third hopper was present to collect internal waste water. The ground floor, from north to south, contained a service door, two double-paned Crittall-type windows and a public door. Either side of the doorway was a single Crittall-type window with leaded panes at the top. On the first floor were two sets of Crittall-type windows; at the north end these were arranged as a triple pane surrounded by two single panes under one hood, and to the south two double-paned windows under one hood. The north end appeared to have been extended to the north-west with a half-gable roof.

The ground-floor infill contained a single, two-pane-wide window, surmounted by a decorative hood. It was the same style as those on the south-east elevation. The rear of the original building contained a single, squat replacement Crittall-style window in modern pvc with a plain sill and lintel.

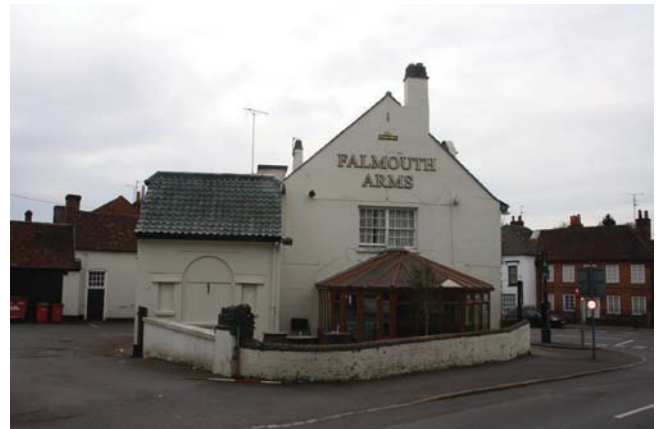
Plate 4. Exterior, north elevation with conservatory,  
looking south, Scale: 2m

The north-west elevation (Fig. 15, Pl. 4) consisted of the rear extension, the original building and the modern conservatory. The rear extension contained a set of three blocked windows arranged in the Venetian

style of a central curved opening (but in this case probably containing a rectangular window) with a single window either side, surmounted by decorative hoods and a tile course above.

The original building had a pair of eight-over-eight-paned sash windows beside each other on the first floor. A chimney was also present within the south-west facing roof.

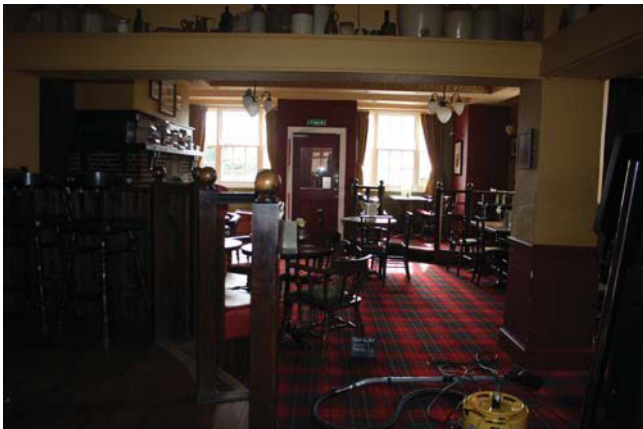
Plate 7. Interior, room 2 towards street entrance, looking south east.

The ground floor was sub-divided by room and numbered 1–10. The main entrance was located within the south-east gable end, giving access to room 2. Room 2 (Pl. 7) was a large open room with windows on the south-east and south-west walls. A fireplace was located on the north wall. The fireplace (Pl. 8) was of mixed brick and decorative carved stone construction with a tiled hearth. A wooden mantelpiece had been added above it. The north-west end of the room had wooden panelling up to picture rail height, whilst the south-east end was plastered with a dado rail. A number of beams crossed the ceiling decorated with shells, butterflies and birds on the underside and grapevines on the internal (vertical) sides (Pl. 9). Doors/openings either side of the chimney breast led to room 9 (female toilet) and a short corridor leading to room 8 (male toilet). Above the openings was a decorative curved archway, mirroring that in the fireplace (Pl. 8). A curved, raised area gave access to the bar counter, and corridor 1. Beside this and up two steps was access to the main bar area, room 3.

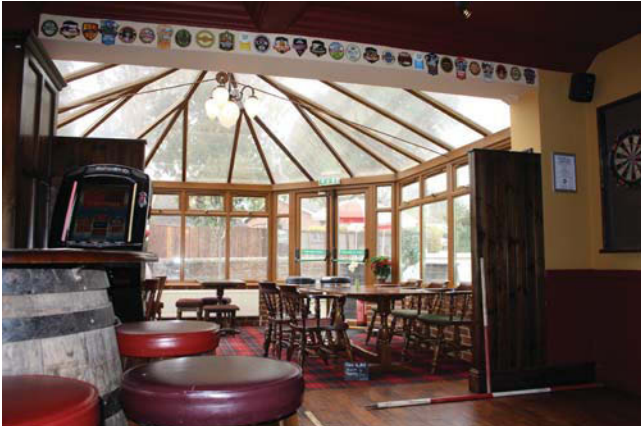
Plate 13. Interior, room 4, looking north north west,  
Scales: 2m and 1m.

Behind the bar area was access to the kitchen. Opposite the bar was seating within the former entrance lobby, into which windows had been inserted, looking into the rest of room 1 and into room 2. The room was a combination of wooden panelling at the south-west end and plaster with a dado rail to the north-east (Pl. 11). Around the ceiling was moulded coving. Stripped timber covered the floor. On the north-west wall at the junction with the conservatory was a fireplace. The fireplace (Pl. 12) was brick built with a brick hearth and a simple, separate, cast-iron grate. The mantelpiece was formed of a single timber, which appeared to be oak. Beyond room 3 was the modern, brick and wood conservatory (room 4, Pl. 13).

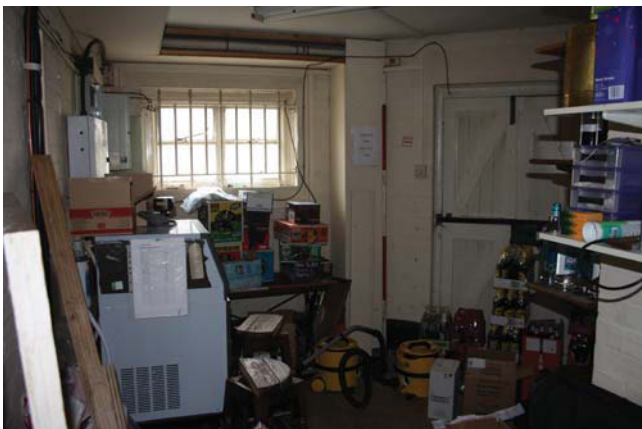
Plate 15. Interior, room 6, looking north east.  
Scale: 2m.

Behind rooms 2 and 3 and accessed from the bar or room 2 was the service area and public access to the rear car park. Corridor 1 was L-shaped and gave access to rooms 5, 6, 7 and 10. Corridor 1 was of plain plaster with a dado rail and plain ceilings. Bricks within the porch were laid in stretcher bond and measured 220mm long by 64mm thick, bonded in lime mortar. On either side of the rear entrance were rooms 7 (male toilet) and 10 (female toilet). The kitchen (room 5) was located to the northwest of the corridor. The room itself was functional with tiled walls, plain ceilings and bars across the windows (Pl. 14). Access to the cellar was in the south-west wall, beside a blocked fireplace. Stairs to the first floor were located in the north-west corner with an additional external door. The stairs were bounded on either side by walls and had a wooden banister rail on one side. These were of modern construction. At the far end of corridor 1 was the store (room 6), accessed through a pair of doors. The room was a store and functional in its decoration with a plain ceiling and painted brick walls (Pl. 15).

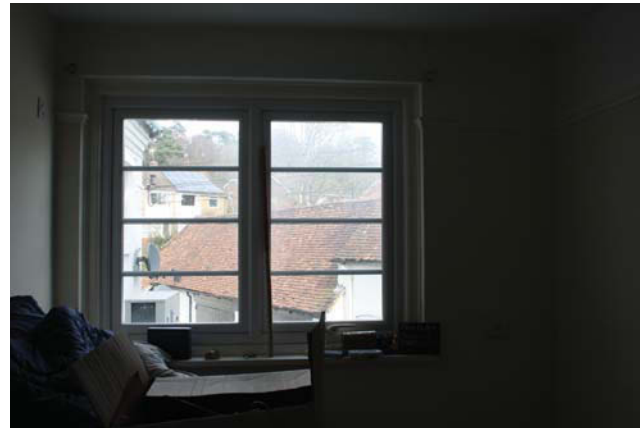
Plate 18. Interior, room 18 window, looking north east, Scale 1m.

windows whilst allowing enough room for a doorway into room 14. On the north-east wall was a blocked fireplace. Room 18 had a picture rail around some of the walls and a single window overlooking the rear yard (Pl. 18).

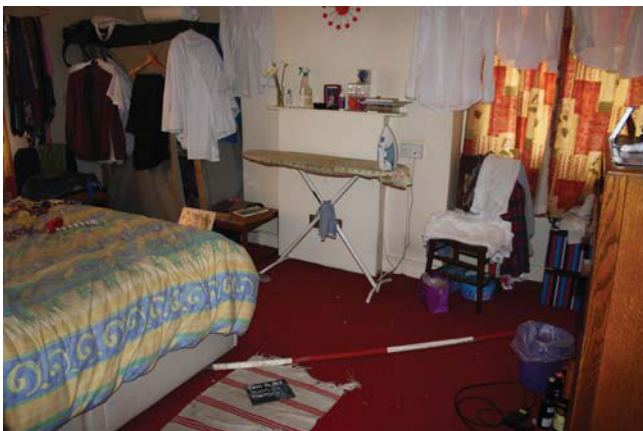
Plate 19. Interior, room 14, looking west. Scale: 2m.

Room 14 (Pl. 19) in the west corner of the building contained two windows; one overlooking Woolhampton Hill and the other overlooking the Bath Road. A blocked fireplace was present on the north-west wall. Next to it was room 15 which had the curved sash window with a picture rail on the wall (Pl. 20). Beside it room 16 (Pl. 21) also had a picture rail and a single window overlooking the Bath Road. At the far end of the corridor was room 17, which contained three windows overlooking the front, side and rear of the site. The front window was a dormer sash window with a curved top (Pl. 22), whilst the gable end window was a curved sash. On the rear wall was a blocked fireplace with a cupboard either side into the eaves. Around the walls was a picture rail.

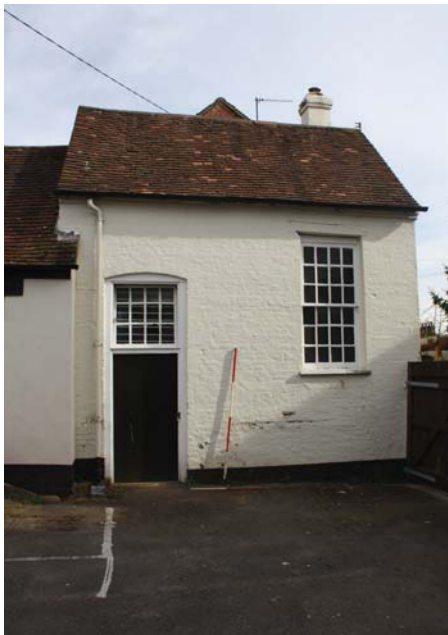
Plate 23. Exterior, outbuilding, looking south east.  
Scale: 2m.

Externally room 19 was brick built in English garden wall bond and painted white, with the lowest few courses painted black (Pl. 23). In the west face was a blocked archway with the highest part approximately 1.20m above the ground surface. The arch was a flat arch with a soldier course of bricks laid on edge with a header course above it. A wooden lintel was present immediately beneath the arch. To the north was a doorway with a twelve-pane window above it. The same type of arch was used to construct the door opening. Toward the southern end of the west elevation was a large twelve-over-twelve-pane sash window with a flat lintel above of unknown material. In the southern wall was a blocked window, above which was a curved arch.

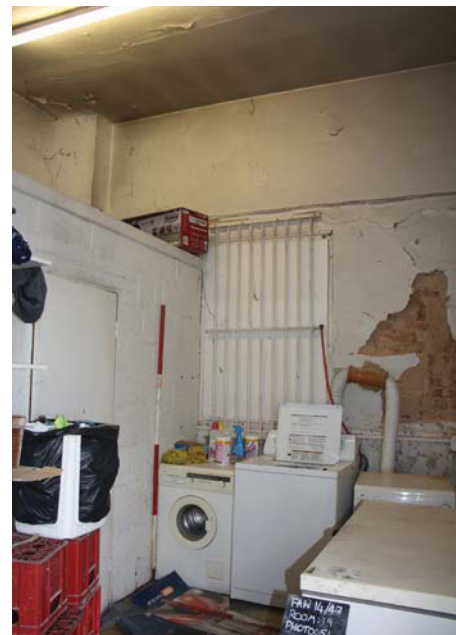
Plate 24. Interior, room 19 south corner,  
Scale: 2m.

Internally the walls and ceiling were plastered. Bars were present behind the blocked window in the southern wall and a modern concrete block partition had been built (Pl. 24).

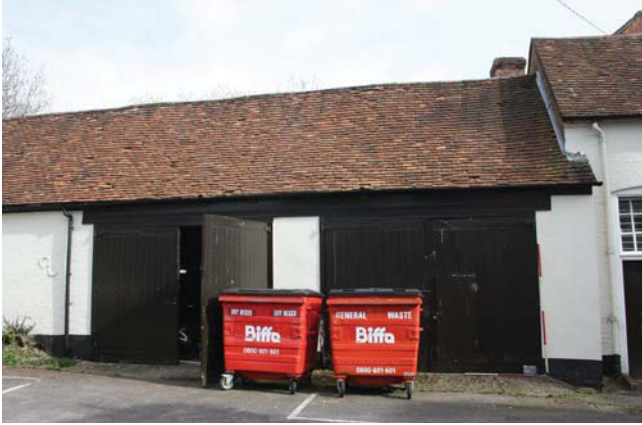
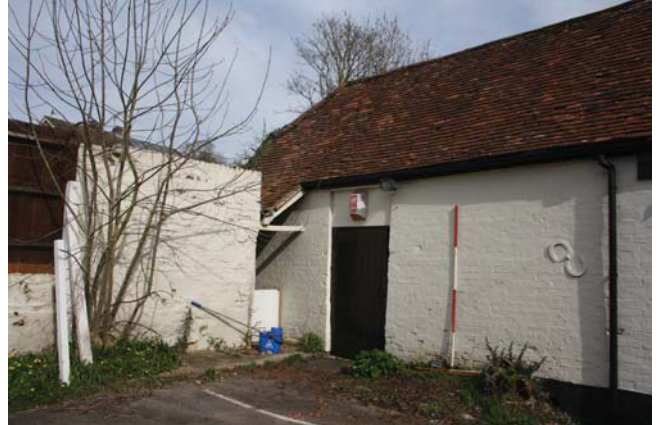
Plate 25. Exterior, outbuilding main doors, looking south east, Scale: 2m.

Externally the barn was brick-built in Flemish bond and painted or rendered white, with the lowest courses painted black (Pls 25 and 26). The west wall contained two pairs of cart shed doors at the southern end and a

single door at the northern end. The roof line had been extended slightly at the north end to provide a small sheltered storage area. The roof was of red tile.
