**Bulldown Farm Barns,  
Bramley, Hampshire**

**Building Recording**

**Site Code: BDB13/213**

**Report 13/213**

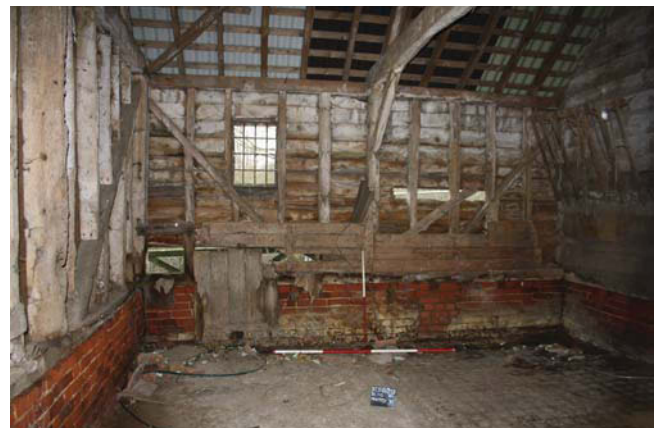
Plate 4. Interior, Unit A, south facing wall,  
Scales: 2m and 1m.

The brick plinth was typically eight courses high internally with the bricks laid in Flemish bond, topped and tailed with a row of headers on the gable ends (Pl. 4). The long walls were of English bond, capped with three rows of Flemish bond and a row of headers. The walls were bonded with lime mortar. The bricks measured 231mm x 110mm x 66mm (9 <sup>1</sup>/<sub>8</sub>” x 4 <sup>5</sup>/<sub>16</sub>” x 2 <sup>9</sup>/<sub>16</sub>”).

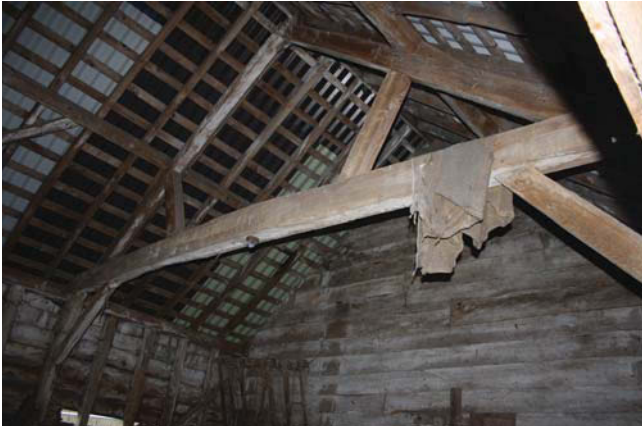
Plate 5. Interior, east wall and roof trusses.

Roof construction (Pl. 5) consisted of wall plates laid over the top of the principal posts behind the jowls, and the tie-beams were then laid over both of them. A pair of principal rafters supported a purlin on either side and met at a plate which supported a raised ridge plank. The truss was of queen strut construction. The tie-beam was supported on straight braces tenoned into the internal faces of the principal posts. The rafters were of quarter tree trunks.

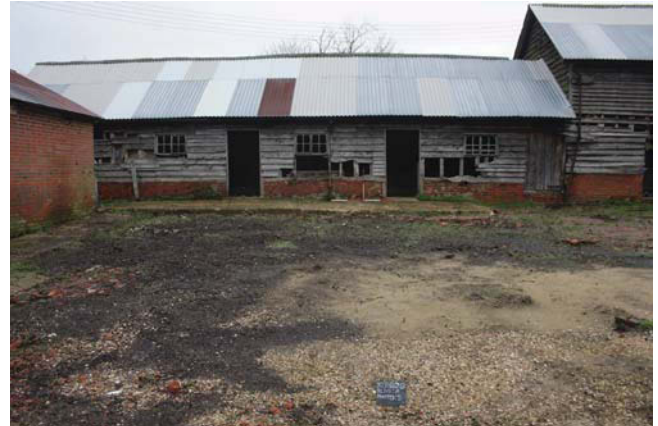
Plate 6. Exterior, south elevation of Unit A,  
Scales: 2m and 1m.

Unit A3 was located to the east of Unit A2 and together with unit A4 formed the north side of the courtyard (Pl. 6). It consisted of four unequal-sized bays and was probably most recently used as a cow shed. It was of similar construction to unit A2 with no difference seen between the brick plinths. The timber framing was also of the same construction.

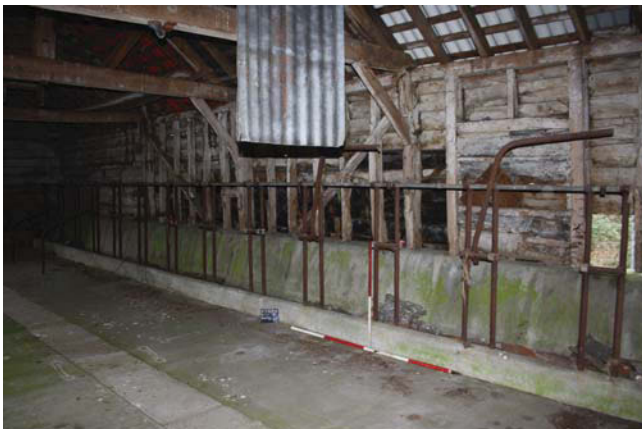
Plate 7. Interior, Unit A, concrete troughs,  
looking north west, Scales: 2m and 1m.

Internally it had a concrete floor with a concrete manger along the north wall sub-divided by cast iron scaffold poles (Pl. 7). Within the southern wall were three doors. The two western doors were of the split stable door type whilst the easternmost door was partially set into the brick plinth. Within the east and west gable walls was a doorway giving access to units A2 and A4 respectively.

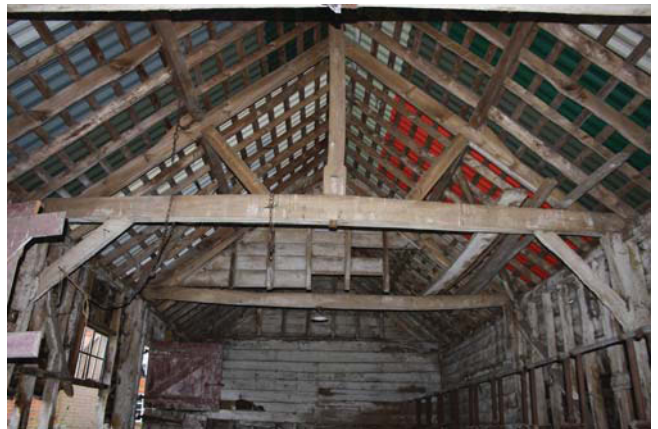
Plate 8. Interior, Unit A, trusses 1 and 2,  
looking west.

Roof construction (Pl. 8) consisted of wall plates laid over the top of the principal posts behind the jowls, and the tie-beams were then laid over both of them. A pair of principal rafters supported a purlin on either side and met at the king post which in turn supported a ridge plate. On either side of the king post was a raking strut. The tie-beam was supported on straight braces tenoned into the internal faces of the principal posts. Truss 1 had been modified and the king post and raking struts removed. Trusses 2 and 3 both had carpenters' marks on the principal posts and rafters, numbered 2 and 3 respectively. The rafters were of quarter tree trunks.

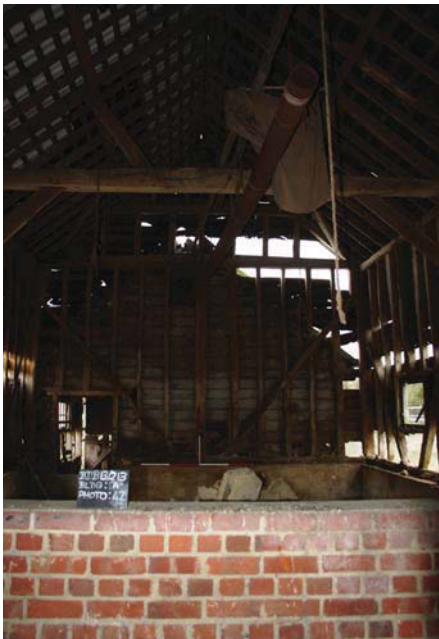
Plate 11. Interior, Unit A, looking east,  
Scales: 2m and 1m.

The brick plinth was similar to that found in units A2 and A3 and typically eight courses high internally with the bricks laid in English bond; part of it had been rendered (Pl. 11). The walls were bonded with lime mortar. The bricks measured 231mm x 110mm x 66mm ( $9\frac{1}{8}'' \times 4\frac{5}{16}'' \times 2\frac{9}{16}''$ ) matching those in the previous units. Internally the barn had been sub-divided with a low brick wall between bays 2 and 3. It was of English bond with cement mortar to a height of 0.9m.

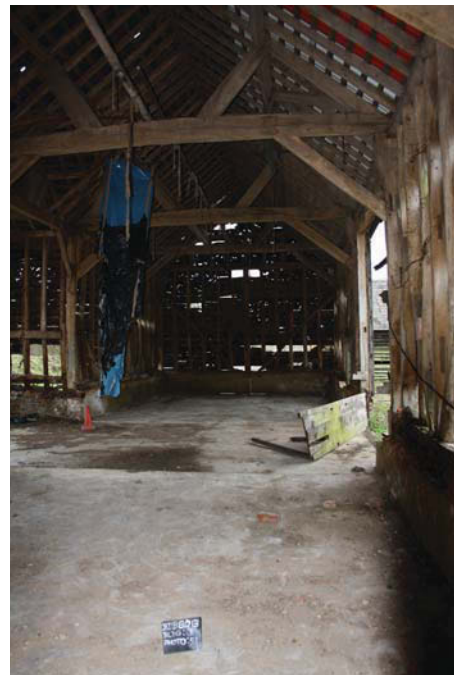
Plate 20. Interior, Unit B, looking south.

The timber framing (Pl. 20) appeared to be of oak, though no analysis was undertaken. Where tool marks could be seen on timbers they had regular, slightly bowed, striations, suggesting that they had been converted using a mechanical band saw. The framing was raised off of long lengths of cill lapped together and laid over the brick plinths. The bays were denoted by principal posts supporting the main roof trusses; they had a scantling of 180mm (7") squared. On their internal faces they had a simple jowled head. The wall panels had diagonal braces, alternating direction on each panel. The remainder of the panel was constructed of vertical studs of varying scantling seated either on the cills or braces. Much of the wood showed signs of re-use with empty mortices and peg holes. Externally the building was clad with overlapping timber weather boarding.

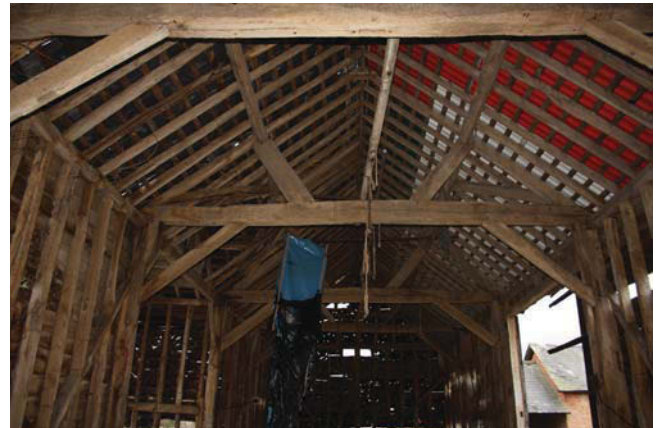
Plate 22. Interior, central truss of Unit B, looking south.

Roof construction (Pl. 22) consisted of wall plates laid over the top of the principal posts behind the jowls, and the tie-beams were then laid over both of them. A pair of principal rafters supported a purlin on either side and met at a plate which supported a raised ridge plank. The truss was of queen strut construction. The tie-beam was supported on straight braces tenoned into the internal faces of the principal posts. Carpenters marks were present on trusses 1 and 2, suggesting that the construction was a kit of parts with the queen struts labelled II and VI with corresponding marks on the tie beam.

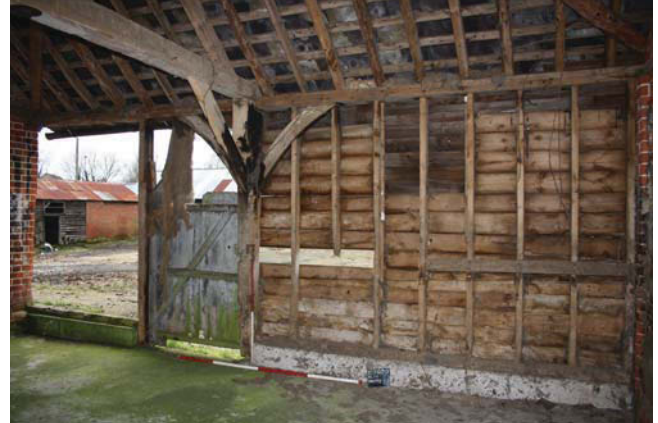
Plate 26. Interior, south facing interior wall of Unit C,  
Scales: 2m and 1m.

The timber wall was built off a concrete plinth and consisted of vertical posts tenoned into mortices in the cill and wall plate. Externally the wall was clad with overlapping timber weather boarding. A door was located to the west of the principal post (Pl. 26).

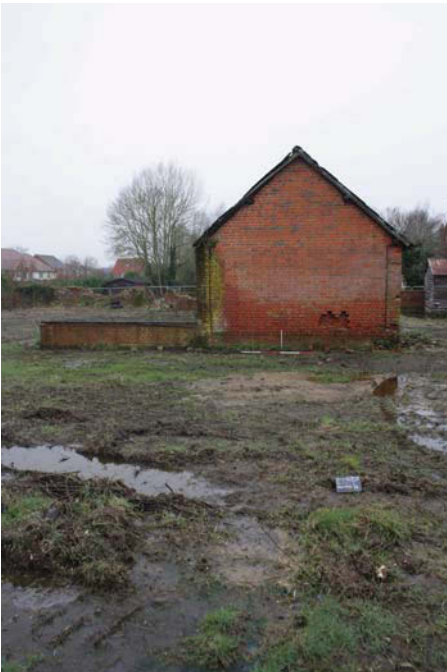
Plate 27. Exterior, east elevation of Unit C,  
Scales: 2m and 1m.

The east gable wall (Pl. 27) was built off a brick plinth consisting of at least five courses of English bond brickwork, with the bricks measuring 230mm x 107mm x 73mm (9 <sup>1</sup>/<sub>16</sub>" x 4 <sup>1</sup>/<sub>4</sub>" x 2 <sup>7</sup>/<sub>8</sub>") and bonded with lime mortar. At the north and south ends of the plinth was a brick pillar. The plinth had been extended to the south to form a courtyard. Within the brick pillars it was infilled with Flemish bonded brickwork, which was not well tied into the pillars.

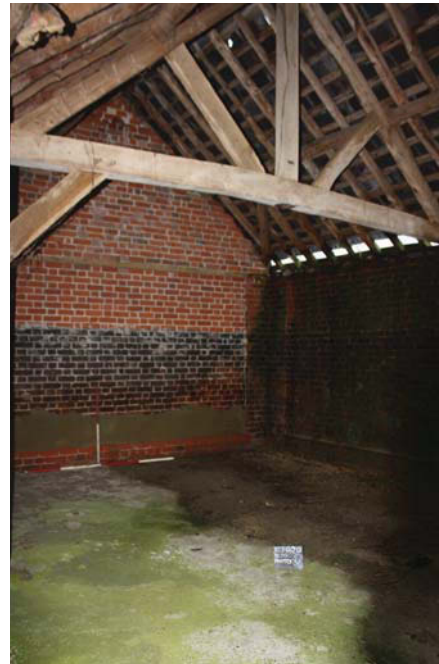
Plate 28. exterior, west facing interior wall of Unit C,  
Scales: 2m and 1m.

Roof construction (Pl. 28), most likely of oak, consisted of wall plates laid over the top of the principal post behind the jowl, with the tie-beam then laid over both of them. A pair of principal rafters supported a purlin on either side and met at the king post. On either side of the king post was a raking strut. The tie-beam was supported on straight braces tenoned into the internal face of the principal post. A pair of slightly arched braces, tenoned into the principal post supported the wall plate.

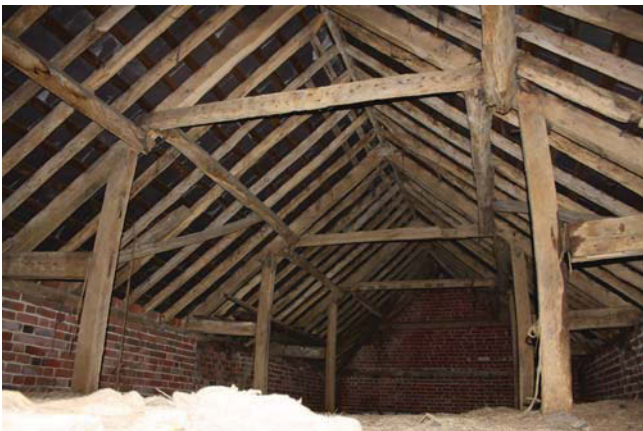
Plate 31. Interior, Unit C, hayloft, looking west.

Roof construction (Pl. 31), most likely of oak, consisted of timber wall plates laid over the brick work with interrupted tie beams tenoned into queen posts which in turn were supported on the floor joists. The floor joists

were supported on the brick pilasters. The truss itself had a collar and the purlins were staggered. The principal rafters were of squared wood, whilst the common rafters were split tree trunks.
