**Ivinghoe and Pitstone Chapel, High Street,  
Ivinghoe, Buckinghamshire**

**Building Recording**

**Site Code: IPC14/44**

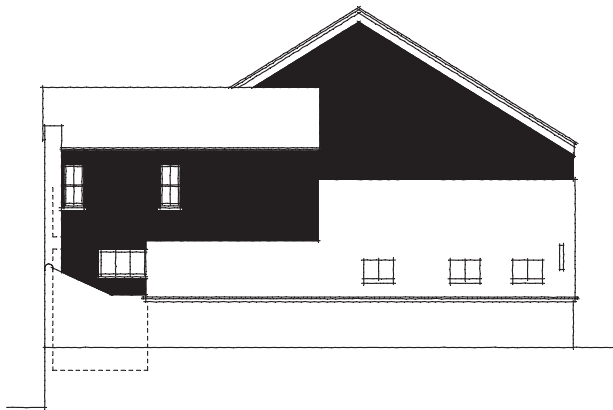
Figure 6. Elevations (1).

The north façade of the chapel (Fig. 6) could be split into two sections; the main chapel (Pl. 1) and the set back side entrance lobby at the west end (Pl. 2). The side entrance was built in the same style as the chapel with yellow bricks, laid in Flemish bond with red brick detailing. The bricks however were slightly smaller, measuring, 225mm x 110mm x 70mm (8¾" x 4⅜" x 2¾"). Within the façade was a large double width door under a curved flat arch with a similarly curved window under a flat arch on the first floor. The door was accessed up two stone steps. The door itself was of wooden construction with vertical central panels. Filling the gap between the door and the curved arch was a wooden-framed window. The first floor window was tall and narrow, probably of wooden construction and divided into three panes.

The south façade (Fig. 6; Pl. 11) consisted of the lean-to extensions on the ground floor, the first floor accommodation area and the rear of the chapel. The lean-to extensions were of plain brick with no openings within it. At the east end were three skylights. The rear of the accommodation area contained two, two-over-two-pane wooden sash windows and a chimney stack in the south-west corner. The rear of the chapel had also been rendered in the same cement mortar made to look like ashlar. The bargeboard was plain.

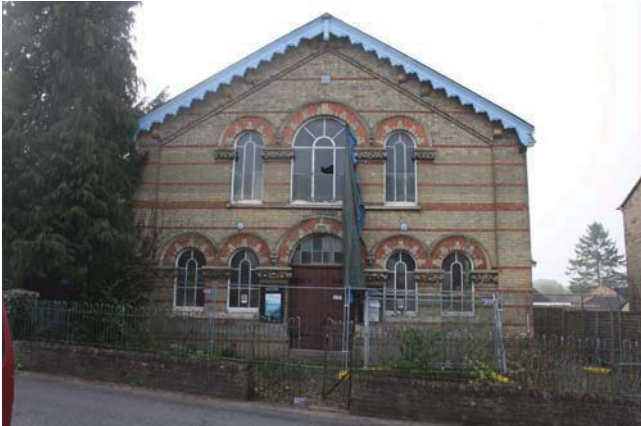
The gable end of the chapel fronted onto the street. The shape was further emphasized with raised brickwork following the line of the gable end. Within the façade was a central doorway with a pair of windows either side, above which was a large central window flanked by a smaller window either side. Above the door and all the windows was a curved flat arch, embellished with red bricks in the Italianate style. Above the brick arches was a curved hood and where the ends met was a floral carving. The windows themselves were wooden, of six panes with a fanlight above to create the curved design, and with sandstone sills. The doorway consisted of a pair of simple timber plank doors stained brown with a curved window above. Immediately to the west of the entrance was the date stone (Pl. 3) inscribed: 'This stone was laid by T. Chamberlain ESQ of Windsor Sept<sup>br</sup> 14th 1865.' Between each of the openings were different carved foliage capitals (Pls 4–8) which included fairly standard designs of ivy with berries, acorns and oak leaves, grape vines, mixed foliage, and probably geraniums, all sprouting from similar stems. Around the eaves was a decorated bargeboard with trefoil shaped cut-outs.

Plate 1. Exterior, front elevation, looking south,  
Scale 2m.

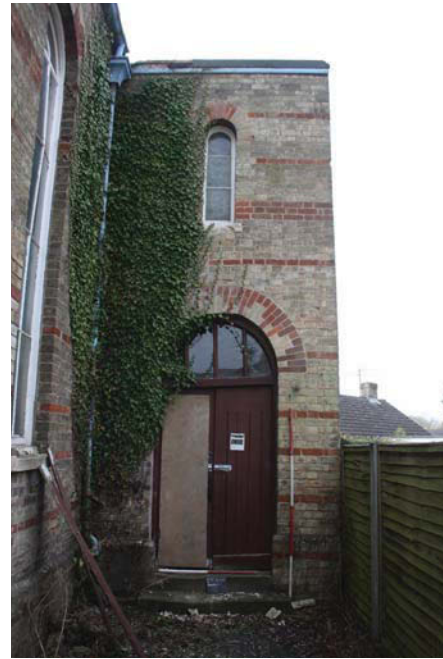
Plate 2. Exterior, door on front elevation,  
looking south, Scales: 2m and 1m.

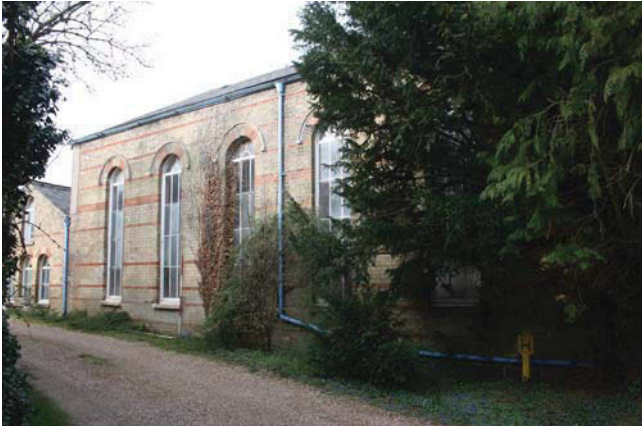
The east façade (Fig. 7) contained the chapel at the north end, the Sunday School in the centre and at the far east end the lean-to extension. Within the chapel area (Pl. 9) were five double height, curved windows of the same design as those on the north façade. The windows were divided into twelve panes with a fanlight above. Within the centre of the building was a cast iron hopper and down pipe. A second hopper and down pipe was also located at the junction between the chapel and Sunday School buildings. The gable end of the Sunday School (Pl. 10) fronted this façade and was much lower than the chapel. Within the wall were three windows on the ground floor with a single central window in the apex of the roof. The windows were of the same style as those within the chapel but on a smaller scale and without the hoods above the flat arches. To the east the roof

Plate 9. Exterior, East elevation, north end.

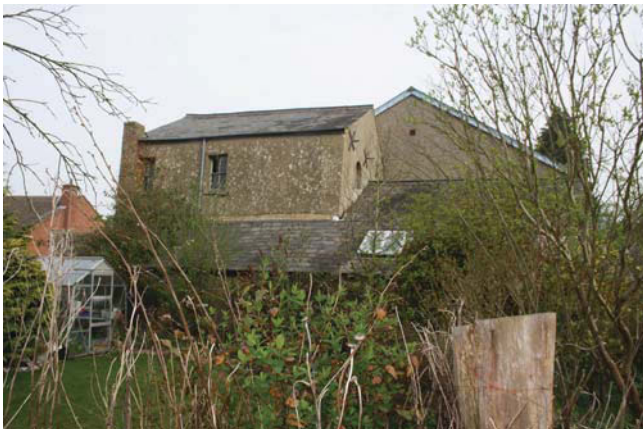
Plate 11. Exterior, rear elevation, looking north.

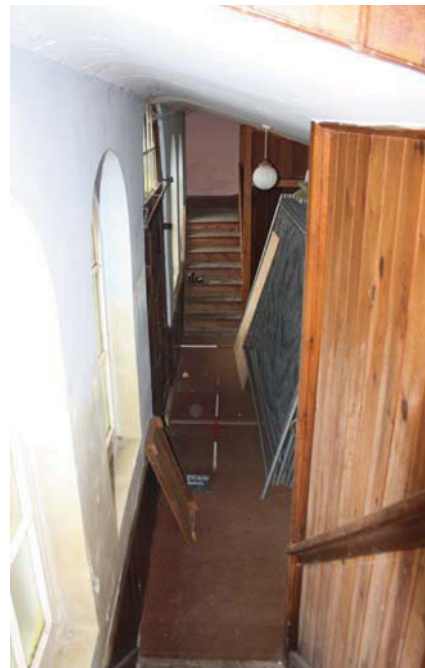
The chapel was accessed via a set of double doors in the north wall, giving access to a small wood-panelled lobby (Pl. 12). On either side of the entrance was a set of stairs with a half landing giving access to the stalls and beside the stairs was a door giving access to the main room of the chapel. The stairs partially obscured one of the tall windows on either side. They were constructed of pine wood and at the top of the stairs was a pair of wooden panelled doors (Pl. 13). The stalls themselves were entirely constructed of pine and consisted of three rows of pews and a central lectern with a simple wooden cross on the back (Pl. 14). The stalls themselves were supported on a pair of cast iron columns with a 90mm (3½”) diameter (Pl. 18).

Plate 12. Interior, front entrance lobby, looking east,  
Scales: 2m and 1m.

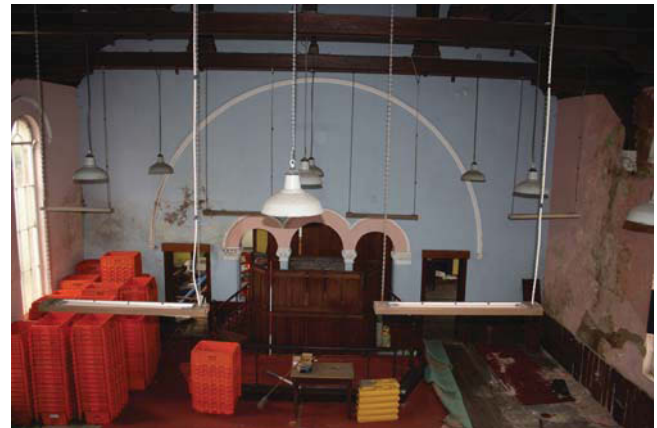
The main room within the chapel was a large rectangular space, open to the height of the raised collar. The pulpit was located within the centre of the south wall (Pl. 16), directly opposite the main entrance. The pulpit was set on a raised dais, in a half octagon shape, around which the altar rail was located. The rail itself (Pl. 17) was predominantly wooden with a turned newel post at either end and turned balusters at the corners. Between the wooden supports were decorative cast iron twisted balusters with flower (daisy?) supports. The pulpit itself was the same shape as the dais and accessed via a set of steps on either side (Pl. 18). It was of stained pine construction with plain, tongue-and-groove type panelling at the bottom and panels with curved heads above.

Plate 16. Chapel, pulpit from balcony, looking south, Scale: 2m.

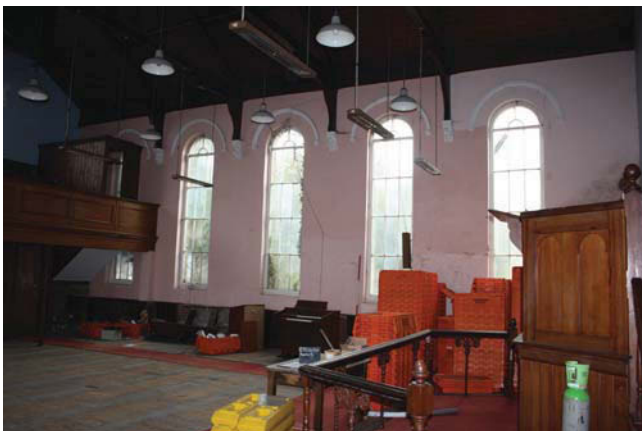
Within the east wall (Pl. 19) were four tall windows and within the west wall were three with a further window on either side partially obscured by the stalls. Each of the windows had a moulded hood above and beneath the windows was wooden plank panelling. In the north wall, partially obscured by the stalls, were three windows each with a moulded hood above.

Plate 19. Chapel, east wall, Scale: 2m.

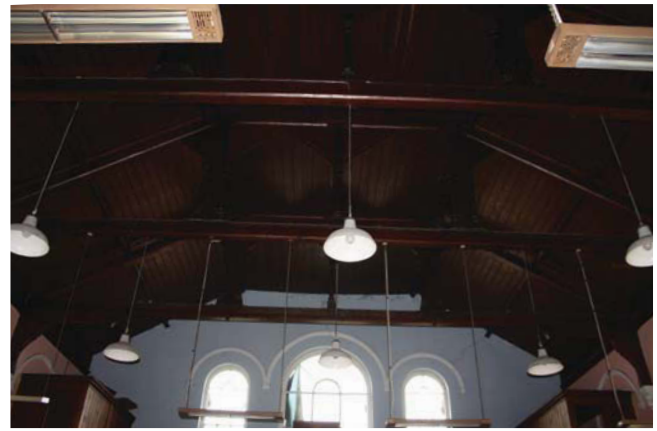
There were four roof trusses located between each of the windows. The trusses (Pl. 20) were of pine construction with a raised collar supported on three posts with additional half-turned posts on either side for decoration. The principal rafters supported two purlins on either side. The truss was chamfered and supported on braces which rested upon corbels set into the walls. The corbels were relief-decorated with foliage (Pl. 21).

Plate 20. Chapel, roof trusses, looking north.

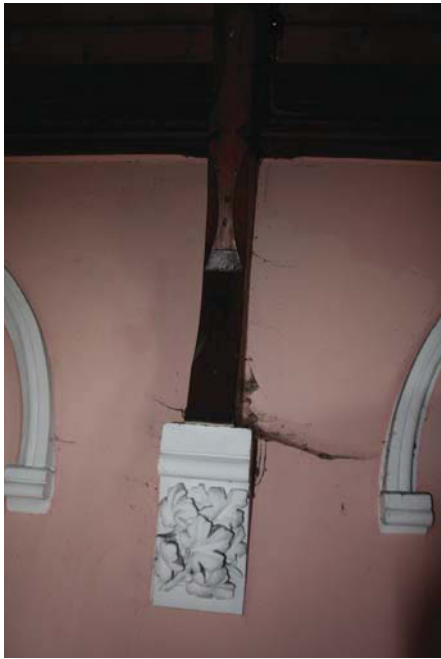
Plate 21. Chapel, truss support detail, west wall.

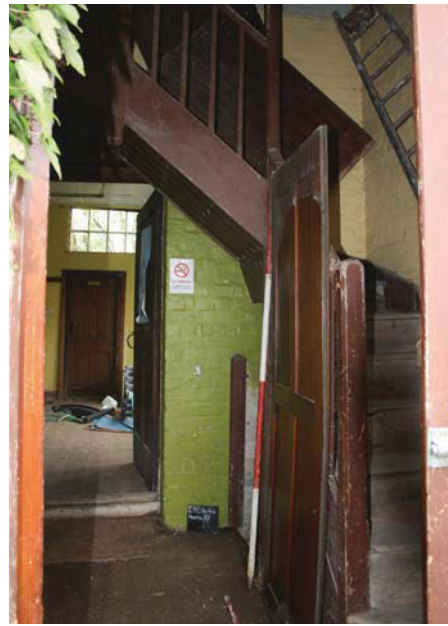
The lobby was a small, square room with access to the Sunday School and a set of open-well stairs giving access to the first floor accommodation (Pl. 22). Beneath the stairs was access to the area beneath the floorboards of the Sunday School. The stairs were constructed of pine and were of closed string type with a plain newel post and plain, square balusters. Within the west wall was a narrow blocked window of the same style as that within the north façade. Within the east wall (part of the chapel) was a blocked window of the same style as those within the western façade. The stairs were built into the blocked window. There was no access to the first floor accommodation due to the stairs being rotten.

Plate 22. Entrance lobby stairs, looking south,  
Scale: 2m

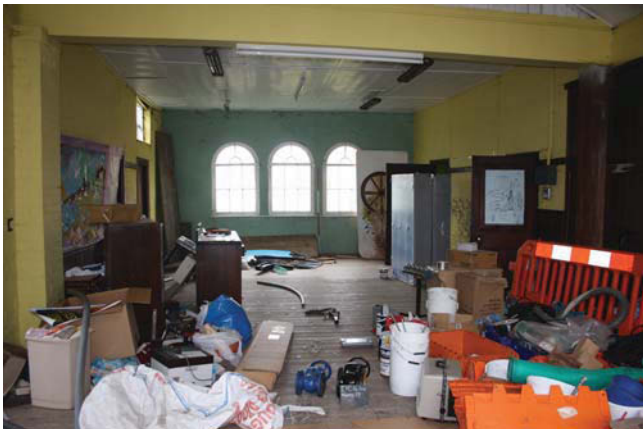
The Sunday School consisted of a single room behind the chapel and side entrance lobby. It was accessed from the side entrance lobby or via two doors from the chapel, one on either side of the pulpit. Within each of the gable ends was a set of three windows. Those in the west wall (Pl. 23) were the same as those described in the east façade. Between the two doors to the chapel was a set of three openings that had been shuttered off with five wooden panels (Pl. 24). The floor was of pine floorboards and the walls were of painted brick. A ceiling had

Plate 23. Sunday School hall, looking west,  
Scales: 2m and 1m.

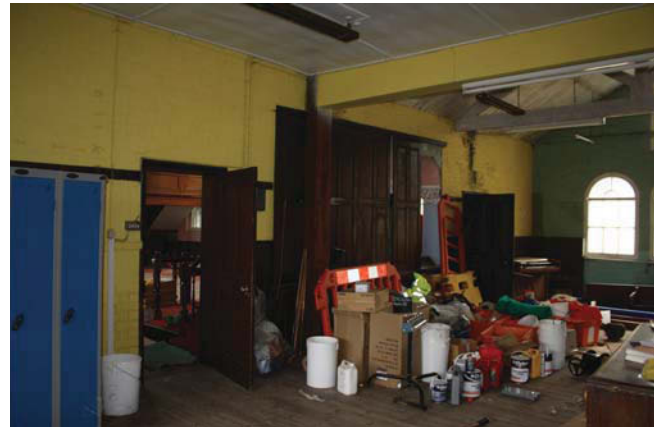
Plate 24. Sunday School hall, looking north east.

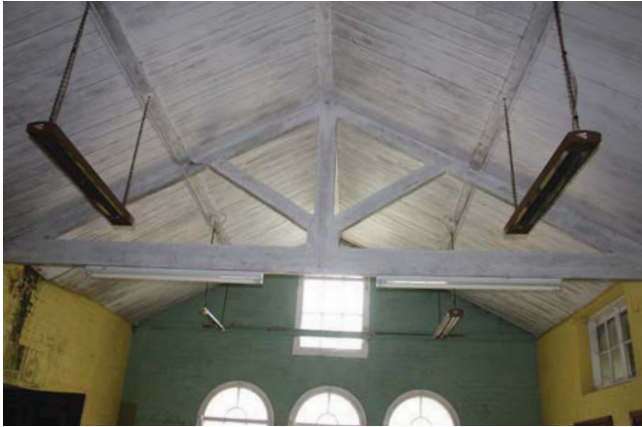
been inserted at the west end to accommodate the first floor accommodation. This was supported on a lintel, the supports for which partially blocked the opening behind the pulpit. The eastern end of the Sunday School was open to the roof; a single truss was present of king strut type (Pl. 25). Within the southern wall were a number of doorways giving access to the rooms within the lean-to. From east to west these consisted of the gents toilet and the ladies toilet (Pl. 26), both at a slightly higher level with a concrete floor, the kitchen (Pl. 27), an office and a door to a small courtyard. Above the toilets and the external door was a side sash style window. Within the office was a blocked fireplace in the corner and a side-hung sash window in the west wall (Pl. 28). Above each of the doors, except those to the ladies and gents toilets, was a curved brick flat arch.

Plate 25. Sunday School, roof truss, looking east.
