**Sir Winston Churchill Pub,  
Loughton, Essex**

**Building Recording**

**Site Code: LUWC14/64**

**April 2014**

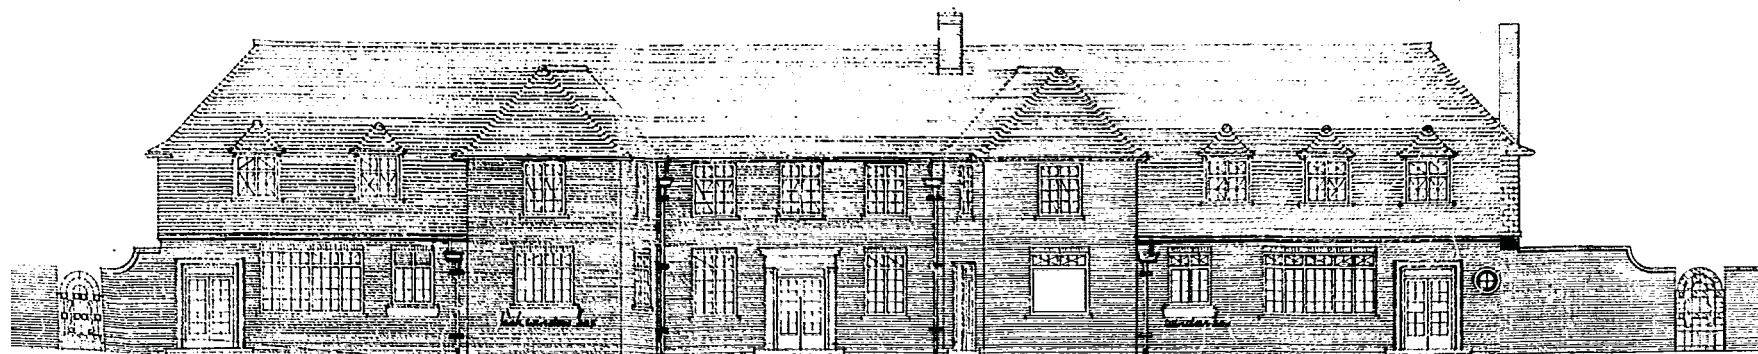
Figure 3. Main Elevations, 1955.

It would appear that the current pub was designed by the Surveyors department of the Stag Brewery. The original plans for the building were obtained from Epping Forest District Council and show that the external layout of the pub has only slightly altered and a few doors have been converted into windows (Fig. 3). Internally the changes have been greater, in particular on the ground floor (Fig. 4), which in the original plan has been divided into three main areas - the restaurant and lounge, the saloon and the public bar with an off sales area located within the eastern projecting gable. The bar itself has also been altered to reflect the more open nature of the current pub. The service area was designed as one open space with the stairs to the cellar located in the northwest corner. The main kitchen for the restaurant was located on the first floor (Fig. 5) with a dumb waiter present in the north-west food service area on the ground floor. The first floor has not changed in layout, only in function, with all the rooms now used as bedrooms. The cellar (Fig. 6) has been further sub-divided and the stairs moved to the north-west wall.

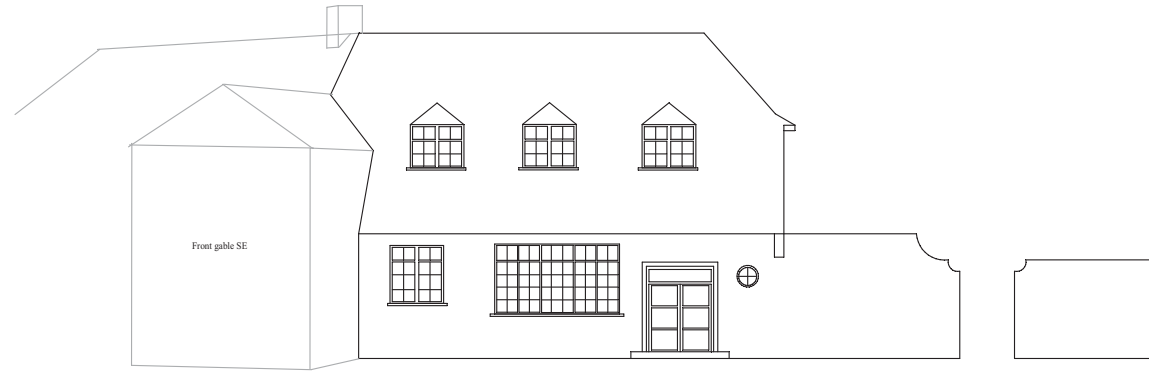
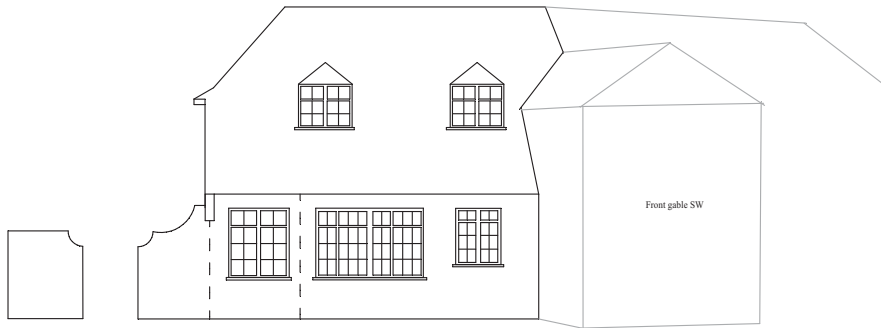
Figure 8. Elevations

The south-east façade (Pl. 4), fronting onto The Broadway (Fig. 8) contained two windows of different sizes on the ground floor with a second entrance at the north-east end. The doorway consisted of a pair of doors sub-divided into three panels, the top two of which were of glass. Above the doors was a narrow window labelled 'Bar.' Around the doorway was a moulded stone architrave. A set of steps within the terrace was located opposite the doorway. Further to the north-east was a small round window edged with a soldier course of bricks. On the first floor, set within the roof were three dormer windows. The roof projected beyond the ground floor wall slightly and was supported on a brace constructed of red ceramic tiles.

The south-west façade (Pl. 5), fronting onto Barrington Green (Fig. 8), contained three windows on the ground floor of varying sizes. Set within the roof above were two dormer windows. Like the Broadway wing the roof extended beyond the ground floor wall and was supported by a brace constructed of red clay tiles. The window at the north-west end was a later replacement for a doorway which can be seen in the slight variation in brickwork and mortar both around and beneath the window.

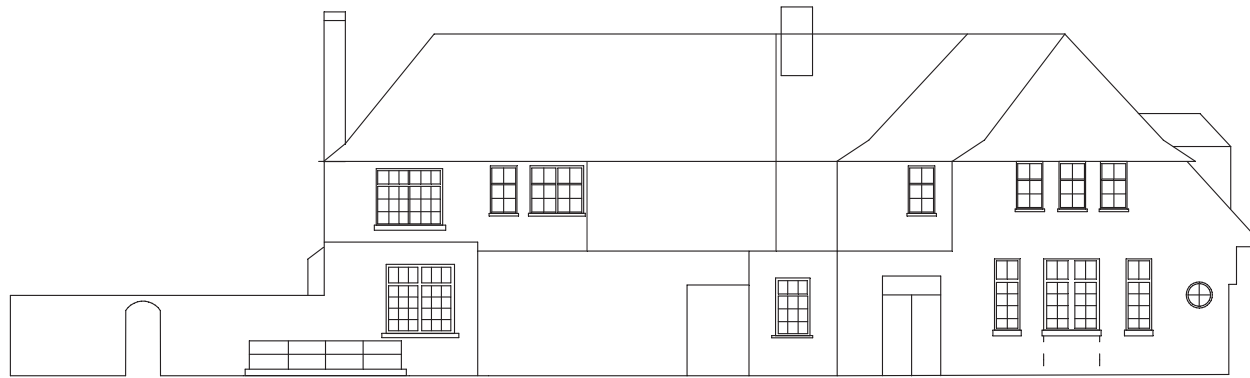
Figure 9. Elevations

The north-west elevation (Pl. 7), facing onto the beer garden (Fig. 9) contained four windows on the ground floor, including a circular one at the south-west end, and a double door at the north-east end. Above the windows was a second pub name sign, matching the one above the front entrance. On the first floor were three windows above those on the ground floor. The roof above the doors was flat with a further window visible on the first floor but set back. The central ground floor window was a later addition in lieu of a door, evidence for which could be seen in the brickwork beneath the window.

The north-west elevations (Pl. 9) consisted of the rear wall of the courtyard, the rear of the pub, the bottle store, dry goods, and the kitchen (Fig. 9). The rear courtyard wall contained a single wooden plank gate set within a brick archway. Further to the south-west was a set of stairs giving access to the boiler room. These were of concrete construction surrounded by functional, scaffold pole type railings painted black. The banister rail was of the same type. Within the rear of the pub section was a single window. On the first floor and set back were three windows of varying sizes and part of the projecting block for the stairs. There were no features within the side of the bottle store. The side of the dry goods store showed where a section had been demolished, with the north-west to south-east aligned wall left jagged and different bricks used to build a new external wall. The kitchen elevation contained a single window.

The north elevations (Pl. 10) were only present on the first floor (Fig. 9) and consisted of two windows and a section of the projecting block for the stairs. Set within that was a plain white fire door giving access to the flat roof area.

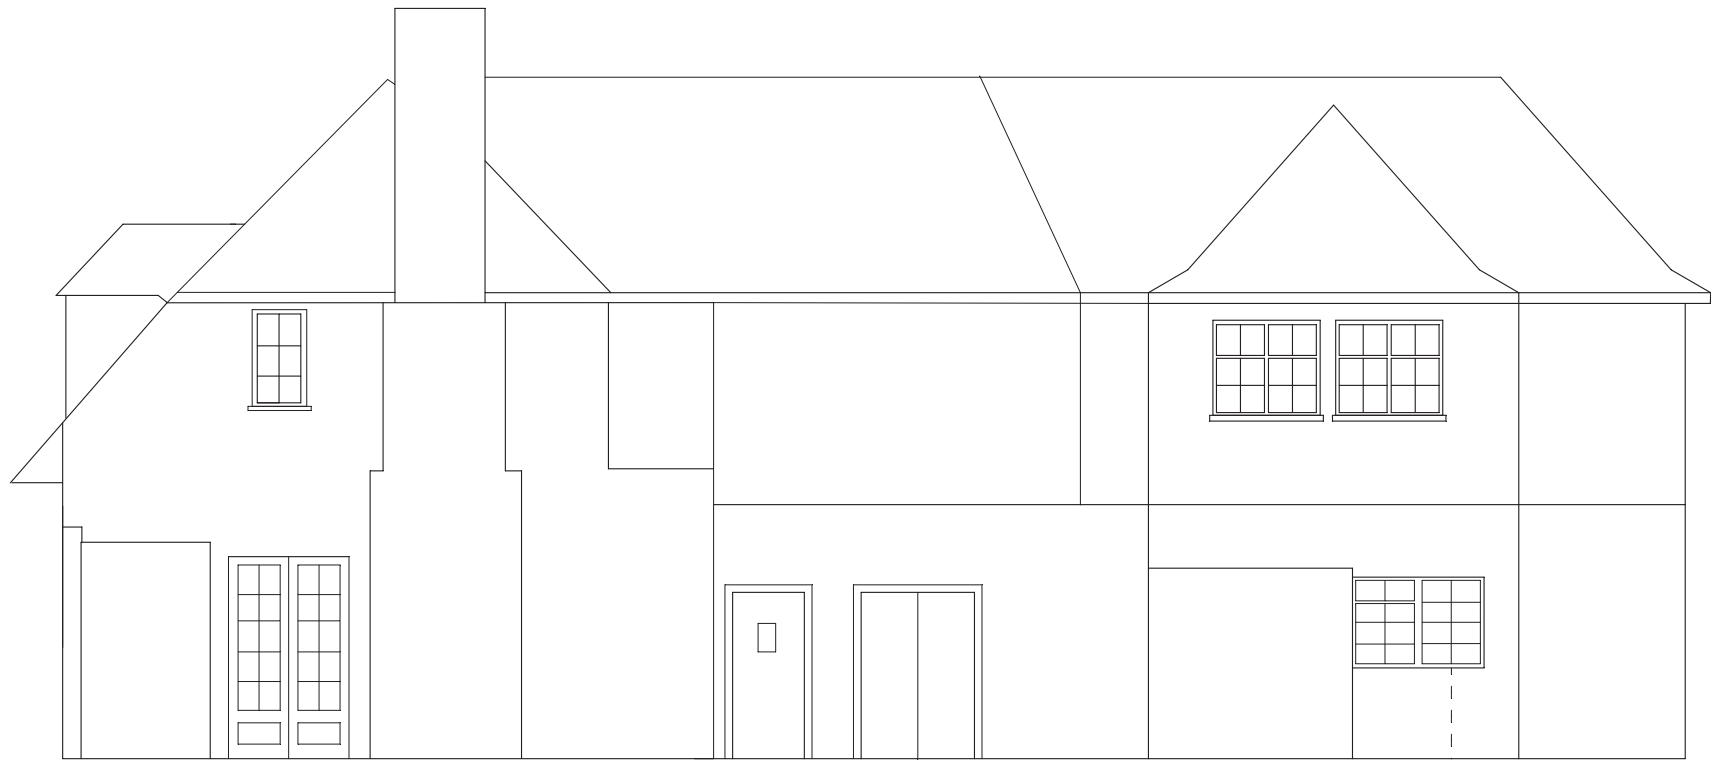
Figure 10. Elevations

The north-east elevations (Pl. 8) consisted of the rear of the bottle store, dry goods, kitchen and the pub (Fig. 10). Within the bottle store section were two doors, a single, multi-panelled door with a small central

window, and a pair of timber plank doors. Both had a concrete step. In the ground next to the double door was a pair of wooden trap doors accessing the barrel slide and cellar. The dry goods store was largely obscured by a modern, plastic shed. The kitchen elevation contained a single window painted white. This was a crude later insertion, replacing an earlier door, and no effort had been made to match the bricks or blend the blocked section with the original brickwork. Set back on the first floor were two windows in a projecting gable. The section exposed of the pub contained no openings or features.

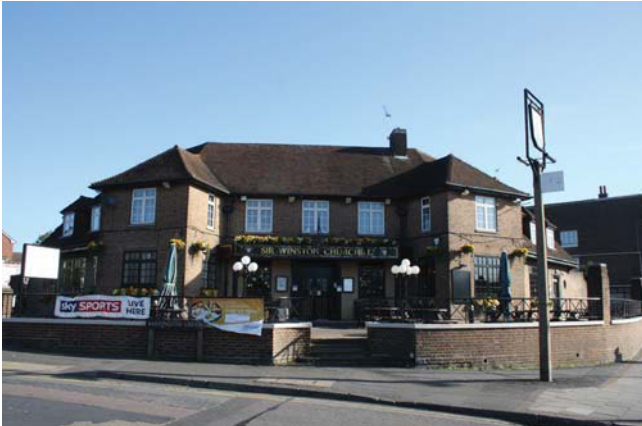
Plate 1. Exterior looking N – General shot

The main entrance was located in the south facing façade (Fig. 7) which incorporated a projecting gable on either side. The entrance (Pl. 2) had been emphasised with a raised step covered in tiles upon which was a porch supported on four squared, wooden pillars stained black. These had a scantling of 0.195m x 0.17m (7½" x 6¾"). Above this was the main pub sign, 'Sir Winston Churchill' in gold on a black background. Suspended above the sign was a lantern-type light. Completing the entrance setting was a pair of ornate streetlight-style lights each supporting five globe lights (Pl. 3). The planning application for this entrance, dated June 1996, shows it was designed by Cube Architects of London. The entrance itself was located centrally and consisted of a pair of double doors, the upper part of which contained a glass window whilst the lower half was sub-divided into two panels. It had been painted black with gold around the outside of the lower panels. On either side of the door was a window, the sills of which had been covered in brass to match the black and gold coloured theme. On the first floor were three windows.

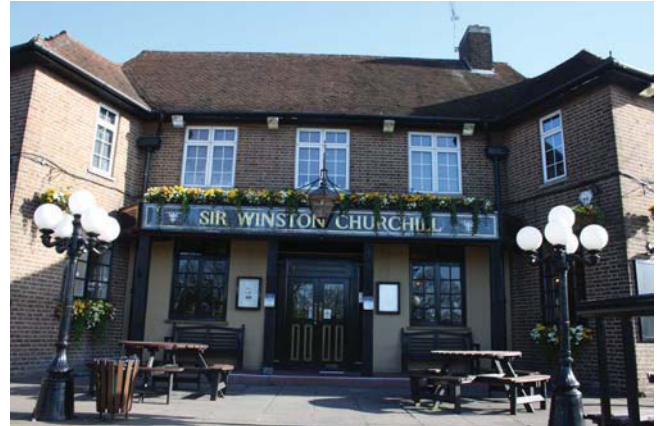
Plate 2. Exterior looking N – General view  
Scale: 1m

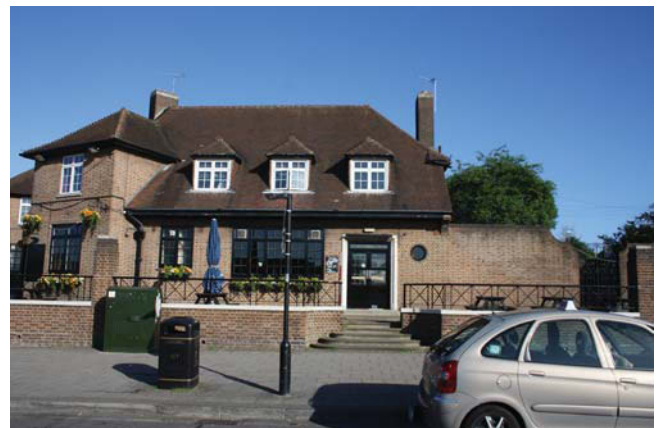
Plate 4. Exterior looking NW – General view  
Scales: 1m and 2m

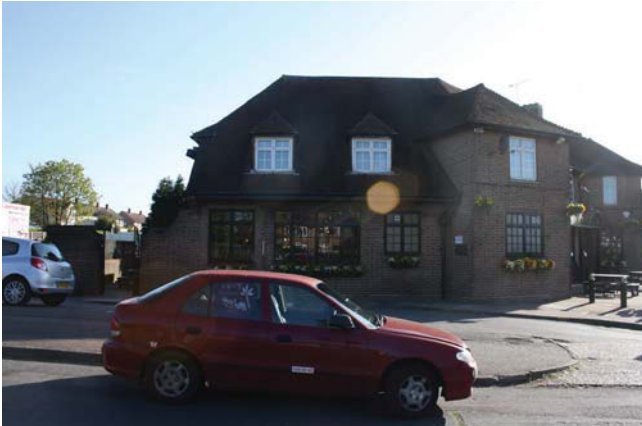
Plate 5. Exterior looking SE – General shot

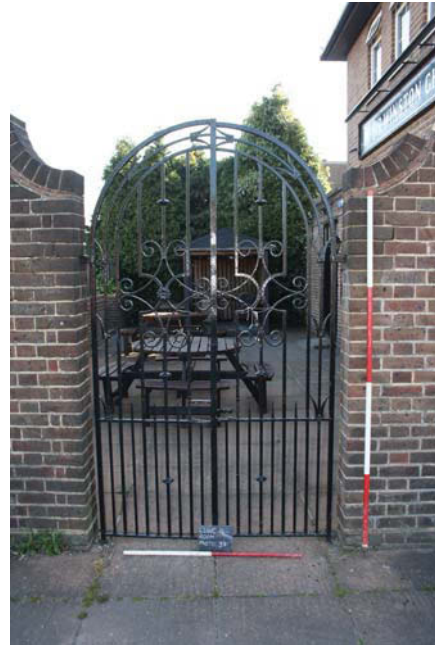
Beyond the building the wall continued, to enclose the patio area within the beer garden. Set within the wall was a pair of decorative wrought iron gates (Pl. 6), the same as those in the southeast facade. Either side of the gates the wall contained concave curves which reduced the wall height. The wall was topped with a soldier course.

Plate 6. Exterior looking NE – Detail of gate  
Scales: 1m and 2m

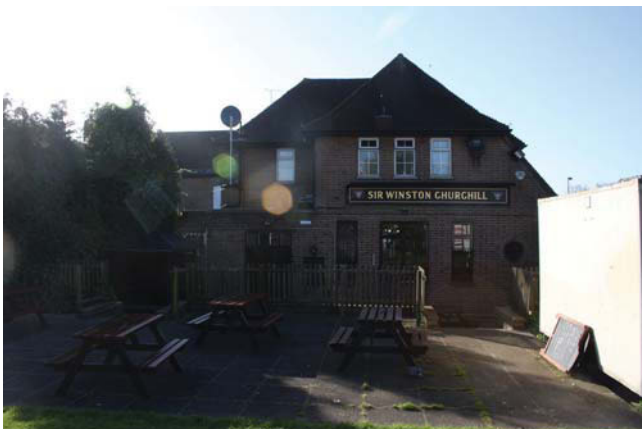
Plate 7. Exterior looking SE –General shot

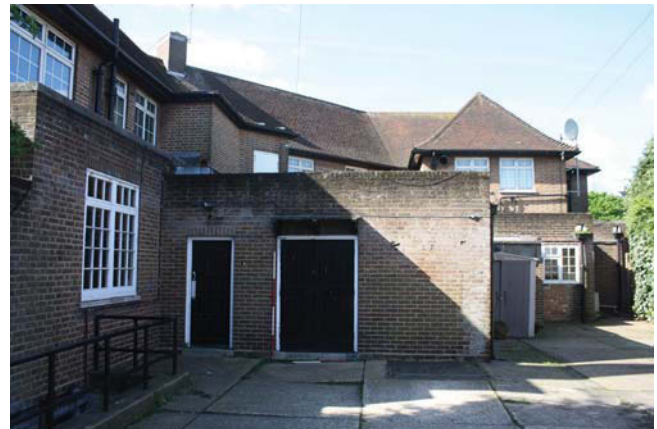
Plate 8. Exterior looking SW – General shot  
Scales: 1m and 2m

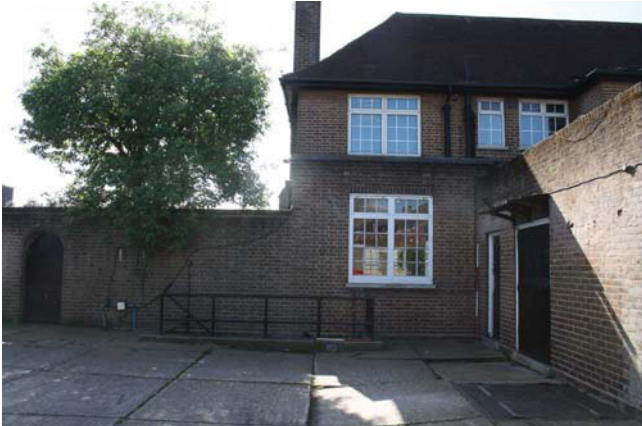
Plate 9. Exterior looking SE – General shot towards stairs  
Scales: 1m and 2m

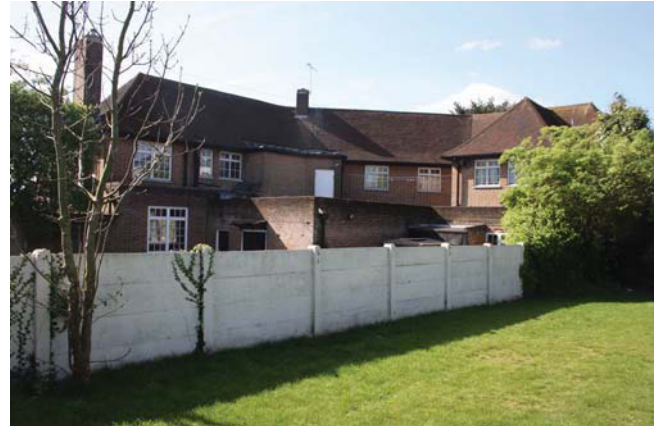
Plate 10. Exterior looking S – General shot

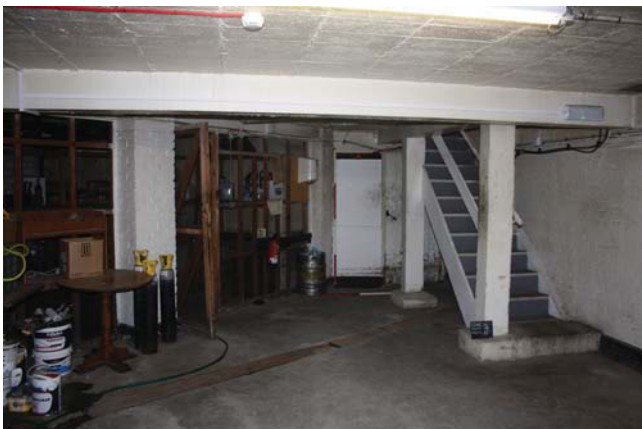
The cellar (Pl. 11) was accessed via a set of stairs located between the kitchen and bottle store which gave access to the main room (17). The floor was of concrete with a drain running diagonally across it and the ceiling was of concrete block. The barrel slide, located opposite the stairs had been removed (Pl. 12). The internal walls within the cellar, where they were original, were of brick construction laid in Flemish bond and later walls were stud and wooden sheet. The walls had been painted white with a black concrete skirting board.

Plate 11. Room 17 looking SW - General shot  
Scales: 1m and 2m

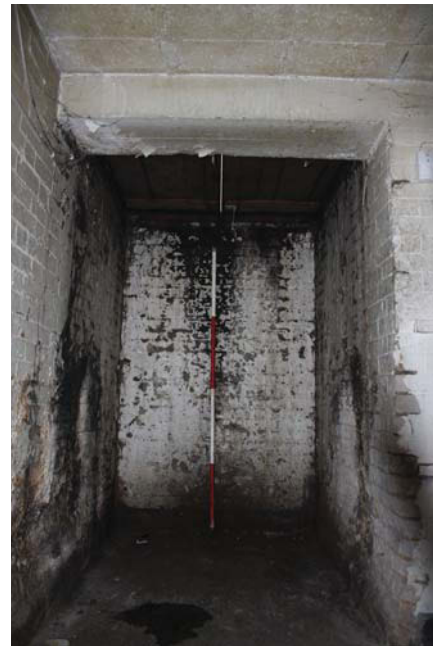
Plate 12. Room 17 looking NE – Barrel slide  
Scale: 2m

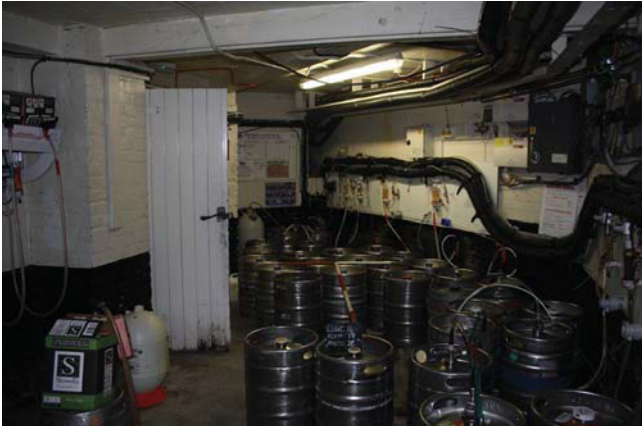
A second room had been partitioned off in the south-west corner of the cellar for use as a cold beer store (Pl. 13). Shelving along the southern wall had been erected for extra storage and was contained within a wire cage. To the south-east was another area that had been partitioned off; this was not accessible.

Plate 13. Room 17 looking SE – Cold beer store  
Scales: 1m and 2m

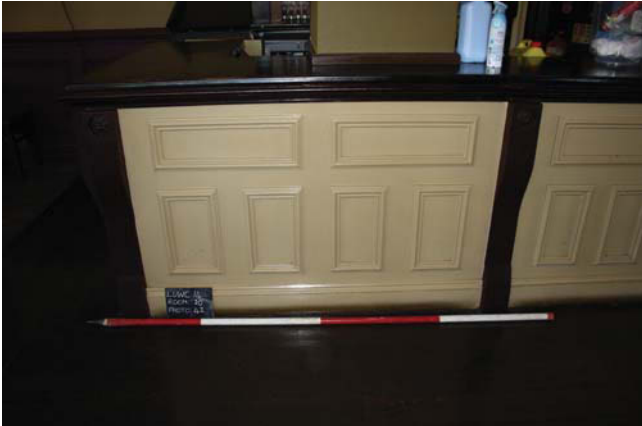
The bar was predominantly located along the north wall within room 20 but extended to the north-east and north-west. The counter was of dark wood, beneath which were moulded panels (Pl. 17), similar in style to those found on the wall. Each panel consisted of two horizontal moulded panels above four vertical moulded panels. Dividing the panels and supporting the counter top were shaped wooden pilasters with vertical grooves beneath a flower motif. The panelling on the bar within room 23 was the same as that on the walls. At the rear of the bar

Plate 17. Room 20 looking NE – Detail of bar  
Scale: 2m

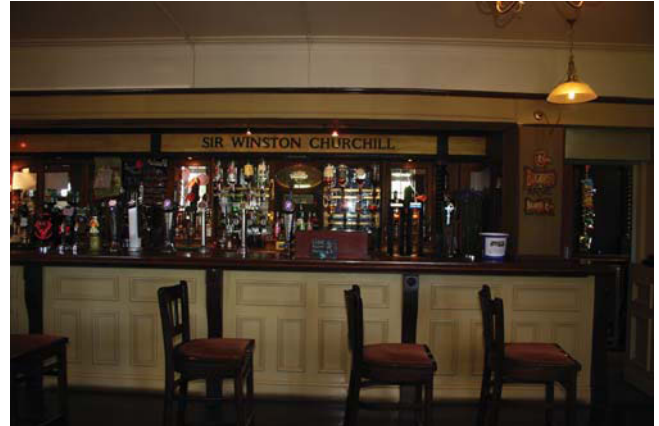
was a sign, 'Sir Winston Churchill' in black on a yellow background (Pl. 18). The sign was supported on solid twisted wooden columns (Pl. 19).

Plate 18. Room 20 looking N towards bar

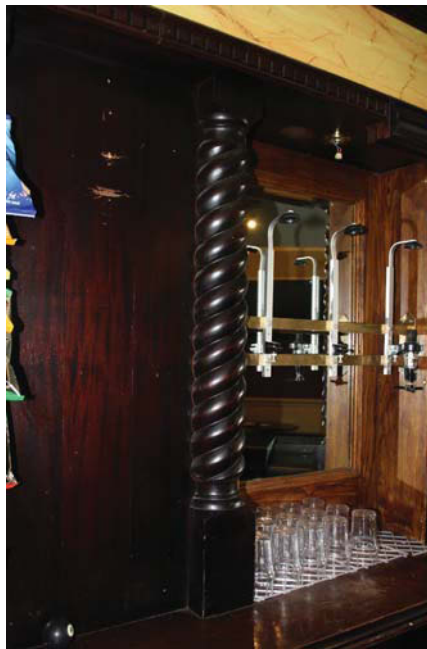
Plate 19. Room 20 looking NE – Detail of twisted post  
bar support

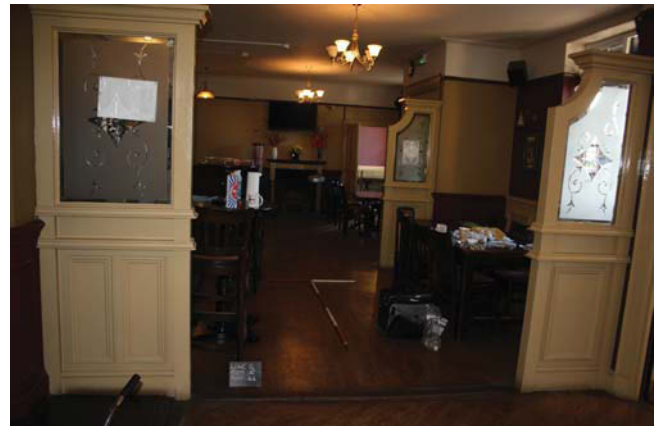
Room 20 fronted onto Barrington Green and the junction between Chigwell Lane and the Broadway. The main entrance was located at the eastern end of room 20 (Pl. 20) with a second set of doors in the north-west wall giving access to the beer garden. In the west corner was a modern, raised section containing tables and chairs (Pl. 20). It was accessed up two steps and railings denoted the junction between the change in floor levels. The railings consisted of square wooden posts with vertical grooves capped with a round ball, between which were twisted metal balusters. In the eastern wall was a fireplace (Pl. 22). Internally it was of cast iron with a wooden surround, similar in style to the pilasters found within the bar panelling. It was a replica in the Adam's style. To the south of the fireplace was access to room 23.

Plate 20. Room 20 looking E – General view  
Scales: 1m and 2m

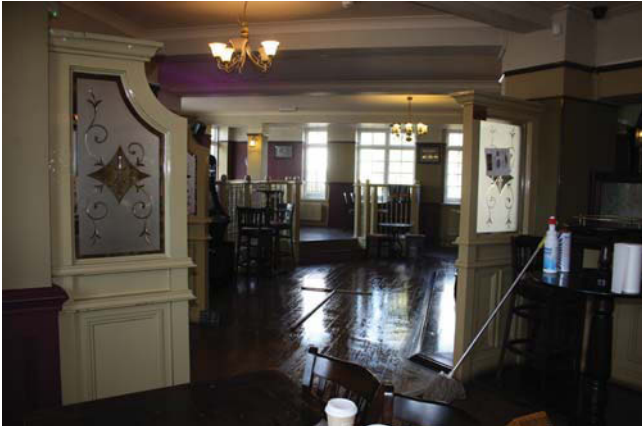
Rooms 20 and 23 were the main public rooms. Both were similarly decorated in cream and purple with wooden strip flooring, except one section of room 23 which was covered in grey tiles. Around the bar counter within room 20 was a slightly raised wooden floor, stained darker than the rest of the floor. Around the walls was a dado rail, with a picture rail above and relatively plain coving (Pl. 16). Beneath the dado rail was wooden panelling, containing square moulded panels.

Plate 21. Room 20 looking NW – General shot  
Scales: 1m and 2m

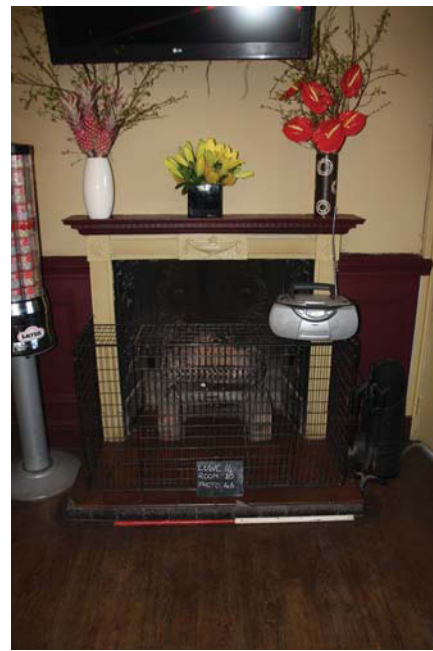
Plate 22. Room 20 looking E – Detail of fireplace  
Scale: 1m.

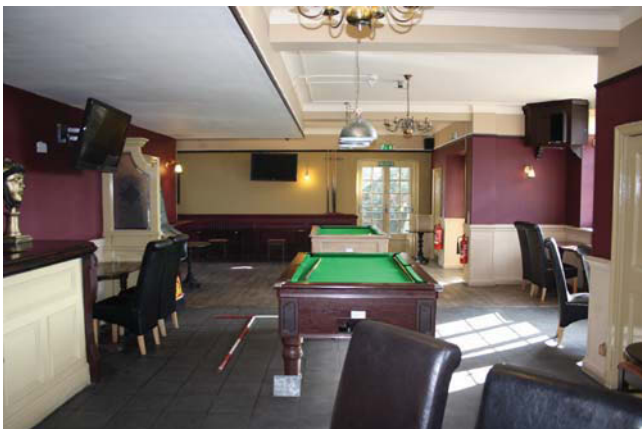
Room 23 fronted onto the Broadway and contained an entrance at the eastern end of the room (Pl. 23). A second set of doors, giving access to the paved courtyard were located within the north-eastern wall. Towards the north-west the ceiling was lower, within the area of the former bar. In the north-west wall, to the east of the former bar was a cast iron radiator beneath the window (Pl. 24) and in the north-east wall was a blocked fireplace.

Plate 23. Room 23 looking NE – General shot  
Scales: 1m and 2m

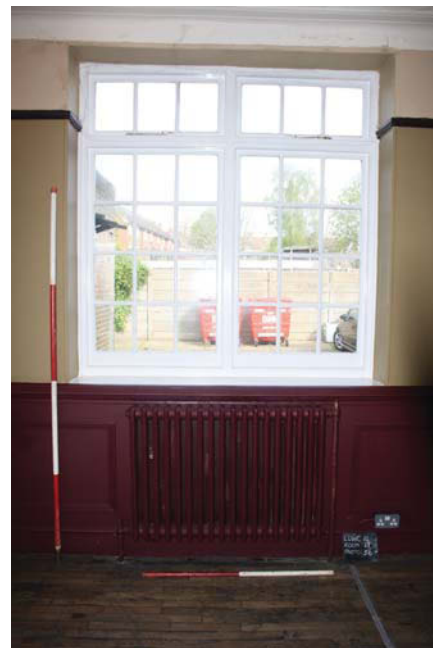
Plate 24. Room 23 looking NW to window and radiator  
Scales: 1m and 2m

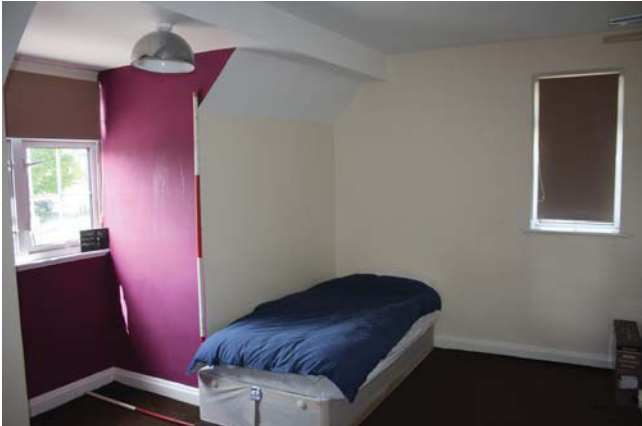
Plate 29. Room 4 looking W towards window,  
Scales: 1m and 2m

coving, picture rails or radiators. The walls were all of plain plaster with plain white fire doors and the windows had all been replaced with modern double glazing.
