**Poplar Cottage, Poplar Lane,
Hurst, Berkshire**

Building Recording

Site Code: PCH14/77

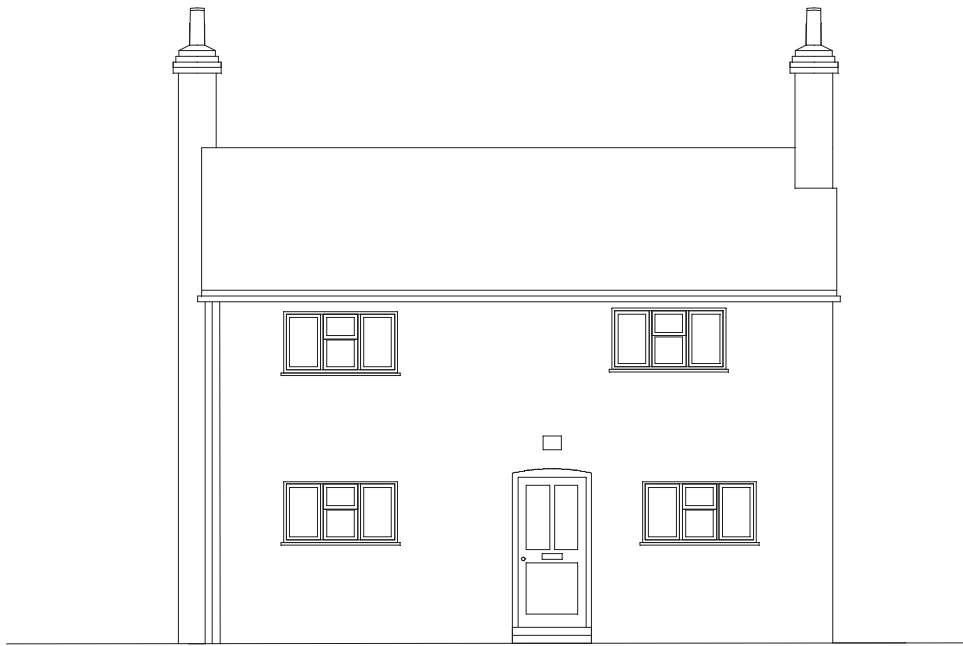
Figure 8. Cottage Elevations

The cottage was set back slightly from Poplar Lane and aligned northwest–southeast and could be sub-divided into the main cottage and a lean-to. The front entrance was in the southeast face looking out over the fields. The cottage itself was brick built and rendered with unpainted concrete pebble dash. No bricks within the main walls were accessible for measurement, and no particular bonding pattern could be discerned for the main building. The lean-to extension to the north was, however, laid in stretcher bond, though no bricks were accessible. The only accessible bricks for measurement were located at the base of the western chimney; these measured 229mm x 102mm x 76mm (9" x 4" x 3"). The roof was a pitched, gable-end roof hung with red ceramic tiles. The windows were casement style windows with wooden frames, painted white with clay tile window sills.

The southeast (front) elevation (Pl. 1) contained a slightly off-centre door with a triple casement window on either side. On the first floor were two triple casement windows. The one at the east end was slightly off-set to the west from the one below whilst the westernmost window was directly above that of the ground floor. The front door contained two panes of glass above a central brass letter box. Beneath the letter box was a single plain wooden panel.

The northeast elevation (Pl. 2) of the main cottage contained no features within the wall; a chimney stack was present at the apex of the roof. Within the lean-to was a door and a window set within weatherboards, above which was a timber lintel, supporting presumably rendered brickwork.

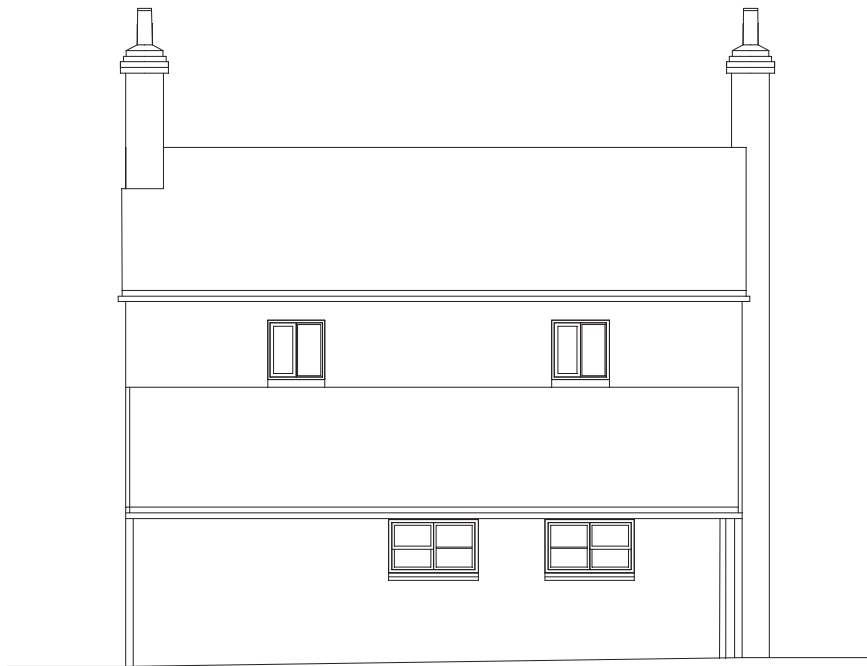
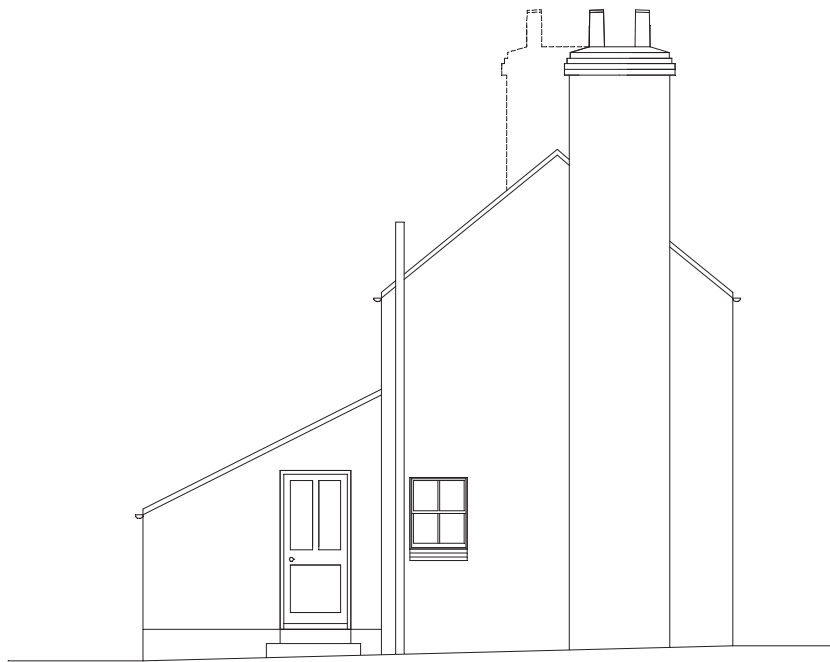
Figure 9. Cottage Elevations

The southwest elevation (Pl. 3) contained an external chimney stack, set slightly off-centre, towards the southern end of the façade. A sash window was present at the northern end of the wall on the ground floor and consisted of a two-over-two pane sash window with horns. Within the lean-to was a door, the same as that found on the front elevation and accessed via two steps up from ground level.

The northwest elevation (Pl. 4) consisted of the rear of the lean-to on the ground floor and the first floor of the cottage. On the ground floor were two small, two-paned casement windows. On the first floor were two larger two-paned casement windows.

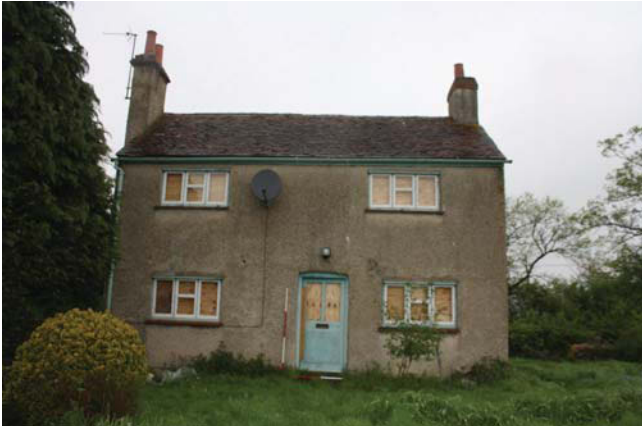
Plate 1. Front elevation, looking northwest,
Scales: 2m and 1m.

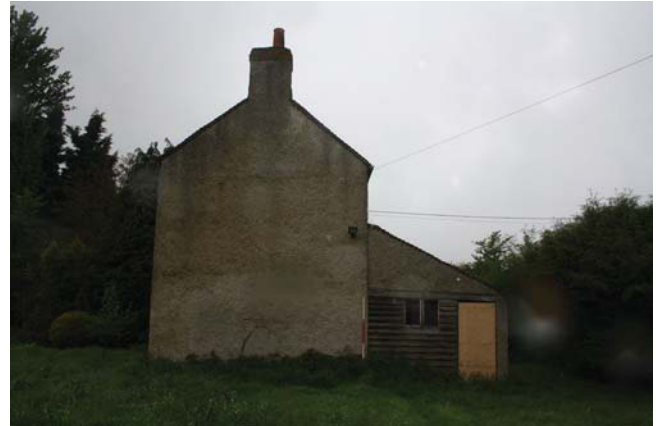
Plate 2. Gable end, looking southwest, Scales: 2m.

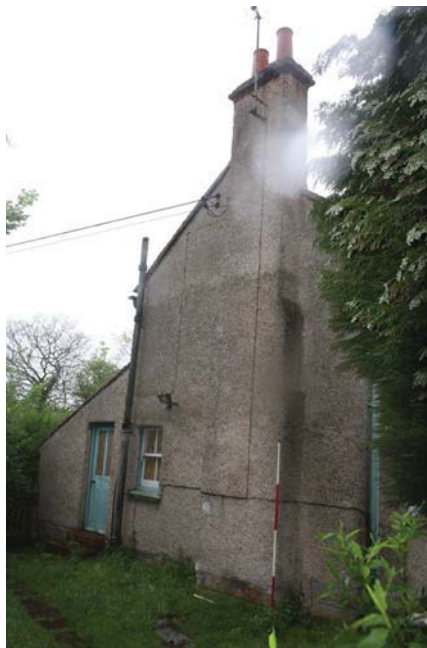
Plate 3. Gable end, looking northeast, Scales: 2m and 1m.

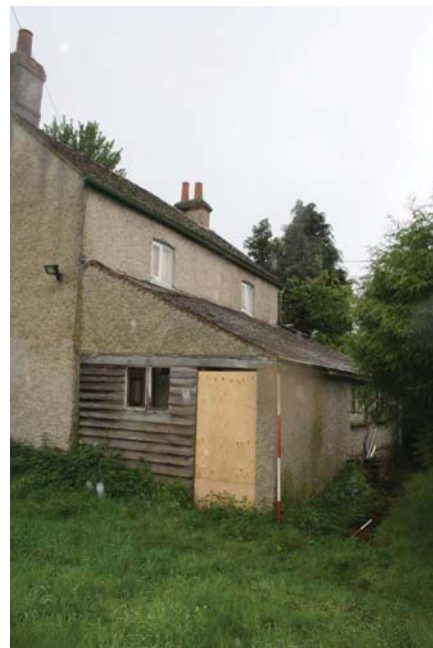
Plate 4. Rear elevation, looking southwest,
Scales: 2m and 1m.

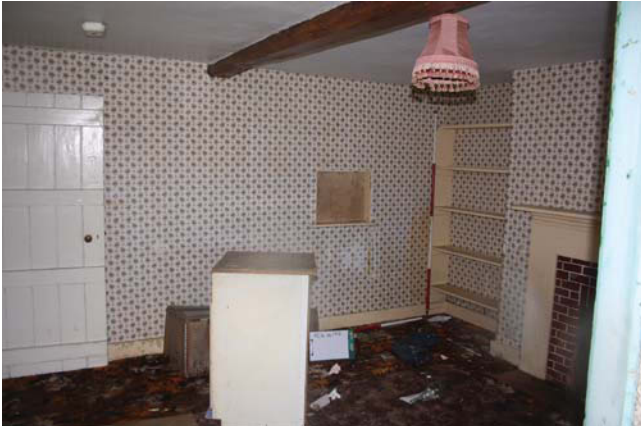
The front door opened into room 1 which was rectangular in shape with a small opening in the northwest wall (Pl. 5) and a fireplace on the east wall (Pl. 6). The small opening was presumably once a window, though it had recently been boarded up, looking into the lean-to. The fireplace was brick built with a tile hearth and a simple wooden mantle surround. Access to the small hallway was through a door at the north end of the west wall. The door was of simple plank and batten style, and typical of the original doors within the cottage. A beam was present within the ceiling, running from the front to the back of the cottage (northwest–southeast). It was most probably of oak, cut by a band saw and chamfered on either side; it had been stained and varnished.

Plate 5. Room 1, looking north, Scales: 2m and 1m.

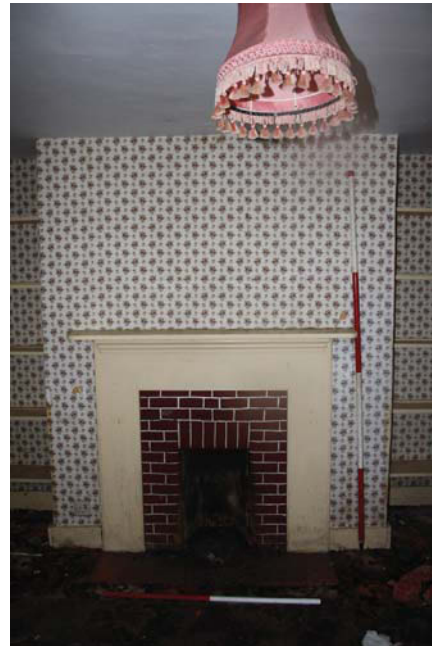
Plate 6. Fireplace in room 1, looking northeast, Scales: 2m and 1m.

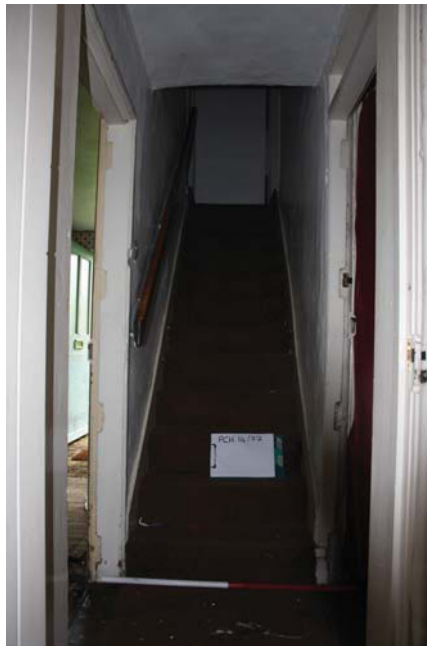
A small, square lobby gave access to stairs to the first floor, room 2 and the bathroom, room 4. The stairs were fairly narrow with a plain wooden banister rail on the northeast wall (Pl. 7). At the top of the stairs was a small square lobby with a further step up on either side to rooms 5 and 6.

Plate 7. Stairs, looking southeast, Scales: 2m and 1m.

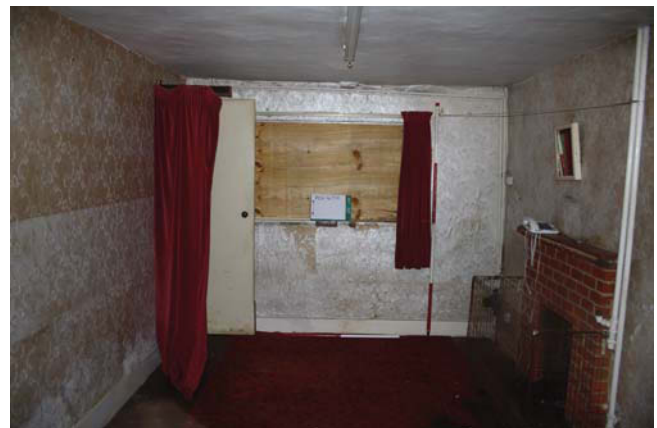
Room 2 was similar to room 1 in size and shape. There was a window in the centre of the southeast (front) wall (Pl. 8). In the south corner of the southeast wall was a door giving access to a cupboard under the stairs. Within the southwest wall was a brick fireplace with a tile hearth and tile mantle piece (Pl. 9). Further to the north was a small window. A pair of sliding doors gave access to the kitchen (room 3).

Plate 8. Room 2, looking southeast, Scales: 2m and 1m.

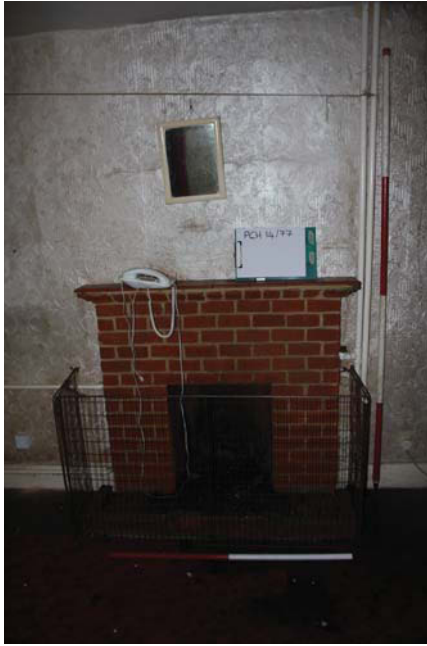
Plate 9. Fireplace in room 2, looking southwest,
Scales: 2m and 1m.

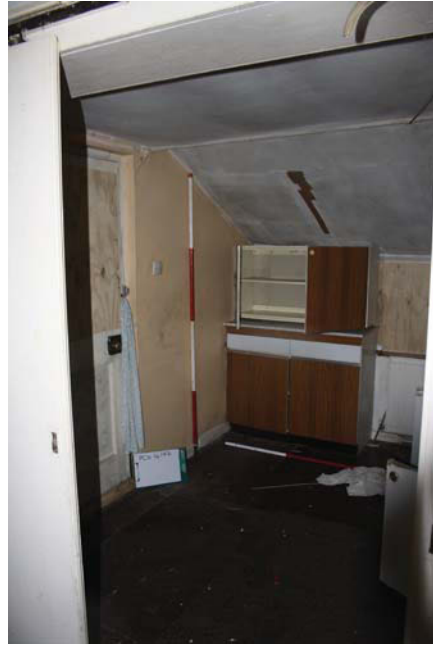
Room 3 was located within the lean-to extension and was latterly used as a kitchen (Pl. 10). Within the southwest wall was an external door and within the northwest wall was a low window. The ceiling sloped down to the northwest wall.

Plate 10. Room 3 (kitchen), looking northwest,
Scales: 2m and 1m.

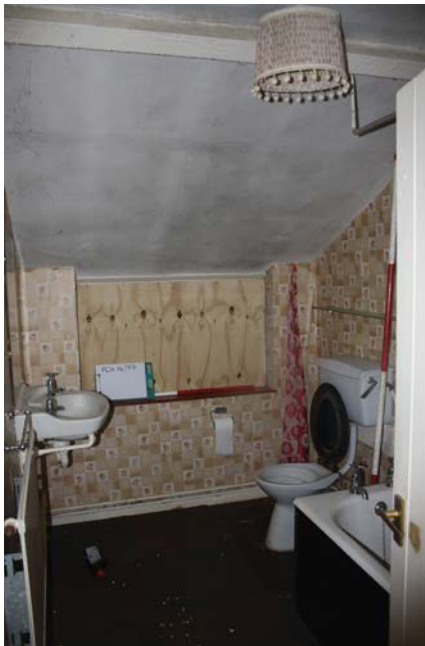
Room 4 was also located within the lean-to extension and was latterly used as a bathroom (Pl. 11). Within the northwest wall was a low window. Like the kitchen, the ceiling sloped down to the northwest wall.

Plate 11. Room 4 (bathroom), looking north,
Scales: 2m and 1m.

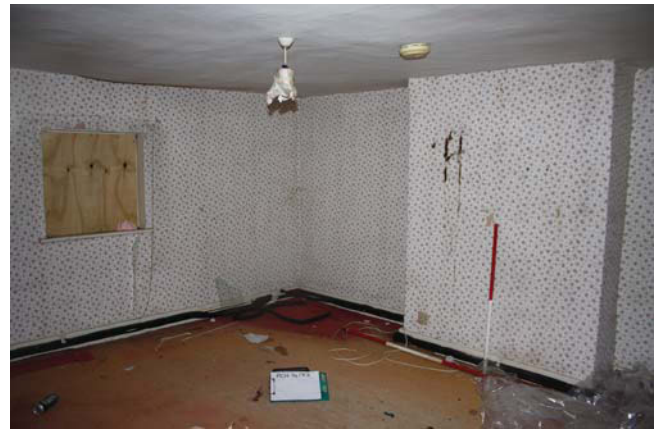
On the first floor room 6 was located to the northeast and room 7 to the southwest. Both rooms were the full width of the house with a window overlooking both the front and rear of the cottage. Within room 6 was a chimney breast in the northeast wall (Pl. 12) and within room 7 was a cupboard over the stairs at the north end of the northeast wall (Pl. 13).

Plate 12. Room 6, looking north, Scales: 2m and 1m.

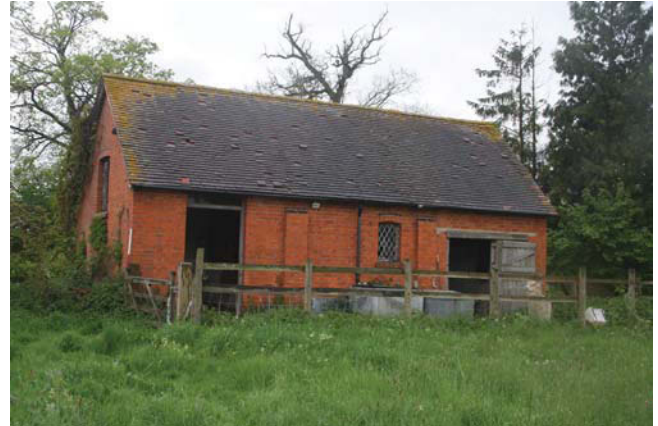
The southeast elevation fronted onto the fields and contained two door openings and a window (Pl. 14). The southwest door opening appeared to be original with a stable style door; however the one at the northeast end was more recent. A concrete lintel was above the stable style door with rebuilt brickwork, laid in stretcher bond, above that. The opening had been partially infilled with a stud wall clad in timber weatherboard. The window was of casement style with diamond leaded panes and typical of all the windows within the building. Either side of the window was a supporting pilaster style buttress.

Plate 14. Front barn elevation, looking northwest, Scale: 2m.

The major change to the barn was the alteration in the northern most door opening on the southeastern façade, which had been enlarged, and presumably lowered. It is likely that the opening was made smaller at a later date with timber infill.

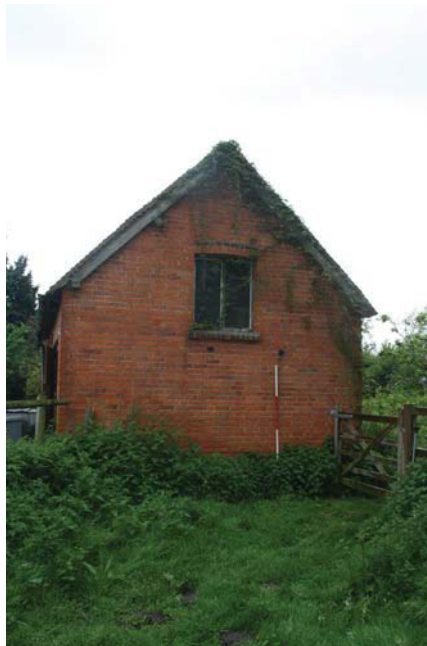
In each of the gable ends was a two-pane casement window (Pl. 15). The rear of the building was largely obscured by foliage, but did not appear to have any features within it.

Plate 15. Gable end of barn, looking southwest, Scale: 2m.

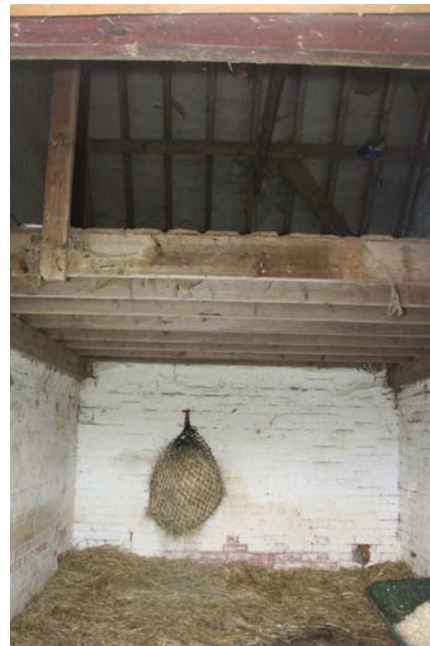
Internally the barn was divided in two by a brick wall with the southern most room further sub-divided by a modern stud wall. The floor was concrete. Within the northern room a small hay loft had been inserted in the roof space (Pl. 16). The roof itself was of queen strut construction with a single purlin on either side supporting the rafters, which met at a ridge plank.

Plate 16. Hayloft in barn, looking northwest.
