**St Peter's Church, Alvescot,
Oxfordshire**

Archaeological Watching Brief

**Site Code: SPC13/13c
(SP 2738 0460)**

Report 13/13c

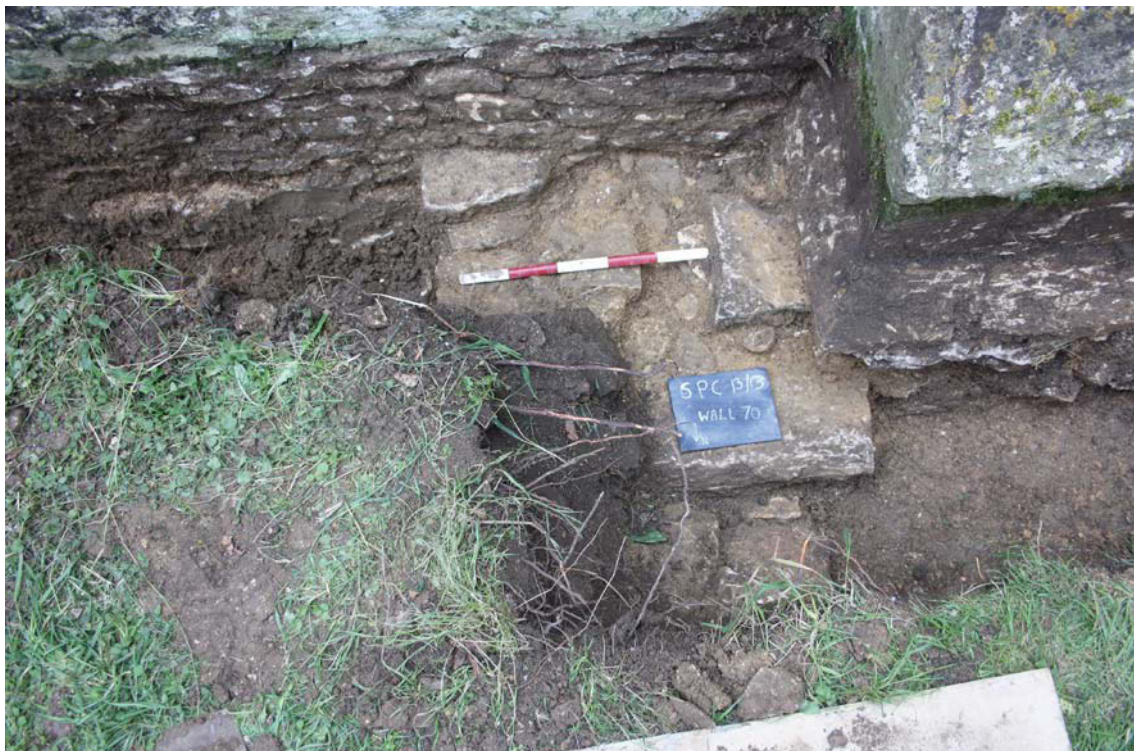
Plate 1. Wall 70, projecting out of north portico, looking south, Scales: 0.5m.

piece of Roman pottery rim sherd was uncovered, and two sherds of 11th-century pottery and one Roman in date came from the overburden above this. This trench lay adjacent to the exterior foundation of the northern portico, uncovering its face along the north wall. A perpendicular limestone block foundation (wall 70; Pl. 1) was uncovered partially underlying the corner buttress (Fig. 2). This wall was at least three courses deep and extended below the excavated trench depth of 0.7m. The top course was 0.42m from the top of the section. Each course was 0.12m thick, including bonding. It extended northwards from the north wall of the northern portico at a roughly 90° angle.

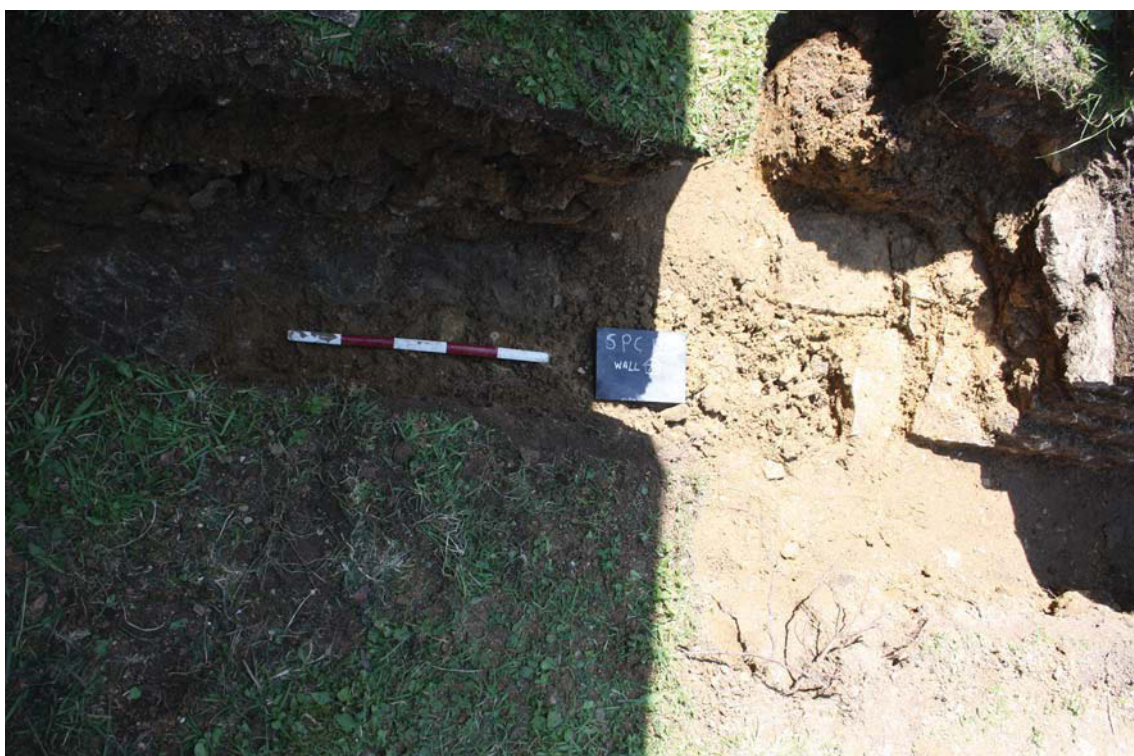
Plate 2. Wall 71, looking south, Scales: 0.5m.

The trench was extended eastwards, uncovering the exterior foundation of the north exterior wall of the north portico. It was seen to curve outwards slightly, even with the above wall straight, offset from vertical by 0.15m northwards. This exposed north portico foundation measured 5.4m in length. Once the north-east corner of the chapel wall was reached the cross section of the underlying wall (71) was encountered under loose stone rubble (fill 72 within robber cut 15) at a depth of 0.65m. The trench was continued eastwards to run in front of the north-western corner of the exterior foundation for the sacristy (Fig. 2). *In situ* stones for the wall were uncovered from the first course at the base of excavation (Pl.2). A drain was sunk within the base of the old boiler room slab that exists to the south. Natural clay was directly under the thin slab. An existing small grill cover drained the top of the step above the slab. This drain lead to a soakaway positioned to the north.

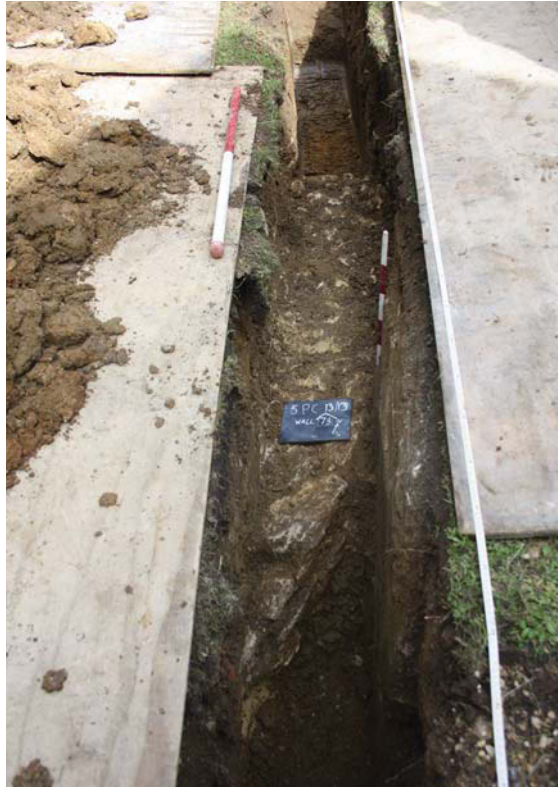
Plate 3. Wall 73, in northern soakaway trench, looking north, Scales: horizontal 1m, vertical, 0.5m.

This trench was excavated to a depth of 0.9m. The top of another limestone foundation was encountered (73) (Pl.3). Though loose rubble was encountered, especially over the corner point just below the turf of the graveyard, *in situ* foundation was only recorded 0.56m below the top of the section. The corner of this wall projected eastwards out of the trench, and it was recorded to turn north at 3.3m along the trench. Two courses existed. This portion of the wall needed to be removed to allow the pipe in the trench to reach the soakaway location in the existing church path.

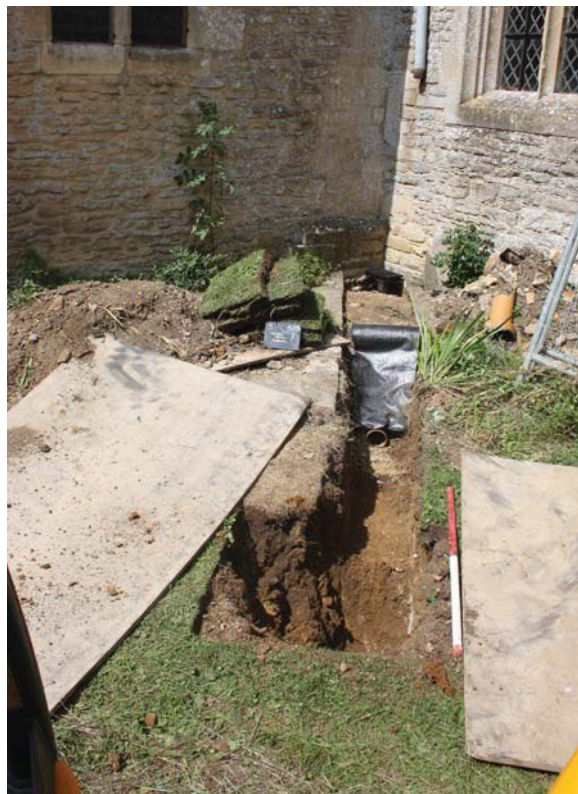
Plate 4. Southern soakaway off exterior southern nave downpipe, looking north west, Scales: 1m.

The only works to occur to the south of the church, was a replacement drainage trench and soakaway, draining a downpipe of the corner of the exterior nave wall and eastern portico wall (Fig.2; Pl.4). These works broke out the previous pipe that discharged rainwater into the ground, with a new pipe laid to a depth of 0.4m. Underlying 0.27m of previous pipe trench backfill, in which a 1931 coin was uncovered, rubble overburden was encountered. This was observed within the base of the pipe trench and within the section of the soakaway on the church path. The base of the soakaway was 0.83m deep. No natural geology was reached. A single fragment of green-glazed ridge tile was uncovered at the base this excavation. No other deposits were encountered in this trench.
