**Chapter House, High Street,  
Hurley, Berkshire**

**Archaeological Watching Brief**

**Site Code: CHH14/38**

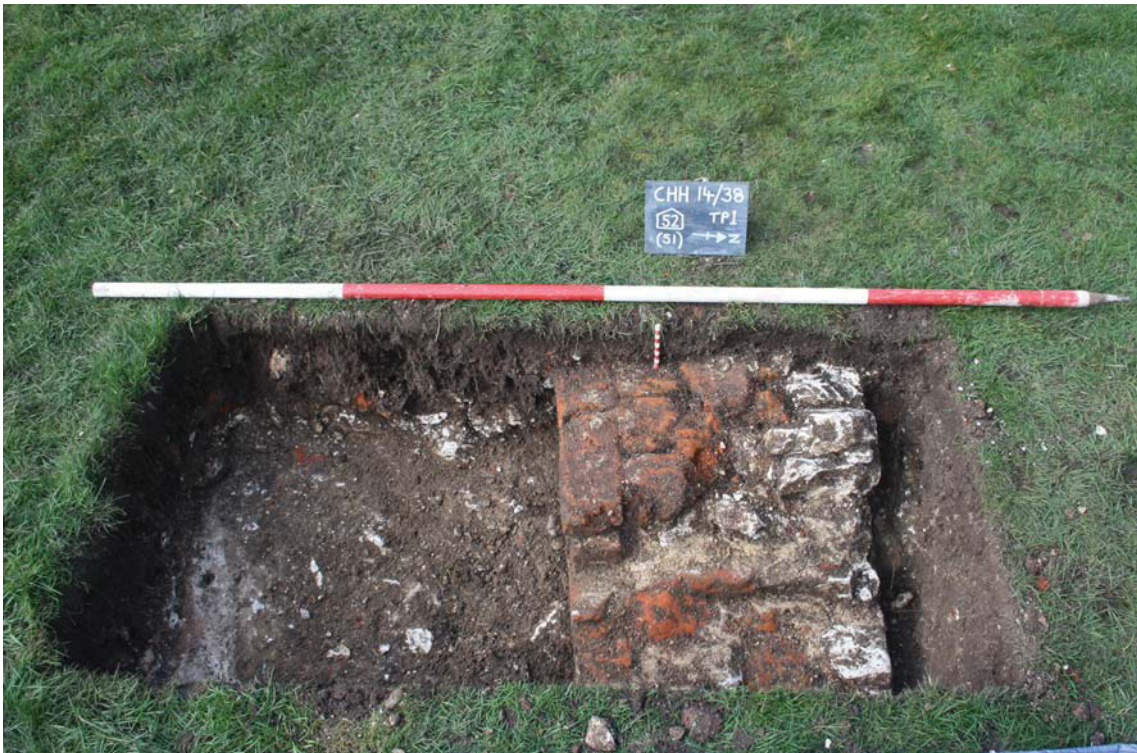
This test pit was 1.50m long and 0.70m wide. It was dug to a maximum depth of 1.05m. A post-medieval wall (52) was observed running east-west at a depth of 0.10m, below the turf and topsoil. This was 0.55m deep and 0.60m wide and consisted of eight courses of unfrogged brick measuring 200 x 120 x 80mm, with a single row of large roughly hewn chalk blocks on the northern extent of the brickwork. These chalk blocks were faced to the north, suggesting this was the exterior face, but roughly hewn on the internal side, and both bricks and chalk were bonded by a light grey-yellow sandy mortar. The wall was set upon a foundation (60) of large roughly hewn, unfaced compacted chalk blocks set in mid brown-grey silty-clay. This was partially excavated to a depth of 0.15m. No cut for the foundation or the wall was observed. Three distinct deposits were observed, two of which butted wall 52. A light brown-grey sandy-silt layer (51) 0.30m thick containing fragments of brick, tile and chalk which resembled demolition rubble lay over 0.32m of loose mid-brown grey sandy-silt (58). Neither of these deposits were related to any visible cut features. Below layer (58) was a dark grey-brown sandy-silt deposit containing occasional burnt tile and chalk fragments. This deposit could possibly pre-date the construction of the wall (52), although whether it was cut by the foundation (60) or butted against it is uncertain. No dating evidence was recovered from this layer.

Plate 1. Test pit 1, showing wall 52, looking west, Scales: horizontal 2m, vertical 0.1m.

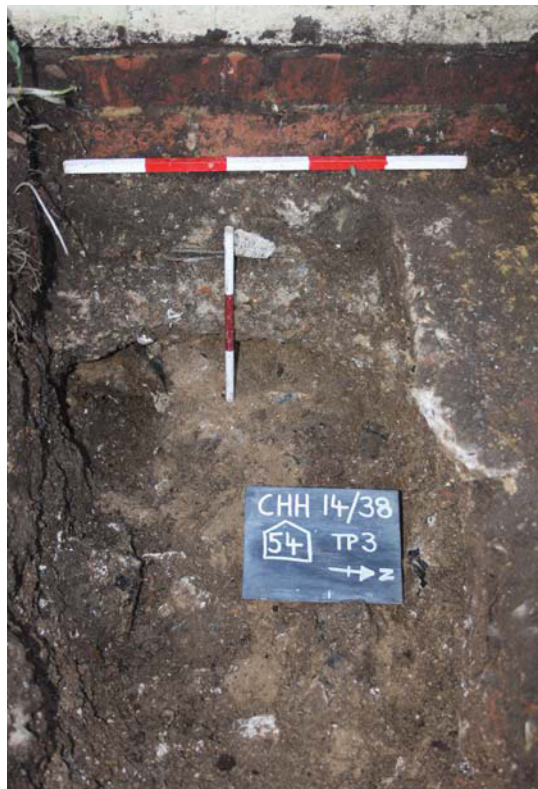
This test pit was positioned against the eastern wall of the existing Chapter House to determine the nature of the foundations. It was 1.00m long and varied in width from 0.35 to 0.60m due to the presence of a modern drainage pipe. The maximum depth reached was 1.00m. The brick wall foundations of the existing house were observed to a depth of 0.70m. Butting up against the wall was 0.30m of garden topsoil and under this, 0.40m of a dark brown-grey sandy-silt (56). This was cut by a possible pit or landscaping feature [1] with sharp concave sides

Plate 2. Test pit 2, looking west to top of wall 54, Scales: horizontal 0.5m, vertical 0.3m.
