The Parade, rear of 109 and 111 Ruddlesway, Dedworth, Windsor, Berkshire

**Archaeological Evaluation**

Site Code: RDW14/48

September 2014

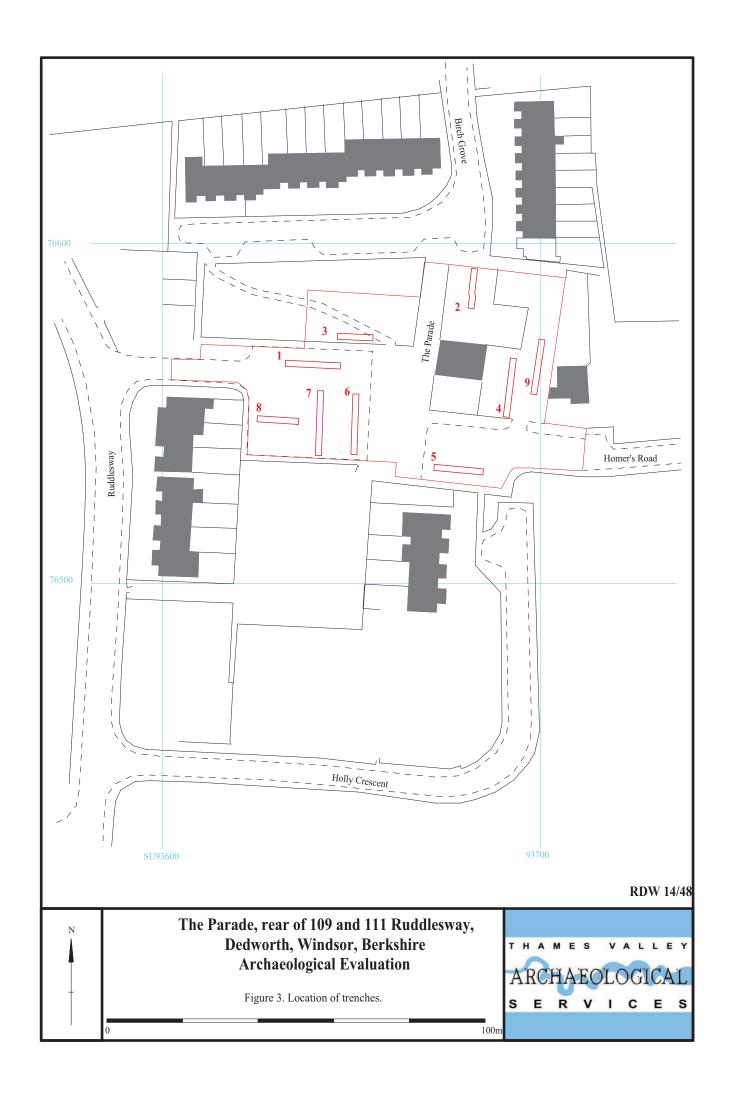
Nine trenches were eventually dug and ranged in length between 9.4m and 17.2m and between 0.48–0.78m in depth. All were 1.6m wide (Fig. 3). A complete list of trenches giving lengths, breadths, depths and a description of sections and geology is given in Appendix 1.

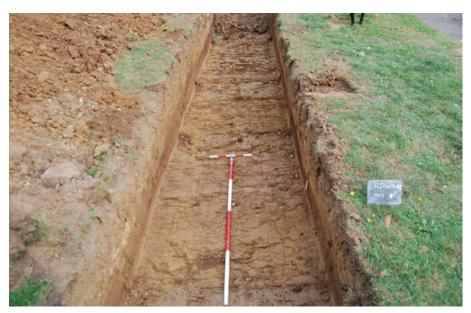
Plate 1. Trench 3, looking east, Scales: 2m and 0.5m.

Trench 3 was aligned east—west and was 9.4m long and 0.78m deep. The stratigraphy consisted of 0.24m of turf/topsoil above 0.21m of brown clay with gravel made ground. This overlay up to 0.25m of a dark brown humic clay interpreted as a buried old topsoil. This in turn overlay brown clay natural geology. A few fragments of brick/tile were pressed into the natural geology (retained on site). No deposits of archaeological interest were observed.

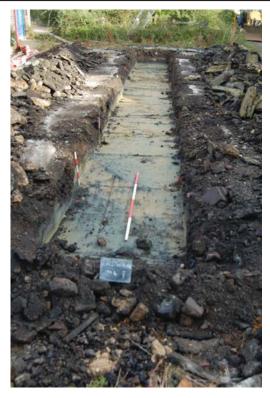
Plate 3. Trench 4, looking north, Scales: 2m and 0.5m.

Trench 4 was aligned north—south and was 15.6m long and 0.65m deep. The stratigraphy consisted of 0.05m of Tarmac above 0.5m of brick rubble made ground above brown clay natural geology. A service run was observed at the southern end of the trench. No deposits of archaeological interest were observed.

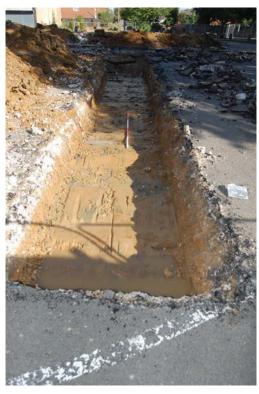
Plate 4. Trench 8, looking east, Scales: 2m and 0.5m.

Trench 8 was aligned east—west and was 11m long and 0.65m deep. The stratigraphy consisted of 0.10m of Tarmac above 0.25m of concrete above 0.25m of gravel made ground, above brown clay natural geology. No deposits of archaeological interest were observed.

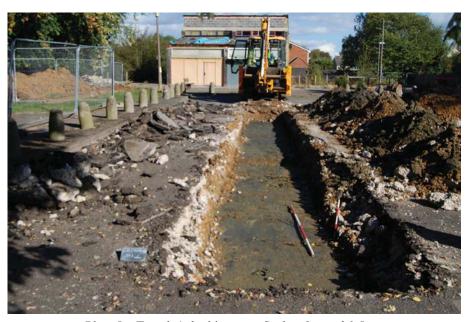
Plate 5. . Trench 1, looking east, Scales: 2m and 0.5m.

Trench 1 was aligned east—west and was 14.6m long and 0.55m deep. The stratigraphy consisted of 0.1m of Tarmac above 0.2m of concrete above blue/grey clay natural geology. A service run was observed towards the

centre of trench. A few fragments of modern brick/tile were pressed into the natural geology (retained on site).

No deposits of archaeological interest were observed.
