**St Mary's Church, Church Street, Meysey Hampton,  
Fairford, Gloucestershire**

**Archaeological Watching Brief**

**Site Code: SMC14/143**

**July 2014**

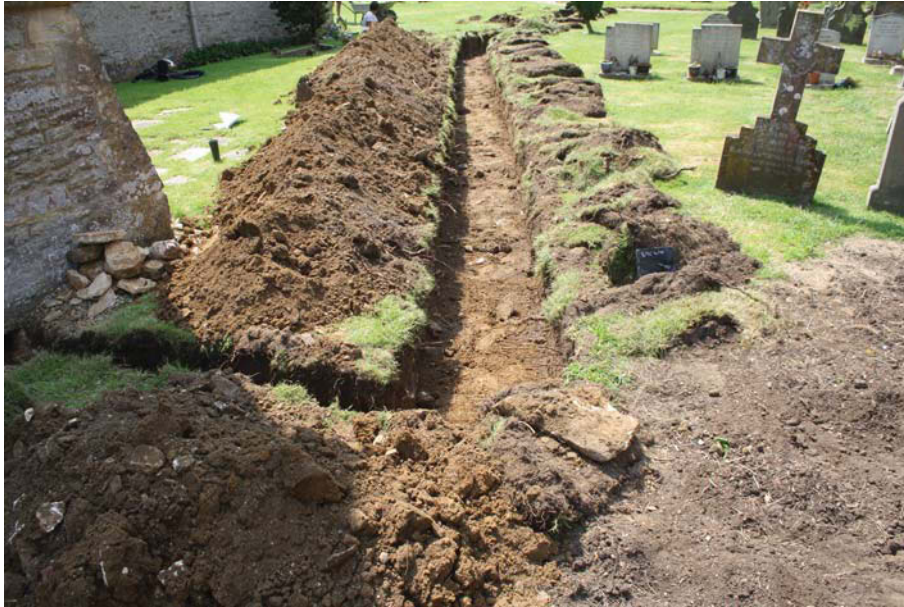
The drainage trench had the same stratigraphy as the pipe trench, including fragments of waste stone and disarticulated human bone. Two graves were disturbed during the excavation of this trench. At 7m from the eastern end of the trench an articulated skull and vertebrae were disturbed (sk52) and excavated from grave 1 (Pl. 2). The grave cut was not clear in the base of the trench, however the skull was disturbed at a depth of 0.55m, and the body was aligned east-west with the skull at the western end. The grave was not fully excavated as it extended beyond the extents of the trench.

Plate 1. View of trench, looking west.

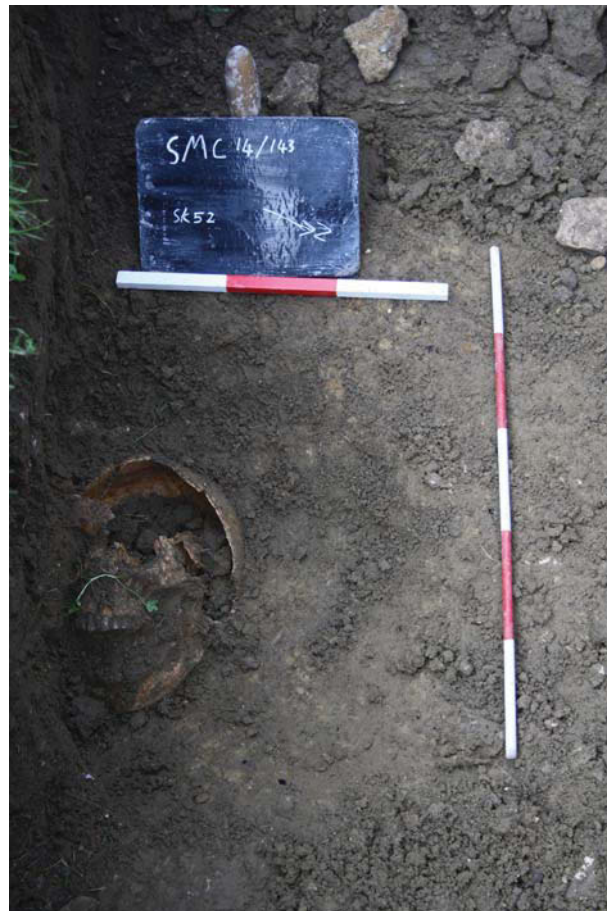
Two articulated individuals were uncovered and retained at the church for reburial. The individual from grave 1 is likely to have been aged between the late teenage years and early 20's as shown by mostly but not completely healed cranial sutures. The fragments of pelvis recovered from grave 2 suggest they were from an adult female. Also recovered was approximately 20 fragments of disarticulated human remains. None of the burials or disarticulated bones were datable from the presence of associated objects.

Plate 2. Picture of skull, looking southwest, Scales: 0.30m and 0.50m.
