**5-7 Brighton Road, Crawley,  
West Sussex**

**Building Recording**

**Site Code: BCW14/101**

**Building Recording  
For PMC Construction Co Ltd**

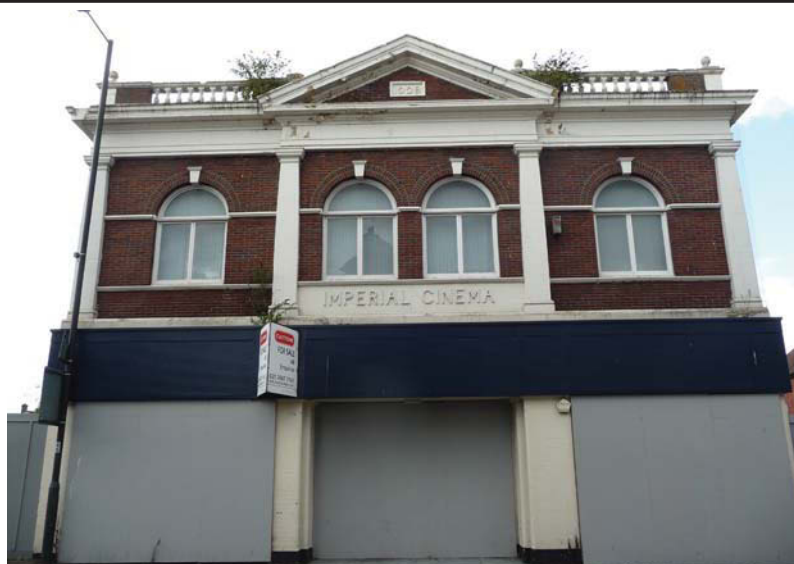
Plate 19: Exterior, east facing elevation, looking west

The far eastern end of the former cinema building is to be retained as part of the new development, and is clearly visible from Brighton Road. Although the building was constructed in red brick, the decorative neo-classical design of the Brighton Road frontage is apparent at first floor level and above. The building materials used in the neo-classical elements of the frontage is not clear, as they have been rendered and painted white. Two columns on the north-east and south-east corners of the building support a relatively plain entablature, although this has been moulded in such a way that the cornice, frieze and architrave can all be identified from ground level. Two central columns protrude slightly, and support their own similarly styled entablature. The cornice of this central entablature is surmounted with a pediment. A plaque within the pediment gives the date 1928, whilst a larger plaque between the lower parts of the two central columns contains the words 'Imperial Cinema'.

There are four windows with semi-circular heads at first floor level, which appear to be original features, although historic photographs (Pls 14 and 15) suggest that the frames were not originally painted white. Each window has decorative brickwork around the head, and there are two moulded "string courses" running along the elevation. The roof structure cannot be seen from Brighton Road, partly due to the presence of a parapet which runs along the top of this elevation. This parapet is largely constructed from red brick, with decorative balustrades either side of the central pediment. Historic photographs indicate that the top portion of the ground floor has been obscured by hoarding since at least the 1980s (Pls 17 and 18), and further hoarding boards had been put up prior to the building survey taking place. The presence of the hoarding means that the three arched bays which were a feature of the cinema building are not clearly visible at present. However, the arches can be seen internally. In summary, this elevation of the building appears to have changed very little since it was built in 1928.

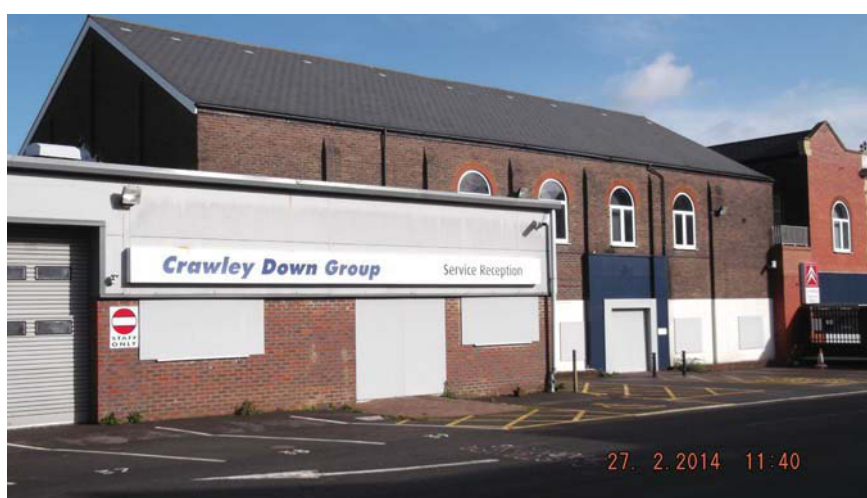
Plate 20: Exterior, general view of south facing elevation, looking north east

The south facing elevation of building A (Pl. 20) has obviously been altered since it was originally built, and historic photographs suggest that this happened sometime after the 1980s (Pls 17 and 18). The changes included the insertion of a semi-circular headed window at first floor level (built to match the four along the east facing elevation), and a large rectangular window on the ground floor. Differences in the brickwork of this elevation also support the idea that these features are quite recent additions. It seems possible that the rear part of this building, which includes a small first floor balcony, may have been altered at the same time as the windows were inserted (Pl. 21). Unfortunately no historic photographs were available clearly showing this elevation. The large ground floor window was boarded up at the time of the building survey, but could still be seen internally. A large Citroen sign is affixed to the external wall, close to where the boundary wall meets it. The gable end of the roof of building A can be clearly seen in this elevation.

Building B had been demolished prior to the building survey taking place, but photographs were taken before and during its demolition (Pls 20 and 22). This large building had a simple gabled roof structure, and was originally built as the cinema's auditorium. It was built using reddish brown bricks, and the south facing elevation had six equally spaced shallow brick buttresses. Prior to its demolition there were four windows with semi-circular heads at first floor level, along with four rectangular windows and two entrances on the ground floor. Although no historic photographs of the outside of this building could be traced, it is likely that all the openings in this elevation are recent additions. This is supported by the fact that the building did not originally have a first floor, and also by historic photographs of the interior (Pls 9 and 10) which do not show any windows. Parts of the original south facing elevation of this building were obscured by the modern workshop building (C) and large fittings around the two entrances. There were two drainpipes along this elevation, and the slate roof of the building was clearly visible.

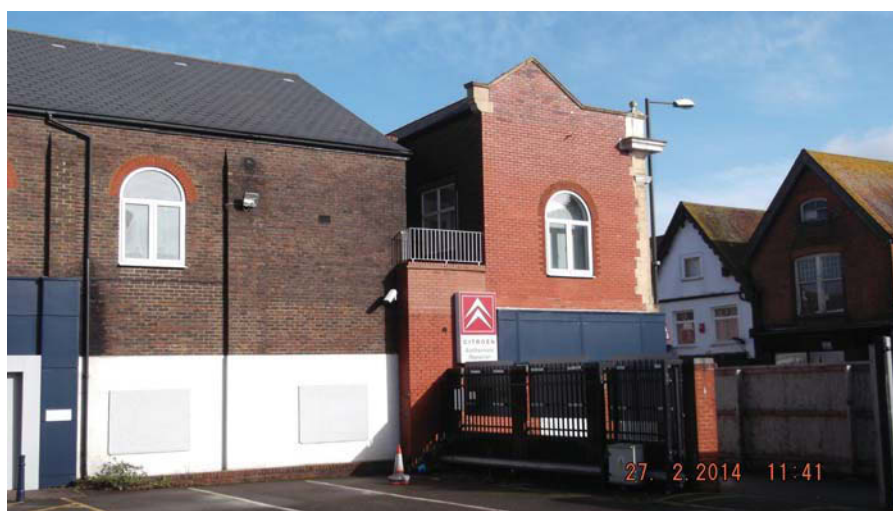
Plate 21: Exterior, general view of south facing elevation, looking north

Prior to the demolition work, only a small section of the west facing elevation of building A was visible as it was largely obscured by building B (Pl. 21). The visible section coincided with the first floor balcony. There was one rectangular window with a concrete lintel and sill. The modern appearance of this window suggests that it was not an original feature of the building.

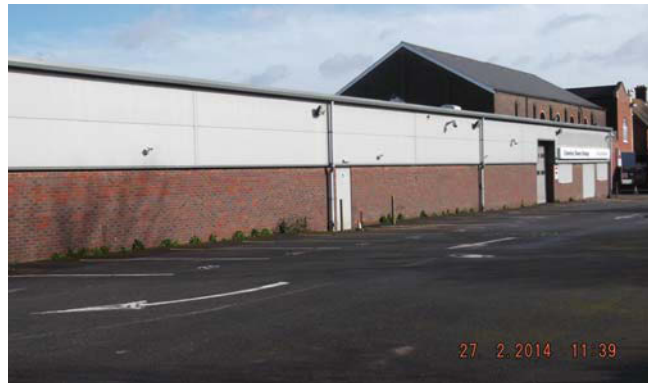
Plate 23: Exterior, general view of south-facing elevation, looking north east

Building C was the main workshop for the vehicle dealership which formerly occupied the site. Although the lower parts of the walls are faced with brick, it is probable that the building was largely constructed from concrete and steel sometime after the 1980s. The building was demolished before the survey was carried out, but

a number of photographs were taken shortly before its demolition (Pl. 23). The building was not recorded in detail, but two entrances and two rectangular windows were noted along its south facing elevation.

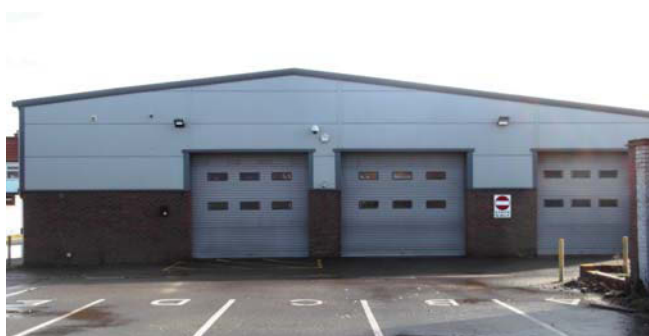
Plate 24: Exterior, general view of west facing elevation, looking east

The west facing elevation of Building C was photographed shortly before its demolition (Pl. 24). These photographs clearly show its asymmetrical design, and three large entrances.

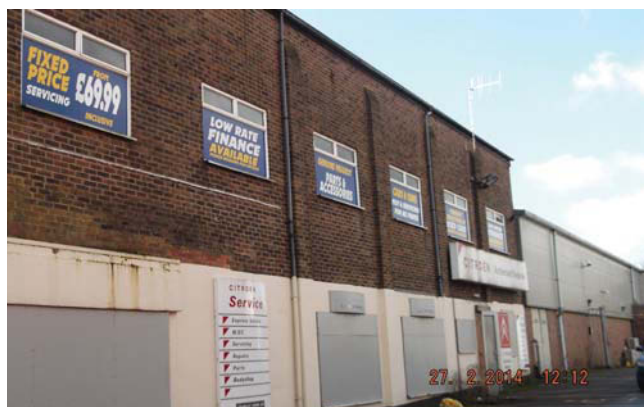
Plate 25: Exterior, general view of north-facing elevation, looking south west

The north facing elevation of Building C is just about visible in some of the photographs taken shortly before it was demolished (Pl. 25). A small section of this building, which housed an electricity sub-station, was still standing at the time of the building survey. The presence of various windows and entrances along this elevation can be gleaned from the pre-demolition photographs and plans.

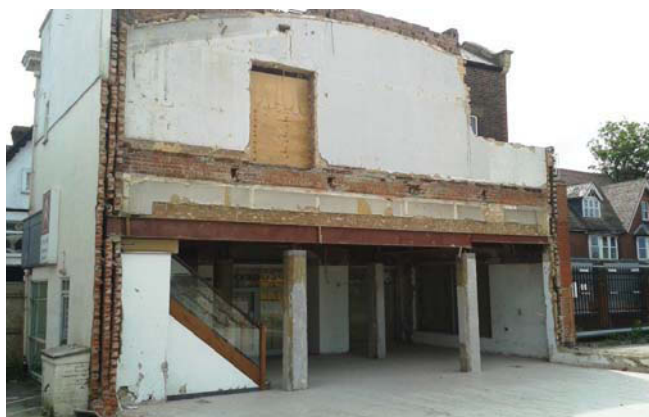
Plate 26: Exterior, view of remaining section of former cinema building post-demolition, looking south east

This building, which fronts onto Brighton Road, was originally built in 1928 to house the cinema's foyer, first floor lobby and projection room (Pls 26 and 27). The cinema's offices and toilets may also have been situated in this building, but there is firm no evidence for this. Historic photographs and maps suggest that the southern bay of the building was occupied by a separate business, at ground floor level at least, although no internal walls survived to support this. Pre-demolition photographs show that the wall between Buildings A and B had been removed at ground floor level to create one large open space, and a low ceiling inserted. Various partition walls are shown on these photographs and on the architects' plans, all of which were clearly later additions. The same is true of the staircases linking the ground and first floors. The low ceiling between the two floors was removed during the demolition work, and the late 20th century structural changes were clearly revealed. The most obvious of these was the insertion of a new steel girder frame, supported by four large steel and concrete pillars (Pl. 28).

The only traces of this building left by the time the survey took place were the scar of its curved ceiling immediately to the west of Building A (Pl. 26), and the first floor doorway which originally provided access to the balcony of the auditorium. However, some internal photographs of this building were taken prior to it being demolished. These photographs clearly show how the original cinema auditorium was affected by the insertion of a new floor. On the ground floor this was coupled with the removal of the wall between Buildings A and B to create a large open space with a low ceiling. Various windows and entrances were inserted to the walls of Building B so that it could function as a vehicle showroom. It is unlikely that any original features on the ground floor would have survived these changes.
