**Stag and Hounds, 302 St Leonard's Road,  
Windsor, Berkshire**

**Building Recording**

**Site Code: SAH14/259**

**January 2015**

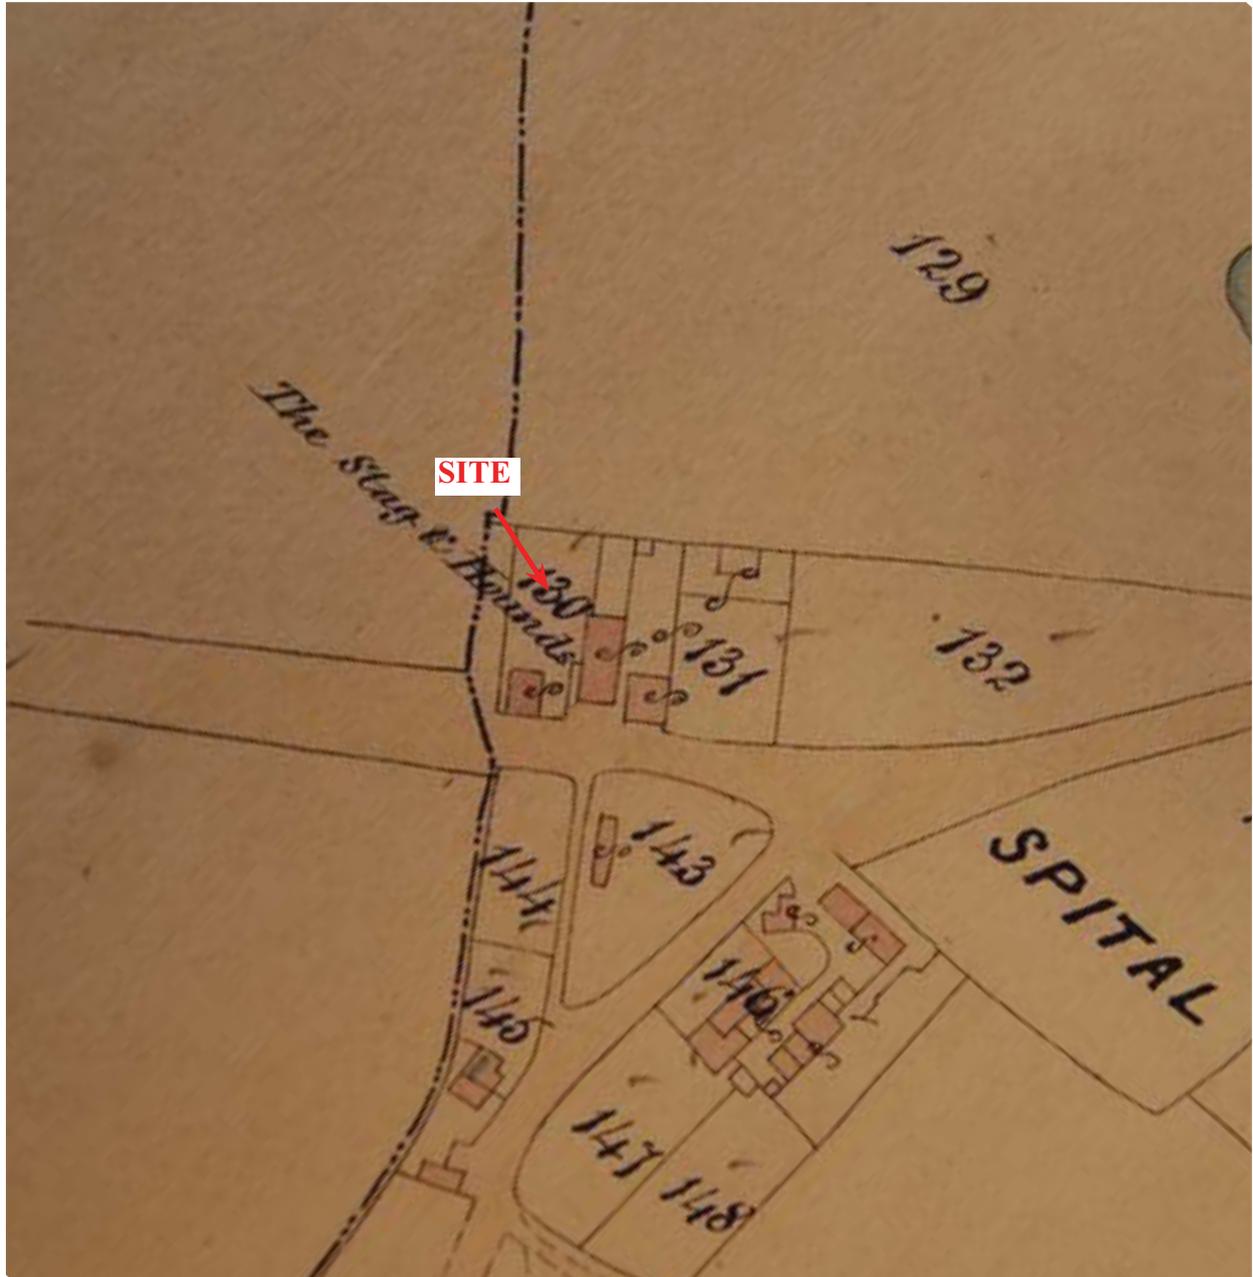
Stag and Hounds, 302 St Leonards Road,  
Windsor, Berkshire, 2015  
Archaeological Building Recording  
Figure 4. Tithe map of 1852

The tithe map of 1842 (Fig. 4) is the earliest plan to show the location of the Stag and Hounds in detail. The buildings are shown fairly schematically. The buildings appear to be much closer to the road than the current location, even allowing for the widening of pavements by the time of the first Ordnance Survey. They are shown as two separate buildings, with a rectangular building at the west on a north-south axis, which is likely to represent the cottage, with a barn (now demolished) at the rear. The Stag and Hounds appears as a square building at the east, with no outbuildings indicated, though a long narrow building aligned north-south at the east of the plot, adjacent to the meadow, may well represent a stable block. The tithe information describes a building and garden (130), the Stag and Hounds (with two buildings, 131) and a meadow (132), with the apportionment showing the landowner as Reid Neville, the occupier as Angel Thomas.

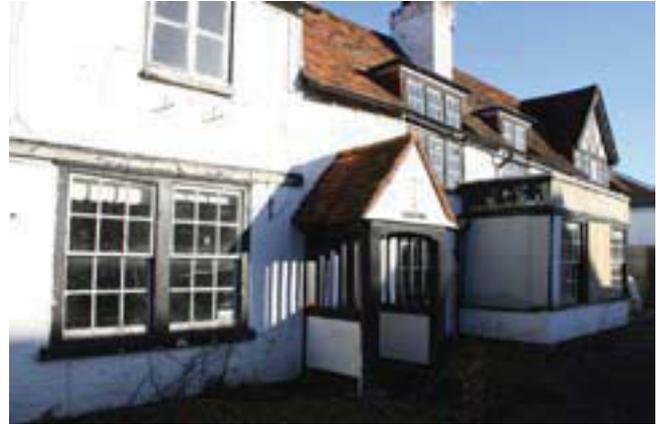
Plate 2. Exterior, front elevation (porch and bay window), looking north east, Scale: 1m.

The pub building comprises a rectangular building of two storeys (plus a cellar). The front elevation (Pl. 2) comprises a flat front with the porch and square single storey bay added at the right projecting to the south. The first floor roof is of a single pitch, joined at the west to the roof of the cottage. A brick built chimney stack (to the left of centre) is white painted with three cylindrical plain pots. The fairly steeply-pitched roof is covered in plain red clay tiles which appear to be original. A first floor dormer gable projects to the south, and the rear of the building at the north has a shallower pitched roof, with clay lap tiles. A further modern extension at the east has a clay tiled roof, with a tiled gable first floor extension (19th century) to the rear at the east, and a 20th century extension at the west has a flat roof.

The walls are built to a variation on English garden wall bond (where this is visible), with header courses in between each 5 stretcher courses and are white painted, with plaster render on the first floor and eastern part of the ground floor. Timber framing is exposed at the wall plate and through part of the first floor.

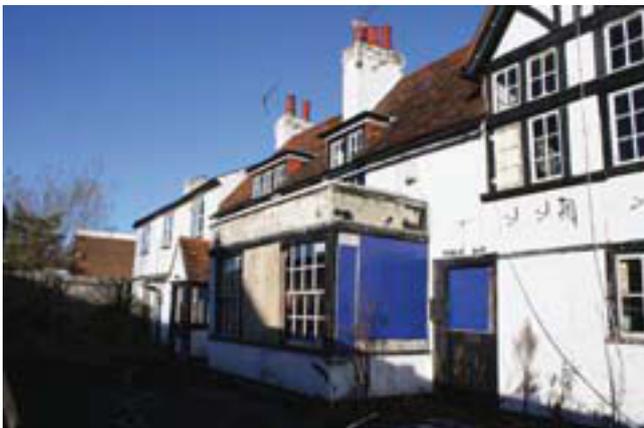
Plate 3. Exterior, front elevation, looking north west, Scale: 1m.

At the right of the front elevation, two pairs of windows are set within the exposed timber frame of the large gable dormer, though struts are likely to be of 19th or 20th century date. These are a likely early 20th century insertion and comprise two pairs of square four light windows above eaves level, with the centre two as top-hung casements. Below these are two pairs of six-pane windows, with the pane at the right and left side hung on simple pin hinges, and the central pair fixed (Pl. 3).

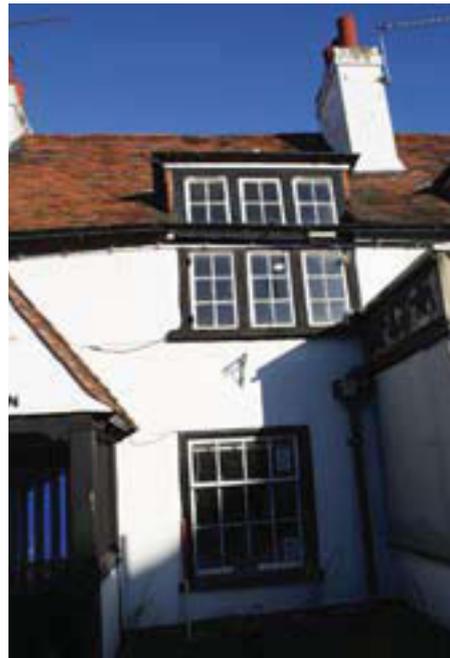
Plate 4. Exterior, frontage windows detail, looking north, Scales: 1m.

To the right of the door is a four over eight sash window, with thin glazing bars and small rectangular panes, with a wooden sill (Pl. 4). To the left is the rectangular bay projecting to the south. This has three vertically-hung eight-over-eight sash windows with fairly thin glazing bars, with a further eight-over-eight sash either side on the returns. These have wooden sills and are of early 19th century date. Between the windows, and at the corners of the bay, are plaster strips with fluted moulding.

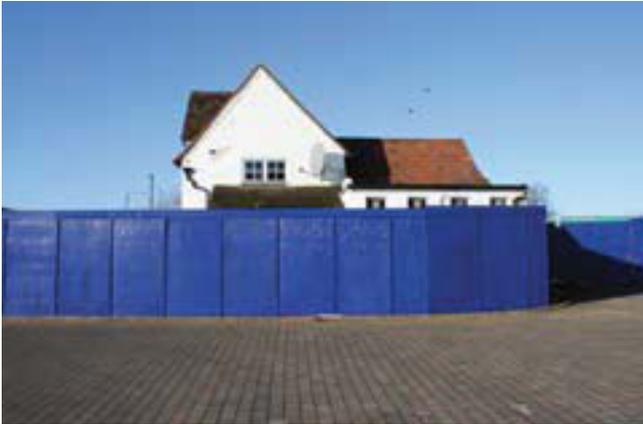
Plate 5. Exterior, eastern gable end, Scale: 1m.

This elevation comprises the white painted rendered gable end of the main pub building, with a pair of side-hung windows of 20th century date at 1st floor level, each comprising four panes. Below this is the ground floor extension with a single low pitched clay tiled roof with exposed ends of rafters.

To the left, a modern single-storey extension has a rendered brick wall and flat roof, with four single pane fixed windows with vents. The west extent of the pub building adjoins the cottage.

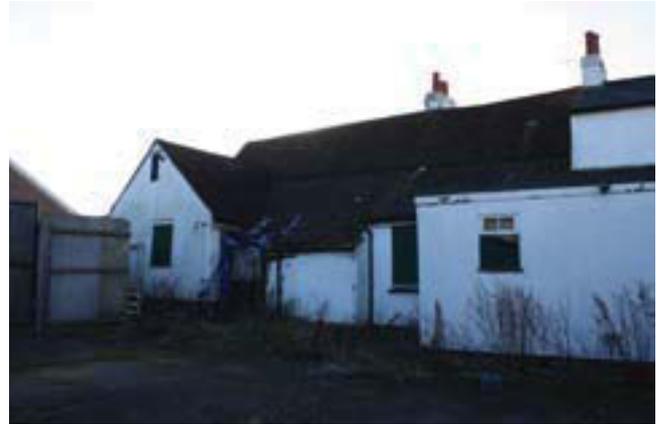
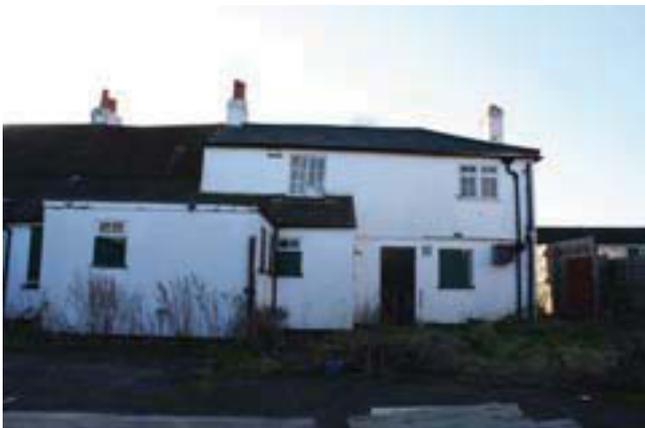
At the left, the flat-roofed modern extension has a plain plastered wall with a vent. The first floor of the gable has a small crittal-type window of six panes with rectangular lights in a steel frame, side hung on pin hinges. It is of likely early 20th century date. At the ground floor is a three-over-six sash window though this was covered with a board at the time the building recording was being carried out. Below this, the entrance to the cellar has also been covered with a board, and two modern security lights have been fitted to this part of the building.

To the right of this, a doorframe with simple moulding (possibly of 19th century date) has a wooden door of modern date. The pitched-roof extension has red clay 'double Roman' pantiles and is a shallower pitch to the roof above, and is of likely 20th century date. At the eaves by the doorway, a small area of repair has been carried out using the plain tiles seen throughout the rest of the roof.

At the right of the doorway are two square ceramic vents, and to the right is a further extension of likely 19th century date, though this is also roofed with 'double Roman' pantiles, at a slightly steeper pitch than those at the left.

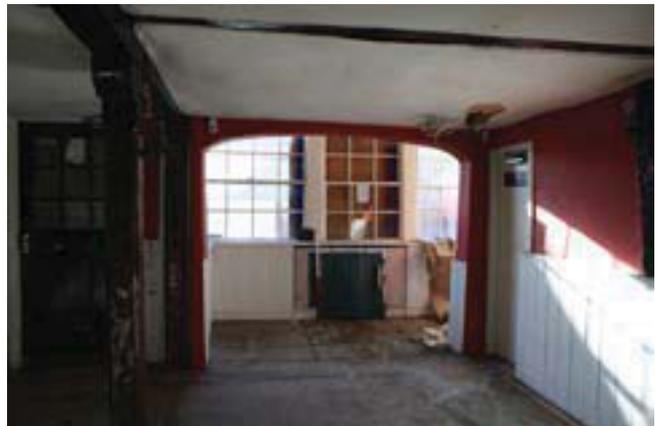
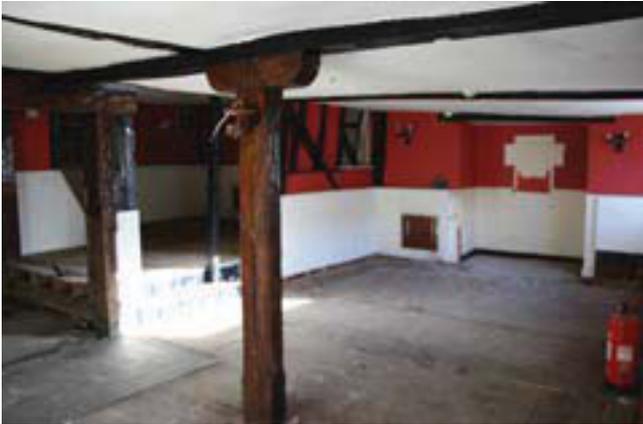
This comprises the main room of the public house. It is a rectangular space, with the wall between rooms 1 and 2 removed to create a single space. At the south, an extension creates a small additional area of seating, surrounded by sash windows and with exposed floorboards. The entrance to this extension is formed by a wide four-centred arch with plaster render, in a form characteristic of the early 19th century. To the west of this, the wall is

plastered and painted above wood panelling, and a modern 4 panelled door leads to the west into room 5. The panelling covers the likely location of a chimney breast, and it is likely that the hearth would have originally been open both in room 1 and 5.

At the west, a large alcove suggests the former location of a fireplace, which is indicated by the wall thickness at this part of the building. However, no chimney stack is present.

The ceiling is low and fairly uneven, with a pronounced slope from the north side of the room down towards the south. The exposed timbers seen in the south and west of this room appear to be hand rather than machine cut, as do the three beams which are aligned north-south in the ceiling of the room. The two at the east have a chamfer, with a lamb's tongue stop at each end, though the beam adjacent to the door does not have the chamfer. It does, however, appear to be of the same age and condition as the other two and these appear to be original. It is supported by a Samson post with a pillow in the centre of the room, these two pieces appear to be a later addition, though hand-cut and of possible early 19th date. The Samson post has chamfered sides, with simple triangular stops. The beam has several empty mortises suggest the removal of internal partitions. The walls have painted plaster with modern painted wood panelling up to dado height.

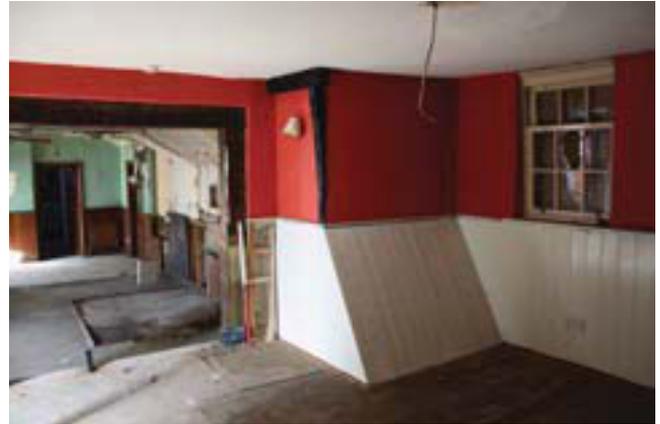
Plate 10. Interior, room 2 looking north west,  
Scale: 1m.

At the north-west of this space, a post supports the beam. It has chamfers above the height of the panelling but not below. Where the panelling has been removed, the wood is neat and machine cut; above this level it is rusticated, with the finish made intentionally uneven. It is likely that the posts to the south of this, in room 1,

have had similar treatment, though their dating is uncertain. The chamfer here is in two parts, with triangular stops at mid height.

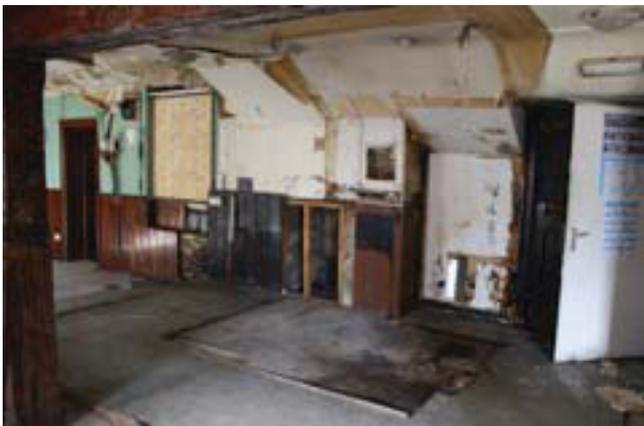
Plate 11. Interior, room 4, looking south,  
Scale: 1m.

This room occupies the central space at the north of the ground floor and has a partially sloping ceiling at the north. The original extent of the space is unclear, as the date of the outshut is not certain. The walls are plastered and painted and the exposed timbers comprise a beam at the south, aligned east-west. This appears to be hand-cut but has no chamfer, and is supported by a post with the upper half chamfered (with lamb's tongue stops) but no chamfer below. This area was formerly the bar area, although the bar structure has been removed. At the north, an area of modern wooden panelling has been removed to reveal a cavity and an area of brickwork. Although the flue was blocked, it appears this is the location of a former fireplace, most likely to have been removed in the early 20<sup>th</sup> century.

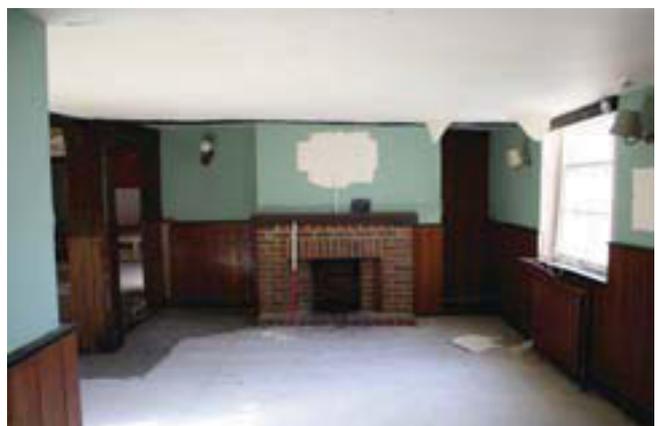
Plate 12. Interior, room 5 fireplace, looking east,  
Scales: 1m.

At the west of the space, a step down and a change in ceiling height leads into room 5, though the rooms are no longer partitioned. This room has 20<sup>th</sup> century wooden panelling, at high dado height though the level is dropped on the south wall to accommodate the sash window.

The east of this room has a modern brick built fireplace with timber mantle. This replaces an original fireplace in this location. At the south is the door of the public house, which is timber set in a wooden frame with a simple ovolo moulding, and to the west of this a change in ceiling height suggests a separate phase of building. There are two exposed hand-cut beams in the ceiling, aligned north-south, and the ceiling slopes down towards the south as in room 1. The ceiling beam at the west of the space is supported by a pillar which has modern wood panelling below, and plaster above (Pl. 13). The timber and pillar delineate the extent of the original building, and the timber is likely to represent the original wall plate. For this reason, the space to the west of this is discussed separately as part of the cottage (see rooms 1A, 2A below).

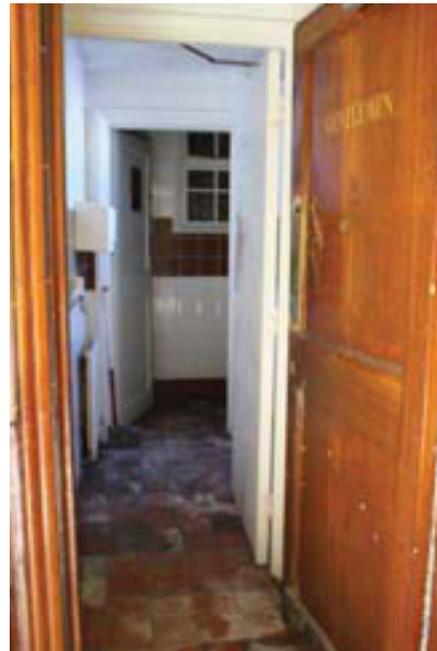
Plate 14. Interior, room 7, looking west,  
Scale: 1m.

At the north of room 5, a doorway leads into one of the two extensions housing a female and male bathroom. Room 6 is carpeted, has two internal walls and modern fixtures and fittings. Room 7 has one internal partition wall and is also carpeted, with tiled walls.

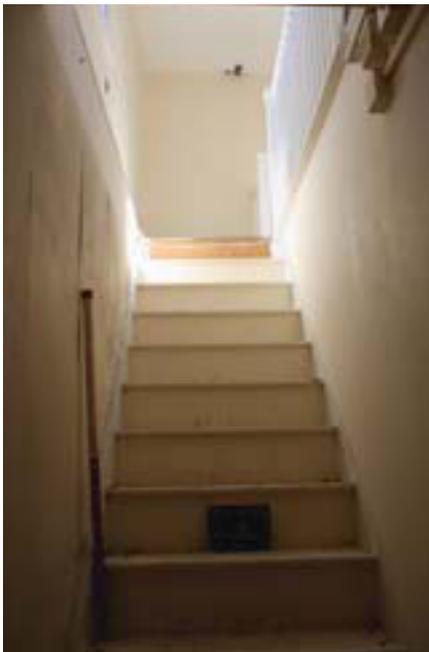
Plate 15. Interior, stairs, looking east,  
Scale: 1m.

The first floor of the building is reached via a staircase at the north, within the cottage part of the building (Pl. 15). Any direct evidence for the original stair location has been removed, however the likely location would be perhaps within room 4 (rising from east to west) or at the north of room 5.

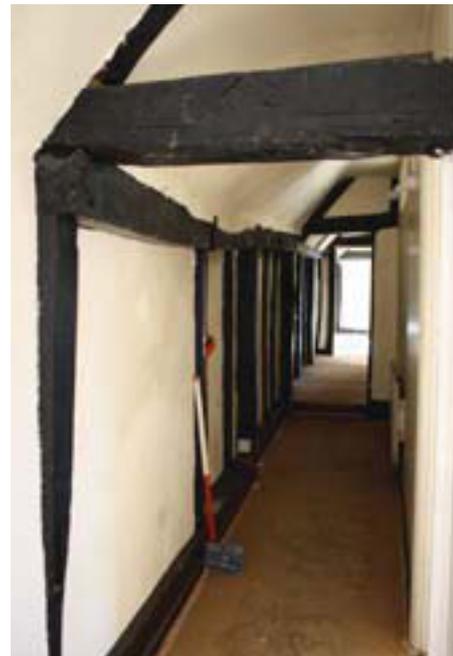
Plate 16. Interior, first floor corridor, looking west,  
Scales: 1m.

The stairs lead to a landing, still within the cottage, where three steps down to the east lead to a corridor (Pl. 16). Here, exposed timbers along the north wall are largely hand-cut, although two phases appear to be represented, with several posts appearing less weathered than the typically fairly weathered original timbers. Occasional machine-cut additions were also observed. Several empty mortises were observed, which are suggestive of timber-reuse as their location is not likely to indicate removal of parts of the structure. An iron clamp has been added on the north side.

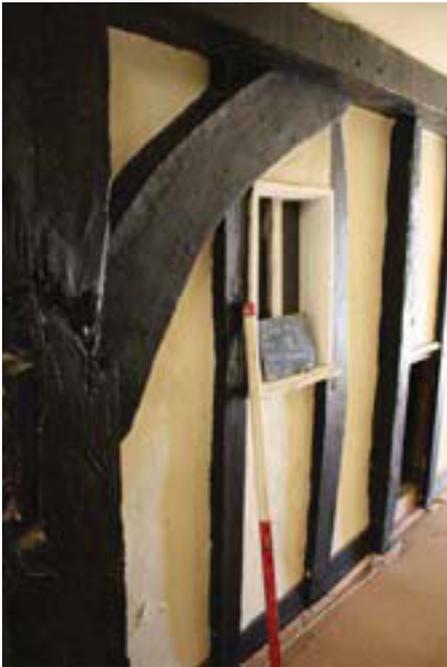
Plate 17. Interior, corridor window, Scale: 1m.

The timber framing includes a lap joint within the wall plate, and two convex braces, which appear to be original and are fairly irregular. Adjacent to these is a small window of two rectangular fixed panes in a wooden frame set within the timber framing (Pl. 17). A small panel of the lath and plaster has also been recently removed, with the result that the interior of the roof of the outshut could be observed. Here, the condition and finish of the timbers suggest a 20th century date for the construction of the outshut roof.

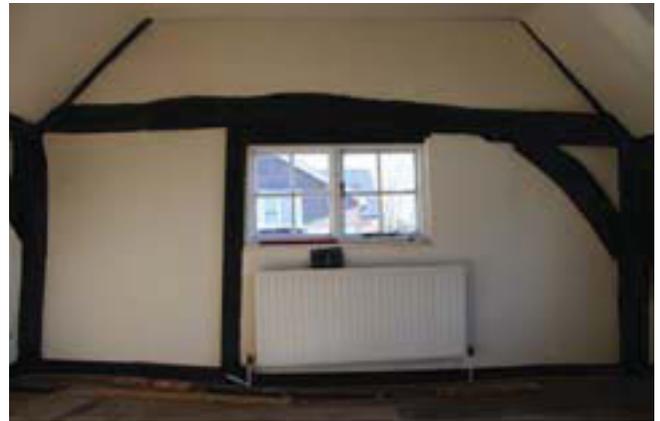
Plate 18. Interior, room 8, looking north, Scale: 1m

The first floor rooms comprise rooms 8, 9, 10 and 11. At the end of the corridor at the east, room 8 occupies the south eastern corner of the building. The floor comprises exposed boards (which appear unlikely to be original) and the floor surface slopes down toward the south. The walls are lath and plaster, with exposed timber framing in some areas, including a concave brace on the east wall, and the timbers forming the large gable. The windows within this appear to be early 20<sup>th</sup> century steel examples but are within wooden frames comprising a mixture of hand cut and machine cut pieces, indicating some replacement though it appears that the overall form of this part of the building may have remained consistent through the phases of building. At the north of the room, a central substantial post extends into the ceiling and although the joint is not visible, is likely to carry the ridge purlin (Pl. 19). This has a chamfer, and at the west side of the post has a carpenter's mark of two incised lines (Pl. 20).

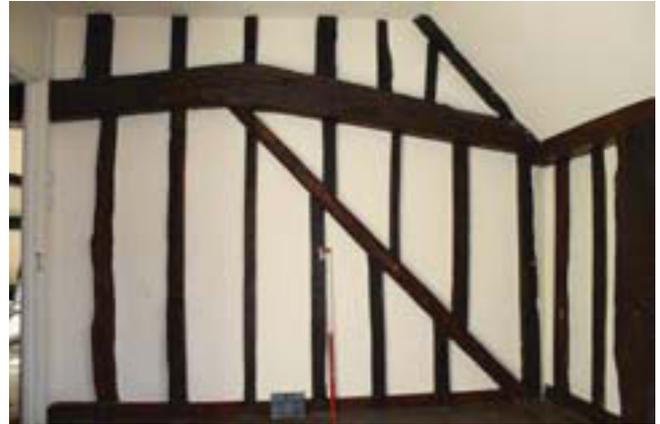
Plate 22. Interior, room 10 wall detail, Scale: 1m

From the corridor, a wooden doorframe with plain moulding and thin four-panel wooden door, both of 19th century or later date, lead into room 10. This has exposed timber framing in the east, south and west walls, which has fairly close-set posts (one of which is a modern replacement) and a concave brace adjacent to the window on the south wall. At the east, below ceiling height is a large tie beam with a passing brace from the north side of the wall down to the south. The angle of this beam is unusual and may have been caused by sideways buckling of the structure (Brunskill, 1985, p20).

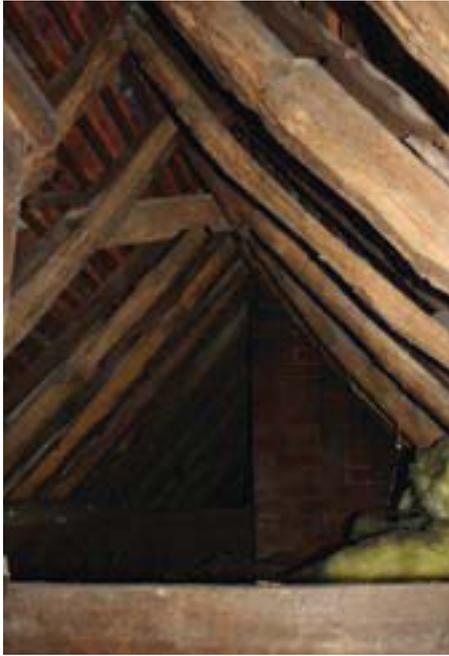
Plate 25. Interior, roof space, looking west.

The loft space enables the inside of the roof structure to be examined, although for reasons of health and safety it was not possible to gain access to the entire space. The chimney comprises brickwork as seen throughout the exterior, and has no apparent areas of damage or repair. The timbers which were observed in the roof structure comprise fairly thin and irregular hand-cut rafters, with hand-cut purlins. The tie beam adjacent to the loft hatch appears to be a modern replacement, and the rafters have what appear to be modern machine-cut timbers fixed to the exterior of the original roof structure, and a modern collar at the west of the space adjacent to the chimney. A further (apparently modern) post and brace arrangement support the rafters at the west end.
