**Piddinghoe Sports Park, Piddinghoe Avenue,  
Peacehaven, East Sussex**

**Archaeological Watching Brief**

**Site Code: PSP12/138**

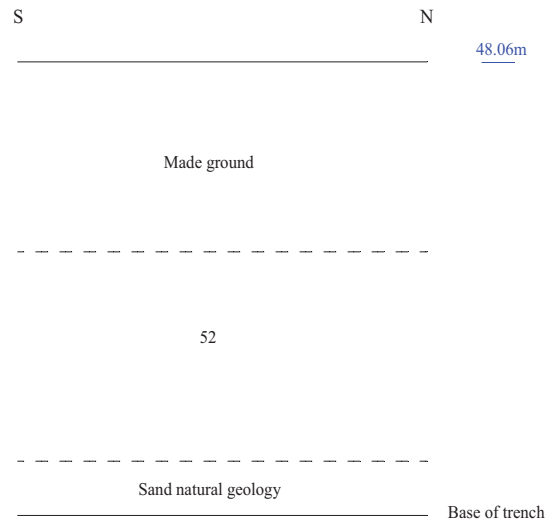
Pavilion Porch Trench  
(Area A)

Trenches for a new fence line and porch associated with the Pavilion were also monitored. These trenches were up to 12m long, 3m wide and reached a depth of 1.20m (Pl. 2). The stratigraphy consisted of 0.50m of made ground upon 0.55m of colluvial deposit (52), directly above a sand deposit, interpreted as the natural geology (Fig. 6). No archaeological features were observed but a flint core and two fragments of burnt flint were recovered from layer 52.

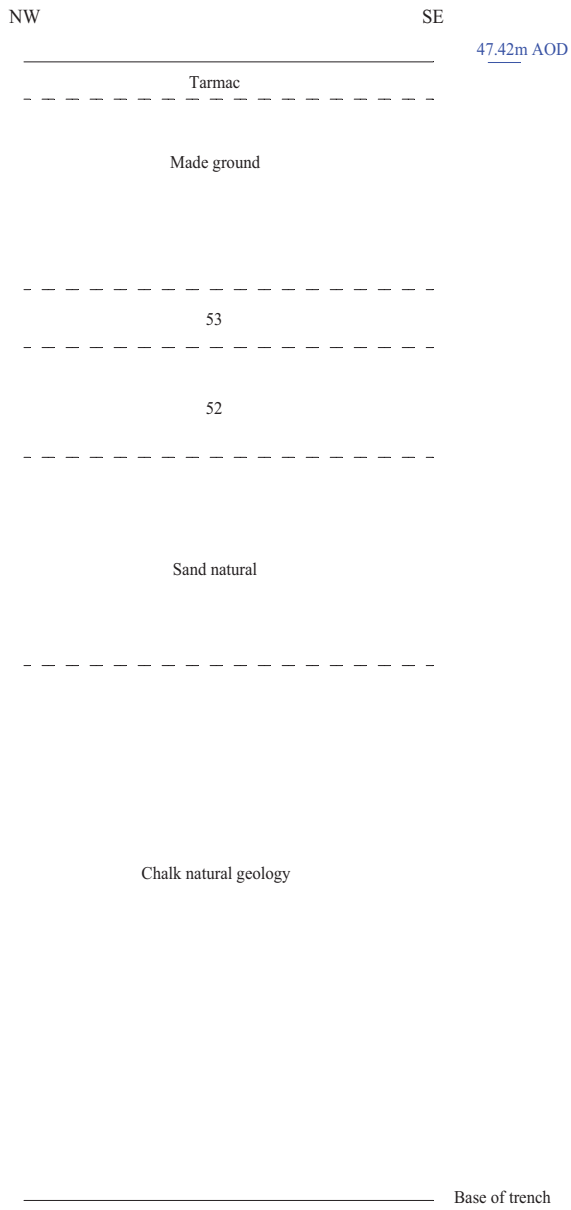
Soak Away Trench  
(Area A)

A soakaway trench and run measured up to 9m long, 3m wide and 3m deep (Pl. 3). The stratigraphy consisted of 0.10m of Tarmac, over 0.50m of made ground, 0.15m of buried soil (53), upon 0.27m of colluvium (52), overlying 0.55m of sand natural which lay directly above a lower chalk natural (Fig. 7). The presence and nature of the buried soil implies that the original ground level sloped gently towards the west. No archaeological finds or features were observed.

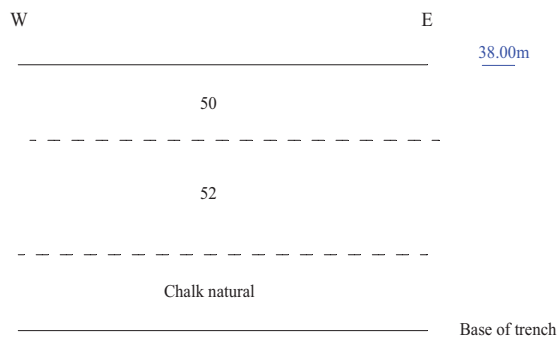
Fence Posts General Stratigraphy  
(Area B)

A 600m line of thirty-seven fence posts was also monitored in Area B (Pl. 8). The post holes were up to 0.70m deep and the general stratigraphy consisted of 0.20m of topsoil (50) above 0.38m of colluvium (52), directly above 0.20m of chalk natural (Fig. 8). All spoil heaps were checked and only a fragment of 20th-century tile was recovered from the colluvium (52); this was not retained. The stratigraphy implies that this part of the site has been truncated at some point in the recent past. The topsoil and subsoil had been removed down to the colluvial layer with new turf installed, perhaps during the previous phase of park development.

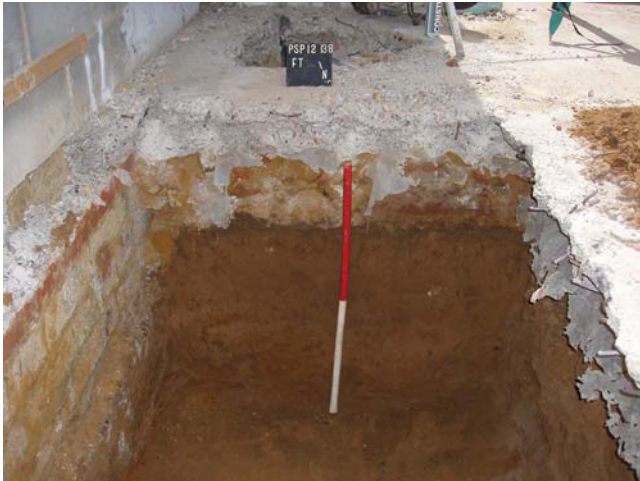
An area centred on NGR TQ 41895 01250, covering approximately 7200 sq m was monitored (Fig. 4). The groundworks observed included the excavation of footings for the new Gateway Building. The footing trenches were up to 20m in length, 1m in width and reached a maximum depth of 1.20m (Pl. 1). The stratigraphy consisted of 0.55m of made ground upon 0.35m of colluvium (52), directly above a mid brown sandy clay deposit, interpreted as the natural geology in this vicinity (Fig. 6). No archaeological features were observed but ten flint flakes, a scraper and fragments of burnt flint were recovered from the colluvial layer (52).

Plate 1. Gateway building, footing trench, looking S,  
Scale: 1m.

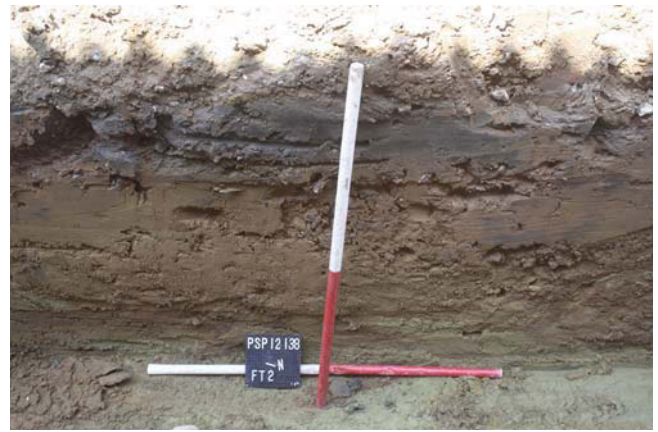
Plate 2. Pavilion porch, looking W, Scales: 1m and  
0.5m.

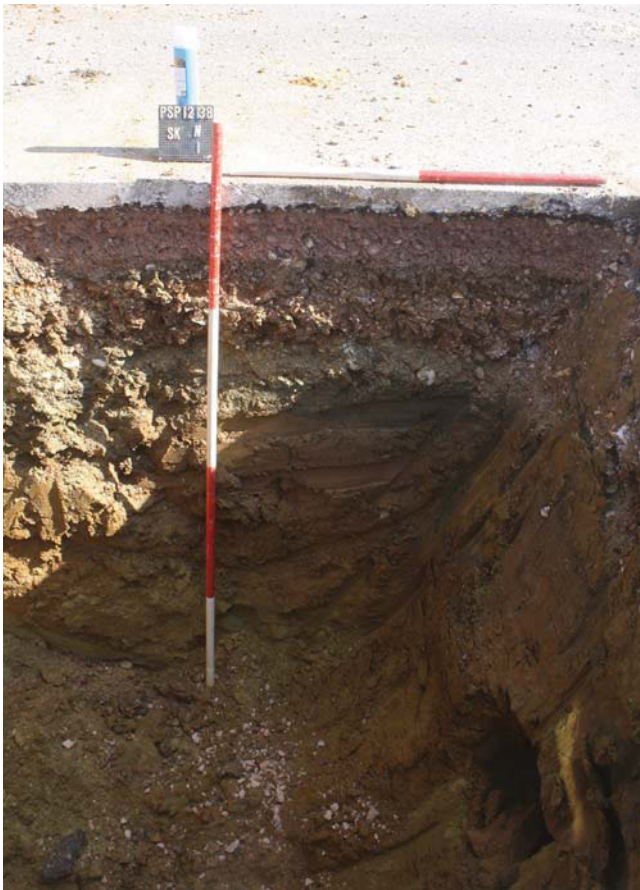
Plate 3. Soakaway, looking N, Scales: 2m and 1m.

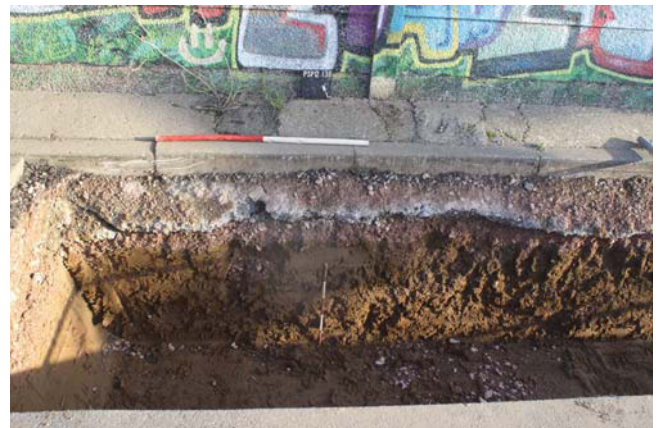
Of the three boundary trenches monitored in Area A, only one reached sufficient depth to impact upon archaeological deposits (Pls 4 and 5). This was the boundary trench located immediately to the west of the Peacehaven Football Club buildings, that was excavated in two segments. Each segment was 14m long, 2m wide and up to 1.07m deep. The general stratigraphy consisted of 0.47m of paving and made ground, directly above 0.60m of colluvium (52) (Fig. 7). No archaeological finds or features were observed.

Plate 4. Boundary trench, looking N, Scales: 1m and  
0.5m.

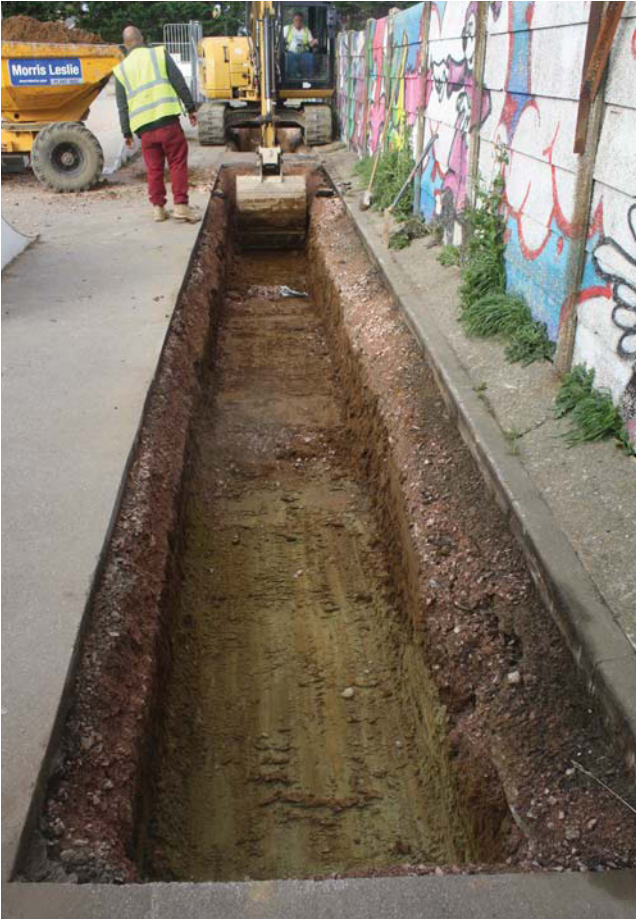
**Plate 5. Boundary trench, Area A, looking NW.**

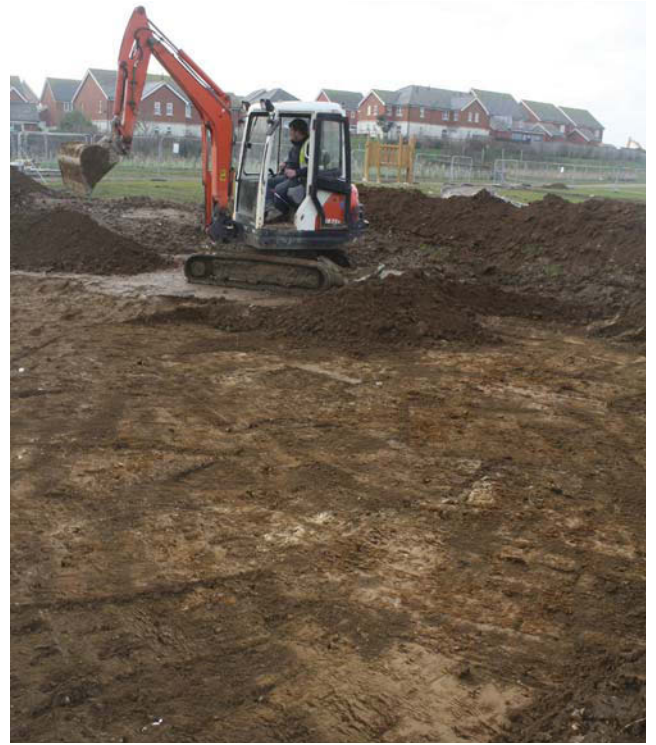
An area 7m in length, 4m width and up to 0.40m was excavated in order to create the climbing logs zone (Pl. 6). The stratigraphy consisted of 0.10m of turf and topsoil (50) on top of 0.30m of subsoil (51). The levels reached here were not deep enough to impact upon potential archaeological deposits. However, the five pits excavated within this zone to install the climbing logs did reach sufficient depths. All of the pits were up to a further 0.50m deep and the stratigraphy ranged from 0.50m of colluvium (52) in Pit 1 to the south (Pl. 7), to 0.20m of colluvium (52) directly above a chalk natural in Pit 5 to the north (Fig. 8). No archaeological finds or features were observed in these pits.

**Plate 6. Climbing log area strip, looking SW.**

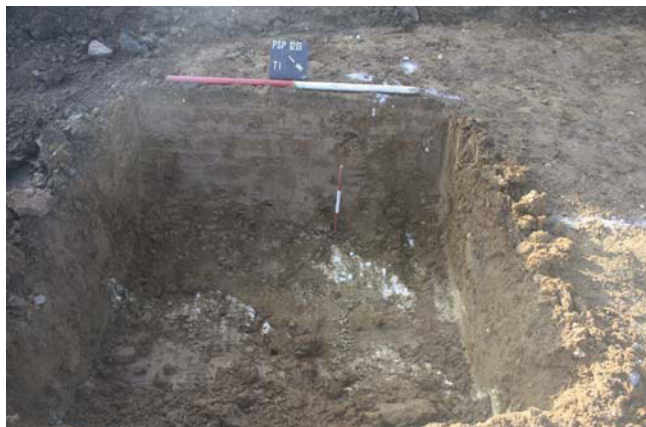
**Plate 7. Climbing log hole 1, looking SW,  
Scales: 1m and 0.5m.**

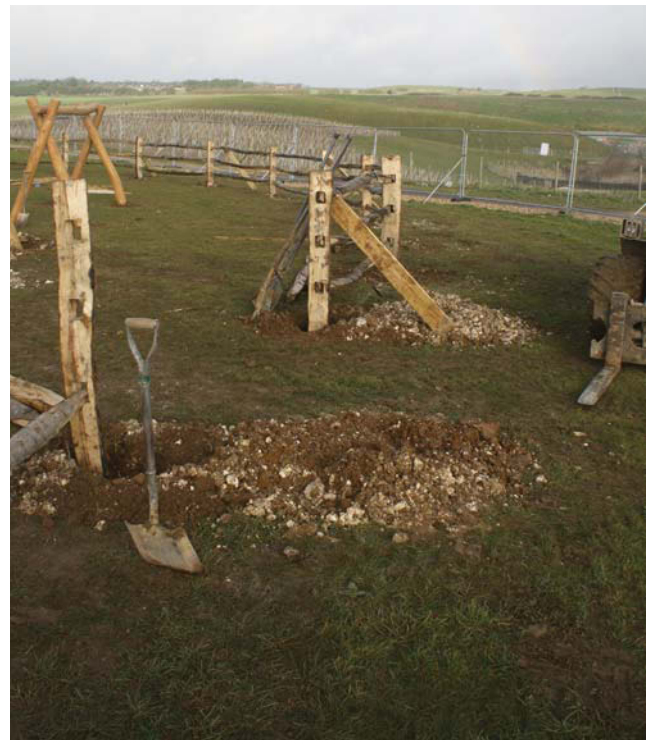
**Plate 8. Fence posts, Area B, looking N.**
