**Former Stable Building, Lane End Farm,
Shinfield, Berkshire**

Building Recording

Site Code: SRR14/220

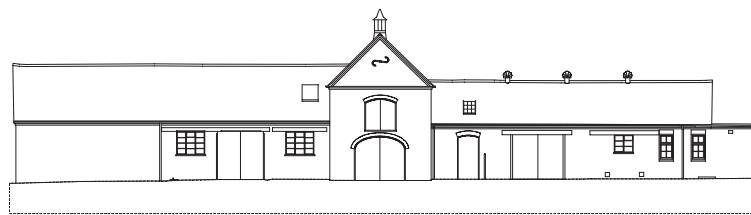
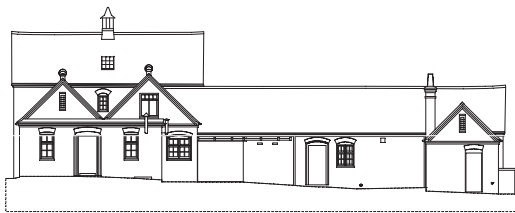
Figure 7. Elevations

External (Fig. 7)

Externally a number of alterations could be seen. Within elevation 1 it is possible to see a blocked doorway in the eastern corner of the yard. It is also likely that the opening within the southeastern gable end has been altered. It may have been inserted, though the bricks have been matched in to make this less clear, making it the same as the southwestern gable end, or it contained a pair of doors above which would have been a wooden lintel (Pl. 2).

Within elevation 2 a small extension has been added at the southwestern end, adjacent to the gable end and roofed with a catslide roof. Within the northeastern gable end there is a blocked window adjacent to an altered doorway. It would appear that a concrete lintel has been inserted, beneath which has been bricked up (Pl. 3).

Not all of elevation 3 could be seen due to a number of obstructions and lack of access. At the southeastern end of the range the wall of rooms 7 and 8 had been rebuilt using textured bricks. Two metal, 'Crittall' type windows had been inserted either side of the doorway. The doorway however appears original (Pl. 4). A further metal window is present at the northwestern end of the range.

Access to elevation 4 was not possible and observations were made from a distance. The biggest alteration was the addition of a flat roofed extension at the northeast end of the range, seen from the historic maps as having occurred by 1936. In one of the gable ends above this extension was a metal window, likely to be a replacement for a wooden air vent as seen in the other gable ends.

Much of elevation 5 was also obscured. At the southwestern end of the range were two plastic double glazed windows either side of a blocked doorway. Below the windows has been rebuilt. Originally there may have been a larger doorway present, as suggested by the large wooden lintel (Pl. 5).

Within elevation 6 (Pl. 6) the central area had been entirely rebuilt and two windows inserted beneath a possibly original wooden lintel. Two of the original doorways at the southern end of the elevation had been blocked up, with one having a later window inserted into it.

No changes were seen in elevation 7, and elevation 8 could not be accessed.

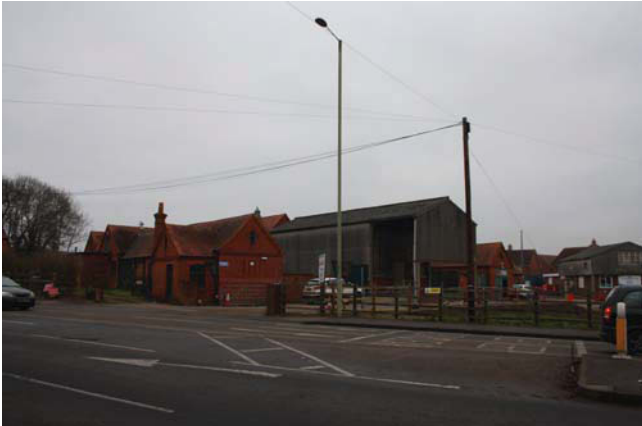
The buildings making up the farmyard were set around a courtyard, in a 'U-shape' arrangement (Fig. 6 and Pl. 1). A later building has been constructed in the centre of the courtyard to create an 'E-shape' arrangement. The main

Plate 1. View of farm complex, looking east.

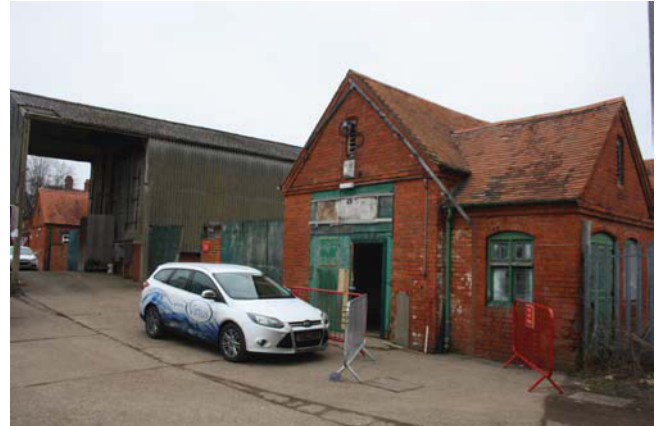
Plate 2. SW elevation, looking north, Scales: 2 x 1m.

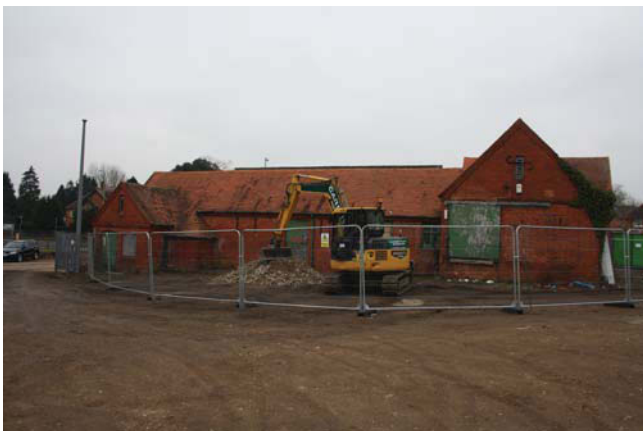
Plate 3. SE elevation, looking west.

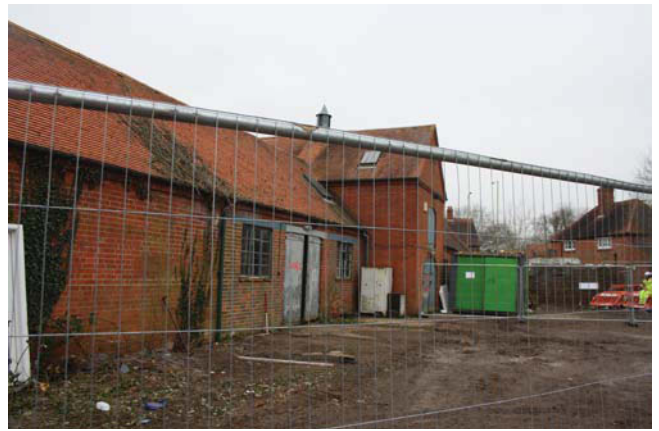
Plate 4. NE elevation, looking west, Scales: 2 x 1m.

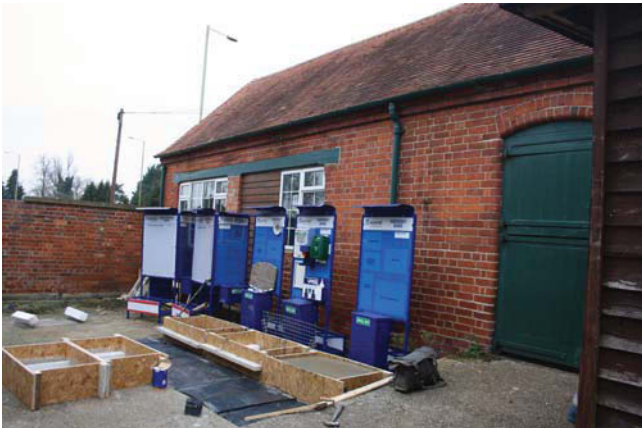
Plate 5. NE elevation within the courtyard, looking west.

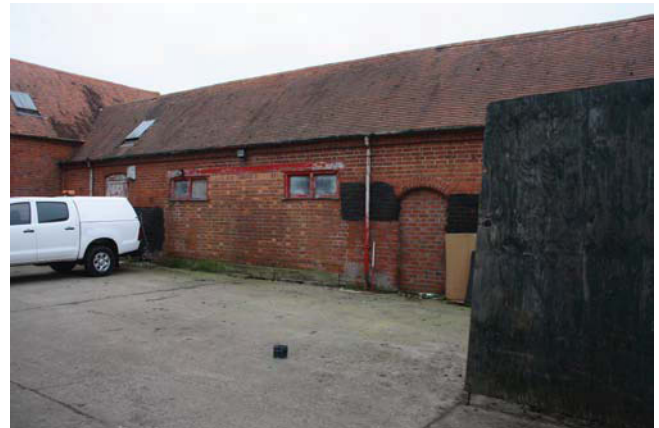
Plate 6. NW elevation within the courtyard, looking east, Scales: 2 x 1m.

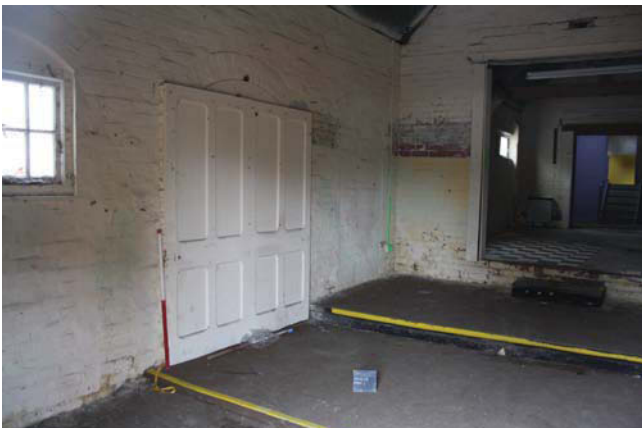
Room 1 was located at the far southwestern end of the projecting range, entrance was via a door in the gable end. The floor was of concrete and had two shallow steps within it, creating three platforms corresponding to three doors opening onto the central courtyard. All three were blocked; two with bricks and the central one with a wooden panel (Pl. 7). The room was probably sub-divided into three stalls with wooden divisions. Entrance to room 2 was within the southeast wall.

Plate 7. Blocked doors in room 1, looking north, Scales: 2 x 1m.

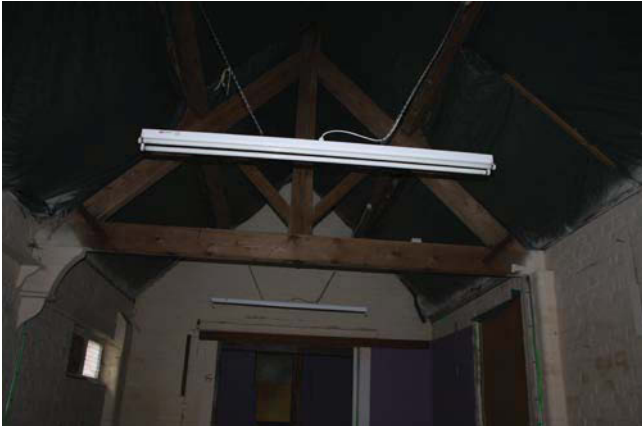
Within the opposing wall was a single door. A single roof truss was present (Pl. 9), across the centre of the wall, supported on a brick pillar on the southeastern side and a bracket on the northwestern side. The truss itself was of pine, king post construction held together by wooden pegs. This was typical of all the roof trusses seen within the building. Some of the timbers within the trusses had been cut by a circular saw.

Plate 9. Roof truss within room 3, looking northeast.

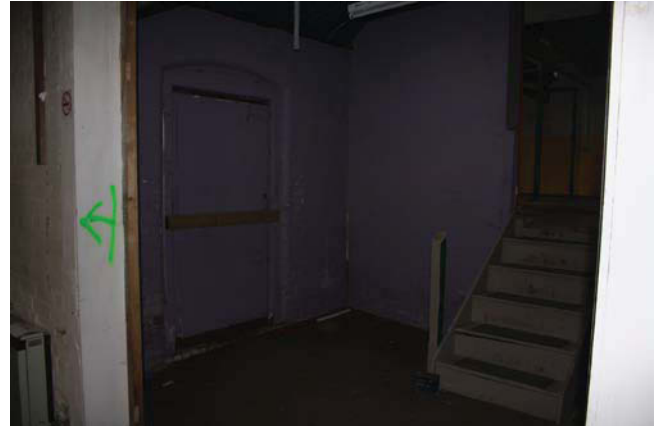
Room 4 (Pl. 10) was located to the northeast of room 3, via an opening in the wall. The opening was the same as that between rooms 1 and 3, with a steel lintel and most likely a later insertion. Within the floor was a slight change in level. Two doors were present, one accessing the central courtyard and the second set within the opposing wall, also giving access to the outside. Access to room 5 was to the northeast, up a set of wooden steps. Once again the opening was supported by a steel lintel and was probably a later insertion.

Plate 10. Room 4, looking north, Scales: 2 x 1m.

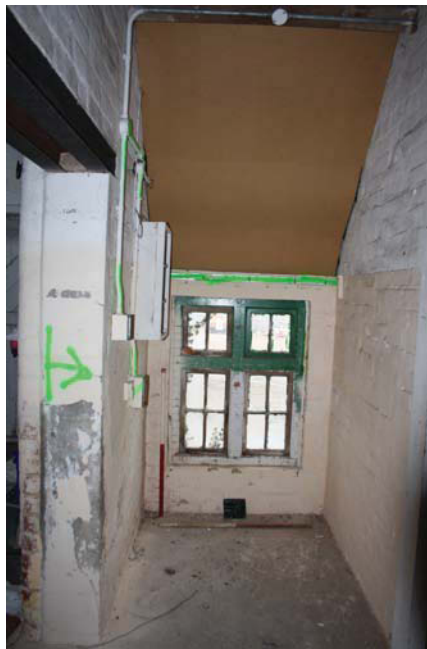
Room 5 (Pl. 11) was very narrow with a single window in the southwestern wall. The floor level had most likely been raised at a later date, along with that within room 6.

Plate 11. Window in room 5, looking southeast, Scales: 2 x 1m..

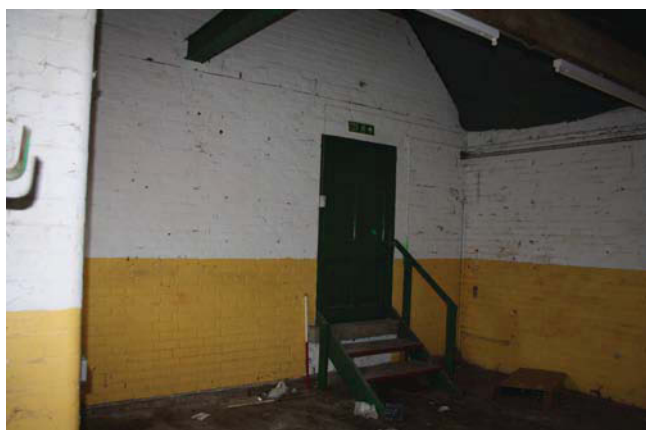
Room 7 was to the northwest of room 6, with a lower floor level. A small set of steps up, gave access to room 6 (Pl. 13). Within the northeastern wall, which had been partially rebuilt, was a set of double doors (original opening) and a Crittall-style window (new build). A single truss could be seen supporting the roof; the same as the others within the building. Within the roof space a steel RSJ ran the length of the room, probably a later insertion and related to raised walkway above room 8 (Pl. 14).

Plate 13. View to steps in room 7,
looking south, Scales: 2 x 1m.

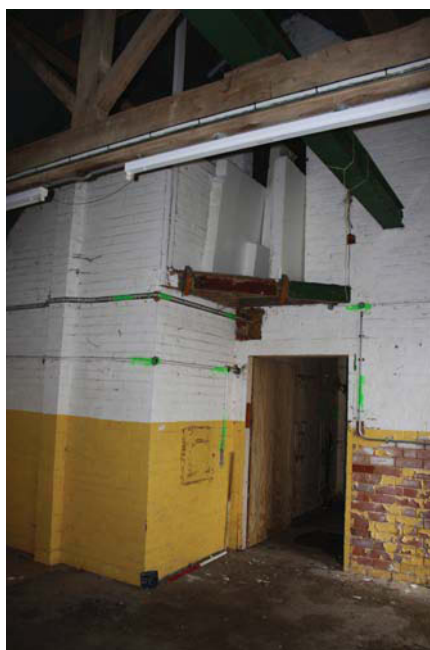
Plate 14. View to raised walkway above room 8,
looking west, Scales: 2 x 1m.

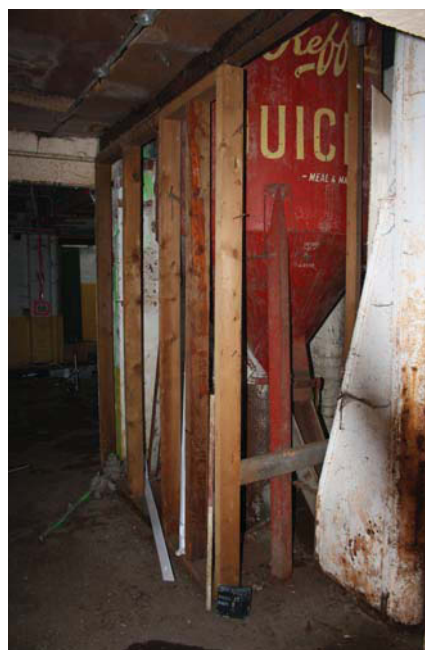
Room 8 acted as a passageway between rooms 7 and the central double storey room. Within the northeastern wall was a replacement 'Crittall'-style window, largely blocked by a modern grain silo (Pl. 15). Within the northwestern end of rooms 7 and 8 was a brick built grain silo, supported on two brick pillars.

Plate 15. Grain silo in room 8,
looking north, Scales: 1 x 1m.
