**The Woolpack, Church Street,
Wantage, Oxfordshire**

Building Recording

Site Code: WIW15/120

June 2015

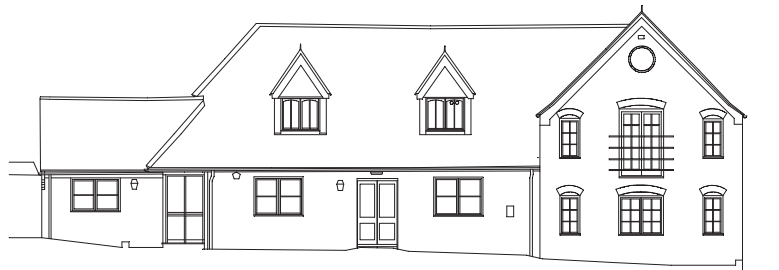
South facing rear elevation

Within the south facing elevation it was possible to see the scar in the brickwork created from the rebuilding/extension that occurred in 1990 (at the west end of the building). There were two pairs of windows within the façade; one pair of ground/first floor windows within the modern rebuild/extension and one pair of ground/first floor windows in the older section. Those within the modern section were six over six sash windows whilst those in the older section were four over four sash windows (Pl. 4). Both of the ground floor windows were set beneath brick soldier arches. Within the older eastern end of the building the bricks were laid in Flemish bond, bonded in lime mortar and measuring 216mm x 108mm x 70mm (8 1/2" x 4 1/4" x 2 3/4").

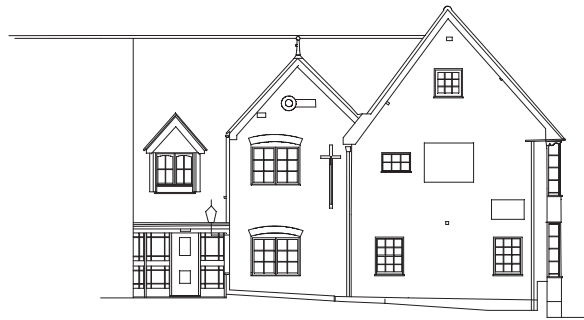
Gable end of Church Street Range (East facing)

The east facing gable end (Pl. 2) contained a further two, smaller, sash windows on the ground floor, a single smaller sash window of three over three panes on the first floor and a central nine pane window set within the roof space. Within the render could be seen a scar for an earlier, single storey building now removed

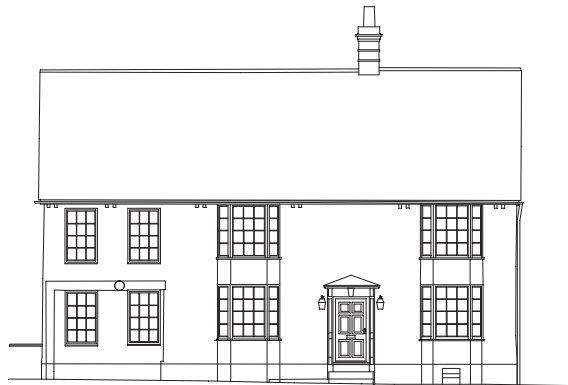
Church street frontage (North facing)

The main, Church Street (north) elevation consisted of four windows and a door on the ground floor and four windows on the first floor (Pl. 1). The door itself was off-centre, set within a simple, classical style surround and topped with a small pediment, supported on three wooden consoles. It was accessed up two steps. The door itself was of the Georgian six panel style. Either side of the door was a double height trapezoidal shaped, small bay window. Beyond the bay windows, to the east were a further two windows on each floor. On the ground floor

these were located beneath a large, possibly timber lintel, supported on thin trapezoidal shaped posts, again possibly of wooden construction. This arrangement was suggestive of an old shop frontage. Set between the posts, at the base of the building were a few rows of painted bricks of indeterminate bond and mortar type. These measured 220mm x 102mm x 63mm (8 5/8" x 4" x 2 1/2"). It was not certain whether these were original or part of the infill associated with the likely conversion from a shop frontage.

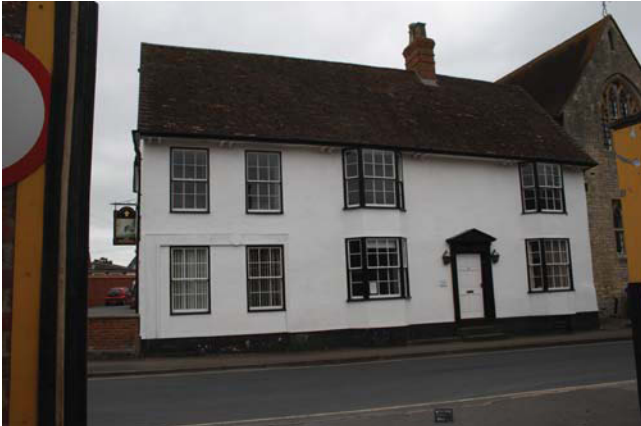
Plate 1. Exterior, front elevation (Church Street), looking south.

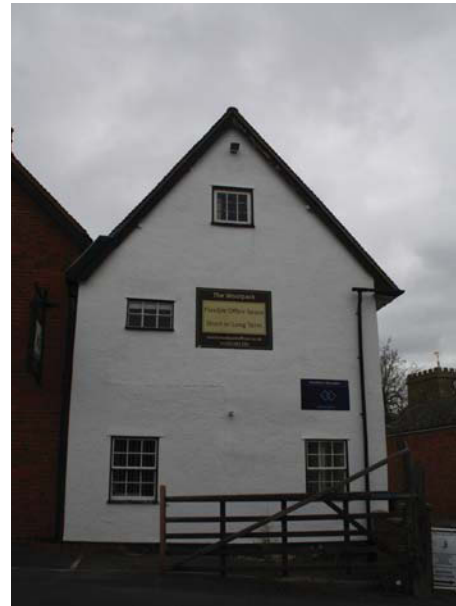
Plate 2. Exterior, gable, east facing.

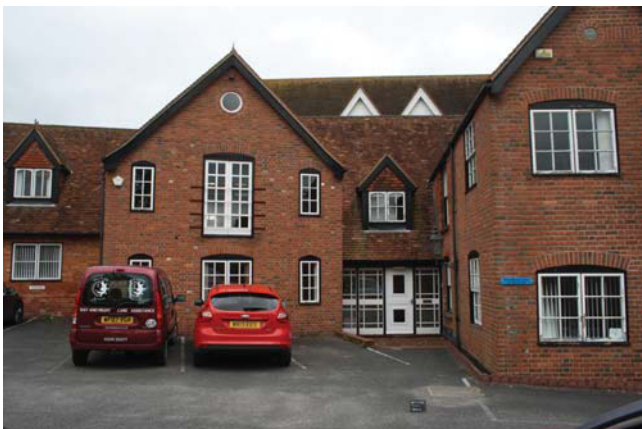
which on the first floor were actually French doors. Within the apex of the gable was an oculus window. The windows were all located beneath brick soldier arches with the oculus being edged in bricks laid on edge (Pl. 3).

Plate 3. Exterior, east facing rear extension elevation and outbuilding 1.

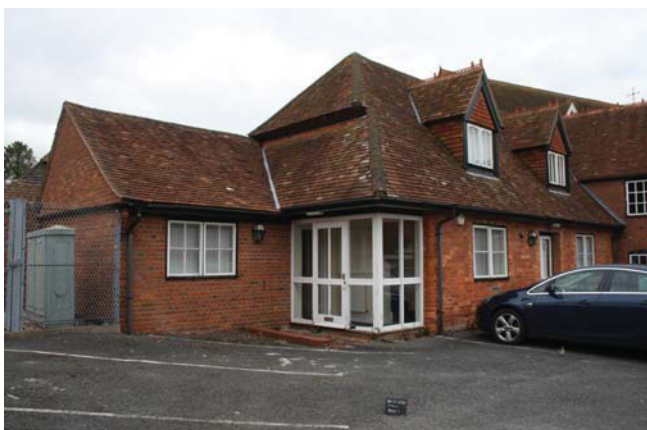
The building was brick built of English bond, bonded in lime mortar. The bricks measured 222mm x 108mm x 63mm (8 ¾" x 4 ¼" x 2 ½"). Within the western façade were a pair of casement windows either side of a central doorway on the ground floor with a further pair of dormer windows within the roof space. The brickwork around the ground floor windows and door had at a minimum been repointed or possibly infilled to accommodate smaller openings. The roof had been extended at the southern end to accommodate a modern glass wall with a door in the southern façade.

Plate 5. Exterior, rear extension, looking north west.

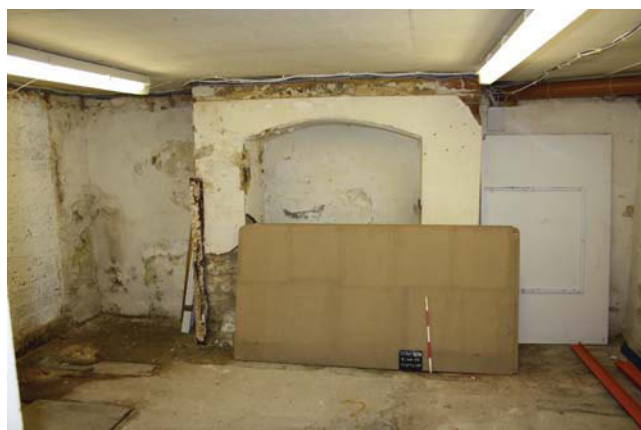
Room 43 was roughly square in shaped with structural support for a fireplace base within the south wall (Pl. 6), the majority of the room had been plastered over and painted white. Within the east wall was a blocked doorway, infilled with concrete blocks above which was a brick arch. Earlier plans show this to be the location of the barrel slide from the yard.

Plate 6. Room 43, view to fireplace base, looking southwest. Scale 0.5m.

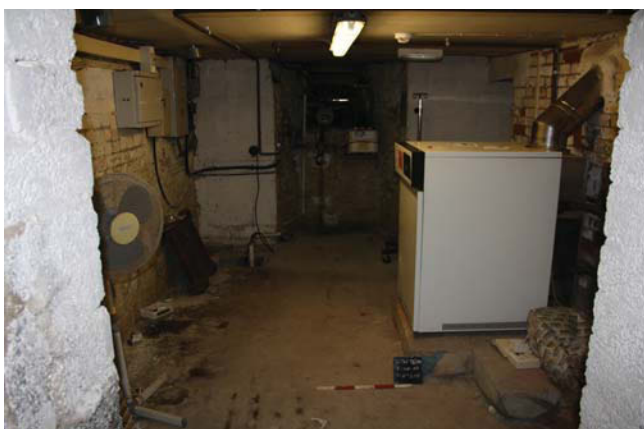
Room 44 was rectangular in shape with a 'corridor' extending along the street frontage to the east. It was constructed of a combination of brick and concrete blocks. The 'corridor' along the street frontage was largely of concrete construction with concrete lintels and supports present. The brickwork had been painted white and was of indeterminate bonding and mortar. The bricks measured 228mm x 108mm x 63mm (9" x 4 1/4" x 2 1/2"). A second beer chute was present beneath the ground floor bay window (Pl. 7). Plans for the 1990 renovation show that steel I-beams have been inserted into the four corners of the room and along the Church Street frontage, accounting for some of the concrete blockwork. It was not possible to determine if the corridor originally led into another room under Room 3 but it seems probable, and the corridor may have been designed to avoid undermining the fireplace and chimney block.

Plate 7. Room 44, view to beer slide, looking northeast. Scale 0.5m.

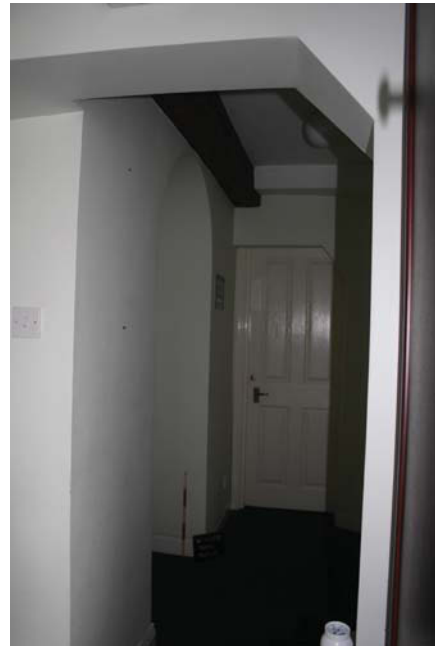
Room 2 (Pl. 10) was a small entrance lobby, into which the front door opened; access was available to rooms 1 and 3. Within the ceiling were two beams, likely to be encased steel RSJ's. The main door was opposite the jamb of the fireplace which had a recessed arch within it.

Plate 10. Room 2, oblique of hallway looking west.
Scale 0.5m.

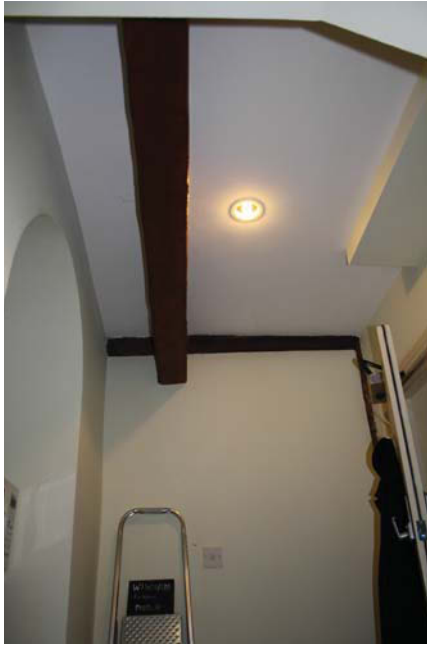
Room 6 was a small lobby area on the south side of the chimney. A small amount of timber framing, consisting of a post and rail was visible in the east wall (Pl. 13). The beam within the ceiling is likely to have been an enclosed RSJ. The jamb of the fireplace had a recessed arch within it; the same as that found within room 2.

Plate 13. Room 6, timber detail in ceiling, looking east.

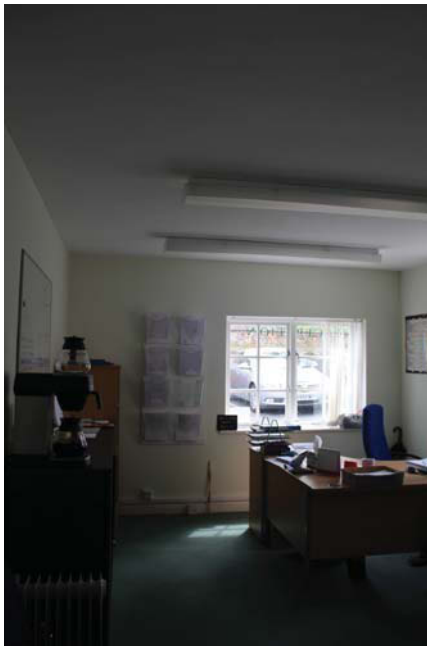
The rear extension could be sub-divided into 11 rooms (numbered 7–17), consisting of cupboards, corridors, rooms, toilets and an entrance hallway. Room 7 was a corridor, running between rooms 6, 8 and 10, as well as stairs to the first floor and cellar. Within the north wall (the rear of the Church Street range) was timber framing consisting of two posts and a rail, tenoned into a beam (Pl. 14). The stairs, located on the southern wall of the corridor were modern. No other timber framing was seen within room 8, a small lobby which gave access to room 9, which was located immediately behind the eastern end of the Church Street range (Pl. 15).

Plate 15. Room 9, to window, looking east. Scale 0.5m.

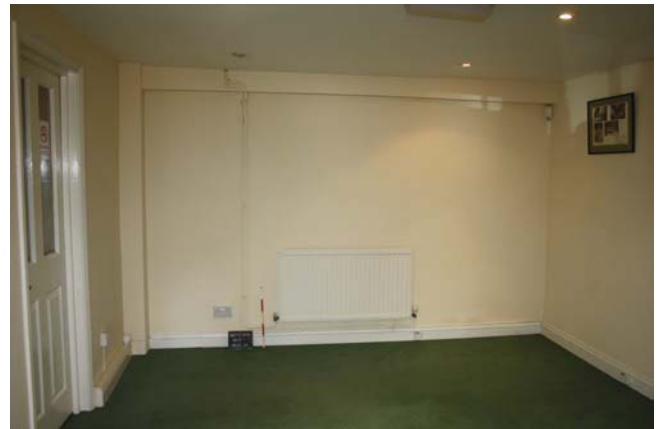
Entrance lobby 10 was of modern construction with a glass frontage. It gave access to room 11 which contained a number of pictures from the 1990 renovation. Room 11 (Pl. 16), in turn accessed corridor 12 which gave access to rooms 14-18. There was nothing of architectural merit within rooms 10-17.

Plate 16. Room 11, to west wall. Scale 0.5m.

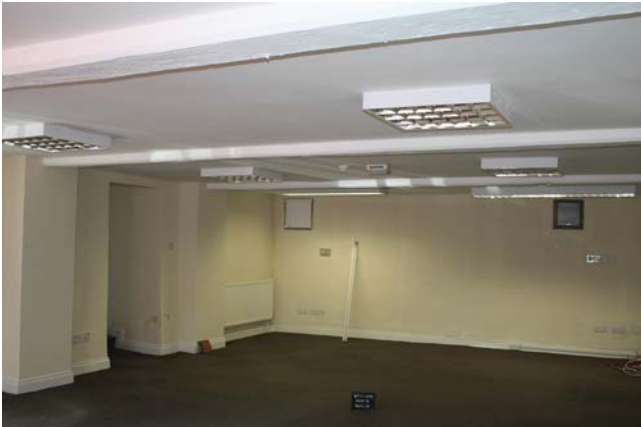
which were possibly supported on a vertical post (now boxed in and plastered over). Each of the beams was chamfered and painted white (Pl.17).

Plate 17. Room 8, general view, looking southwest.

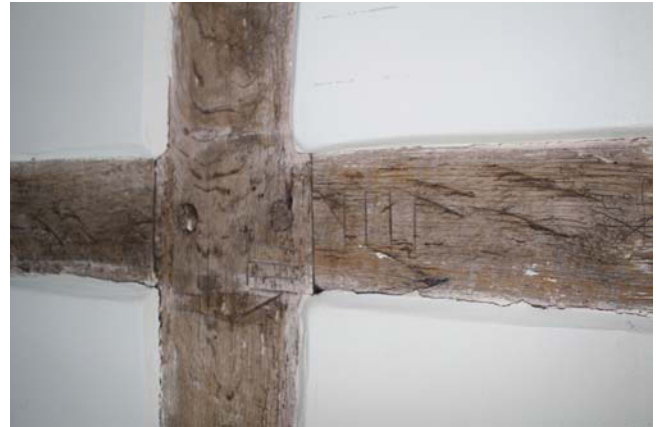
Plate 34. Room 30, carpenter's mark 'VIII', looking northeast.

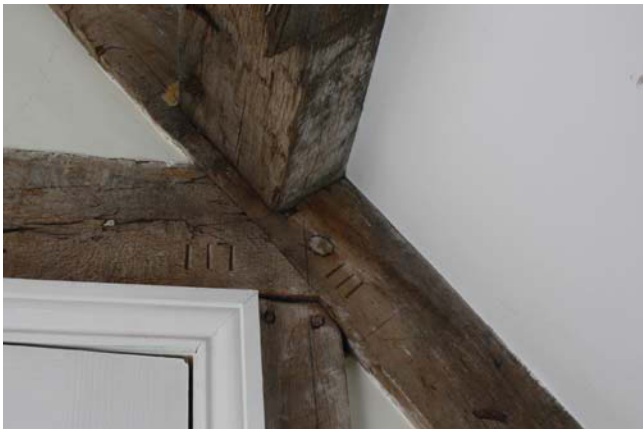
Plate 43. Room 40, detail of carpenter's mark (III), looking northwest.
