**Stag and Hounds, 302 St Leonard's Road,
Windsor, Berkshire**

Building Recording

Site Code: SAH14/259

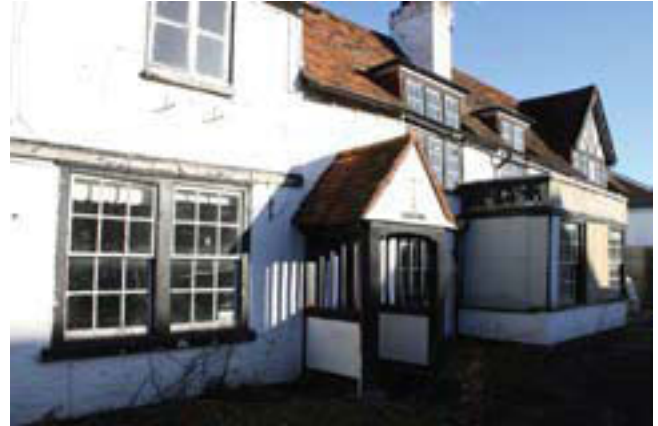
The pub building comprises a rectangular building of two storeys (plus a cellar). The front elevation (Pl. 2) comprises a flat front with the porch and square single storey bay added at the right projecting to the south. The first floor roof is of a single pitch, joined at the west to the roof of the cottage. A brick built chimney stack (to the left of centre) is white painted with three cylindrical plain pots. The fairly steeply-pitched roof is covered in plain red clay tiles which appear to be original. A first floor dormer gable projects to the south, and the rear of the building at the north has a shallower pitched roof, with clay lap tiles. A further modern extension at the east has a clay tiled roof, with a tiled gable first floor extension (19th century) to the rear at the east, and a 20th century extension at the west has a flat roof.

Plate 2. Exterior, front elevation (porch and bay window), looking north east, Scale: 1m.

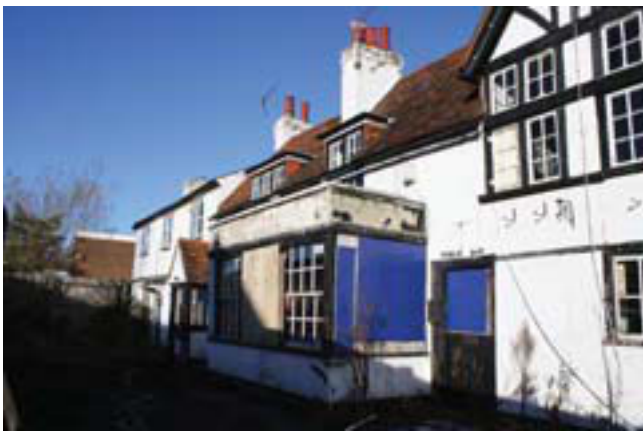
At the right of the front elevation, two pairs of windows are set within the exposed timber frame of the large gable dormer, though struts are likely to be of 19th or 20th century date. These are a likely early 20th century insertion and comprise two pairs of square four light windows above eaves level, with the centre two as top-hung casements. Below these are two pairs of six-pane windows, with the pane at the right and left side hung on simple pin hinges, and the central pair fixed (Pl. 3).

Plate 3. Exterior, front elevation, looking north west, Scale: 1m.

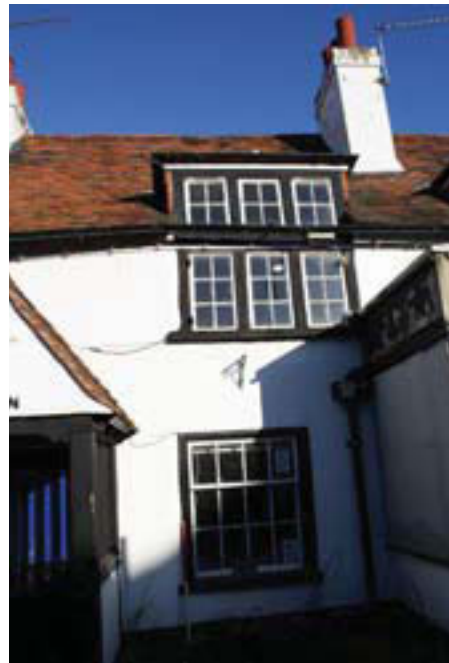
To the right of the door is a four over eight sash window, with thin glazing bars and small rectangular panes, with a wooden sill (Pl. 4). To the left is the rectangular bay projecting to the south. This has three vertically-hung eight-over-eight sash windows with fairly thin glazing bars, with a further eight-over-eight sash either side on the returns. These have wooden sills and are of early 19th century date. Between the windows, and at the corners of the bay, are plaster strips with fluted moulding.

Plate 4. Exterior, frontage windows detail, looking north, Scales: 1m.

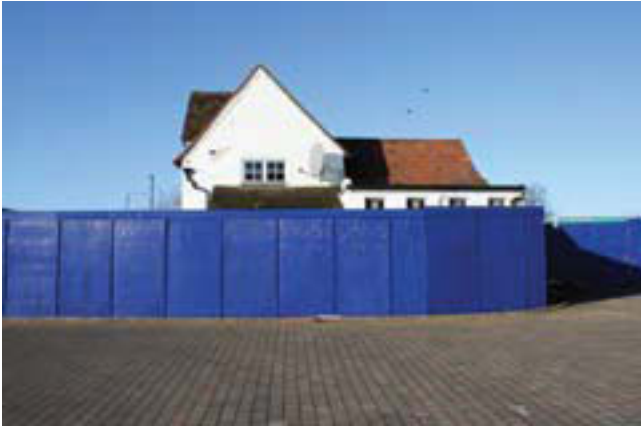
This elevation comprises the white painted rendered gable end of the main pub building, with a pair of side-hung windows of 20th century date at 1st floor level, each comprising four panes. Below this is the ground floor extension with a single low pitched clay tiled roof with exposed ends of rafters.

Plate 5. Exterior, eastern gable end, Scale: 1m.

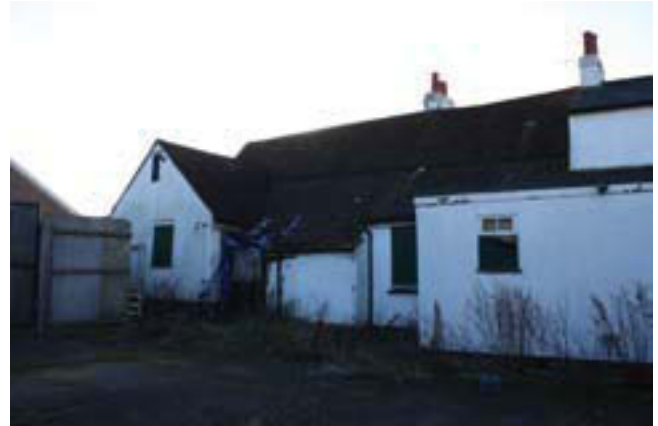
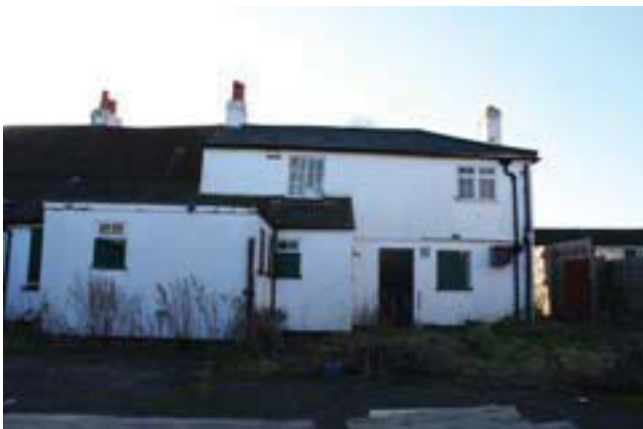
At the left, the flat-roofed modern extension has a plain plastered wall with a vent. The first floor of the gable has a small crittal-type window of six panes with rectangular lights in a steel frame, side hung on pin hinges. It is of likely early 20th century date. At the ground floor is a three-over-six sash window though this was covered with a board at the time the building recording was being carried out. Below this, the entrance to the cellar has also been covered with a board, and two modern security lights have been fitted to this part of the building.

To the right of this, a doorframe with simple moulding (possibly of 19th century date) has a wooden door of modern date. The pitched-roof extension has red clay 'double Roman' pantiles and is a shallower pitch to the roof above, and is of likely 20th century date. At the eaves by the doorway, a small area of repair has been carried out using the plain tiles seen throughout the rest of the roof.

Plate 6. Exterior, rear elevation, looking north east, Scale: 1m

Plate 7. Exterior, rear elevation, looking south, Scale: 1m.

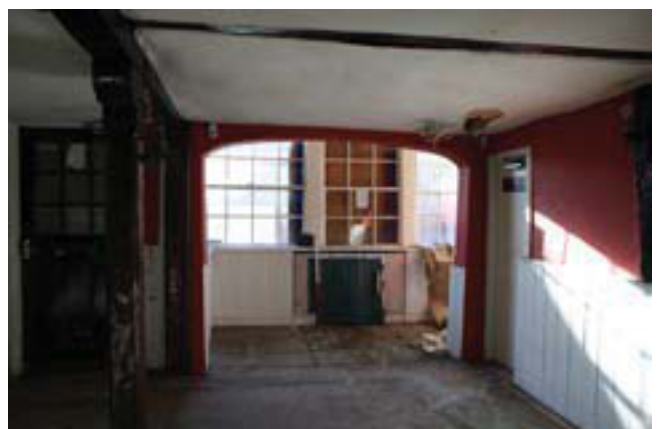
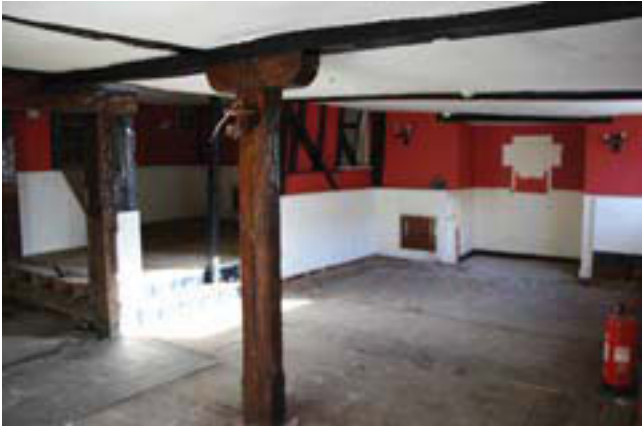
This comprises the main room of the public house. It is a rectangular space, with the wall between rooms 1 and 2 removed to create a single space. At the south, an extension creates a small additional area of seating, surrounded by sash windows and with exposed floorboards. The entrance to this extension is formed by a wide four-centred arch with plaster render, in a form characteristic of the early 19th century. To the west of this, the wall is

The ceiling is low and fairly uneven, with a pronounced slope from the north side of the room down towards the south. The exposed timbers seen in the south and west of this room appear to be hand rather than machine cut, as do the three beams which are aligned north-south in the ceiling of the room. The two at the east have a chamfer, with a lamb's tongue stop at each end, though the beam adjacent to the door does not have the chamfer. It does, however, appear to be of the same age and condition as the other two and these appear to be original. It is supported by a Samson post with a pillow in the centre of the room, these two pieces appear to be a later addition, though hand-cut and of possible early 19th date. The Samson post has chamfered sides, with simple triangular stops. The beam has several empty mortises suggest the removal of internal partitions. The walls have painted plaster with modern painted wood panelling up to dado height.

Plate 8. Interior, room 1, looking south, Scales: 1m.

Plate 9. Interior, room 1, looking north east,
Scale: 1m.

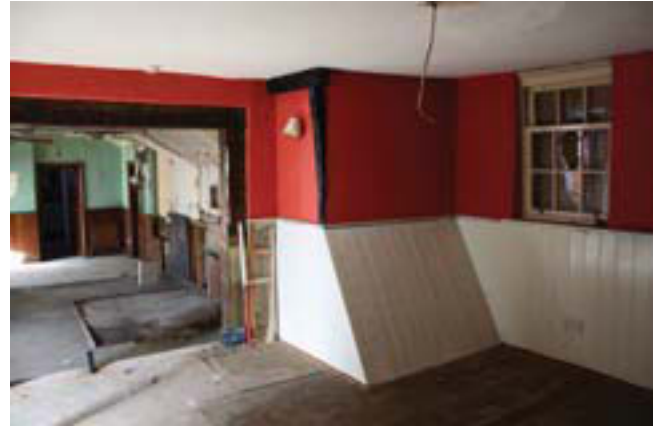
At the north-west of this space, a post supports the beam. It has chamfers above the height of the panelling but not below. Where the panelling has been removed, the wood is neat and machine cut; above this level it is rusticated, with the finish made intentionally uneven. It is likely that the posts to the south of this, in room 1,

have had similar treatment, though their dating is uncertain. The chamfer here is in two parts, with triangular stops at mid height.

Plate 10. Interior, room 2 looking north west,
Scale: 1m.

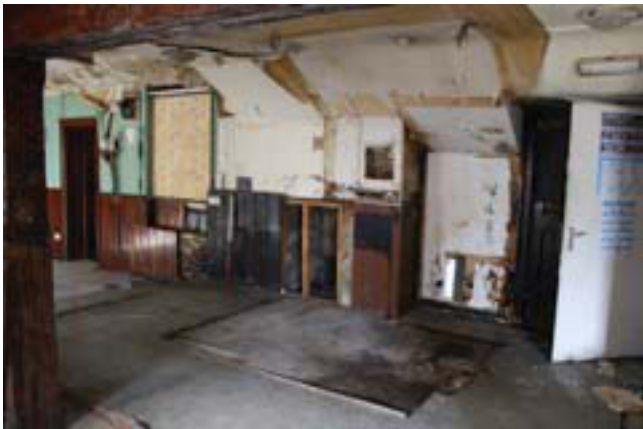
This room occupies the central space at the north of the ground floor and has a partially sloping ceiling at the north. The original extent of the space is unclear, as the date of the outshut is not certain. The walls are plastered and painted and the exposed timbers comprise a beam at the south, aligned east-west. This appears to be hand-cut but has no chamfer, and is supported by a post with the upper half chamfered (with lamb's tongue stops) but no chamfer below. This area was formerly the bar area, although the bar structure has been removed. At the north, an area of modern wooden panelling has been removed to reveal a cavity and an area of brickwork. Although the flue was blocked, it appears this is the location of a former fireplace, most likely to have been removed in the early 20th century.

Plate 11. Interior, room 4, looking south,
Scale: 1m.

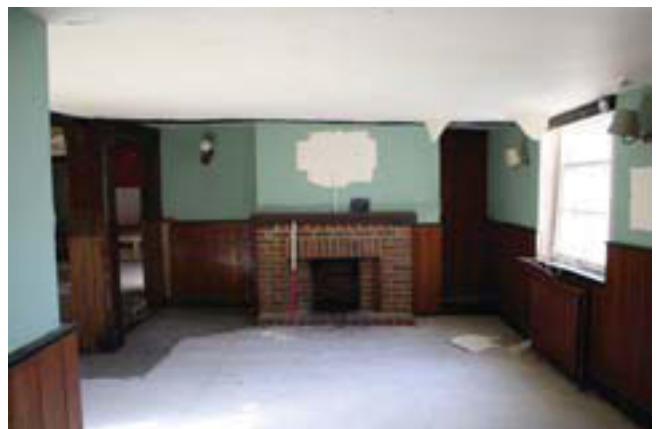
The east of this room has a modern brick built fireplace with timber mantle. This replaces an original fireplace in this location. At the south is the door of the public house, which is timber set in a wooden frame with a simple ovolo moulding, and to the west of this a change in ceiling height suggests a separate phase of building. There are two exposed hand-cut beams in the ceiling, aligned north-south, and the ceiling slopes down towards the south as in room 1. The ceiling beam at the west of the space is supported by a pillar which has modern wood panelling below, and plaster above (Pl. 13). The timber and pillar delineate the extent of the original building, and the timber is likely to represent the original wall plate. For this reason, the space to the west of this is discussed separately as part of the cottage (see rooms 1A, 2A below).

Plate 12. Interior, room 5 fireplace, looking east,
Scales: 1m.

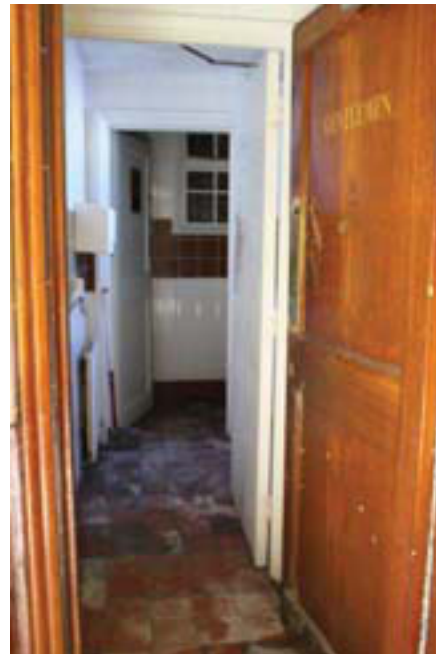
At the north of room 5, a doorway leads into one of the two extensions housing a female and male bathroom. Room 6 is carpeted, has two internal walls and modern fixtures and fittings. Room 7 has one internal partition wall and is also carpeted, with tiled walls.

Plate 14. Interior, room 7, looking west,
Scale: 1m.

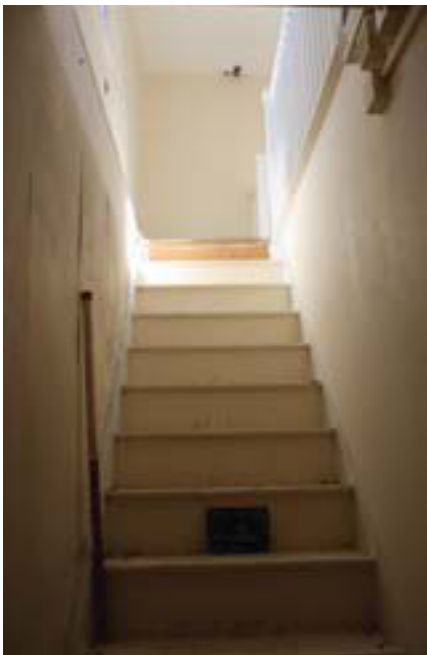
The first floor of the building is reached via a staircase at the north, within the cottage part of the building (Pl. 15). Any direct evidence for the original stair location has been removed, however the likely location would be perhaps within room 4 (rising from east to west) or at the north of room 5.

Plate 15. Interior, stairs, looking east,
Scale: 1m.

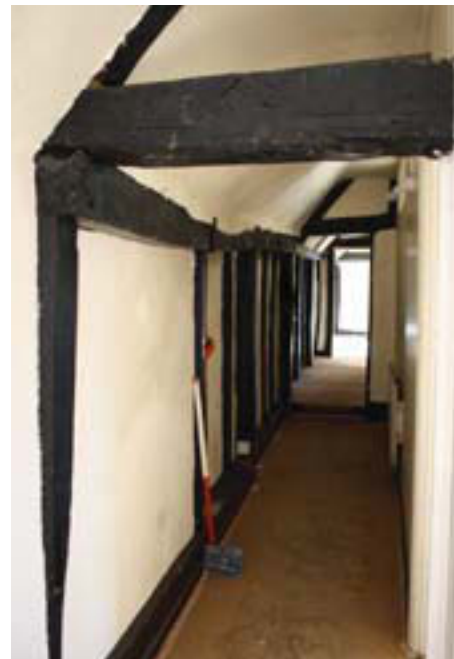
The stairs lead to a landing, still within the cottage, where three steps down to the east lead to a corridor (Pl. 16). Here, exposed timbers along the north wall are largely hand-cut, although two phases appear to be represented, with several posts appearing less weathered than the typically fairly weathered original timbers. Occasional machine-cut additions were also observed. Several empty mortises were observed, which are suggestive of timber-reuse as their location is not likely to indicate removal of parts of the structure. An iron clamp has been added on the north side.

Plate 16. Interior, first floor corridor, looking west,
Scales: 1m.

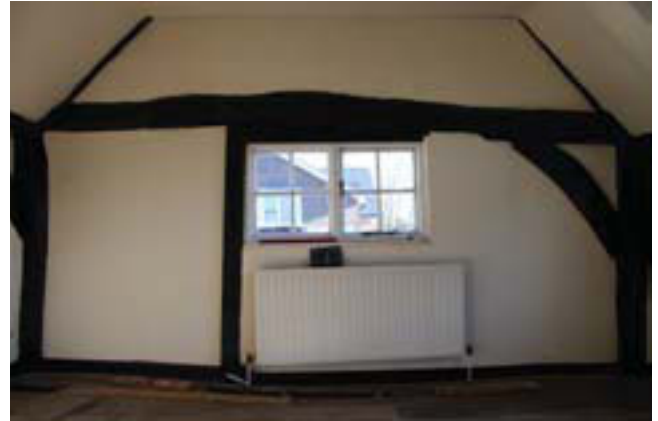
The first floor rooms comprise rooms 8, 9, 10 and 11. At the end of the corridor at the east, room 8 occupies the south eastern corner of the building. The floor comprises exposed boards (which appear unlikely to be original) and the floor surface slopes down toward the south. The walls are lath and plaster, with exposed timber framing in some areas, including a concave brace on the east wall, and the timbers forming the large gable. The windows within this appear to be early 20th century steel examples but are within wooden frames comprising a mixture of hand cut and machine cut pieces, indicating some replacement though it appears that the overall form of this part of the building may have remained consistent through the phases of building. At the north of the room, a central substantial post extends into the ceiling and although the joint is not visible, is likely to carry the ridge purlin (Pl. 19). This has a chamfer, and at the west side of the post has a carpenter's mark of two incised lines (Pl. 20).

Plate 18. Interior, room 8, looking north, Scale: 1m

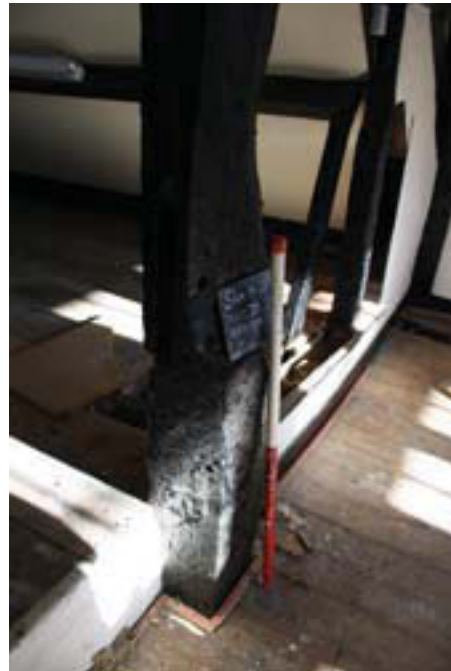
Plate 20. Interior, room 8 and 9 post detail, Scales: 1m.

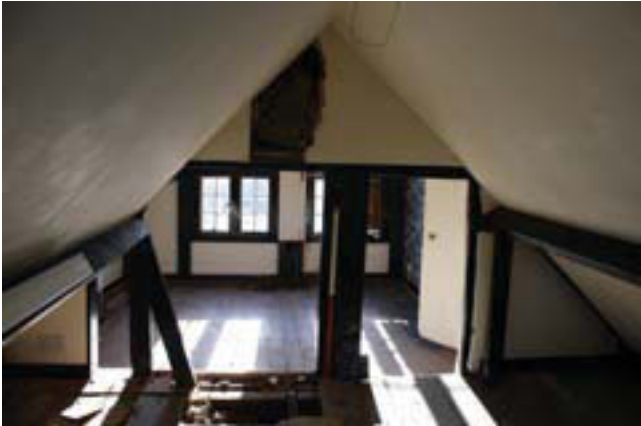
At the north, a small step up leads into a second space (room 9) which is housed within the roof space at the rear. Here, the purlins are exposed and do not extend into room 8. The ridge of the roof of this room is off-centre, suggesting it represents a separate phase of building, extending the ground floor to the north, with a gable providing first floor space. Here, the existing framing has been slightly haphazardly modified to incorporate room 9, with queen posts supporting the purlins and at the west, an additional diagonal strut added to stabilise the structure. This appears to be of later, machine cut wood. At the north, the small crittal-type window is set within the timber frame, with a wooden sill and steel frame.

Plate 21. Interior, room 9, looking north, Scale: 1m.

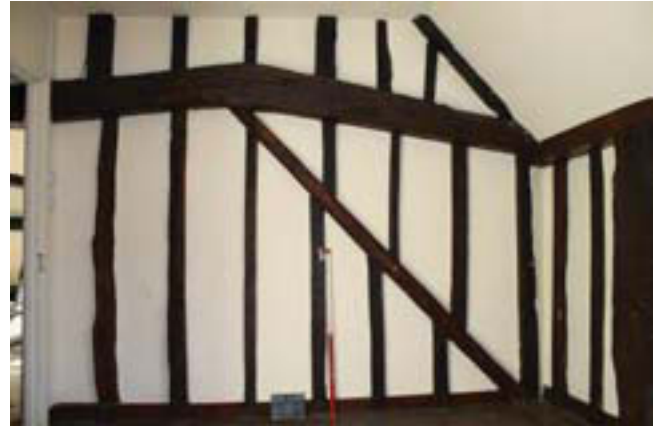
From the corridor, a wooden doorframe with plain moulding and thin four-panel wooden door, both of 19th century or later date, lead into room 10. This has exposed timber framing in the east, south and west walls, which has fairly close-set posts (one of which is a modern replacement) and a concave brace adjacent to the window on the south wall. At the east, below ceiling height is a large tie beam with a passing brace from the north side of the wall down to the south. The angle of this beam is unusual and may have been caused by sideways buckling of the structure (Brunskill, 1985, p20).

Plate 22. Interior, room 10 wall detail, Scale: 1m

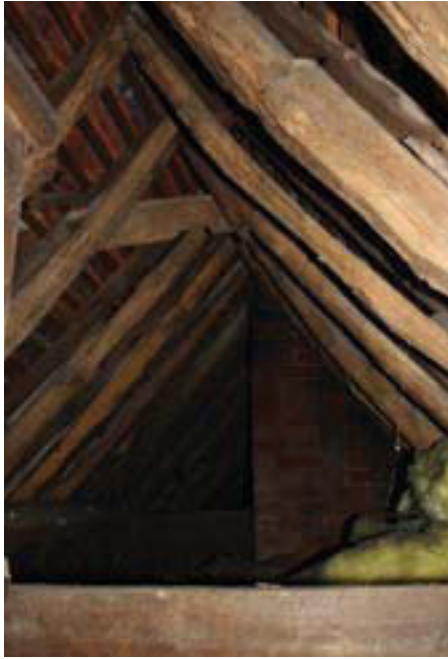
The loft space enables the inside of the roof structure to be examined, although for reasons of health and safety it was not possible to gain access to the entire space. The chimney comprises brickwork as seen throughout the exterior, and has no apparent areas of damage or repair. The timbers which were observed in the roof structure comprise fairly thin and irregular hand-cut rafters, with hand-cut purlins. The tie beam adjacent to the loft hatch appears to be a modern replacement, and the rafters have what appear to be modern machine-cut timbers fixed to the exterior of the original roof structure, and a modern collar at the west of the space adjacent to the chimney. A further (apparently modern) post and brace arrangement support the rafters at the west end.

Plate 25. Interior, roof space, looking west.

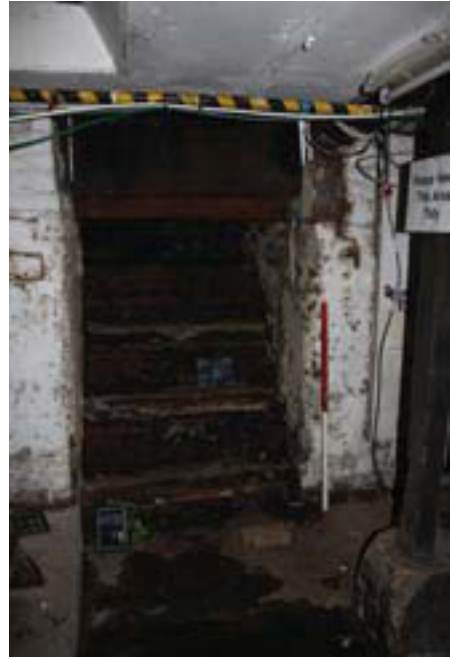
The cellar occupies the space below room 2. Access to the cellar is via the rear of room 4 down towards the east, and comprise a steep set of modern wooden steps. The floor is concrete or render, with the exception of an area at the base of the steps where waterlogged, degraded timber was observed. At the north of the space, steps are recessed into the wall below the external hatch, though no evidence for a barrel ramp was present. The steps are formed of brick, with modern timber edging. The walls are painted or whitewashed brick, and the fixtures and fittings for the beer pumps are fixed to the west wall.

Plate 26. Interior, room 12, looking west, Scale: 1m.

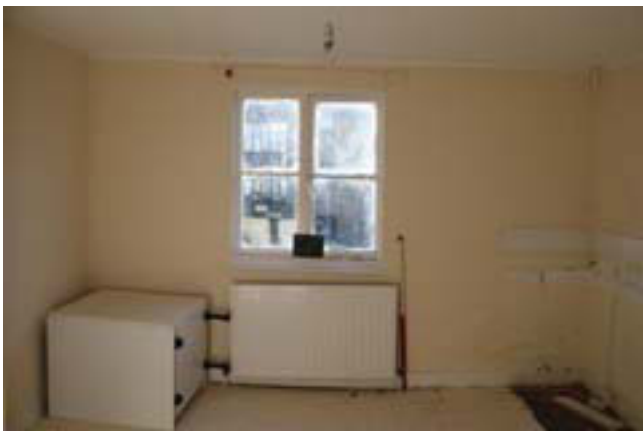
A modern four panel door in a simple moulded frame leads from the landing to the south into room 4b. This room has bare floorboards, painted plastered walls and a side-hung wood framed casement window of four panes, with a wooden sill, modern skirting, and an area of modern tiling at the southwest. At the east, the location of a small fireplace has been plastered but not blocked. It has a small stone hearth which is cracked but in situ.

Plate 31. Interior, first floor, cottage room 4b, looking north, Scale: 1m.
