**St Andrew's School, Chardstock,
Axminster, Devon**

Building Recording and Limited Archaeological Excavation

Site Code: ACD15/162

October 2015

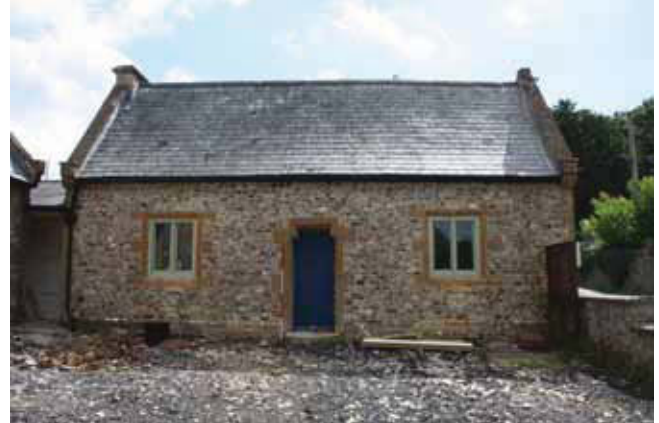
Plate 2. West elevation of former Industrial building, looking East, Scales: 2m and 1m.

At the time of the survey the former Industrial School Building had begun to be converted into a new residence; the ground floor had been sub-divided into two rooms and an upper floor had been inserted (rooms 1–3). Access was through a central, external door with metal studs (Pl. 18) in the western wall giving direct access to room 2. A modern stud partition wall separated room 1. Two windows were present in the western wall, equidistant from the central door, and set into an embrasure (Pl. 19). Stairs had been inserted at the north end of the building, up against a former fireplace. The roof structure consisted of a set of common rafters separated by a collar, meeting at a central ridge plank. Towards the top of the southern gable wall was a small window (Pl. 19).

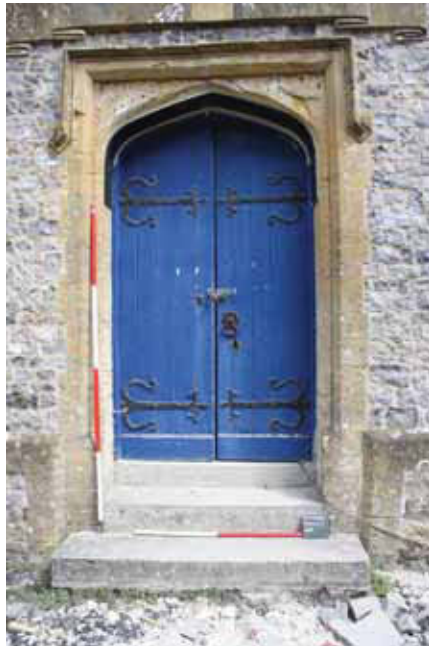
Plate 9. Entrance door to former National School, looking North, Scales: 2m and 1m.

Entrance was through a pair of double arched doors into room 4 (Pl. 9). Internally room 4 was brick built, butted up against the main National School building with a flagstone floor. The bricks were laid in Flemish bond in cement mortar, measuring 216mm x 108mm x 58mm (8¹/₂" x 4¹/₄" x 2¹/₄"). In the east and west walls was a window as well as one in the southern gable end; all set into embrasures. Sub-dividing room 4 from room 5 was a wooden screen with a central studded door. Either side of the door the screen was sub-divided into four panels with mock arches, similar in style to a rood screen. Above the screen was a large multi-paned window (Pl. 10).

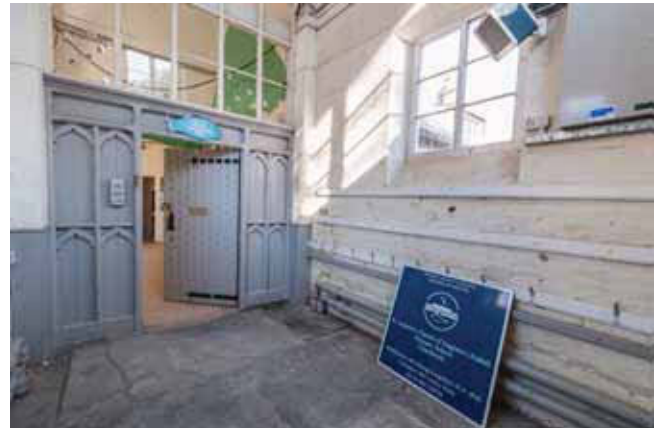
Plate 10. Oblique view of room 4, looking Northeast.

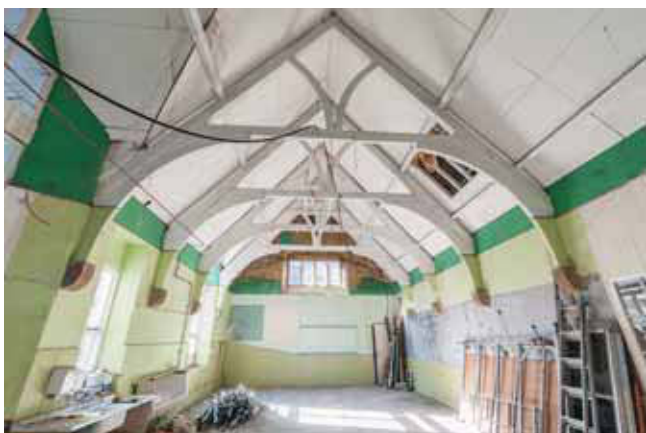
Plate 15. View to west gable end, looking West.

Rooms 5 and 11 made up the main area of the National School. The pair had been sub-divided and the wall plaster boarded over so it was not possible to see whether this was an old wall or entirely new. An earlier photograph shows the division constructed of planks and glass against one of the trusses. A typical Victorian four-panelled door gave access to the room (Pl. 11). Room 5 was access from room 4 and included central part of the room whilst room 11 was accessed from corridor 10. The floor plan prior to conversion suggests that there were originally two rooms located off a central corridor; the width of room 4. Internally they were both of stone construction with wooden floor boards. In the south wall were two pairs of windows either side of room 4; the more central windows were not set within embrasures. In the west wall of room 5 and the east wall of room 11 was a window set in an embrasure, beneath a brick arch. That in room 5 (Pl. 12) was present only in the upper part of the wall whilst that of room 11 was much larger extending lower down (Pl. 13). On the north side of the windows was a separate doorway; this had been blocked up within room 5. The door into room 11 was the same as that between rooms 4 and 5 - of wooden construction with studs (Pl. 14). Within the centre of the northern wall was a blocked arch, giving access to room 18. Roof construction consisted of eight raised trusses sat on stone corbels. A curved brace supported the main rafter which in turn supported a pair of purlins. The rafters were tied with a raised collar which supported a pair of raking queen posts (Pl. 15).

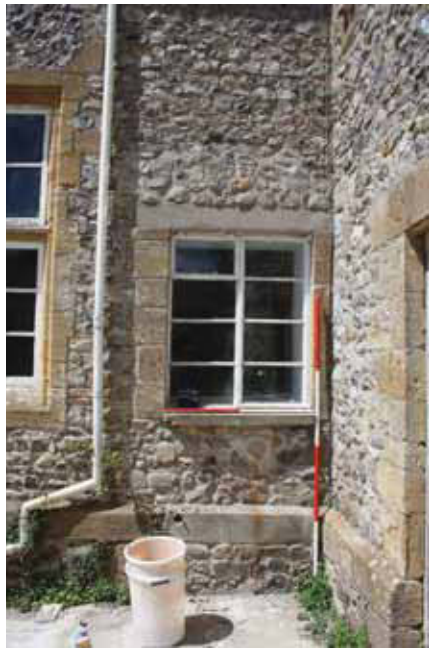
Plate 17. Blocked door (within yard area), looking West,
Scales: 2m and 1m.

Room 18 was accessed from corridor 16 as well as from the internal courtyard and room 19. The blocked arch between rooms 5 and 18 was more visible within this room and above it was a moulded cornice (Pl. 16). Below it was the remains of a picture rail. In the eastern wall, overlooking the central courtyard were three windows; the two central windows were stone mullioned beneath a brick arch whilst the window at the north end

was smaller, located within a blocked doorway (Pl. 17). Further blocked doorways were also located in the north-west corner of the room, one in each of the north and east walls.

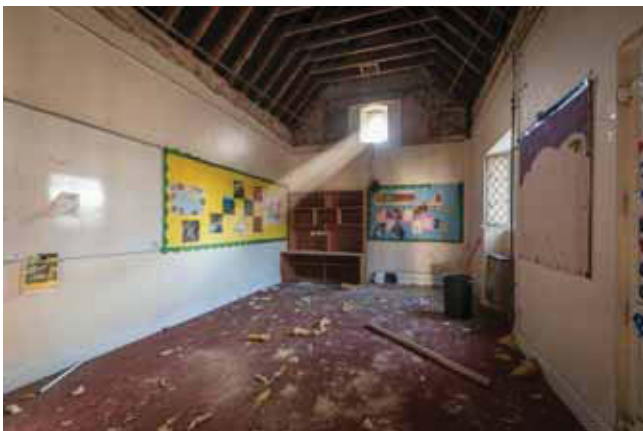
Plate 19. View to window in south gable end,
looking South.

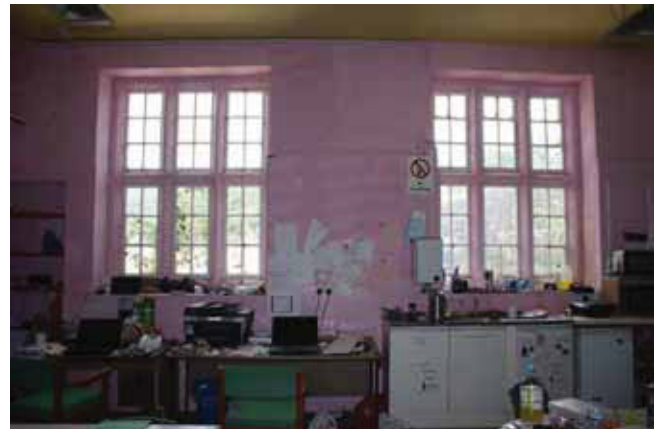
Plate 32. View to windows,
looking North, Scales: 1m.

Room 14 was located at the eastern end of the range with access from corridor 16 and externally from the internal courtyard. A pair of mullioned windows were located in the northern wall (Pl. 32) and a large chimney breast in the west wall (Pl. 33). The fireplace itself was of brick construction, partially laid in Flemish bond, but not consistently; the bricks measured 235mm x 108mm x 70mm (9 1/4" x 4 1/4" x 2 3/4"). Set within the fireplace was a modern wood burning stove. The mantle piece was of simple wooden construction, painted white, and consisted of squared wooden uprights with chamfers supporting a plain shelf. The walls were plastered and the floor carpeted.

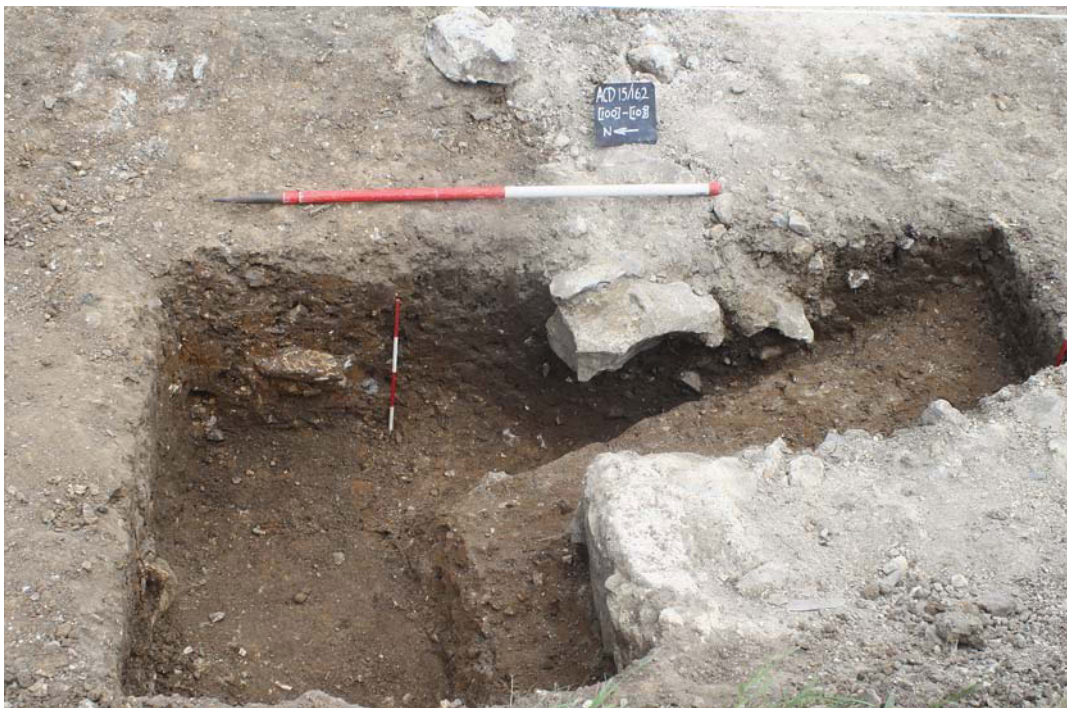
Plate 50. Trench 1 showing features 100-103,
looking East, Scales: 1m and 0.4m.

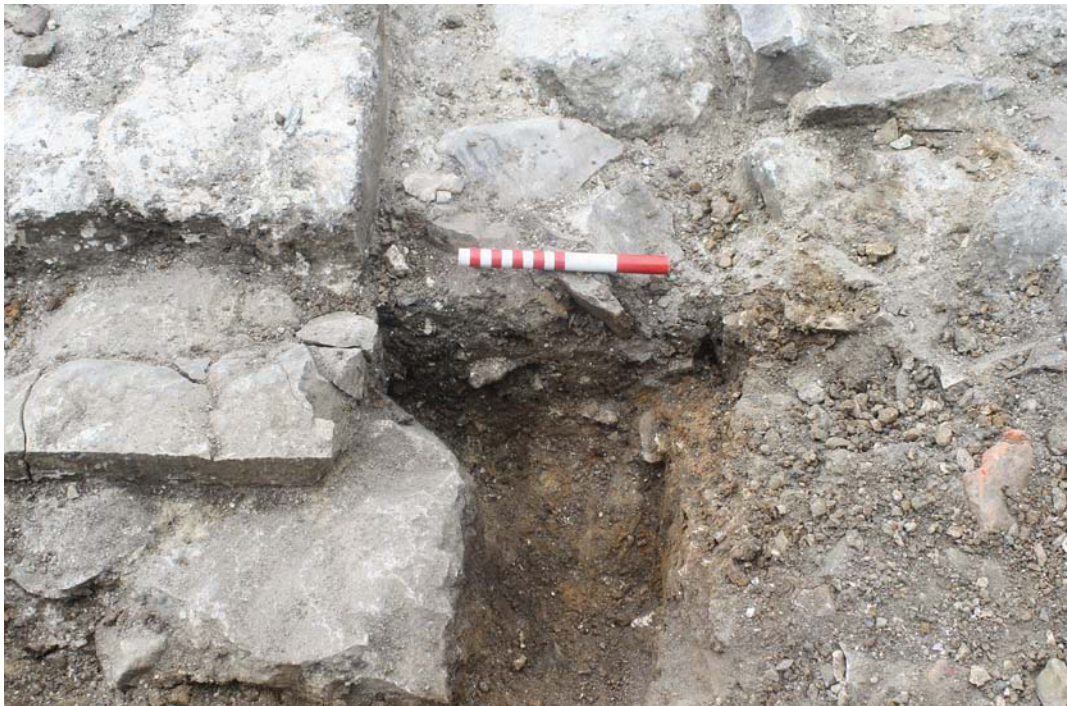
Plate 52. Trench 2 showing the junction of walls 60 and
61, Scales: 0.2m.

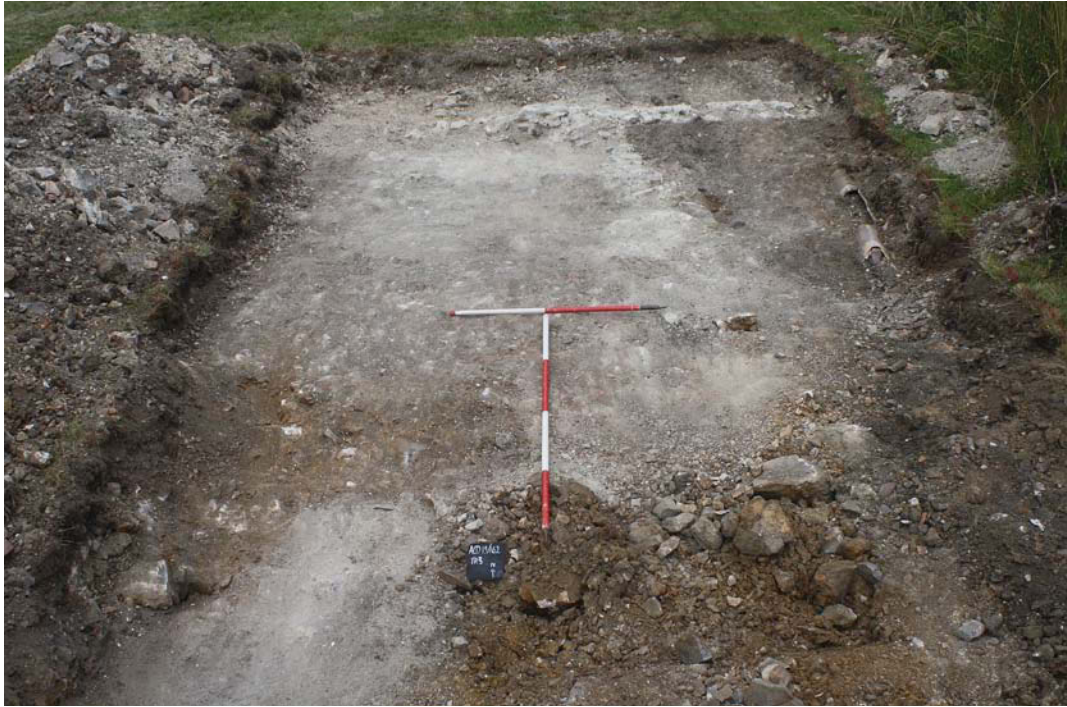
Plate 53. Trench 3,
looking North northeast, Scales: 2m and 1m.

Area 3 was 10.72m long, 4.16m wide, up to 0.25m deep and oriented SSW east to NNE. The relationship between stone and mortar walls 73 and 74 in slots 114 and 115 was not clear due to their degraded states (Fig. 16, section 9). Wall 73 continued eastwards (as 75) in slot 114, although at this point the footing barely survived (Fig. 16, section 10). A spread of mortar associated with a row of bricks (70) set in the north-west corner made by the junction of 73 and 74 was interpreted an area for a toilet cubicle. A sewer pipe ran across the area (Pl. 53).
