# Former Railway Yard, Cadley Road, Collingbourne Ducis, Wiltshire

**Archaeological Evaluation**

Site Code: SCD14/169

**Report 14/169b**

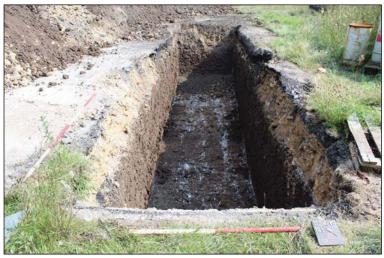
Plate 1. Trench 1, looking north east, Scales: 2m and 1m

Trench 1 was aligned NE - SW and was 8.00m long and 2.04m deep at the north western end sloping gently to a depth of 2.20m at the south eastern end.. The stratigraphy at the deepest section consisted of 0.18m of Tarmac above 0.30m of very compact chalk made ground. This overlay 0.72m of light brown clay silt with occasional

chalk inclusions which was above 1.00m of darker brown clay silt which contained occasional brick fragments. Below this was the natural chalk geology with peri-glacial stripes. No archaeological features were present and no finds were recovered.

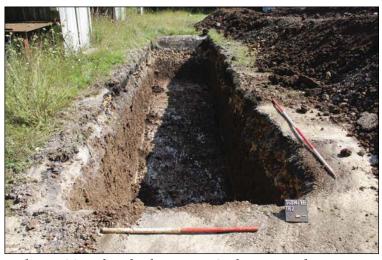
Plate 3. Trench 2, looking east, Scales: 2m and 1m

Trench 2 was aligned E - W and was 8.40m long and was 1.50m deep at the eastern end sloping gently towards the west with a maximum depth of 1.96m. The stratigraphy consisted of 0.15m of Tarmac above 0.35m of compact chalk made ground. Below this was 1.46m of dark brown clay silt with chalk inclusions which was above the natural chalk geology. Peri-glacial stripes were observed throughout the trench but no archaeological features were present and no finds were recovered.

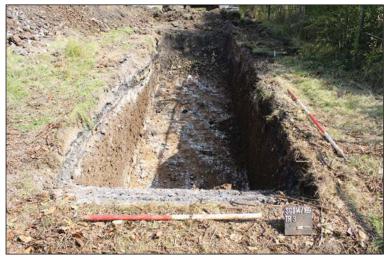
Plate 4. Trench 3, looking east, Scales: 2m and 1m

Trench 3 was aligned E - W and was 8.00m long and was 1.08m deep at the eastern end sloping gently towards the west with a maximum depth of 1.78m. The stratigraphy consisted of 0.18m of light brown silt above 0.12m of tarmac and 0.40m of compact chalk made ground. Below this was 1.08m of mid brown clay silt with occasional chalk inclusions which was above the natural chalk geology. Peri-glacial stripes were observed throughout the trench but no archaeological features were present and no finds recovered.

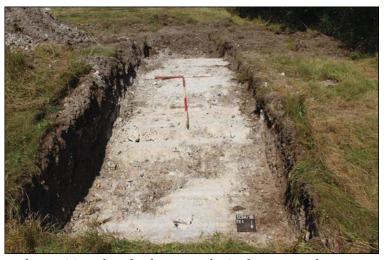
Plate 6. Trench 4, looking south, Scales: 2m and 1m

Trench 6 was aligned NE - SW and was 9.70m long and 0.30m deep. The stratigraphy consisted of 0.30m of topsoil above the natural chalk bedrock. No archaeological deposits were present and no finds were recovered.

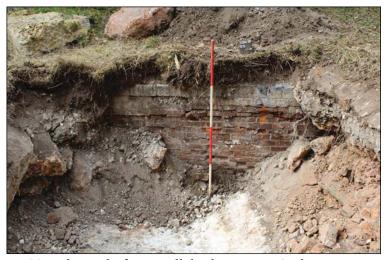
Plate 9. Trench 10 platform wall, looking west, Scale: 2m

Trench 10 was 3.50m long, 3.00m wide and 1.70m deep. The stratigraphy consisted of 0.30m of topsoil above 0.30m of chalk made ground. Below this was 1.10m of rubble made ground above the natural chalk geology. The west platform was observed in the western section of the trench. No archaeological features were present and no finds were recovered.
