**St Edburg's Church, Church Street,  
Bicester, Oxfordshire**

**Archaeological Watching Brief**

**Site Code: SEB14/76**

**Report 14/76**

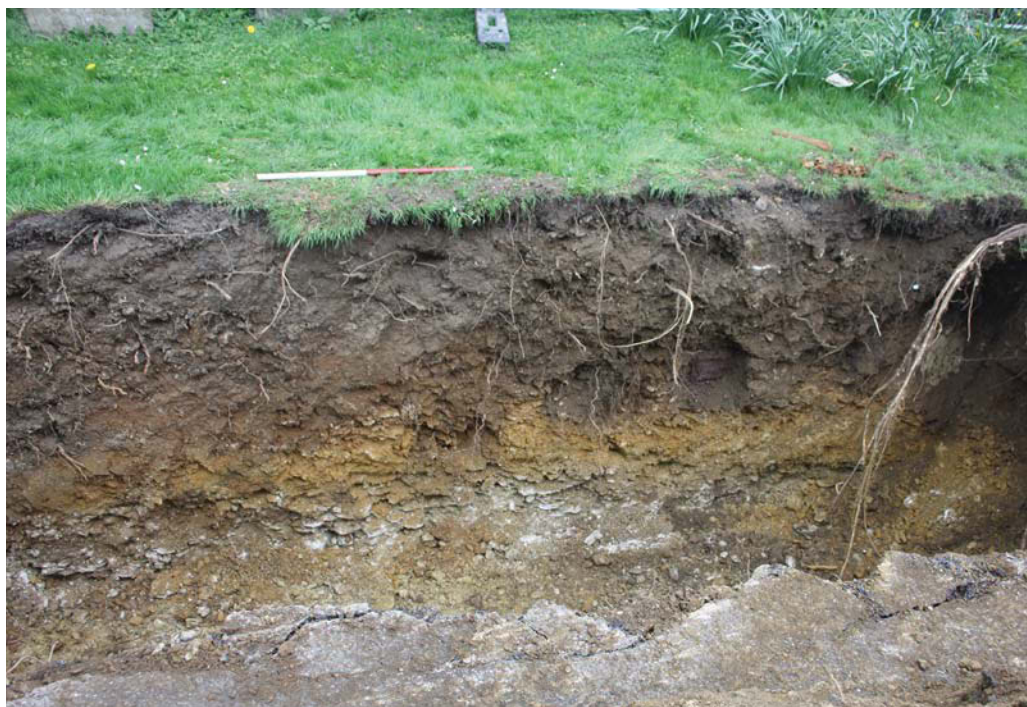
At a depth of 1.3m, the natural cornbrash geology was reached. Grave 202 was noted at 1.65m in section and contained limited bone. Medieval pottery was noted in both of the fills that made this grave (250 and 251). Fill 250 was a firm pale grey brown clayey sandy silt with frequent limestone inclusion. Fill 251 was a firm pale yellow brown grey clayey silt with frequent limestone and contained human bone. Rib bones were recovered and part of the upper left arm and scapula (sk 256). The western end of this grave was contained in the section. A record of the final finished excavated depth was taken once 2m had been reached and all five of the graves were visible in the western section (Pl. 1).

Plate 1. Soakaway section, looking west, Scale: 1m.

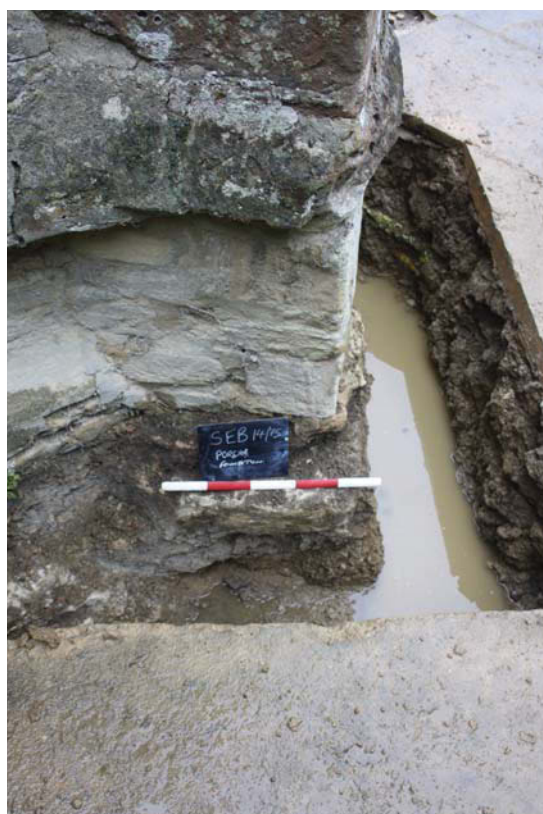
Plate 2. North east buttress foundation on porch, looking west, Scale: 0.5m.

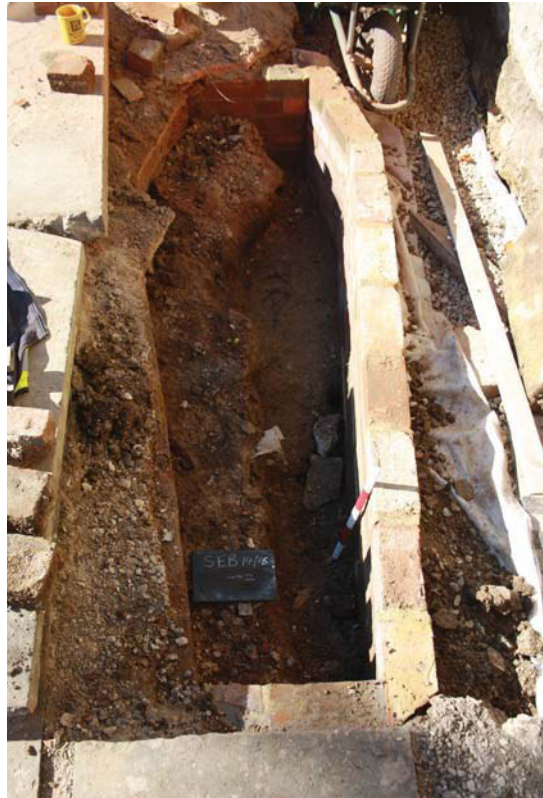
This brickwork was in poor condition and fell within the excavated trench. A crypt (206) was discovered here, but had long since filled with soil as the top slab had fallen with the crypt. It was unclear if this was a deliberate backfill as a void had appeared under the church path. Once the two overlying graveslabs in the path had been lifted the full extent of the crypt was visible. These graveslabs dated from the 1850's. Crypt 206 was 2.2m long by 0.78m wide. The top of the soil in the interior was only 0.4m deep. This soil (263) was excavated on the northern half of the crypt to allow access to the northern section wall and exposed the interior of the top six courses of the northern side of the crypt. This wall was then rebuilt and the void within in filled with Type 2 stone (Pl. 3). A complete gravestone was lifted from the interior of this crypt. Its inscription read (Pl.5)

Plate 3. Crypt 206, after wall rebuild and prior to backfill, looking west, Scale: 0.5m.

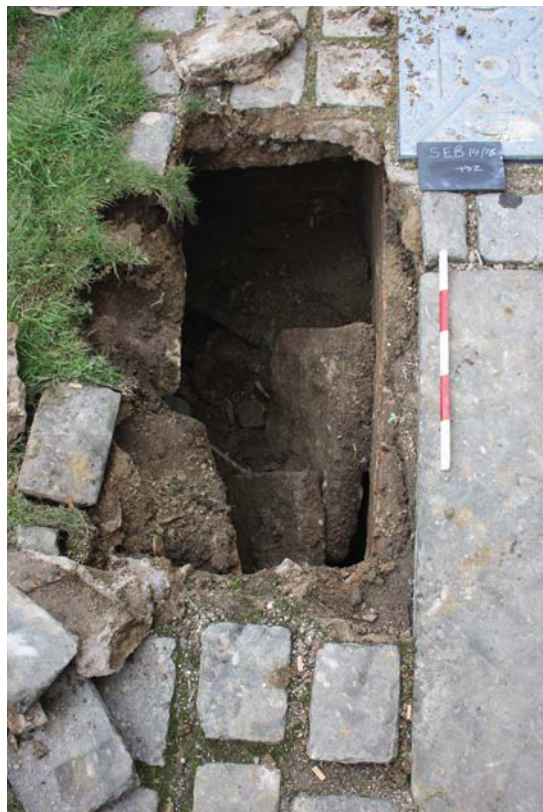
While the works where being carried out the dumper was using the southern church path. A hole opened up under the dumper (Pl. 4). It was observed that a crypt (207) existed at this location just 2.3m south of 206. This exposed the centre of the crypt and showed that it was infilled with soil though the void in the path from a depth of 0.9m deep. This crypt was 2.4m long and 0.77m wide. No soil was excavated from its interior. Once the cobbles had been removed and a broken graveslab was lifted it was observed to contain script. This read 'M.C 1717' (Pl. 6). This was then photographed and the void filled in with Type 2 stone. No human bone was observed in this crypt.

Plate 4. Crypt 207, looking west, Scale: 0.5m.

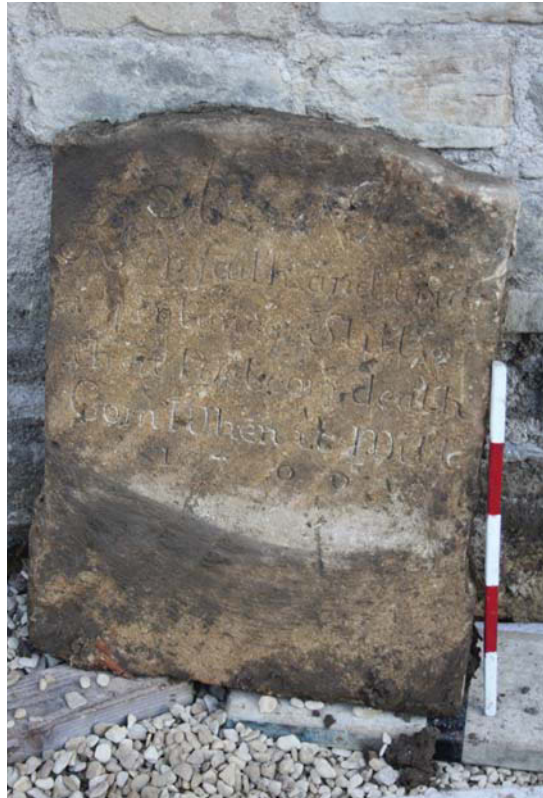
Plate 5. Gravestone recovered from Crypt 206, Scale: 0.5m.

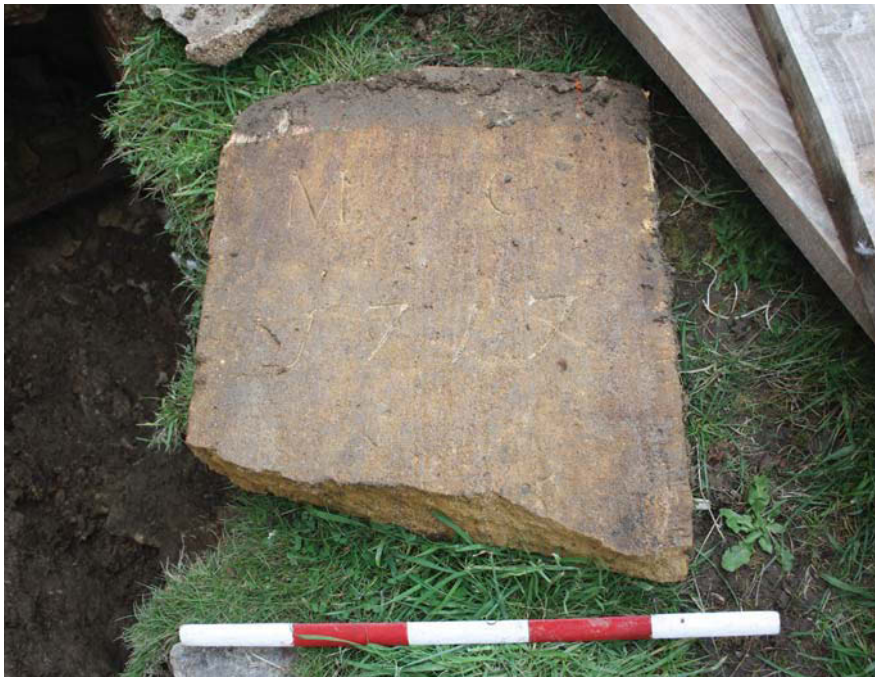
Plate 6. Gravestone recovered from Crypt 207, Scale: 0.5m.

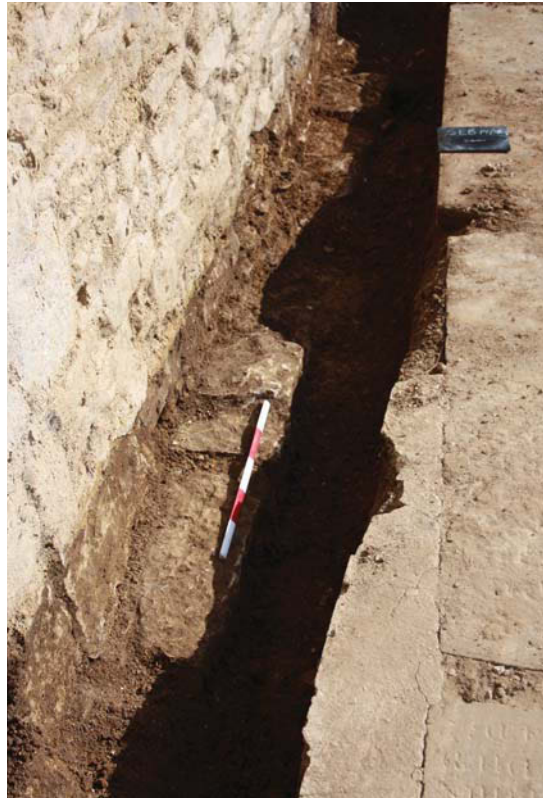
Plate 7. Foundation on South Aisle Chapel, Scale: 0.5m.

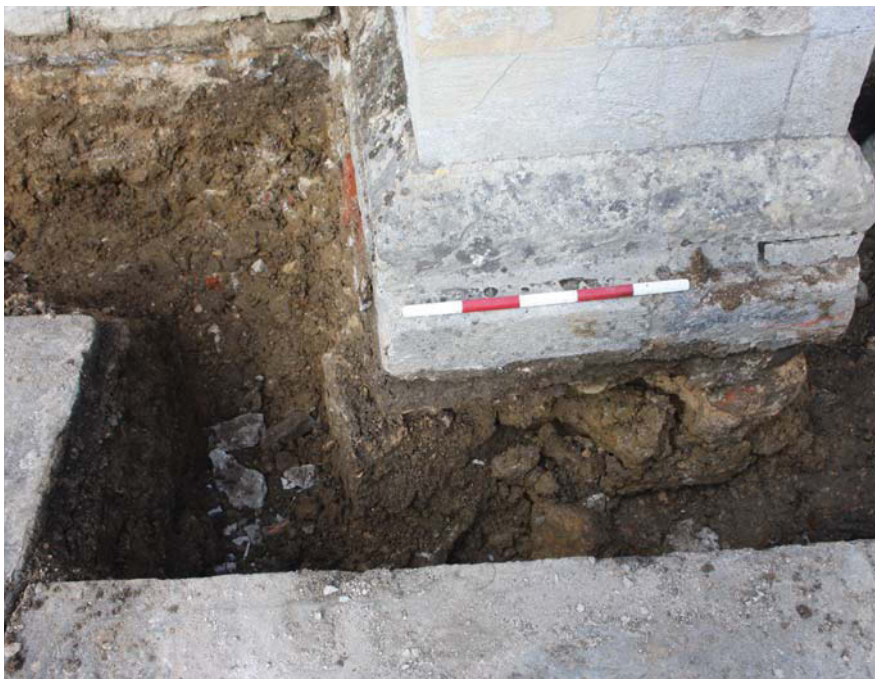
During the rebuilding of Crypt 206, the excavation of the drainage channel continued. This removed the existing brick channel at ground level and excavated to a depth of 0.42m. This exposed the foundation of the southern aisle buttress which was seen to be in poor condition (Pl. 8). When the trench reached the south aisle chapel it narrowed to 0.4m (Pl. 7). The foundation was seen to step out 0.19m, but was not disturbed to allow the pipe to be laid. None of the gravestone paving slabs required lifting along this length. This then turned along the eastern end of the south aisle wall and stopped at the chancel wall to link with existing drainage that continued down the church path to the east. The existing drainage was broken at the south-east corner of the south aisle then linked to the new run. Nothing further of archaeological interest was observed in this stretch.

The investigation of the foundation of the church found it to be in a poor state in some areas especially on the exterior buttress of the south aisle. The porch buttress in the north-east was only 0.5m deep.

Plate 8. South Aisle buttress foundation , Scale: 0.5m.
