**Middleton, Milton Street,  
Polegate, East Sussex**

**Archaeological Watching Brief**

**Site Code: MMS15/51**

**Planning Reference: SDNP/14/01988/LIS**

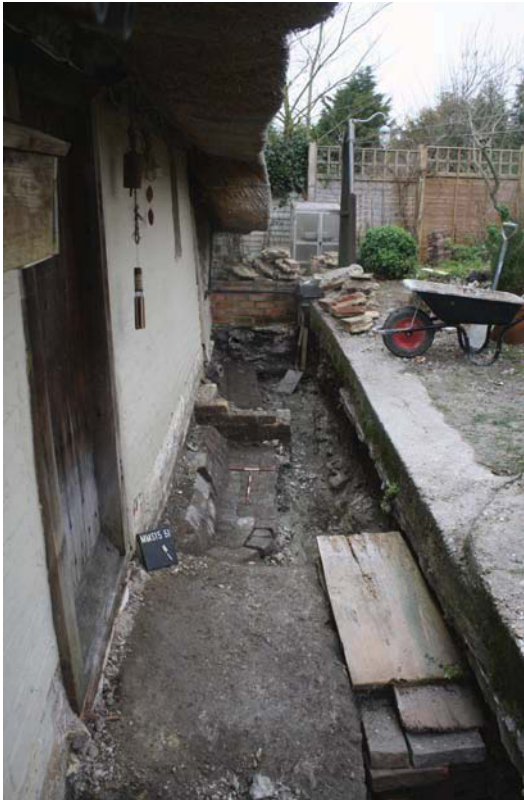
Several areas were monitored during the watching brief (Fig. 3). An existing concrete surface to the south and east of the house was broken up and removed in advance of a new drainage channel being dug. The remains of a brick built drain (51) were observed to the rear of the house, and this had been truncated by a modern silt trap (52) (Pl. 1). Drain 51 extended northwards from the back door of the property, and was 4.8m long and 0.5m wide. It was constructed from frogless red bricks, which could date from the mid 18th to early 20th century. However, some of the pottery recorded from a soil deposit (53) immediately beneath the drain can be accurately

**Plate 1. Drain 51 and trench around east side of house, looking north-east; Scales 0.5m and 0.3m.**

A complete red frogless brick sample (1/2946g: 230 x 110 x 60mm) was taken from a brick built drain (51) which was recorded to the rear of the house. The brick is well formed and fired, being tempered with common iron oxides and marl pellets/swirls to 3mm. The brick could be placed anywhere between the mid 18th and early 20th centuries.

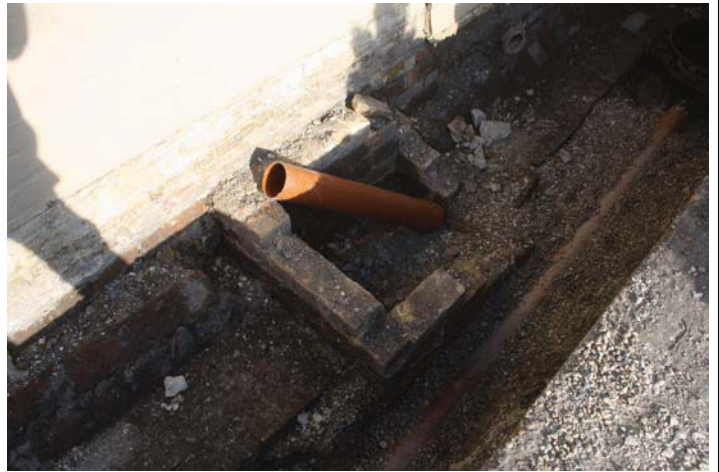
**Plate 2. Drain 51 and silt trap 52**

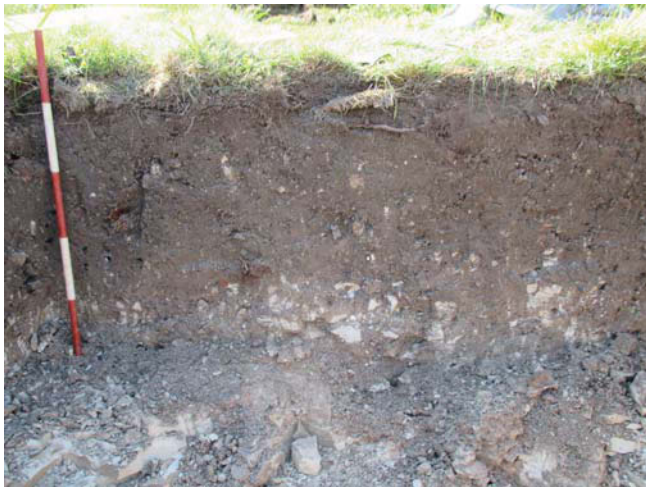
To the west of the house, two areas were monitored in advance of a soakaway and a reed bed (Figs 3 and 4). Topsoil (50) and subsoil (54) were removed by hand to expose the natural chalk geology. No archaeological features were noted cutting into the chalk. The reed bed measured 2.40m by 1.20m, and natural geology was encountered at a maximum depth of 0.30m (Pl. 3). The soakaway measured 1.60m square, and natural chalk was encountered at a maximum depth of 0.78m. The difference in the depth of the natural geology resulted from the fact that the garden sloped down towards the road, largely due to a higher build up of topsoil close to the house. Fragments of pottery, tile, glass and clay pipe were recovered from the topsoil, along with a bone shirt button. Although some of the pottery dated from the early post-medieval period, most of the material dates from the 19th or 20th century.

**Plate 3. Reed bed section facing north, scale 0.5m.**

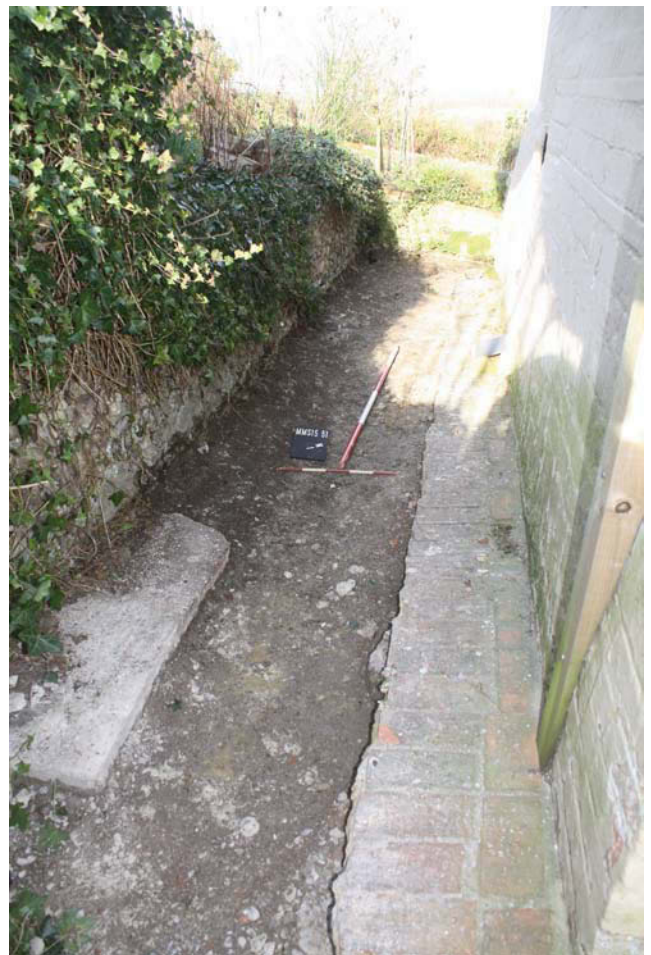
dated to the early 20th century. Elsewhere the concrete surface had been laid on top of a very thin soil layer, which in turn lay directly above the natural chalk geology (Pl. 4).

**Plate 4. Trench at south of house, looking west, scales 2m, 0.5m.**
