**Gorvin Farm, Woolsery,  
Bideford, Devon**

**Archaeological Evaluation**

# **Proposed Wind Turbine, Gorvin Farm, Woolsey, Bideford, Devon**

**An Archaeological Evaluation**

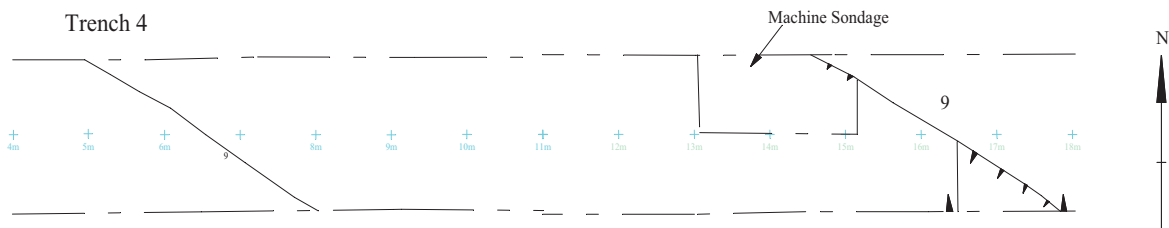
Figure 4. Plan of Trench 4

Trench 4 was aligned west - east and was 20.68m long and 0.38m deep. The stratigraphy consisted of topsoil which was 0.29m thick beneath which was a 0.09m of subsoil. Beneath the subsoil was a yellow brown clay with patches of brown clay and moderate stone fragments which was considered natural geology . Occupying most of the centre of the trench, and cut into the natural clay, was pit 9. This appeared to be roughly rectangular in plan but its full extent was not seen in the evaluation but appeared to be over 3.60m long and 5m wide. Pit 9 was filled with which appeared to be unconsolidated stone rubble and a mid brown red silty clay (61). A hand dug sondage was excavated within pit 9 at the south east corner to a depth of 0.84m below topsoil at which point it became unstable. A machine dug sondage was also excavated to the west, to a depth of 1.6m onto natural yellow clay and this was recorded from above as the fill proved to be unstable. Neither of the sondages produced any datable artefacts. Pit 9 appeared to correspond well with an anomaly found by the geophysical survey.

#### Trench 4 Figs 4 and 5; Pls 4 and 8

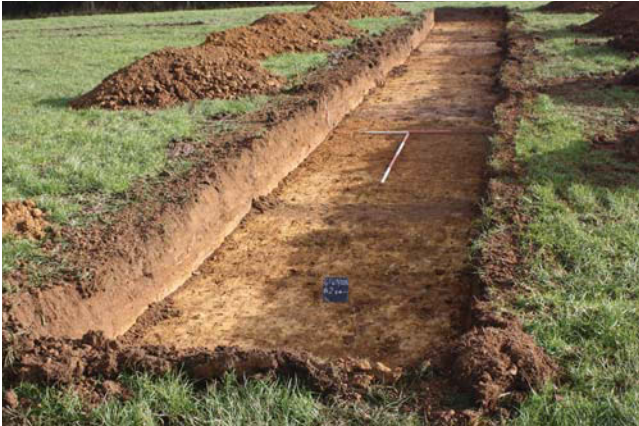
Plate 1. Trench 2, looking east,  
Scales: horizontal 2m and 1m, vertical 0.5m.

Trench 2 was aligned west–east and was 19.44m long and 0.36m deep. The stratigraphy consisted of topsoil which was 0.25m thick beneath which was a 0.11m of subsoil. Beneath the subsoil was a yellow brown clay with patches of brown clay and occasional stone fragments which was considered natural geology.

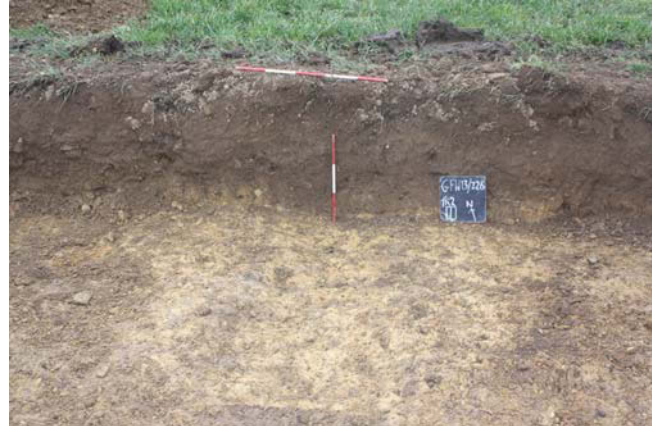
Plate 2. Trench 2, Ditch 1, looking north,  
Scales: 1m and 0.3m.

At 3m from the west end of the trench cutting into the natural geology was Ditch 1 which was linear in plan aligned roughly south to north, 0.45m wide and a maximum of 0.19m deep. Ditch 1 contained a mid red brown silty clay (52) with occasional stone fragments but no datable artefacts were recovered from it. Some 3.5m to the east of Ditch 1 was Ditch 3 that was also roughly aligned south to north 1.05m wide and 0.24m deep. Ditch 3 was filled with a mid red brown silty clay (55) with occasional stone fragments but no datable artefacts. Ditch 3 was cut by Service Trench 2 that was aligned SSW–NNE and contained two fills (53 and 54) as well as a modern plastic pipe at 0.85m below current grass level. Ditch 1 appears to correspond with an anomaly found during the geophysical survey as do both Ditch 3 and Service Trench 2 (Fig. 6). A further, fainter, anomaly was not detected in the trench.

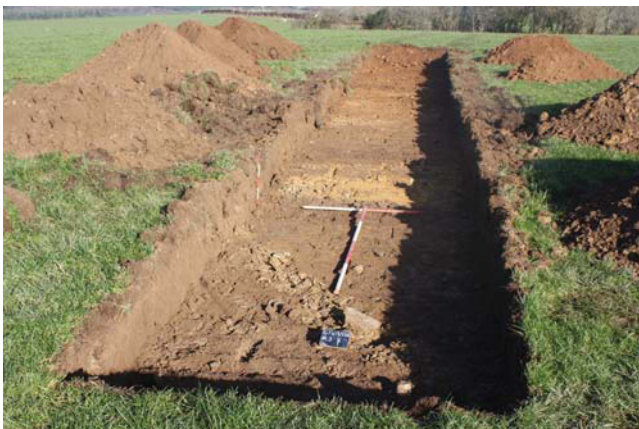
Plate 3. Trench 3, looking north,  
Scales: horizontal 2m and 1m, vertical 0.5m.

Trench 3 was aligned N - S and was 20.17m long and 0.32m deep. The stratigraphy consisted of topsoil 0.20m thick above 0.12m of subsoil. Beneath the subsoil was a yellow brown clay with patches of brown clay and occasional stone fragments which was considered natural geology.

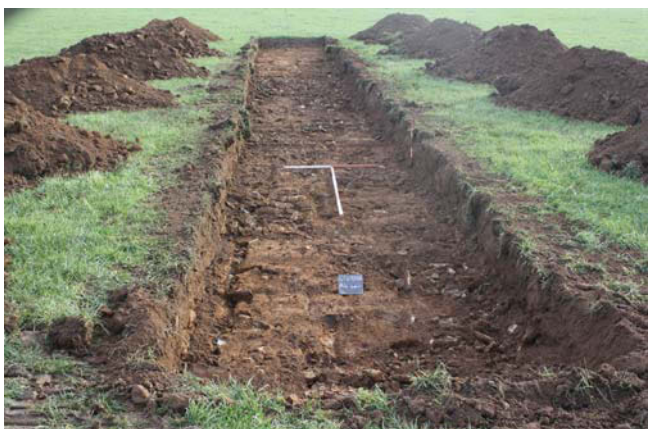
Plate 4. Trench 4, looking east,  
Scales: horizontal 2m and 1m, vertical 0.5m.

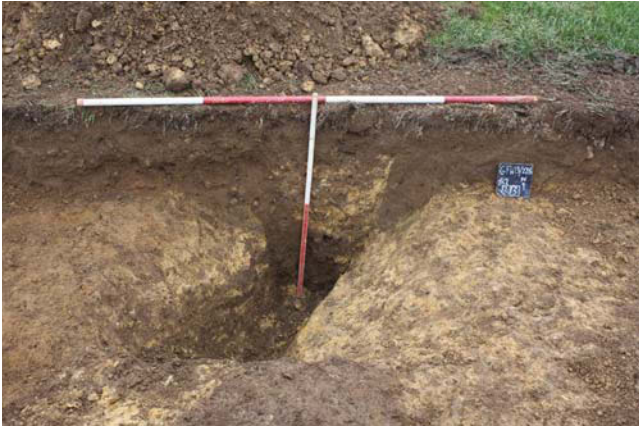
Plate 5. Trench 2, Drain 2 and Ditch 3, looking north,  
Scales: 2m and 1m.

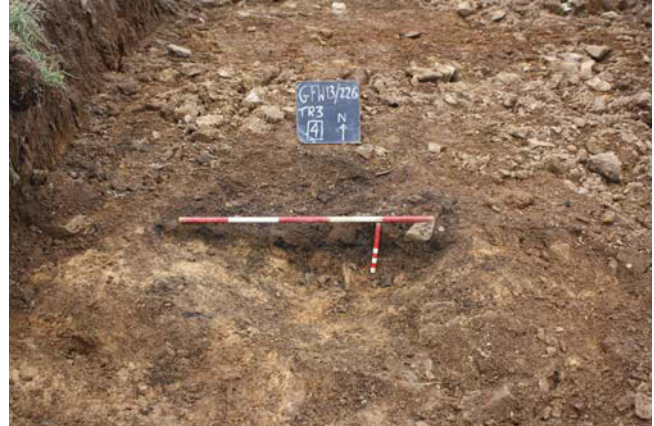
Plate 6. Trench 3, Pit 4, looking north,  
Scales: 0.5m and 0.1m.

At the south-east corner of the trench heading north-west for 3.5m was a modern service trench that appeared to contain a plastic pipe. This area of the trench was not machined down to natural to preserve the modern service. The service trench at its northern end cut Ditch 7 that was aligned west to east, was seen to be 0.50m wide and 0.14m deep but not fully excavated. Ditch 7 contained a mid red brown silty clay (59) with occasional stone fragments but no datable artefacts were recovered from it. Directly to the north of Ditch 7 was Ditch 6 which was also aligned west to east, 0.98m wide and 0.11m deep. Ditch 6 contained a mid blue grey clay (58) with occasional stone: again no datable artefacts were recovered.

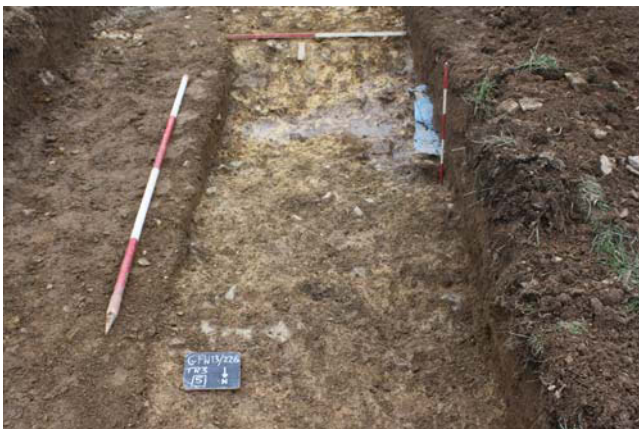
Plate 7. Trench 3, Ditch 5, looking south,  
Scales: horizontal 2m and 1m, vertical 0.5m.

A further 1.5m to the north of Ditch 6 was Ditch 5 which was also aligned west to east and was 1.30m wide and 0.13m deep. Ditch 5 was filled with a mid red brown silty clay (57) with occasional stone fragments but no datable artefacts were recovered from it. In the subsoil above Ditch 5 and covering it was a layer of modern blue plastic sacks. Some 6m to the north of ditch 5, pit 4 was circular in plan, 0.55m in diameter and 0.08m deep. Pit 4 contained a mid red brown silty clay (56) with occasional stone fragments and charcoal but no datable artefacts. Ditches 7 and 6 appear to correspond with an anomaly found during the geophysical survey though this is less clear for Ditch 5.

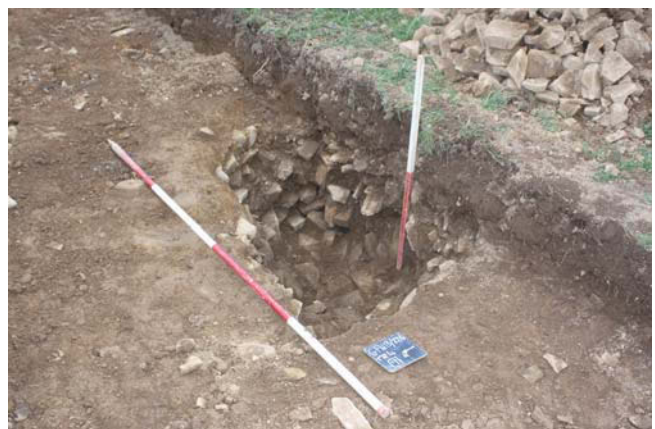
Plate 4. Trench 4, Quarry pit 9, looking east,  
Scales: horizontal 2m, vertical 1m.
