**The Maltings, Hart Street,
Henley-on-Thames, Oxfordshire**

Building Recording

Site Code: TMH15/169

May 2016

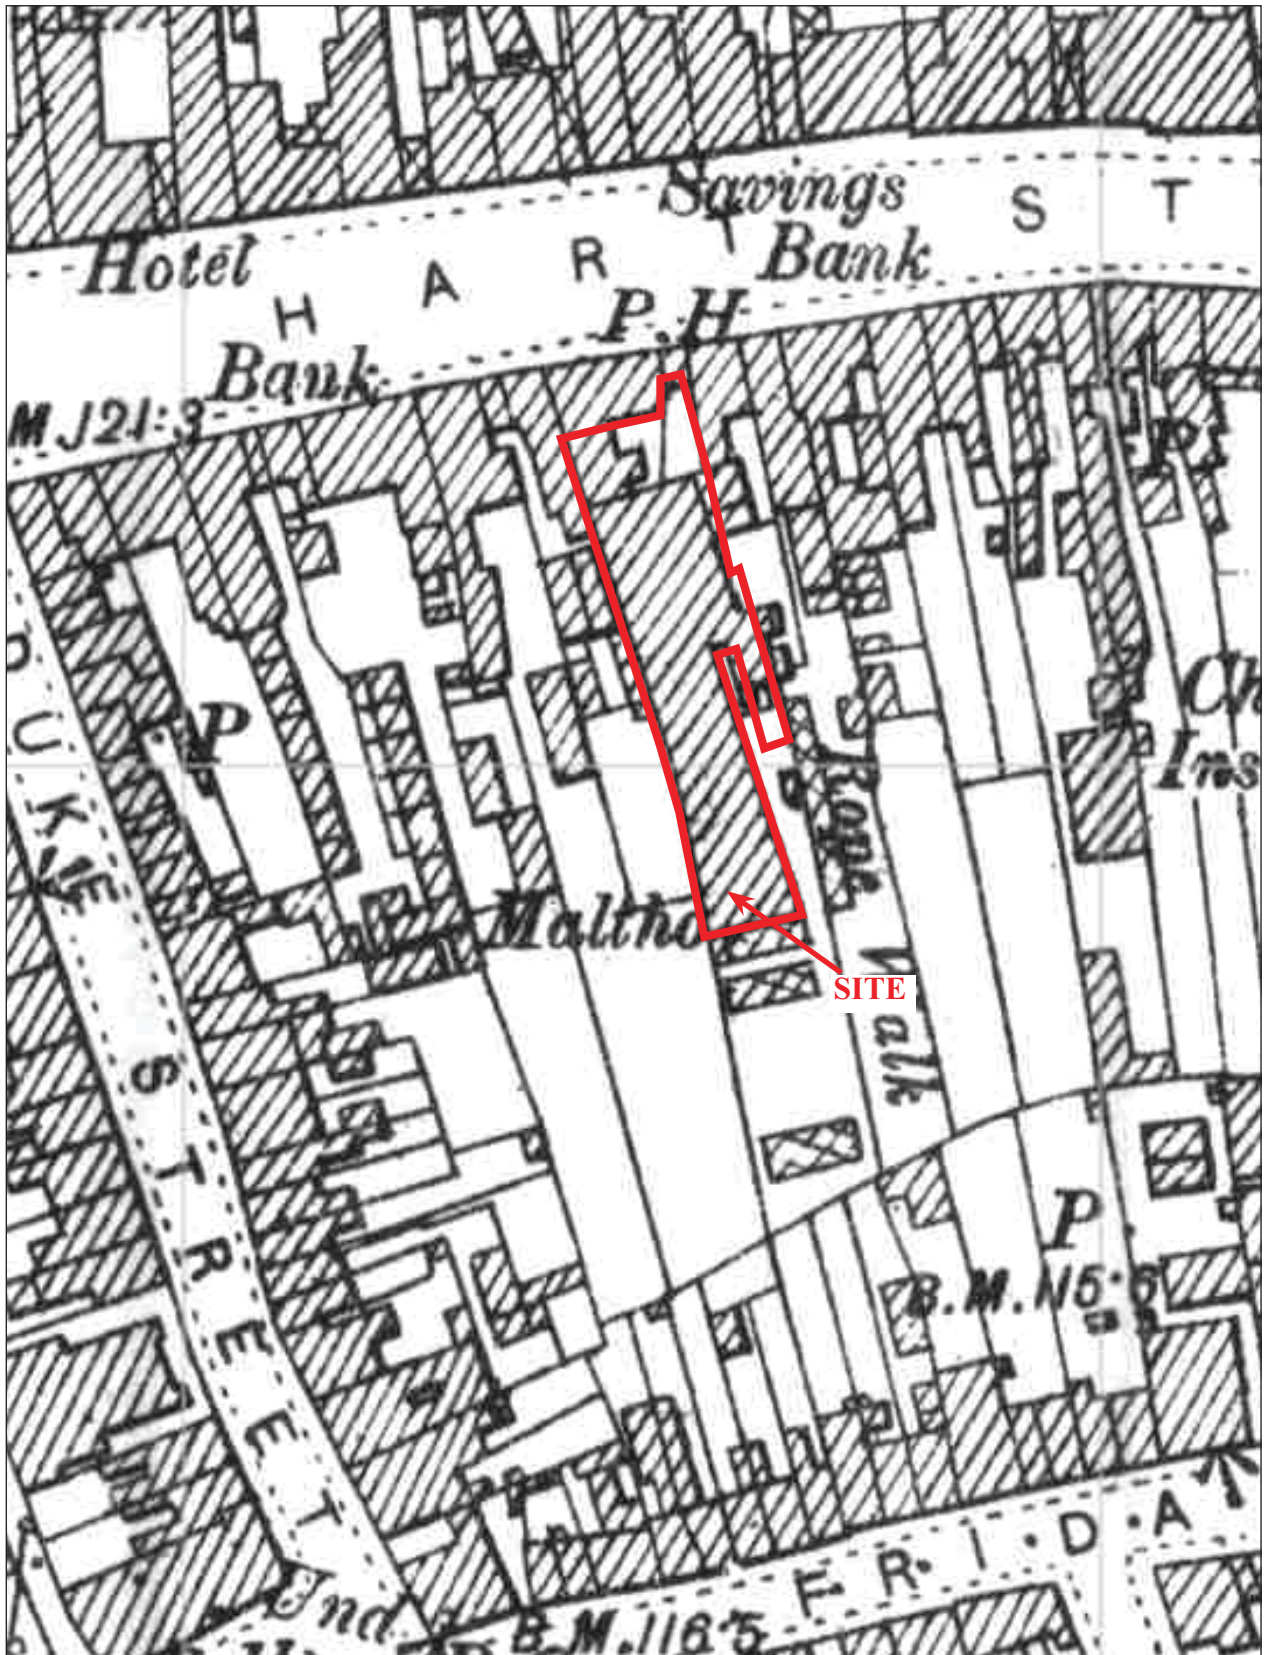
The Maltings, Hart Street,
Henley on Thames, Oxfordshire,
Building Recording
Figure 5. Second Edition Ordnance Survey, 1899.

Later maps are at a smaller scale and show less detail. By 1899 (Fig. 5) changes have occurred to the eastern side of the building with the removal of the corridor to a rear building and to the back garden. Within the garden area it would appear that the sheds present along the eastern boundary have been changed or partially demolished and the small extension of the rear of the Malthouse has been replaced with a glasshouse. An additional two glasshouses are also present within the garden area. The map of 1913 (Fig. 6) is again very similar but with a curved wall shown on the eastern side of the building and the glasshouse attached to the rear of the Malthouse has reverted back to a small extension. No curved wall is shown on the 1925 map (Fig. 7) and the outbuildings along the eastern boundary have now all been removed. By 1962 (Fig. 8) only one glasshouse remains in the back garden. No further change is shown in 1968 or 1989 (not illustrated).

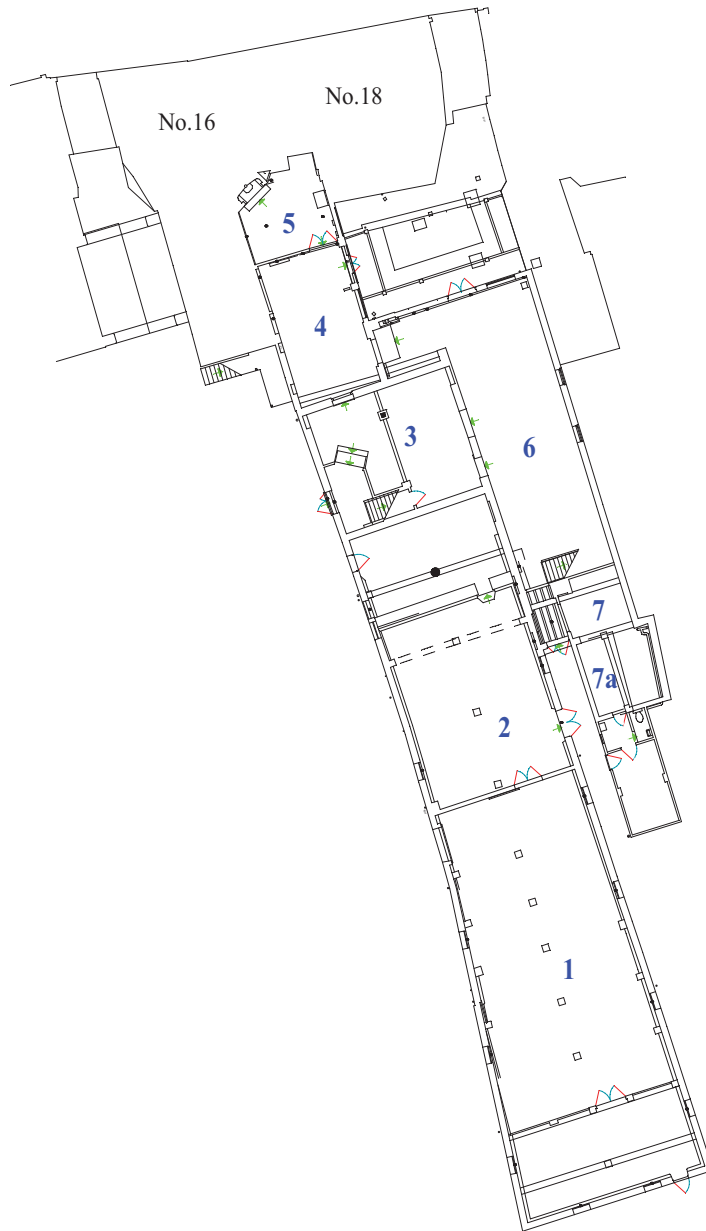
Ground floor

Floor plans can be found in figures 10 (ground floor) and 11 (first and second floor) and elevations in figures 12–13.

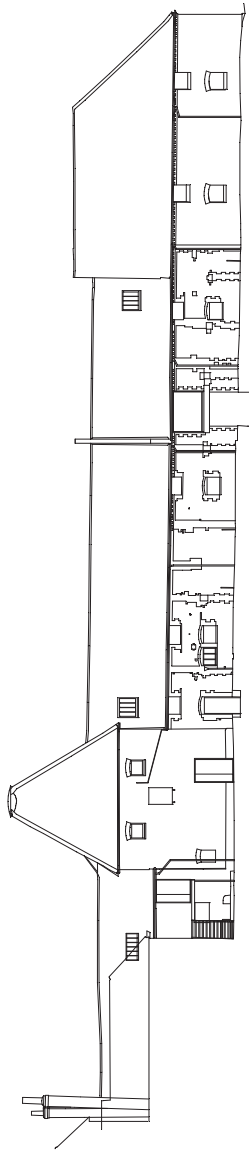
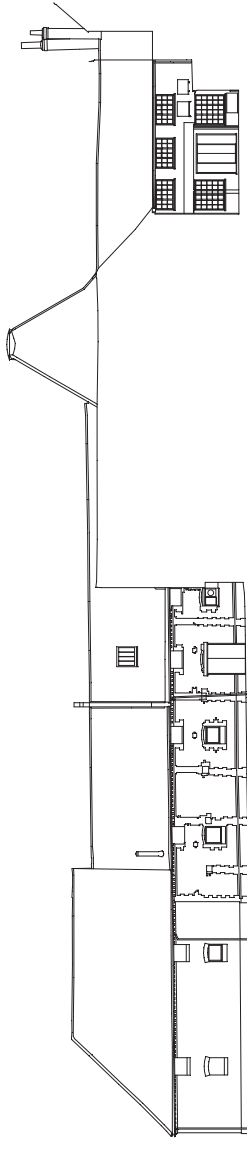
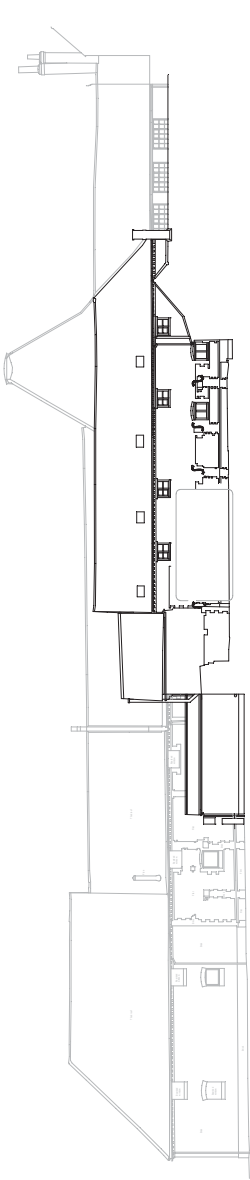
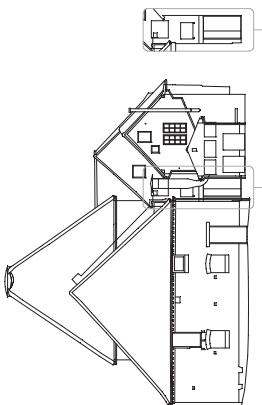
Figure 12. Elevations.

West-facing elevation

East-facing elevation

South-facing elevation

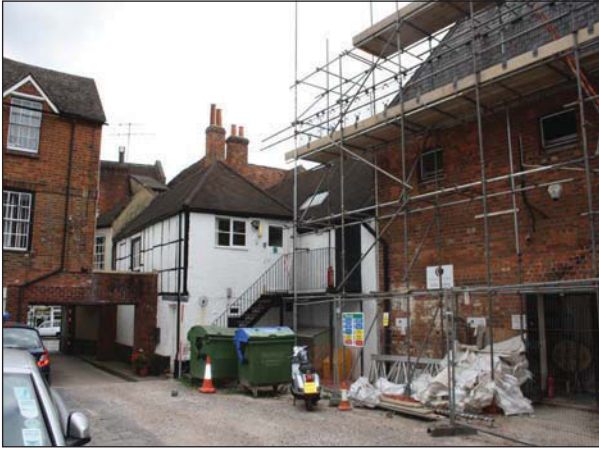
Plate 1. Timber framed range, looking north

Rooms 4 and 5 on the ground floor and room 12 on the first floor appear to have originally been part of number 18 Hart Street, rather than an integral part of the buildings associated with the malting process. Much of the rooms cannot be seen from the exterior, exceptions being part of the east and west elevations (Plates 1 and 2). The majority of the west elevation is obscured by number 16 Hart Street and what can be seen of the walling is further obscured by a modern fire escape, with a single door on the first floor (Pl. 3). The wall itself had been rendered and whitewashed with no timber or brick detail visible. On the eastern side, within the courtyard, the wall had been entirely re-built relatively recently in stretcher bond with cement mortar, probably at the same time as the northern wall of the eastern range. Within this wall was set a large pair of windows, either side of a double door on the ground floor, above which were three large windows on the first floor.

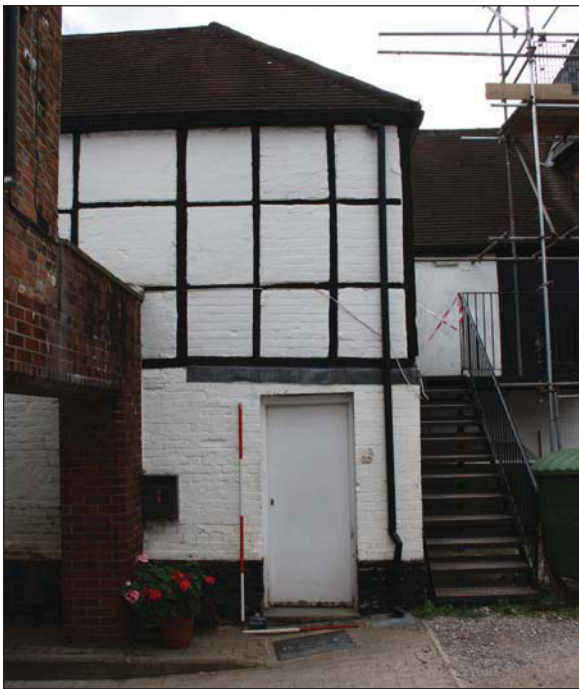
Plate 3. Timber framing, looking north-east

Internally the floors had been concreted/screed over. Room 4 was the southernmost room and could be subdivided into three equal sized bays. Door openings were present within the southern wall into room 3, the eastern wall into room 6 and into the courtyard and within the northern wall into room 5. Within the northern and western walls was timber framing, whilst within the southern wall was an ornate door frame (Pl. 4). Within the northern wall the timber framing consisted of a single post supporting the beam above. Within the western wall the timber framing was more substantial consisting of post and rail box framing. The timber framing was only visible within the recessed areas, possibly suggesting that a secondary wall had been built internally, obscuring much of the original walling. The principal post, supporting beam 2 from the north end, had clearly been reused containing a number of empty mortices. The wooden doorway within the southern wall was Tudor in style with a false four-centred arch and carved decorative infill in the spandrel between the shoulder and opening. The simple

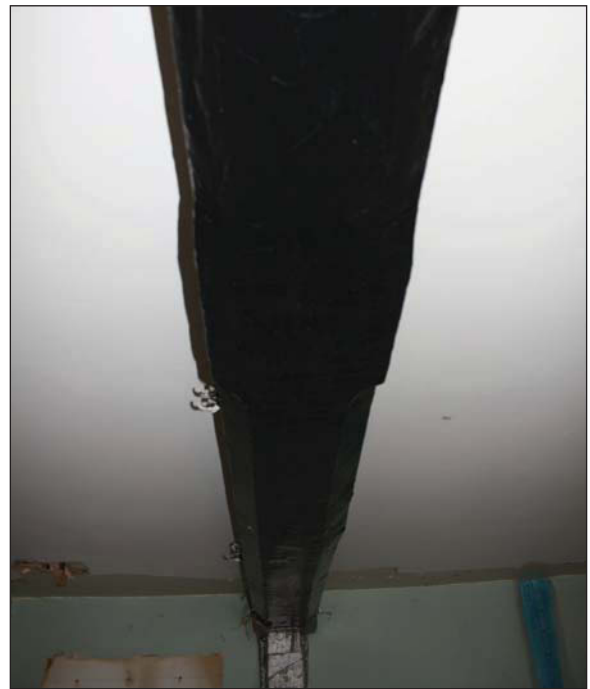
Plate 5. Room 4, Chamfer stops on beam

moulding on the jambs of the frame extended to the bottom (Tudor examples often stop two-thirds of the way down). Within the room were four beams, aligned east-west; the northern most one on the line of the dividing wall between rooms 4 and 5 and the southernmost one just to the north of the malt kiln wall, indicating change to the walling within this area; possibly removal of the original rear wall of this room or a loss of more bays to the south. The beams themselves appeared to sit on top of the principal posts and were chamfered on both sides. The chamfers were complex in nature with a central 'square' on the beam not chamfered and basic stops (Pl. 5).

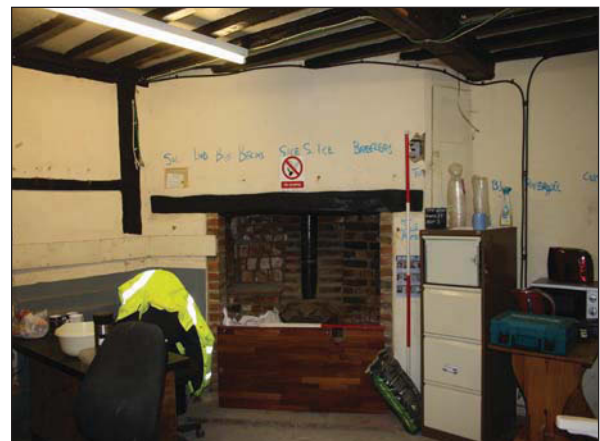
Plate 6. Room 5, fireplace

Room 5 was of an irregular shape with a chimney breast in the north-west corner and a blocked doorway in the north-east alcove. Timber box framing was again present in the western wall and the timbers were exposed on the reverse of the dividing wall between rooms 4 and 5. The ceiling consisted of a central chamfered beam, aligned north-south, into which the joists were tenoned. The fireplace was a corner inglenook, back-to-back with one within number 18 Hart Street (Pl. 6). A timber lintel was located above the opening and within the east side of chimney breast was a cupboard door. The inglenook itself clearly showed a number of modifications with the use of different bricks and tiles to form that present on the day of the survey. In general the bricks measured 213mm x 96mm x 68mm (8 3/8" x 3 3/4" x 2 5/8") and had been re-pointed with cement mortar.

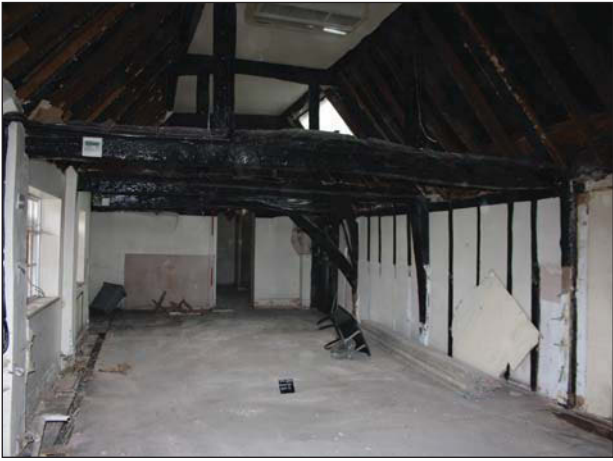
Plate 7. Room 12 looking south-east

A single room (room 12) was located above rooms 4 and 5 on the first floor and could be sub-divided into four unequal bays, corresponding to the sub-divisions on the ground floor. Within the western wall were approximately equally spaced timber posts between the principal posts and supporting the wall plate. The four tie-beams rested on the principal posts on the western wall and on projecting piers within the modern eastern wall (Pl. 7, Fig. 14). The shape of the remaining principal posts varied with differing sizes of jowled heads. Tie-beam 3, from the north, also retained a wind brace; the only one to do so. The roof structure consisted of queen-post construction with the raised collar supporting the purlins, above which the ceiling had been enclosed. Within the northern wall was an alcove, matching that in room 5 below and formerly allowing access to the rest of 18 Hart Street and in the north-west corner was a fireplace, set at an angle to the room at floor level, but rising to a square-on stack above, as seen from the exterior (Pl. 8). The chimney breast itself had largely been filled in, plastered over and a smaller cast iron register grate of likely mid 19th century date inserted.

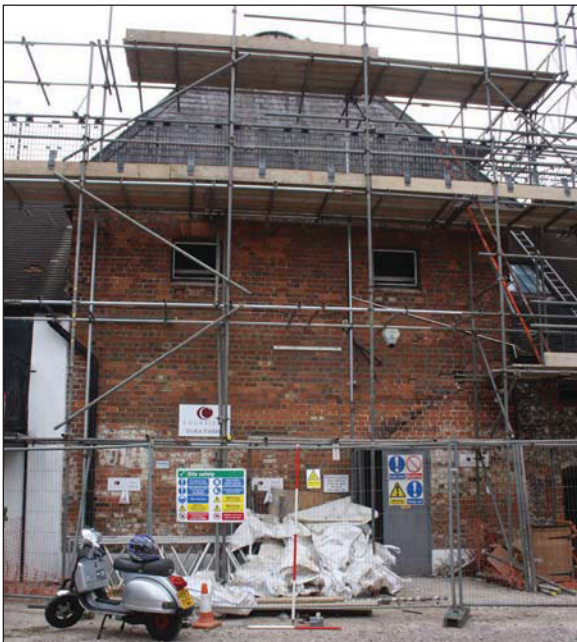
Plate 9. Drying kiln, looking north-east

The malt kiln was not quite square in plan and surrounded by the other buildings on three sides (north, east and south). Only the west face was visible externally (Pl. 9). The malt kiln was brick-built in English bond with the bricks measuring 220mm x 105mm x 67mm (8 5/8" x 4 1/8" x 2 5/8") and bonded in lime mortar. Set within the

wall were a doorway and two windows at second-floor level beneath brick arches. At the north end of the ground floor was evidence for a blocked window, also set beneath a brick arch. The roof was pyramidal in shape and covered in slate tiles.

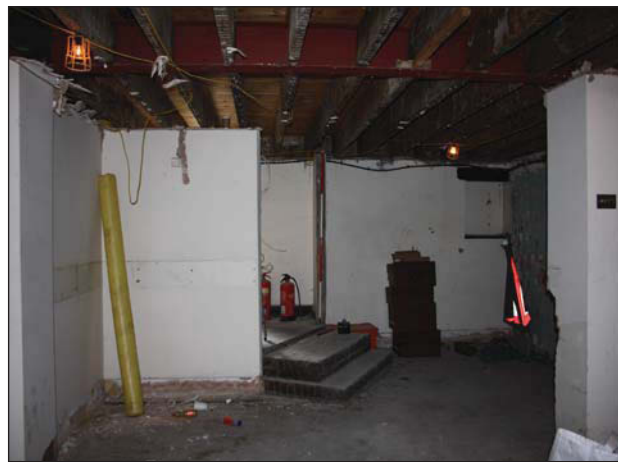
Plate 10. Room 3, kiln steps looking south-west

Internally the space had been divided across three floors of one room each (3, 8 and 9, corresponding to ground, first and second). The ground floor was partially sub-divided to accommodate the staircase in the south-west corner of the room (Pl. 10). The stairs were located on a raised platform with access to the main part of the room down two steps of brick construction with the bricks laid on edge. The stairs themselves were modern, consisting of a simple timber plank construction and wooden hand rail. Within the north wall was access to room 4, whilst in the east wall were two openings into room 6 and a blocked window at the north end of the wall. The first floor was a more recent insertion, supported on a steel RSJ aligned north-south across the room and supported on a brick pillar. The floor joists consisted of planks laid on edge, meeting at the RSJ.

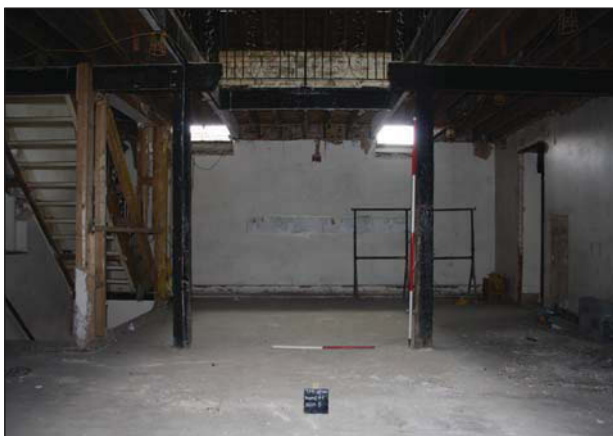
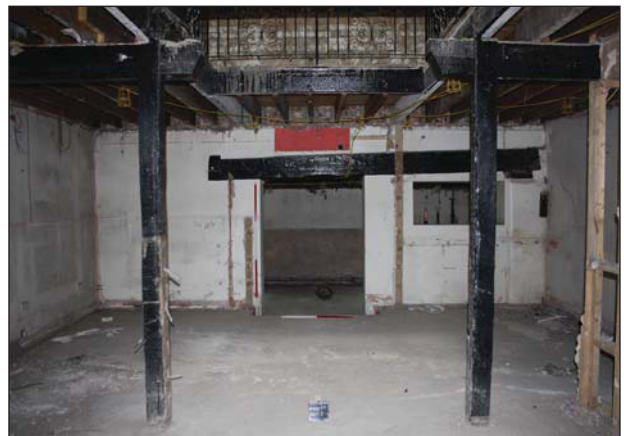
The first floor (room 8) contained the staircase to the second floor, located above the one accessing the first floor. All the walls had been plastered and painted white and within the north wall was access to room 12. Within the east wall was a large opening beneath a substantial timber lintel (Pl. 12), likely to represent a reused earlier timber. The opening gave access down two steps to room 10. To the south of the opening was a window. The bottom halves of the two windows within the west wall were also visible, letting in some natural light. The second floor was supported on a pair of posts towards the centre of the room which in turn supported a beam above which the joists were laid (Fig. 15). The beam was actually in two pieces with chamfered ends to create a central light-well.

Plate 11. Room 8, looking south-west

Plate 12. Room 8, looking north-east

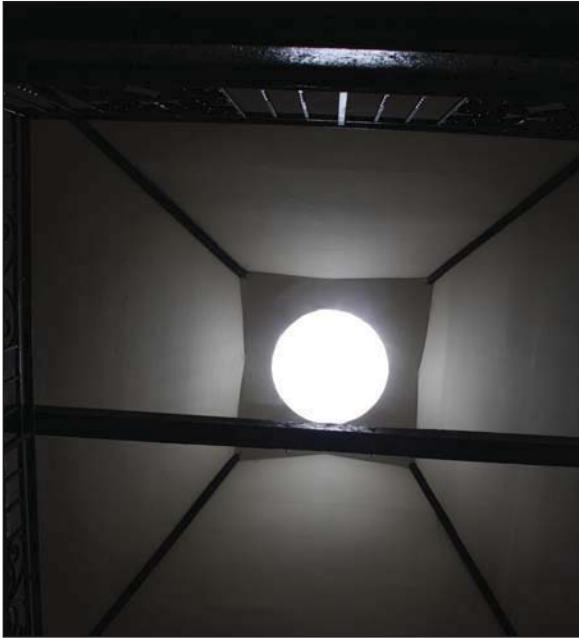
Plate 13. Room 8, roof space

The second floor (room 9) occupied the roof space of the malt kiln and consisted of a walkway around a central open light-well (Pl. 13). Both the stairwell and light-well were fenced with black wrought-iron railings with a combination of twisted balusters and stylized butterflies placed one above the other (Pl. 14). On top of the walls was a wooden wall plate, upon which the roof was placed. Roof construction consisted of hip and jack rafters laid on edge, supporting a purlin upon which were set further rafters which had mainly been plastered over and in turn supported a central roof-light.

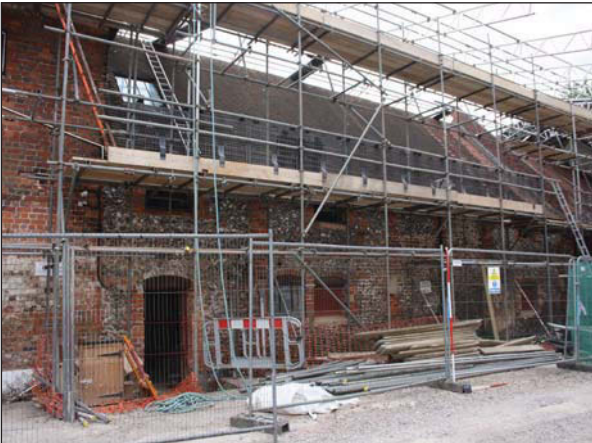
Plate 15. Rear range looking east

The west elevation was a mixture of brick and flint construction at the northern end (Pl. 15) before becoming entirely brick-built at the southern end (Pl. 16). The flint walling was roughly coursed with brick 'pillars' sub-dividing the bays and brick 'quoins' around the doors and windows. In general the bricks measured 215mm x 102mm x 58mm (8 ½" x 4" x 2 ¼"). Between bays four and five was a brick gable that extended above the height of the roof; it also formed the internal division between the rooms. To the north of this division were three windows and a door on the ground floor and three windows on the first floor. On the ground floor the door and windows were set below a brick arch in which the bricks had been laid on edge. On the first floor the windows were set beneath the roof line. Within bay four and beyond to the south, dentillated brickwork was present beneath the eaves. Beyond the brick gable there was a further bay of approximately equal size as bays 1-4 (numbered north to south) in which was located a door at both ground- and first-floor height. It was at this point that there is a change in angle of the west wall, so that it is orientated to face east, increasing the width of the building. Bays 6 and 7 were smaller, with a change in the roof structure occurring at truss 7. Within bay 7 was a window on both the ground and first floor; the same as those to the north. The flint walling continued for another half a bay at which point there was a disjuncture between the end of the flint wall and the start of the brick wall. It is possible that this change in construction materials mid-bay represents the removal of an earlier hipped roof to accommodate the brick extension.

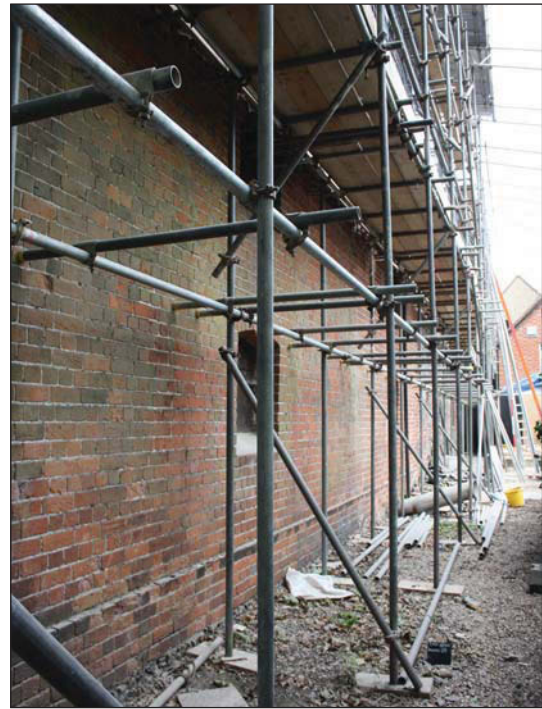
Plate 17. Rear range looking north-west

The eastern elevation (Pl. 17) was of the same construction as that of the western elevation with the same division between the flint and brick constructions. Within the brick built part were four windows; two on the

ground floor and two on the first floor. Within the flint part were three windows and a door on the ground floor and four windows on the first floor. The northern end of this range then became the internal dividing wall between this and the eastern range.

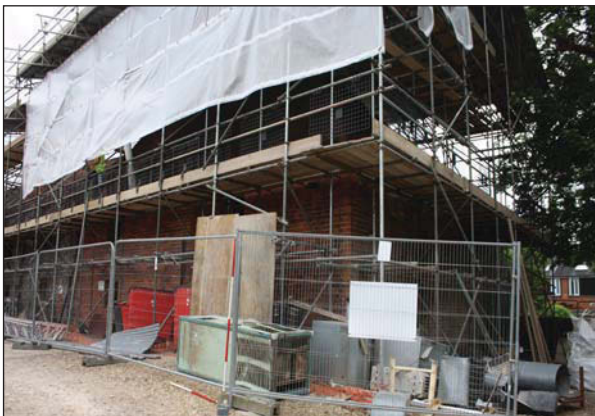
Plate 16. Rear range looking north-east

The southern end of the west elevation was brick-built, laid in English bond with lime mortar, with the bricks measuring 225mm x 105mm x 70mm (8 7/8" x 4 1/8" x 2 ¾"). There were two windows within this section on both the ground and first floors. Like the windows to the north, the ground floor windows were set beneath a brick arch, but in this case constructed with a double row of bricks laid on edge. The windows also had a splayed window sill externally on both the ground and first floors. The south elevation was entirely brick-built and contained two windows and a door on the ground floor and a single door and window on the first floor. The door on the ground floor appeared to be a later insertion with a timber lintel rather than a brick arch above it and broken bricks down the sides.

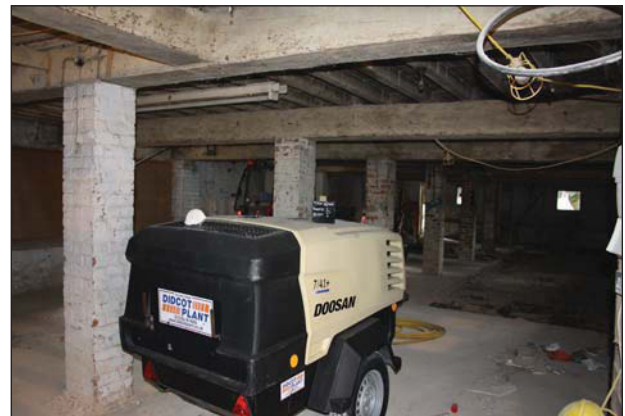
Plate 18. Room 1 looking south-east **TMH 15/169**

Internally, on the ground floor, the space was sub-divided into two rooms, at the point of the mid gable rather than at the division between the different construction materials. Room 1 was located at the southern end of the building and consisted of a large open space with a concrete floor and a concrete ledge running around the wall edge (Pl. 18). The space could be sub-divided into eight bays of differing sizes (numbered 5-12) and the beams were seated on brick piers projecting from the external walls and a central line of brick pillars. The beams themselves were all chamfered, though some only had a slight chamfer whereas others were fully chamfered. The joists were tennoned into the beams. Within bay 8 a staircase had later been inserted, but had been removed at the time of the survey.

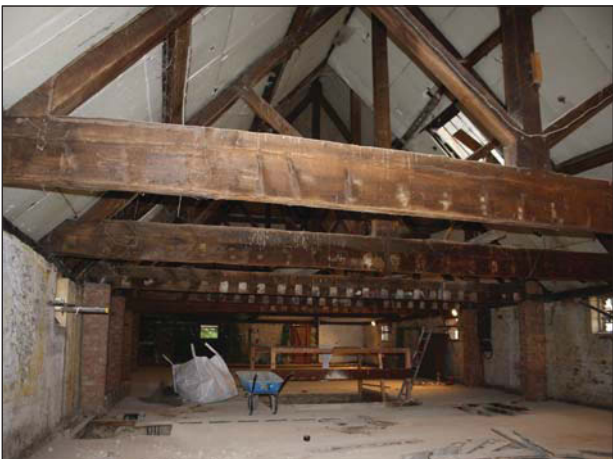
Plate 21. Room 14, looking south-east

On the first floor, the same divisions were present as those on the ground floor. Room 14 was located above room 1, but was inaccessible on the day of the survey due to an unsafe floor. It was however sub-divided into 7 bays (one less than on the ground floor due to the hipped roof). The trusses were supported on a mixture of brick piers and on the wooden wall plate (Pl. 21). All however were of the same type – king-post construction

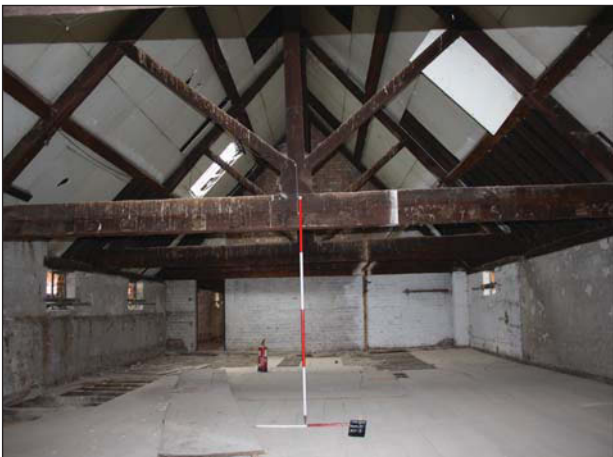
Plate 23. Room 13, looking south-east

Within room 13, located above room 2, were four bays (Pl. 23). Within bay 2, on the eastern wall was a blocked doorway that may have provided access into room 10 (the eastern range). The trusses were the same as those within room 14 and were again supported on a mixture of brick piers and the wall plate. Carpenters' marks seen on the trusses within this room were more clearly chiselled (Pl. 24).

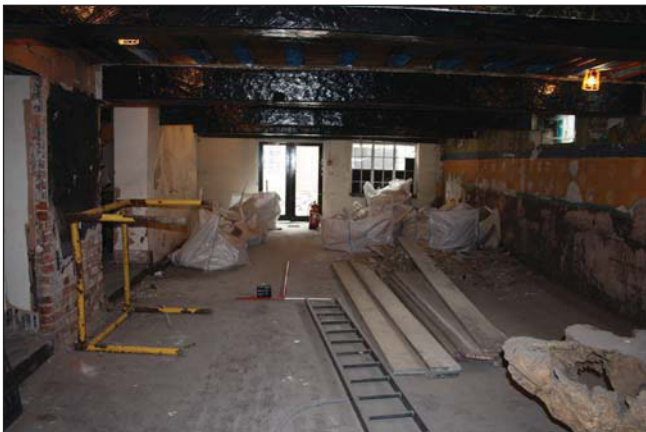
Plate 25. Room 6, looking north-west

Internally the ground floor was sub-divided into eight approximately equal-sized bays (again, numbered from north to south), with bay 1 at the northern end extending around the malt kiln (Pl. 25). Within bay 7 a more recent wall had been inserted to create room 7 to the south (Pl. 26), whilst on the north side of the wall a simple staircase had been inserted. The beams themselves were square in section and had been painted black. Some of the beams had empty mortices suggesting reuse. The joists appeared to be more recent replacements that were laid above the beams on edge. The walls themselves had been plastered and in the east wall were two windows whilst in the west wall there was access to the malt kiln and room 4.

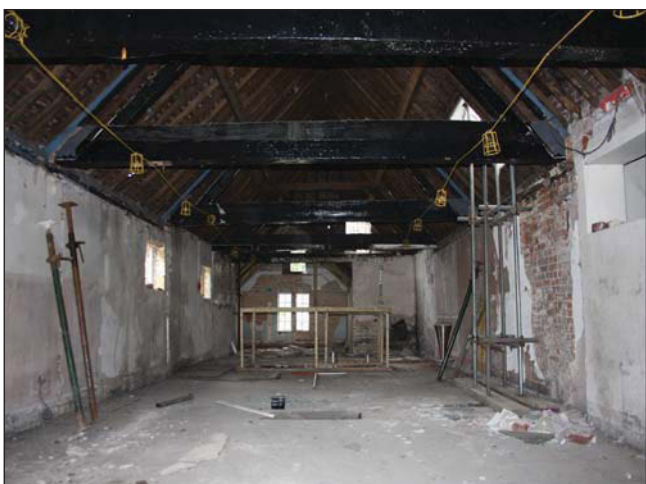
Plate 27. Room 10, looking south-east

The first floor (Pl. 27) could be sub-divided into seven unequal bays, with bays 5 and 6 being larger than the others. Within the east wall were four windows and within the west wall was access to the malt kiln and room 12. The roof itself was of complex construction with a gable end at the south end of the room, but where the room wrapped around the malt kiln, the east roof was hipped. The north-south aligned roof consisted of seven trusses, including the one in the gable end. The trusses were a variation on a raking queen strut type with the queen struts parallel to the principal rafter which supported the collar on which sat the purlins (Pl. 28). Roof construction within the east-west aligned hipped roof contained three trusses of the more classic raking queen strut type.

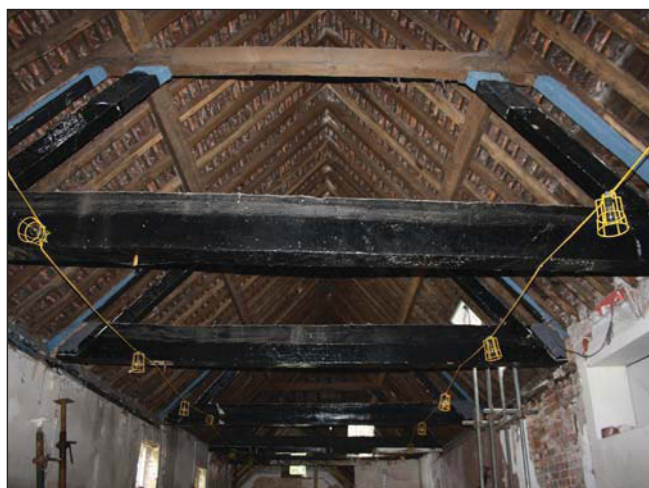
Plate 28. Room 10, roof truss

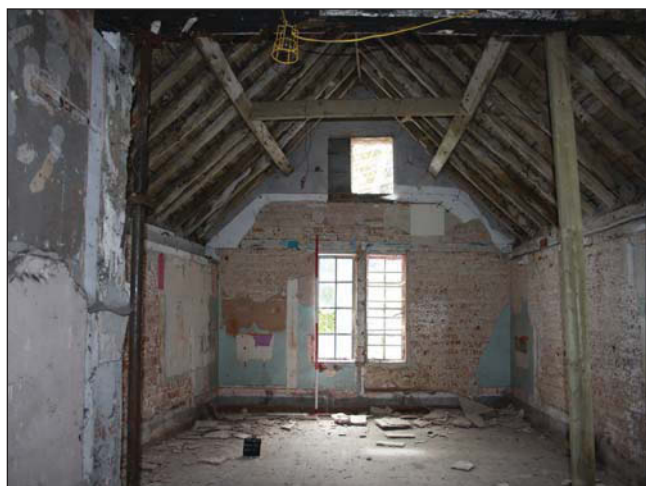
Plate 29. Room 11, gable end, looking south-east

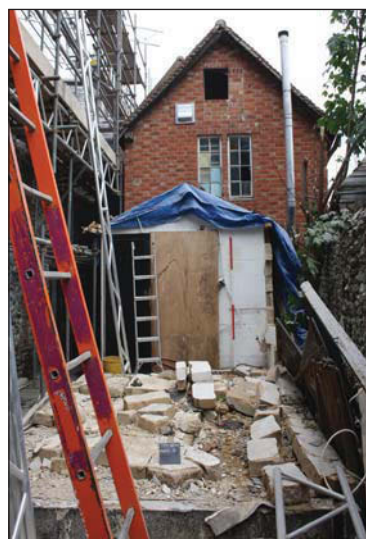
Plate 30. Rear exterior, looking north-west

The modern extensions were located beyond room 7a along the eastern side of the building and had been partially demolished (Pl. 30). A former toilet and anteroom were still present but the room to the south remained only as a concrete floor. Historic planning consents shows this to have been a bottle store built around 1985 (P85/S0367/LB). Both had been built using concrete blocks with internal block walls. The remaining roof over
