**Sterling Industrial Estate,
Kings Road, Newbury, West Berkshire**

Building Recording

**Building Recording
For PSP Consultants Ltd**

Site Code SIE 16-41

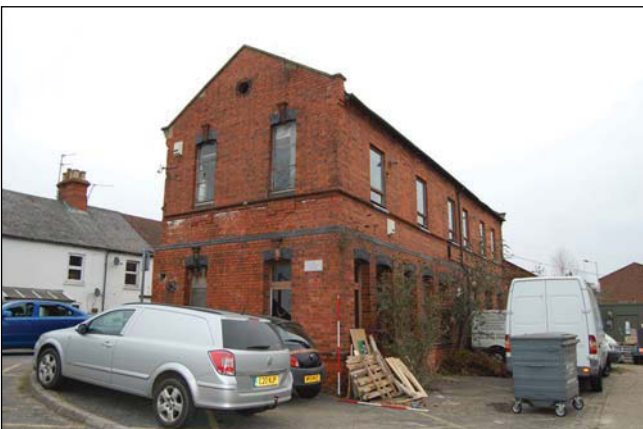
The west elevation has a small oculus window surrounded by header bricks. Two first floor metal-framed three-light windows have blue brick sills and soldier arch lintels with small moulded red brick brackets in a Classical style. The ground floor windows are the same as those above, however the metal frames and lights have been replaced with more recent wood framed two-light windows. Above these (though higher than the level of the first floor) is a projecting plat band of moulded bricks, with an unusual curved, slightly pointed profile. At first floor level, the blue coping course continues from the north elevation.

Plate 3. Exterior, The Counting House, looking north east,
Scales: 2m and 1m.

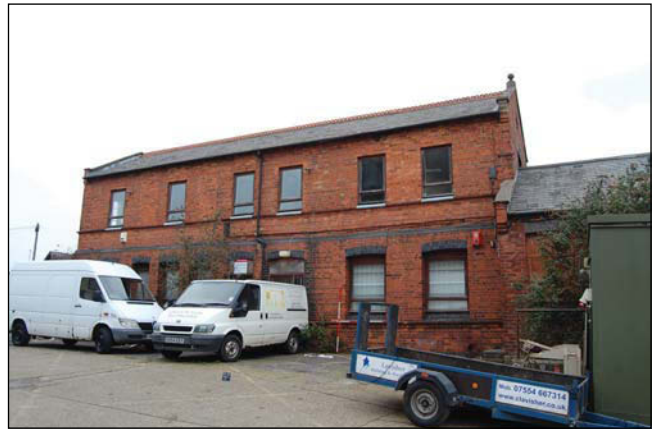
The south elevation is broadly symmetrical and has 6 modern wood-framed two-light windows at first floor level, and the plat band and blue coping brick course continues across the elevation (Pl. 4). A second plat band continues across this elevation above ground level at the west end, with the ground level sloping down at the east end of the elevation. Two areas of replaced brickwork at first floor level indicate removed windows between those at the west of the elevation. At ground floor level, the windows have blue brick double soldier header arch lintels, and again the window frames are modern wooden two-light replacements. A door at the west end has a matching blue brick double soldier header arch and a modern wooden door with security bars.

Plate 4. Exterior, The Counting House, looking north,
Scales: 2m and 1m.

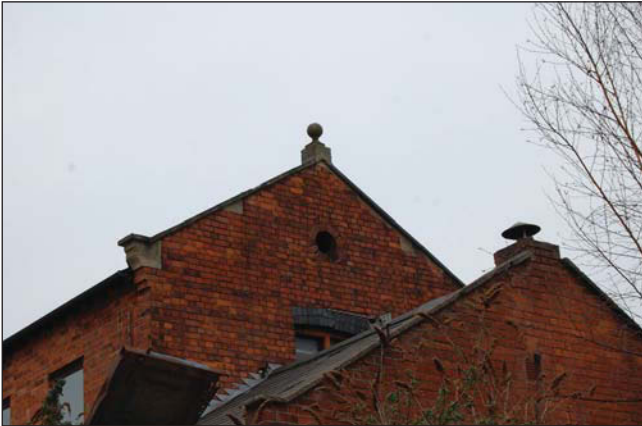
The Counting House is on an east-west axis, with its north elevation fronting Kings Road.. It has a single pitched slate-tiled roof with gable ends and decorative pierced red clay ridge tiles. The east end of the ridge has a stone finial and both ends have stone corbels at the eaves, with simple moulding (Pl. 3). At the southwest, the stone corbel is missing and has been replaced with brickwork. The walls are polychrome brickwork (red, with occasional blue) laid to an English bond.

Plate 5. Exterior, roof gable detail, looking north west.

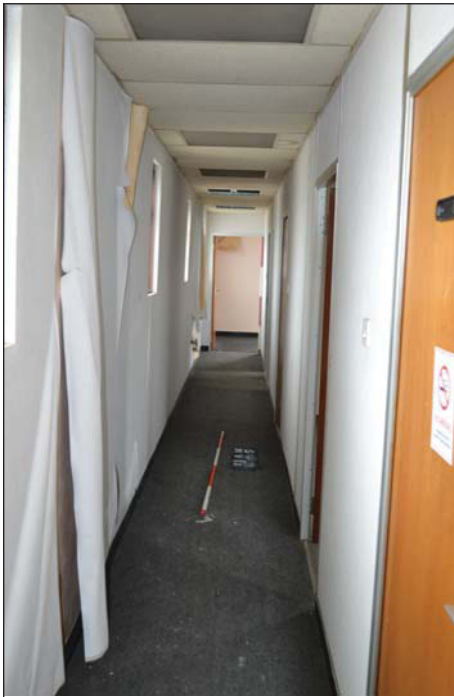
From the west end of the ground floor, a stairwell with three steps leads to a half-landing and straight flight from south up to north where a corridor runs the length of the north side of the first floor (Pl. 11). This floor is

Plate 11. Interior, Counting House first floor corridor, looking east, Scale: 2m.

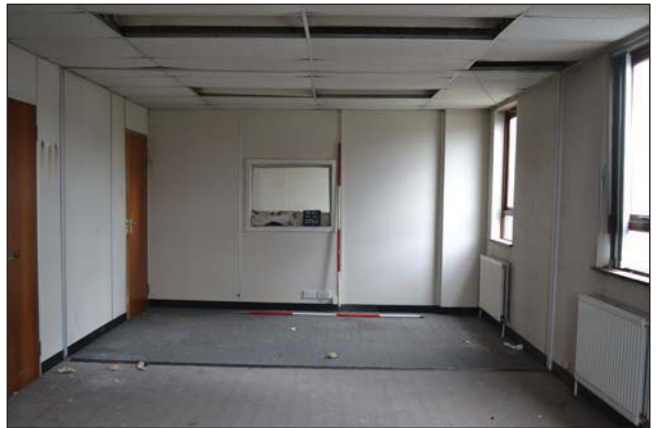
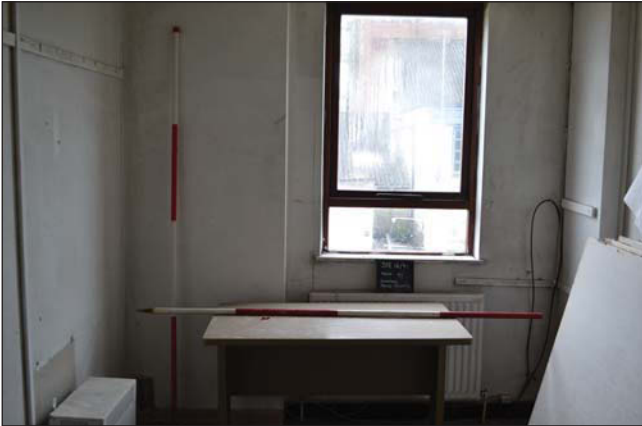
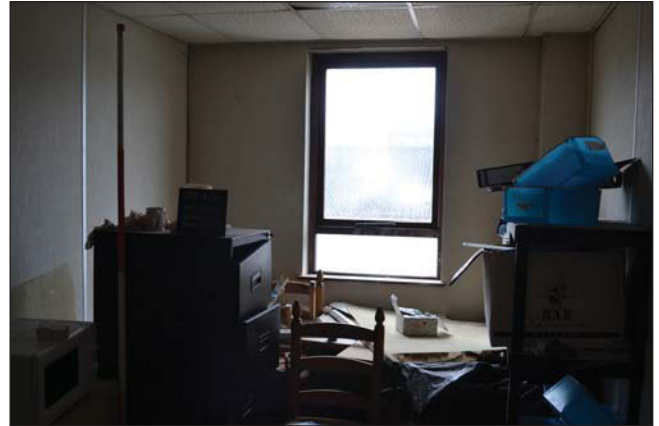
separated into four rooms, with brick walls between room 6 (Pl. 12), room 7 (Pl. 13) and room 8 (Pl. 14) and room 9 (with a modern inserted stud wall between rooms 7 and 8). Again, the walls are plastered and no original features were observed, with the exception of the wood framed four-light fixed window at the east of room (Pl. 15).

Plate 12. Interior, Counting House first floor, room 6, Scales: 2m.

Plate 13. Interior, Counting House first floor, room 7,
looking south south east,
Scales: 2m.

Plate 14. Interior, Counting House first floor, room 8,
looking south, Scale: 2m.

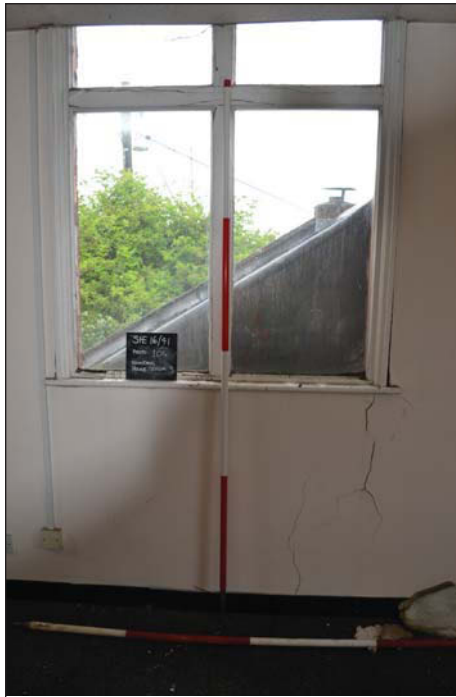
Plate 15. Interior, Counting House first floor, room 9,
looking south, Scales: 2m.

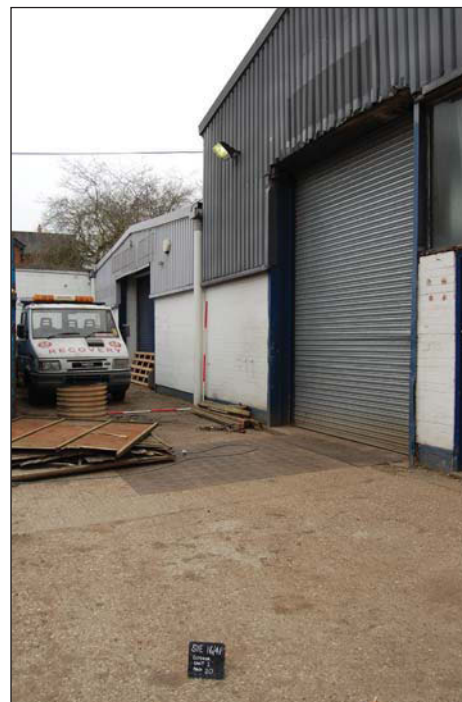
Due to the site layout, only the front elevations and interiors of these buildings are accessible (Pl. 16). These buildings are aligned approximately north-south, and comprise painted brick (laid to a raking stretcher bond) and breeze-block structures, single storey, with the upper part comprising metal and glass. The roof is corrugated steel and the buildings are of 1960's or later construction.

Plate 16. Exterior, Unit 1, looking west,
Scales: 2m.

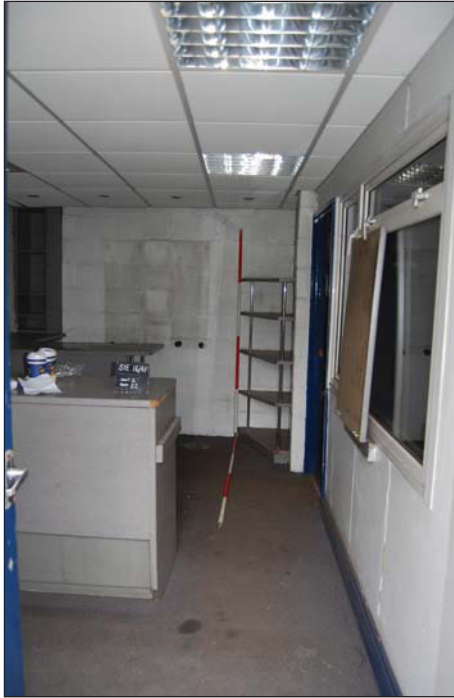
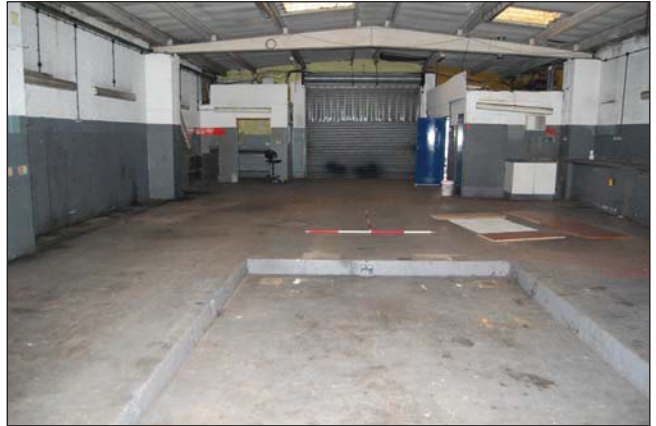
The brickwork is painted and the interiors of these have sub-divisions to form office space and workshop space (Pl. 17) at the south, with the majority of each unit one workshop space (Pl. 18).

Plate 17. Interior, Unit 2, looking west,
Scales: 2m.

Plate 18. Interior, Unit 2, looking south, Scale: 2m.

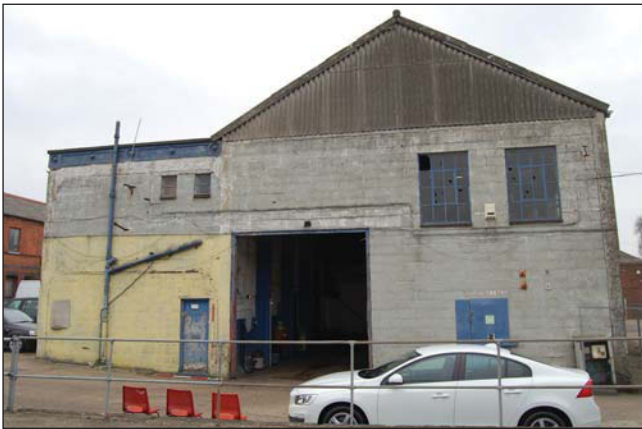
The west elevation (Pl. 19) is of breezeblock, with the original wall at the north with a decorative plaster band at the roof line. This has recessed panels and roundels, reminiscent of ironwork, and is painted blue. The first floor has two small two-light metal framed windows in the northern part, and at the south, a pair of large metal-framed 16-light windows, each with the four central panels forming a side-opening casement. At the centre of the elevation, a wide full height doorway with metal shutters gives access to the interior, and to the left of this is a low brick buttress. The south elevation has five 16-light windows at the upper level, and a smaller window at ground floor level, which has been bricked up.

Plate 19. Exterior, Unit 3, looking west,
Scales 2m.

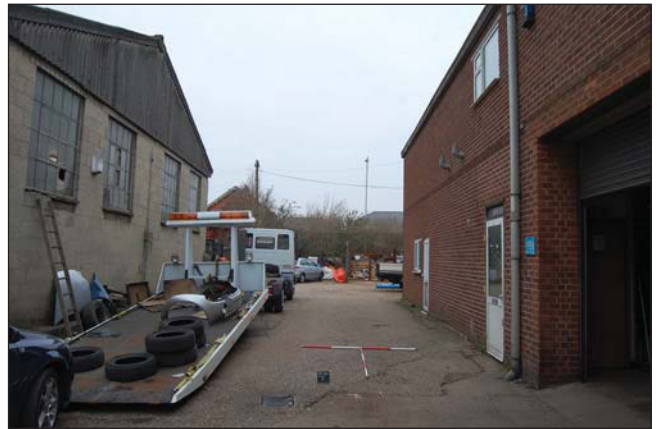
two small two-light windows. The east elevation comprises a plain breeze block wall with four metal-framed windows each of 16 lights (Pl. 20).

Plate 20. Exterior, Unit 3 and 4, looking north,
Scales: 2m.

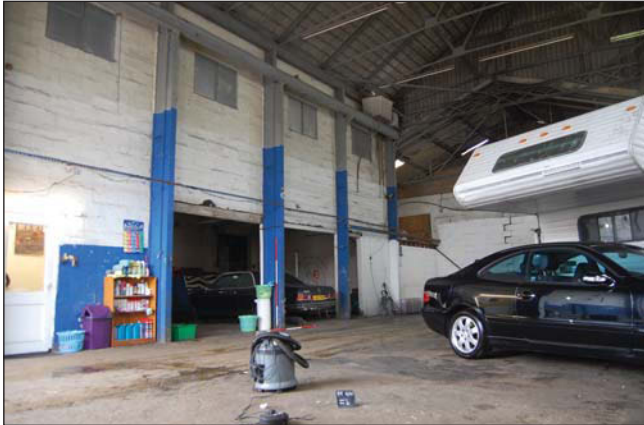
The interior of the building (in current use as a car wash) has a concrete floor and steel columns supporting steel joists forming the roof structure, and more recent partitions within the north-western corner to form an office space (Pl. 21).

Plate 21. Interior, Unit 3, looking south west,
Scales: 2m.

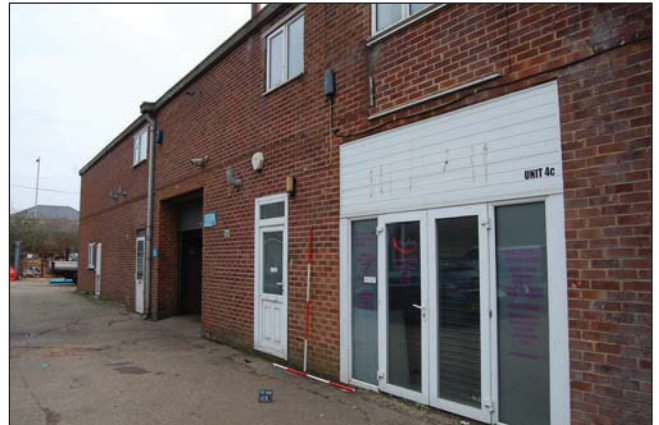
This building is on a north-south axis, with the west elevation facing the estate (Pl. 22). The building is divided into four two-storey units, and is uniformly modern red brick construction throughout, laid to a stretcher bond. Externally, it lacks any detail and has relatively recent windows and doors.

Plate 22. Exterior, Unit 4, looking north east,
Scales: 2m.

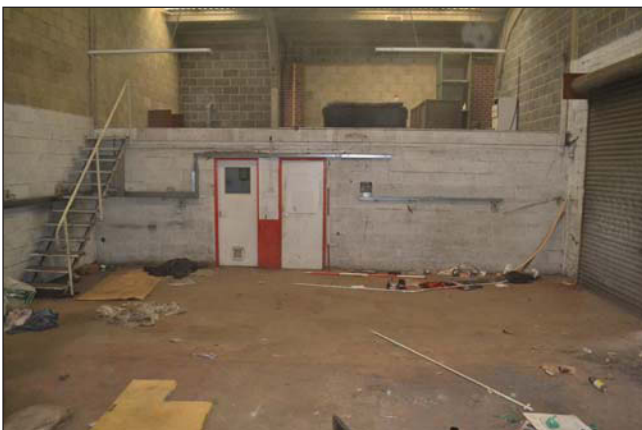
The units were constructed in the 1970's or 1980's and all are bare concrete, laminate or linoleum floored and are bare brick or plastered throughout, with no internal detail of note. Internally, each unit is divided and partitioned into workshop space, with the exception of 4a, which comprises one large space with a mezzanine area at the south (Pl. 23).

Plate 23. Interior, Unit 4a, looking east,
Scales: 2m.

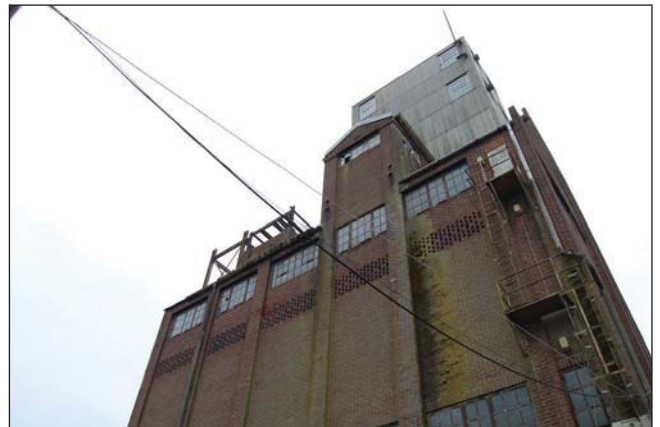
The footprint of this building is rectangular overall, however it comprises a range of buildings, divided into two main blocks joined by a corridor. At the east is the tower building, which comprises a single large brick built block, which is of likely 1940's or 1950's date. It is largely of stretcher bond, with blocks of English bond incorporated into the design, as seen on the east elevation (Pl. 24), which also has a steel frame structure adjoining it. The main part is four stories high, with a central fifth storey from which the steel frame of the tower rises a further four storeys. The north elevation includes seven broad, shallow buttresses, with two wide metal shuttered doors at ground level (Pl. 25). At second storey level are five sets of windows, all with flat soldier arches. The easternmost of the windows comprises a central six-light central set, flanked by nine-light sets. This pattern is reversed in the window to it's right, with a set of nine flanked by sets of six lights. These two types alternate across this storey, with the exception of a single window of six lights at the western end (Pl. 26). Here,

Plate 26. Exterior, Unit 7 upper, looking south.

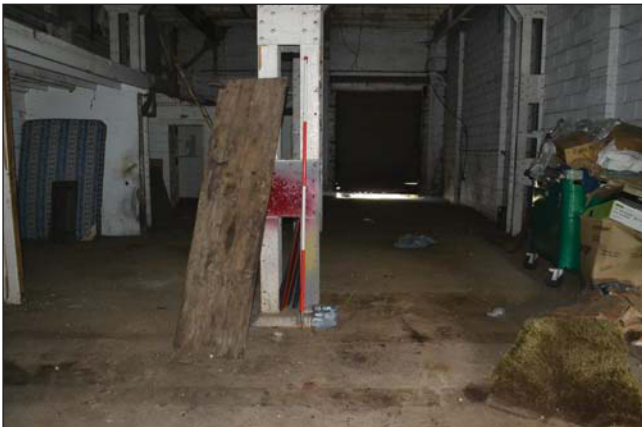
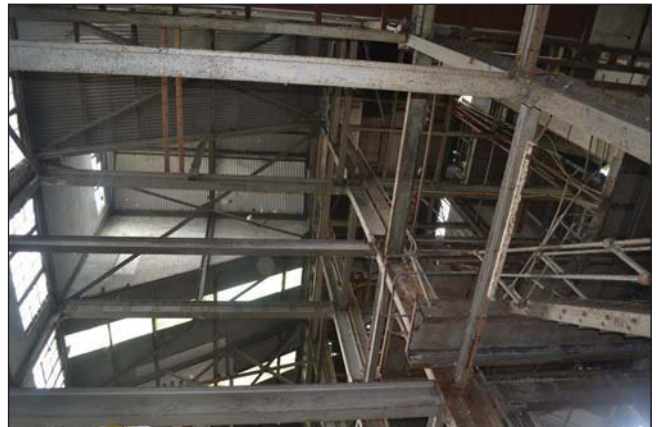
The interior of the tower building consists of an open concrete-floored space with steel girders extending the full height of the space and supporting the steel framing above (Pl. 27). The walls are white-painted bricks and several windows have been infilled with breeze blocks while the east wall appears to have been rebuilt or reinforced with breeze blocks. At the west, brick built partitions support a first floor level, from which a metal gives access to the tower. For reasons of health and safety, the upper part was not accessible but was photographed from below (Pl. 28).

Plate 27. Interior, Unit 7, looking north,
Scale: 2m.

Plate 28. Interior, Unit 7 roof structure.

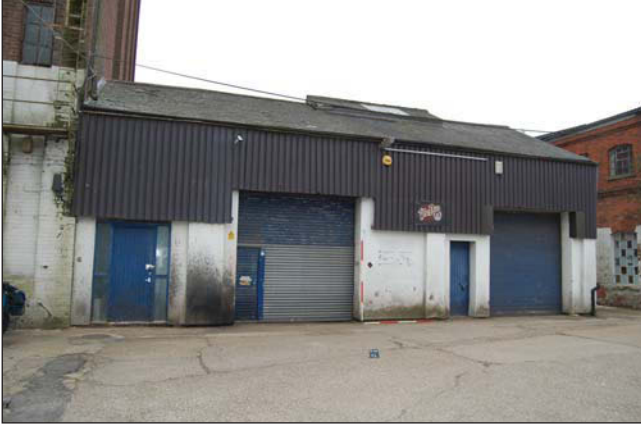
To the west of the tower building (and of separate construction), this section of the elevation is brick built and rendered, clad with corrugated steel at first floor level (Pl. 29). It is divided into two units, each with a wooden door and a metal shuttered door, between which are shallow buttresses. The roof is slate-tiled, with a raised section of corrugated steel and a skylight window.

Plate 29. Exterior, Unit 7, looking south,
Scales: 2m.

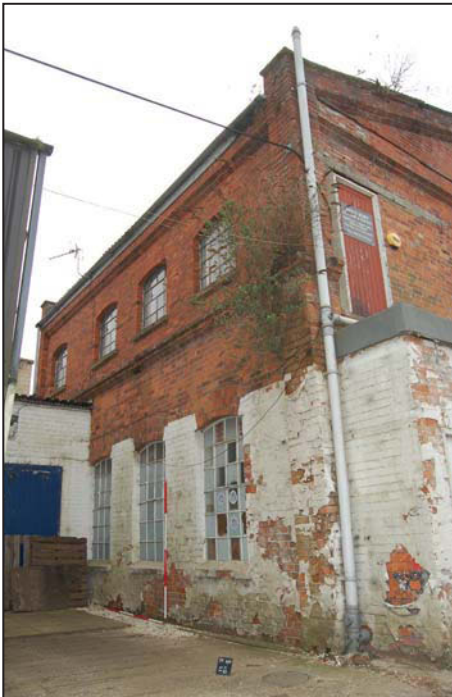
The west elevation of this portion of the building consists of a gable end, with red bricks laid to an English bond, a recessed panel at the gable and a shallow central buttress below. Two bricked up doorways have double soldier header arches with a central keystone (Pl. 30). Set centrally in the gable is a date stone of 1902, though the finish of the brickwork surrounding this suggests it may have been inserted or reinstated more recently (Pl. 31).

Plate 31. Exterior, Unit 7, looking south south east,
Scales: 2m.

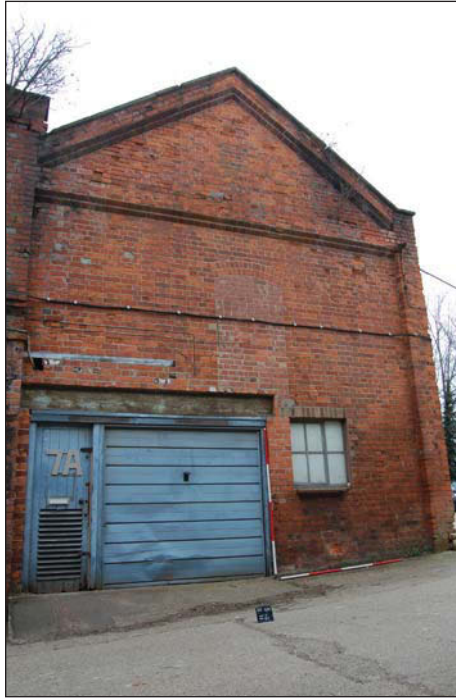
The north elevation of Building 7 (west) comprises two units, rectangular in plan. It has two storeys, with a broad, pediment-like gable and is slate-tiled (Pl. 33). The bricks are red and laid to a Flemish bond, with a double string course above the first floor level and a triple string course above the ground floor. At first floor level, four windows (each of 9 panes under a curved concrete lintel and header soldier arch) survive, while the window at the east has been blocked and replaced with a more recent door. Beneath which is a single storey brick built (stretcher bond) small bay extension to the north with a door and window with a soldier course above each.

Plate 33. Exterior, Unit 7a, looking east north east,
Scales: 2m.

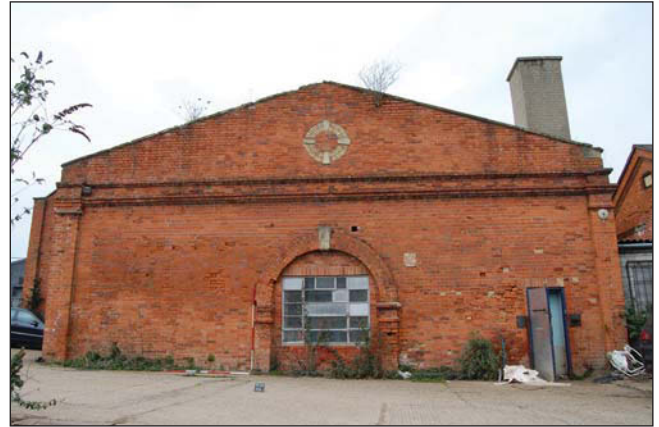
The south elevation of building B (Pl. 34) comprises the broad, pediment-style gable, mirroring the north elevation. There is string course, with a double string course below, and a small central oculus window circled with a double course of pale yellow headers and four small trapezoidal keystones.

Plate 34. Exterior, Unit 7a, looking north,
Scales: 2m.

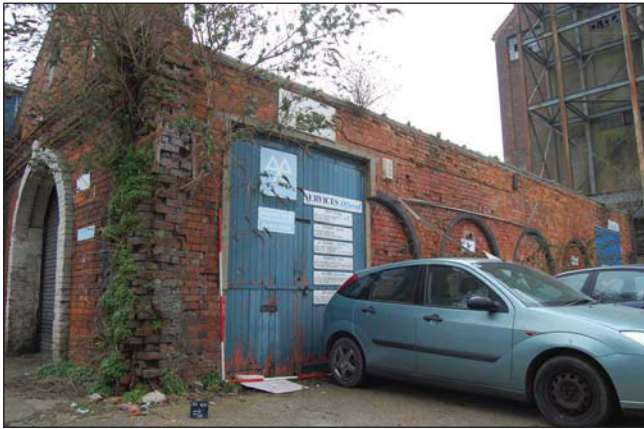
The north elevation of the building is polychrome brickwork (in poor condition), with a series of 5 blind arches with a course of bullnose blue bricks at the underside of each arch (Pl. 41). One arch at the east and one at the west are truncated at the east and west by two wide wooden double doors under concrete lintels.

Plate 41. Exterior, Unit 8, looking south west,
Scales: 2m.
