**Quebec Barracks, Camp Road,  
Bordon, Hampshire**

**Building Recording**

**Site Code: QBB15/217**

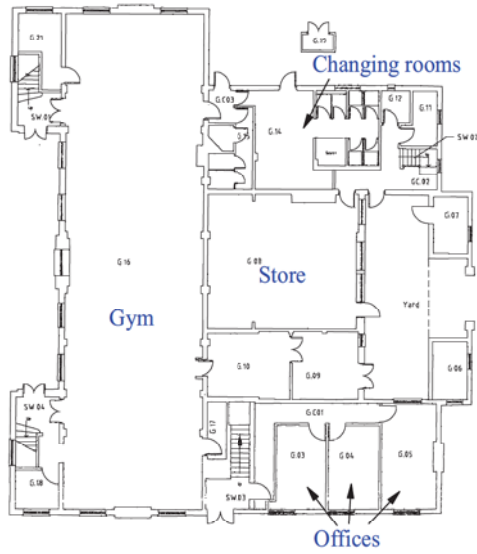
Figure 4. Q3 - Education Block

The education block was one of a pair built between 1910 and 1937 according to map evidence. It was roughly square in shape with projecting wings. It was built using brown bricks laid in stretcher bond with cement mortar. Detail was emphasized with orange bricks - a plat band of bricks stood on end, in line with the ground floor windows, bricks stood on end above the windows and a second band just below the roofline (Pl. 9). The windows were all modern, white plastic replacements with mock panes. The roof was complex in design, reflecting the shape of the building with projecting wings on the corners. Each individual part was, however, hipped in design, and covered with slate tiles. A porch had been added above the main entrance on the south side, constructed of brick and glass (Pl. 10). The entrance on the opposite side of the building (north) had been reduced in size with what appeared to be a window removed. The walls to the yard area and the two store rooms on the east side may be a later addition using the same bricks but laid in English bond (Pl. 11).

Entrance to the block was via a pair of wooden panelled doors, located in the centre of the south wall of the block. Immediately upon entry was a set of stairs giving access to the first floor (Pl. 12). To the right was a further door accessing an internal corridor giving access to three offices (Fig. 4; Pl. 13), a chimney breast was

The rest of the rooms within the building were inter-linked with access from external doors from the yard (east side) as well as the north and two doors on the south side. The entire width of the south side of the building was given over to a gym (Pls 14–15), the two projecting wings contained a set of stairs to the first floor. Changing rooms (Pl. 16) were located on the west side of the building with a further set of stairs, whilst within the centre of the building, overlooking the yard area (Pl. 17) was a store, an office and a further changing room.

The south-east side of the first floor was the same layout as that below – three offices. The north side of the building was sub-divided into seven rooms, including a kitchen, gym, stores and a conference room. Above the changing rooms, on the west side of the building was a self-contained area including a kitchen (Pl. 18) and three store rooms.

Decoratively the building was plastered and painted in various colours with a carpeted floor; the toilets and changing rooms were tiled. It was possible to see some remains of original features such as wide skirting boards, coving and original four-panel doors (Pls 19-20). All of the original fireplaces had been removed and blocked up (Pl. 21).

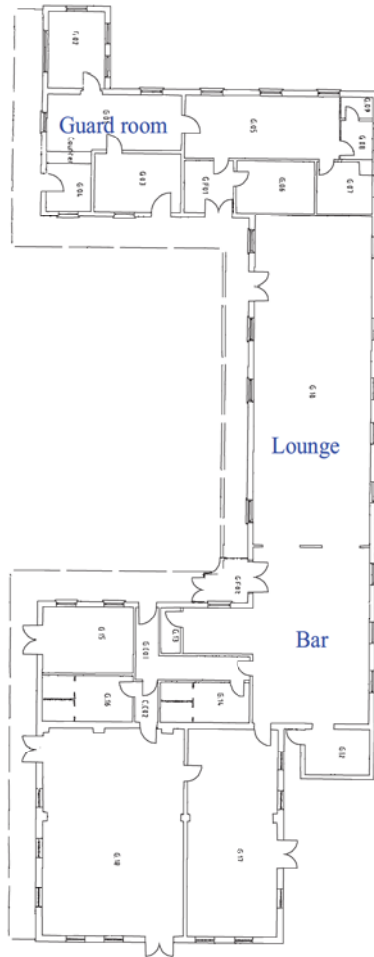
Figure 6. Q5 - Junior Ranks Club

The Junior Ranks Club/Guard Room was built slightly later than the majority of existing buildings at Quebec Barracks, dated from map evidence between 1937–1961. Stylistically it was built in a similar style to the earlier buildings with the same stretcher bond brickwork and vertical bricks above the windows (Pl. 31). The roof was also hipped, but notably covered in ceramic tiles rather than slate tiles. In plan form the building was ‘U-shaped’ with a wing at either end projecting to the west. Around the west side of the building was a covered canopy supported on brick pillars. The building has been extended to the south, clearly seen where the covered canopy does not continue round the extension (Pl. 32). Within the centre of the ‘U’ were a small number of car parking spaces and a raised flower bed (Pl. 33). Within the central wall was a double door and evidence for a blocked door, beside which was a red-painted boot scraper set into the concrete (Pl. 34).

Internally the building was plastered and painted in various colours with a modern, suspended ceiling. The largest room, G.10 consisted of a bar and lounge area (Pls 35-36), located on the east side of the building. The wing to the north was dedicated to the guard room and was separate from the rest of the building. As well as the main guard room (Pl. 37) the rooms were used as stores, sleeping accommodation, a kitchen and toilets. Within room G.01 was a plywood gun rack (Pl. 38). The wing to the south consisted of a store and toilets. The newer extension contained two rooms (G.17–18) of unknown function.

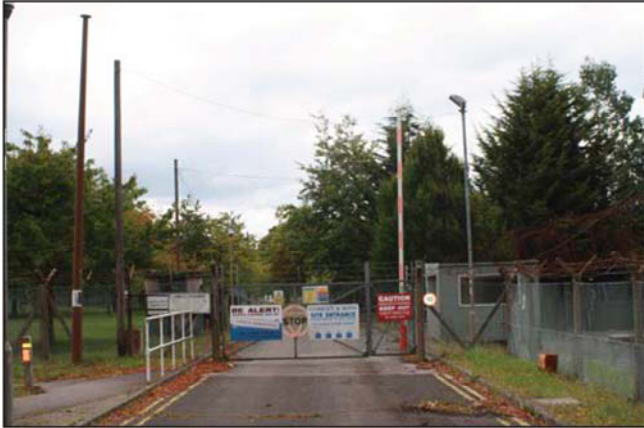
barbed wire (Pl. 1). To the west, outside of the site was a Tarmacked car park. Immediately beyond the gate was a boom barrier. To the east was block Q10 (vehicle control of entry post) consisting of a square, temporary hut with a window on three sides (Pl. 2). On the opposite side of the road was Q14A (a sangar – protected sentry post). It was constructed of concrete, painted in green camouflage, and was circular in shape with additional half-moon protection. The road continued in a straight line in a northerly direction, past block Q4 (sports and social club) before turning to the east past sangar Q14B. The road continues to the east, past three bunkers located in the north-west corner of the site (Pl. 3). The bunkers were rectangular in shape and all that could be seen of them were three low mounds covered in grass. To the south of the road was building Q4, specifically the Sergeants' Mess and the combined mess, whilst to the north was block Q3, specifically the administration squadron headquarters (Pl. 4). Beyond these two blocks the road split to the north, accessing Q13 (electricity substation), sangar Q14C and a car parking area (Pl. 5), to the east, accessing Q5P (RAFP HQ) and sangar Q14D and to the south (Pl. 6) where it continued round block Q4, past block Q5A (Acorn Club) to the east, Q11 (garages) to the west. The road then bent to the south-east (Pl. 7), giving access to Q6 (Centurion) and Q7 (Chieftain) to the west, Q8 (Cromwell), Q9 (Churchill) and two bunkers to the south-west and Q15 (barracks) and sangar Q14E to the south-east. Sangar Q14F (Pl. 8) was located between blocks Q7 and Q8. The sangars encircled the site around the perimeter (clockwise from the entrance, Q14A–F).

Plate 1. Entrance gate, looking north.

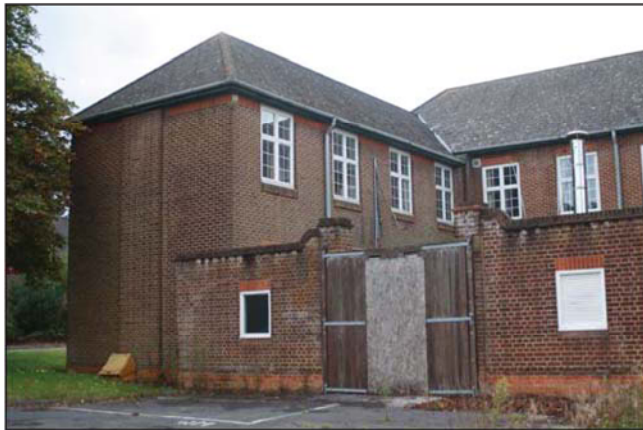
Plate 11. Yard gates and wall of Q3, looking southwest.

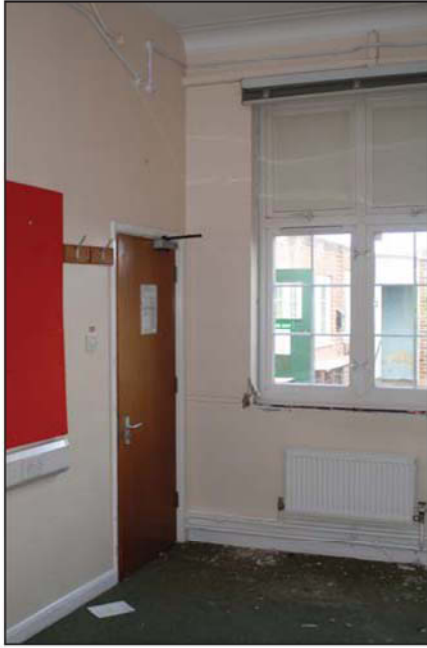
Plate 13. Q3, view to window and door of G.05, looking northeast.

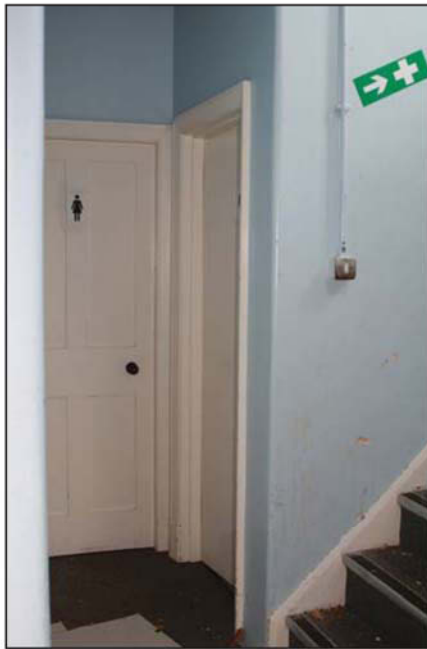
Plate 19. Q3, an original door, looking northeast.

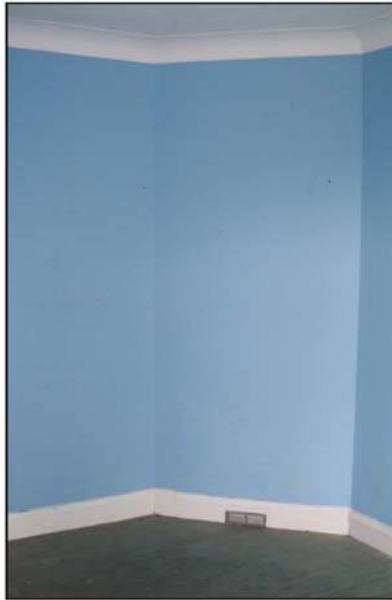
Plate 21. Q3, view to blocked fireplace, looking southwest.

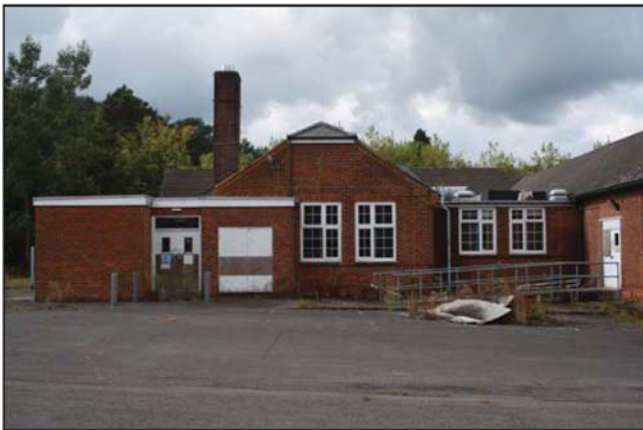
The original building consisted of two separate east-west aligned buildings that were later linked together (Pl. 23). Building 1 was the larger of the two, located to the north. It had a half-hipped roof, covered in slate tiles. The main entrance was located in the centre of the building, on the north side (Pl. 24). It was square in shape, projecting from the roofline and had a flat roof. On the east and west sides was a small window adjacent to a brick pilaster. An additional two pilasters were located either side of the double entrance door on the north side. Within the two pilasters, above the door, the bricks were laid in vertical stack bond. The doors themselves

Building 2 (Pl. 23) was located to the south and was substantially smaller. It had the same half-hipped roof, covered in slate tiles. Little external detail could be seen due to the later extensions surrounding the building.

Plate 23. Rear of Q4 showing later additions and extensions, looking west.

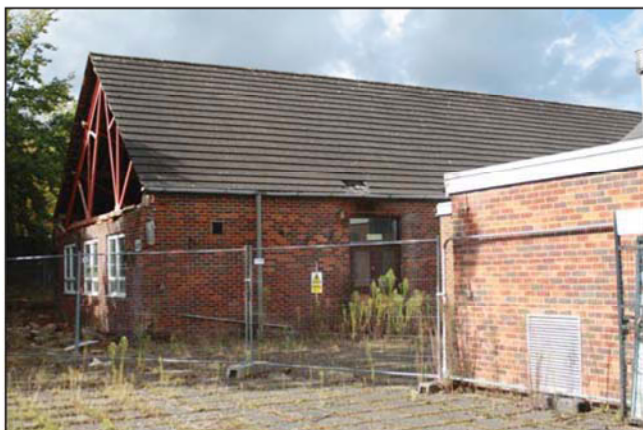
At the west end of building 1, located to the south, was the most recent extension according to map evidence, consisting of a building of similar width but with a gable end roof (Pl. 25). Where part of the gable end had been removed it was possible to see the steel roof trusses – these were of fan type.

Plate 25. Oblique of Q4SS showing truss detail, looking northwest.

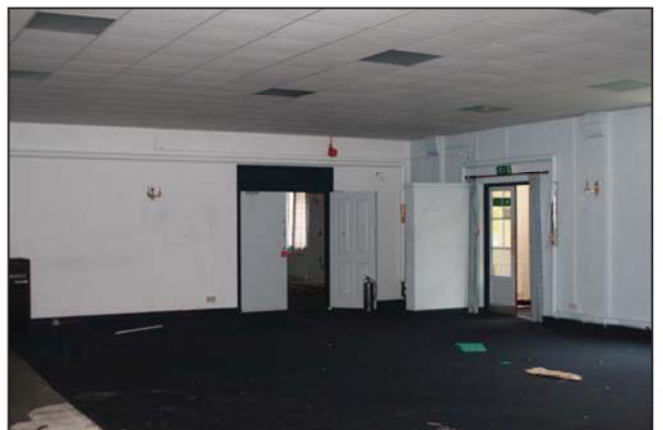
Internally the building had been modernized and there were few original features; most notably the pilasters within building 1, with a jowled head (Pl. 26). The floors were a combination of carpet and tiles, and the walls of painted plaster, brickwork, or tiled depending on the function of the room. A modern, suspended ceiling had been fitted throughout the building. In terms of function, building 1 had been split into three areas; G.01 a bar and lounge area with a wood panelled bar in the south-west corner of the room and a central, wooden dance floor in the shape of an octagon (Pl. 27); G.02 the dining room; and G.03-G.09, a series of rooms including a staff room, stores and toilets.

Plate 26. Q4, oblique of dining room, looking northwest.

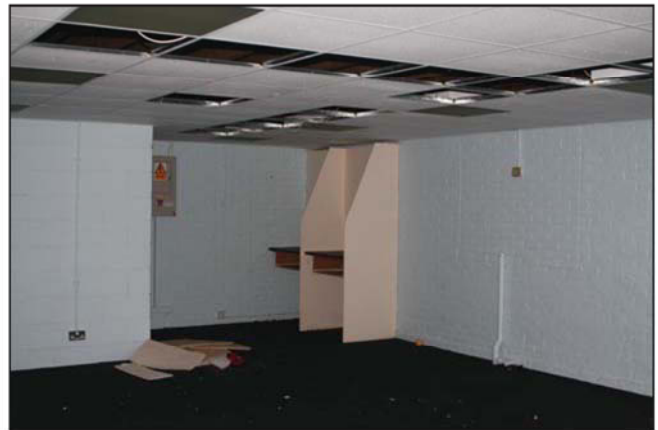
Plate 30. Q4, snooker room showing blocked windows, looking east-southeast.

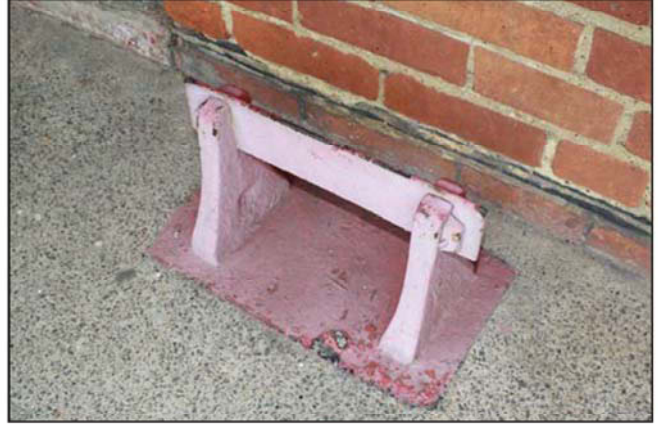
Plate 34. Bootscraper, looking east-southeast.

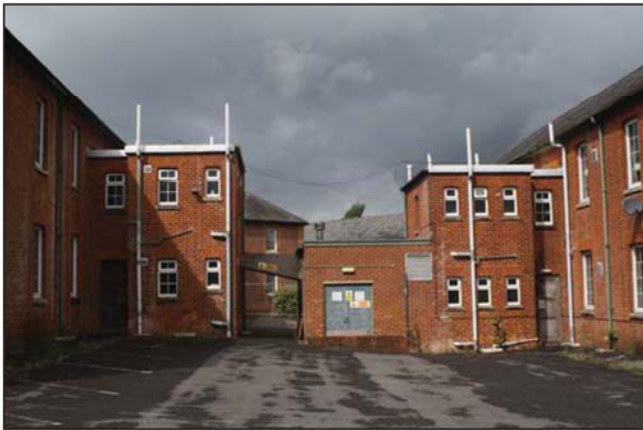
The four accommodation blocks (Q6-9) were built between 1910 and 1937 according to the map evidence and were of a similar build; the only difference being the addition of a boiler room on blocks Q6 and Q9. They were two-storey, brick-built blocks, with the bricks laid predominantly in stretcher bond, though some variation was present, and bonded in cement mortar. A combination of orange and brown bricks had been used to create coloured panels, with the orange bricks framing brown panels. The windows were tall and narrow, consisting of nine panes in three columns and were of tilt-opening style. Above the windows was a flared arch. The roofs were hipped and covered in slate tiles (Pl. 39). The entrance to each block was located in the centre of one of the long sides and consisted of a pair of three-panelled doors with a window above. This was set within a stone surround with the name of the block placed centrally above the window (Pl. 40). The toilet blocks attached to the rear of the building had flat roofs and smaller windows; there was some variation in the number and size of the windows on each block. The blocks of each pair were joined by a concrete brace between the toilet block of one and the boiler room of the other (Pl. 41).

Plate 41. Rear of Q8 and Q9, looking northeast.

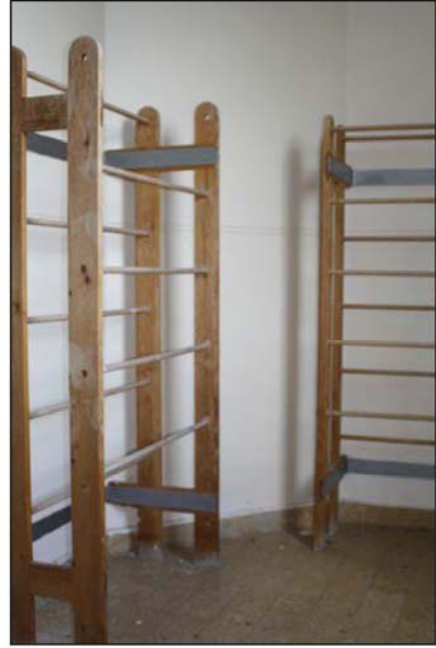
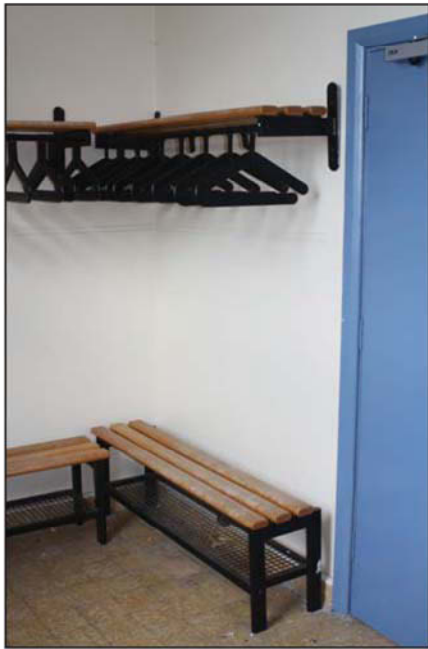
The utility area (room 1.12) contained wooden benches around the walls with a shelf and hanging rail above at one end and drying racks at the other end (Pls 44-45).

Plate 44. Q6, utility room drying racks, looking southwest.

Plate 45. Q6, utility room benches, looking southeast.

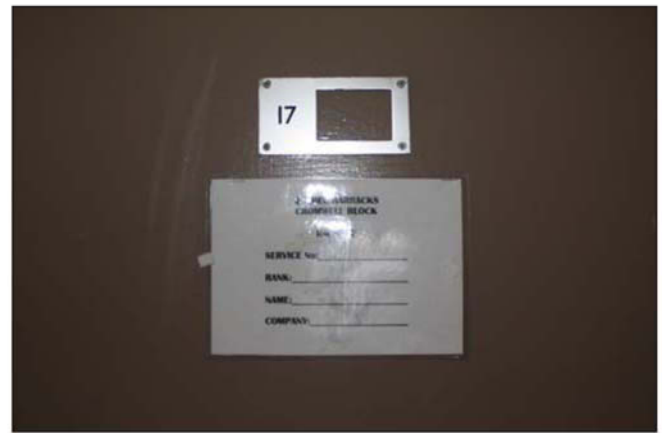
Decoratively the walls and ceilings were plastered and painted, with carpeted or tiled floors. The woodwork was painted a taupe colour. The doors to the personal rooms each had a silver, metal plate with the room number, below which was a temporary laminated card (Pl. 46). The card gave details of service number, rank, name and company.

Plate 46. Q8, door label detail, looking southwest.

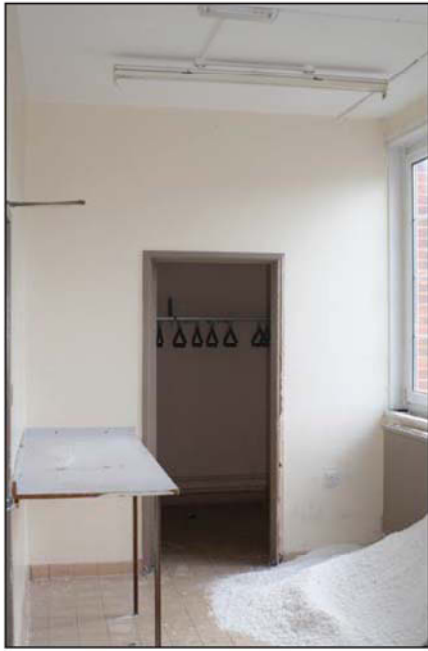
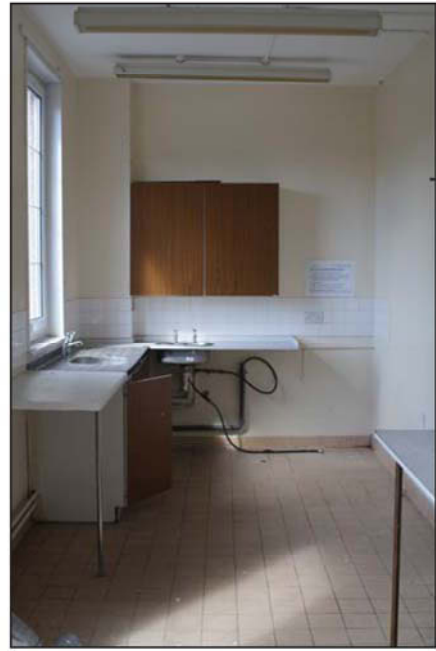
Room G18 was located off of room G19 and consisted of a drying room and utility room. The floor throughout was tiled and the walls of cream, painted plaster. The drying room (G18) contained a rail holding coat-hangers and the utility room (G19) contained a raised kitchen worktop, two sinks and a pair of cupboards mounted on the wall. Beneath the sink was plumbing for a washing machine. Above the sinks were three rows of white tiles (Pls 47-48).

Plate 47. Q8, view to drying room, looking southeast.

Plate 48. Q8, utility room, looking northwest.

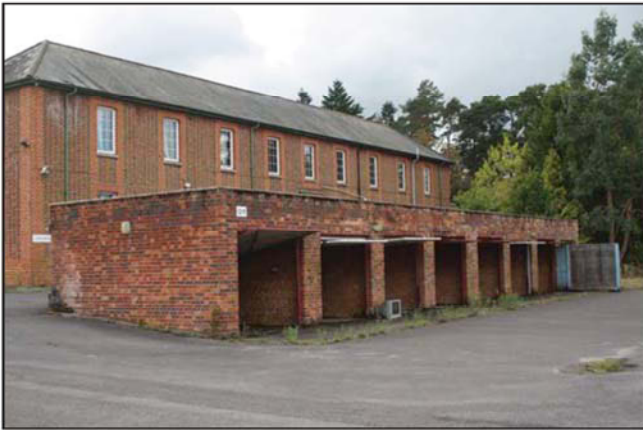
The garage block (Pl. 49) was a relatively recent addition, according to map evidence it was built between 1982 and 1987. The block is brick built with the end wall laid in English bond, each dividing column laid in header bond and the rows above the doors laid in stretcher bond, and a flat roof. The block contained eight garages.

Plate 49. Q11, garages, looking southwest.
