**Ruskin Works, Oakridge Road, High Wycombe,
Buckinghamshire**

Building Recording

Site Code: RWB16/80

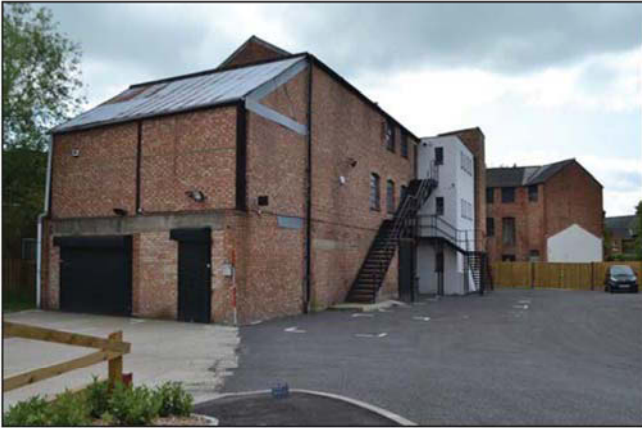
The original building (Pl. 1) is brick built, laid in English bond with double brick arches above the openings. It has a gable end roof covered in corrugated steel sheets. The windows are metal, divided into 30 panes with a small horizontally hung casement at the top consisting of six panes (Pl. 2). No original doors were apparent. The

extension at the northwest end of the building (Pl. 1) is built of a combination of steel columns in-filled with brick laid in stretcher bond. This extension butts the original building with none of the brickwork keyed in. The extension itself is two storeys high with a sloping, lean-to roof covered in corrugated steel sheets. There are no windows and the doors are of roller shutter type, set beneath a concrete lintel. The extension within the centre of the southwest facing elevation (Pl.1) is three storeys high, and is rendered and painted white. The windows are tall and narrow consisting of just three panes set within a metal frame, and the roof is flat. The extension at the southeast end of the building (Pl. 3) is three storeys high and built to match that of the original building, with the same English bond brickwork, bricks arches above doors and windows and the windows themselves. The possible surviving original door was boarded over on the day of the survey. The roof is of gable end type, covered in corrugated steel sheets. The rear (northeast facing) elevation is single storey with a lean-to sloping corrugated steel roof, presumably also covered in sheets. The extension was largely inaccessible due to being immediately adjacent to the riverbank, only the gable end was viewed. The brickwork appeared to be a variation of Flemish garden wall bond (Pl. 4). There were no openings within the extension.

The northwest facing elevation (Pl. 1, Fig. 9) consists solely of the lean-to extension. Within the wall are a pair of roller doors set beneath a large concrete lintel. One door is a loading sized door whilst the other, on the southwest end, is smaller and for access. Within the first floor it is possible to see three vertical steel posts.

Plate 1. Exterior, northwestern end of the building, looking southeast, Scales: 2m and 1m.

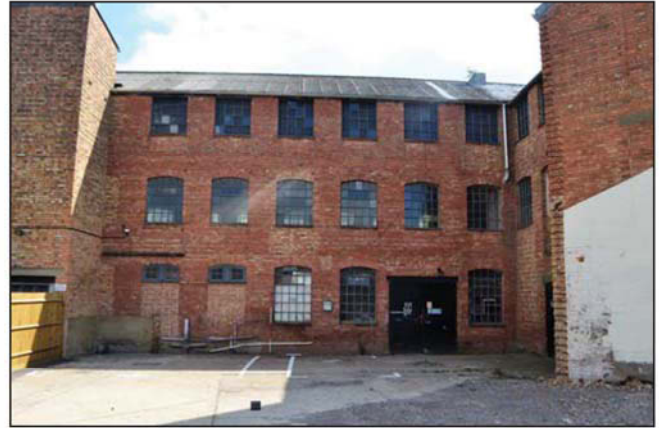
Plate 2. Exterior, original block, showing windows, looking northeast, Scales: 2m and 1m.

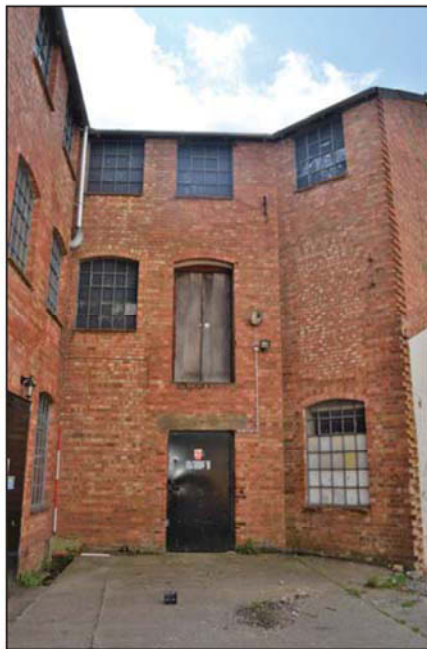
The northwest facing elevation and angled corner of the southeast extension (Pl. 3) contained a door and window on the ground floor, with the door probably a later addition as it is set beneath a concrete lintel. On the first floor is a second door above that on the ground floor, a window and a blocked door. The second floor contains three windows.

Plate 3. Exterior, southeast extension, looking southeast, Scales: 2m and 1m.

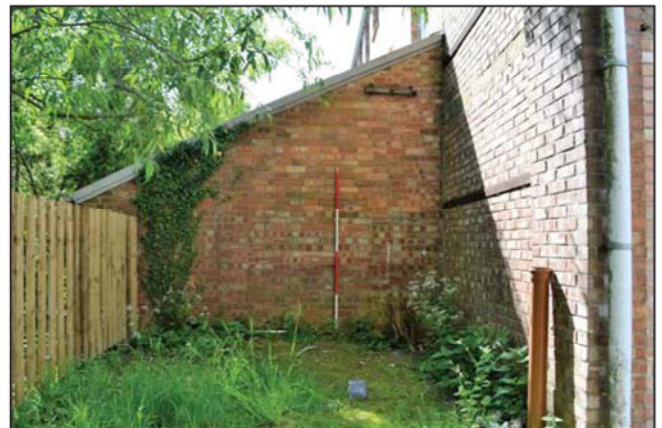
The northwest facing gable end of the single storey rear extension contained no further details (Pl. 4).

Plate 4. Exterior, rear extension, looking southeast, Scales: 2m and 1m.

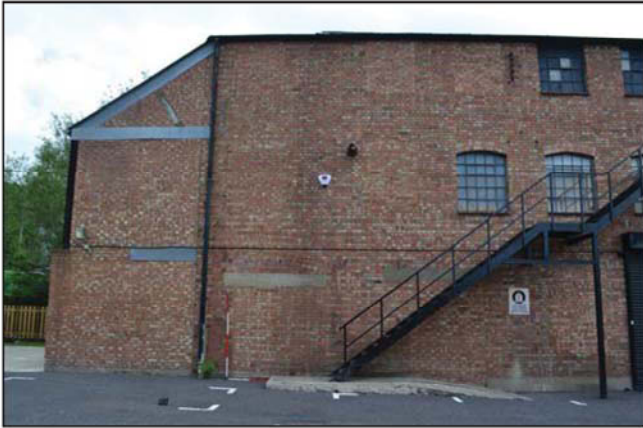
The front (southwest facing) elevation is complex, showing a number of changes, an extension and fire escapes (Fig. 8). The northwestern end of the building (Pls. 5 & 6) has seen the greatest number of changes; on the ground floor there is a double width, original blocked doorway, which has had a concrete lintel inserted within it, adjacent to which is a second blocked doorway as shown by the presence of a concrete lintel. Further along is a blocked window, a roller door and a window. On the first floor are five windows and a door. The two windows at the northwestern end have been blocked up. The door is at the southeastern end and accesses a fire escape that dog-legs round the later front extension. On the second floor are a further five windows and a door; only the two windows at the southeastern end have not been blocked up. The door accesses a fire escape which runs parallel to the building. The fire escapes are both steel, painted black.

Plate 5. Exterior, original building, front elevation, north-west end, looking southeast, Scales: 2m and 1m.

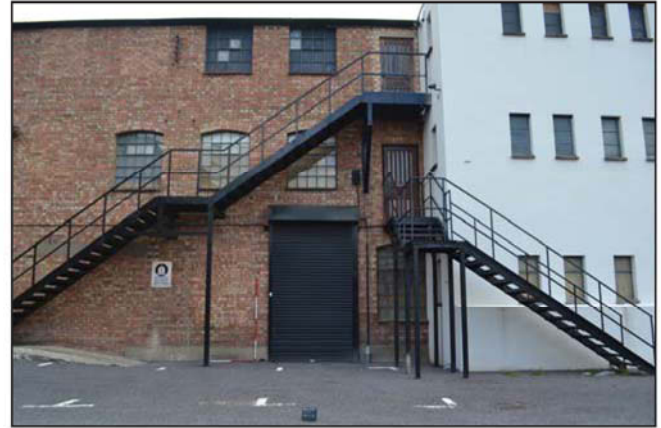
Plate 6. Exterior, original building, front elevation, centre, looking southeast, Scales: 2m and 1m.

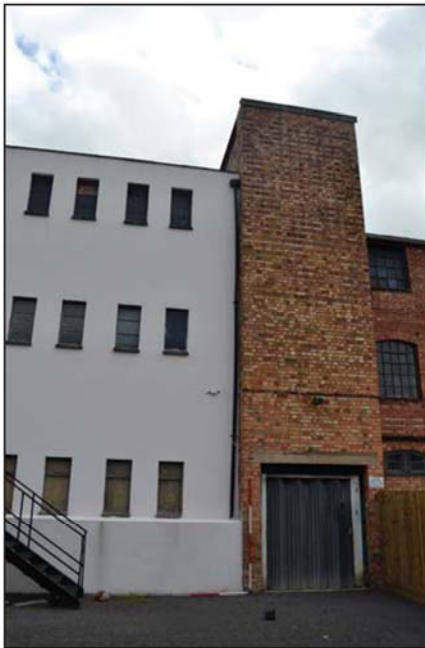
The projecting (front) extension contains four windows on each floor. Adjacent to it is a goods lift (Pl. 7), which appears to be an original feature. On the ground floor is the external lift door, set beneath a concrete lintel.

Plate 7. Exterior, original building, front elevation, centre, looking southeast, Scales: 2m and 1m.

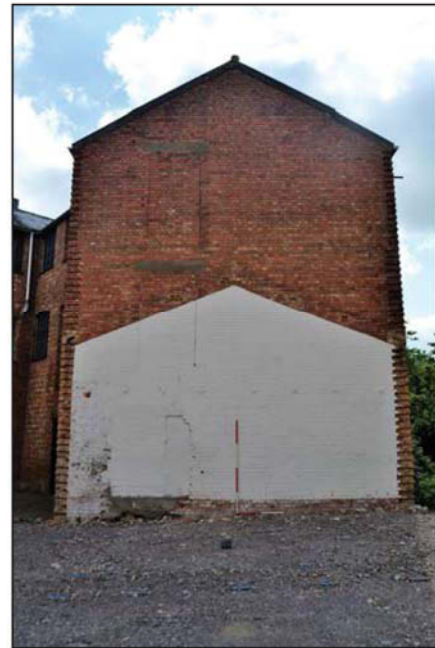
The west facing gable end of the southeast extension clearly shows where a previous, single storey building has been removed with the former internal wall painted white (Pl. 8, Fig. 9). Evidence exists for an early building with the presence of three blocked doorways set beneath concrete lintels at ground, first and second storey height. It is also possible to see where the external walls were keyed in as the existing brickwork is now dog-toothed. The southeast facing elevation and angled corner of the southeast extension (Fig. 9) contains ten windows on each floor (Pl. 9).

Plate 8. Exterior, southeast block, gable end, looking east, Scales: 2m and 1m.

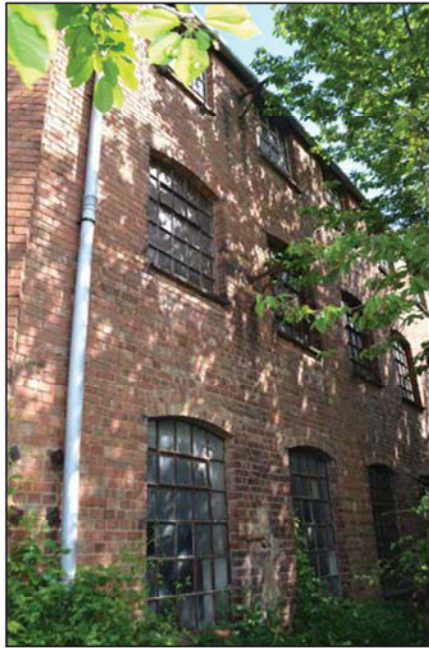
Plate 9. Exterior, oblique view of southeast extension, looking northeast.

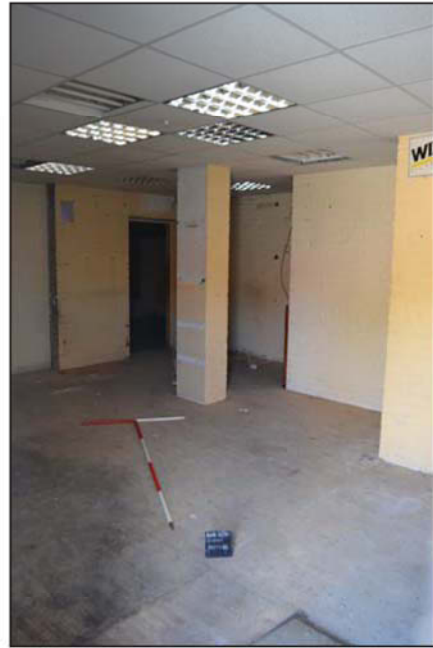
The northwest end of the original building has been largely removed, except for two brick columns to form a large room (room 1, Pl.10). The junction between the original walls and the new extension can clearly be seen due to the difference in width of the walls and different finish. The floor is covered in plywood sheets and a modern, suspended ceiling has been inserted. The room has two external doors in the northwest wall, including a loading bay with a roller door. Internally there is access to room 2 of the rear extension. A wide blocked door in the southwest wall suggests the thin brick wall at the south of the room is a later insertion. In the southeast corner of the room are a set of stairs giving access to the first floor; these are however accessed from room 3. The stairs themselves are enclosed within two brick walls and have concrete treads (Pl. 11).

Plate 10. Room 1, view to stairs and room 2, looking east, Scales: 2m and 1m.

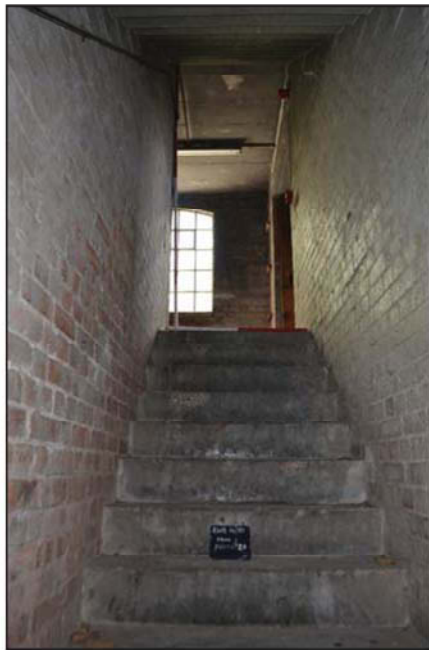
Plate 11. View up the stairs, looking northeast, Scales: 2m and 1m.

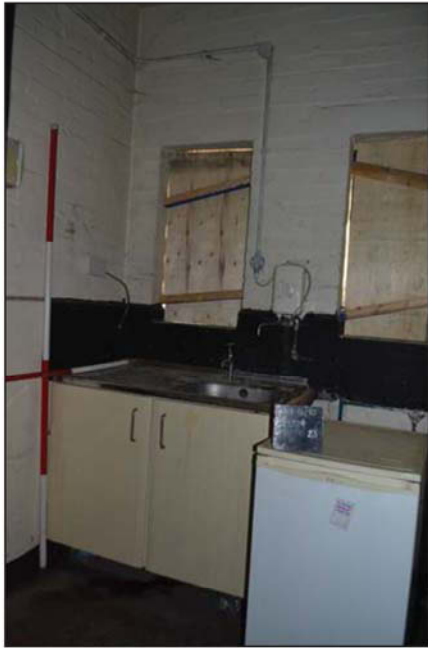
Within the front extension (room 4, Pl. 17) is a small kitchen and cupboard. Not all of the area was accessible. It is accessed from room 3 and contained four windows; two in the kitchen area and two in the inaccessible area.

Plate 17. Room 4, view of kitchen, looking southwest, Scales: 2m and 1m.

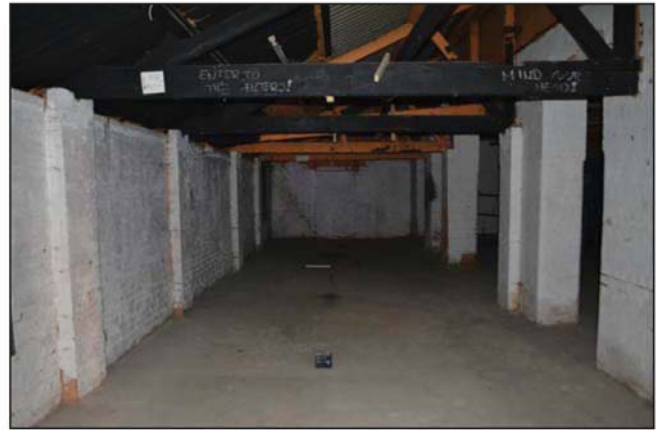
The rear extension is a single room wide and sub-divided into four rooms. Room 2 (Pl. 18) is approximately half the length of the building and is accessed from rooms 1 and 3, where significant sections of the original rear wall have been removed. The floor was of concrete and the walls of whitewashed brick. A blocked doorway was present at the southeast end of the room that would have given access to room 14. The roof trusses rested on the

Plate 18. Room 2, view of room to blocked door, looking southeast, Scales: 2m and 1m.

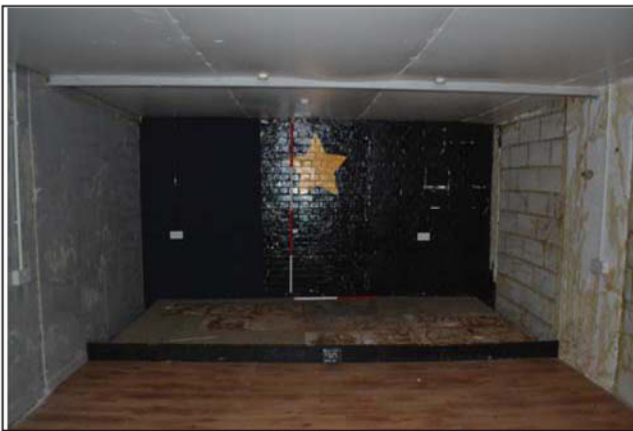
Rooms 12–14 formed the other half of the rear extension and were accessed from room 11. The floor was covered in wood effect flooring and the ceiling was boarded over. Like room 2, much of the back wall of the original building appears to have been removed but has been subsequently in-filled with concrete blocks to create more enclosed rooms (Pl. 19).

Plate 19. Room 12, general view showing blockwork infill, looking southeast, Scales: 2m and 1m.

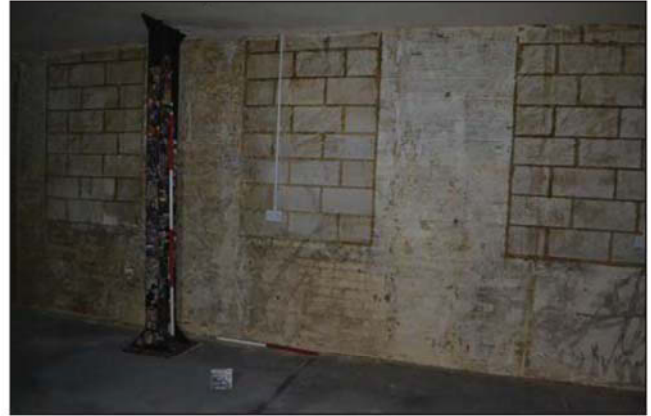
Room 19 is probably a later creation with concrete block walls rather than the brick found throughout the rest of the building. Like room 18 its three windows have been blocked up internally but the glass left in externally within the southeast wall (Pl. 22).

Plate 22. Room 19, Blocked window detail and steel column, looking southeast, Scales: 2m and 1m.

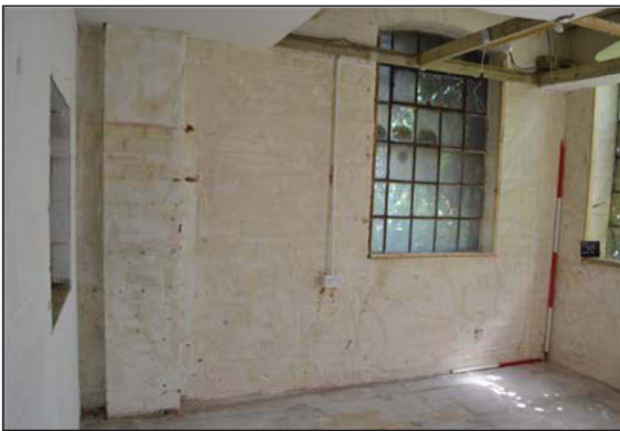
Room 21, at the northeast end of the building contains a blocked window with the northeast wall; it is not known whether the glass is still present externally due to lack of access along the river bank. The dividing wall between rooms 21 and 22 is a continuation of that from room 19, in concrete blocks, and may well be a later addition. Within the dividing wall is a window opening and the door to access room 22. Room 22 (Pl. 23)

contains three windows, that appear to have been previously blocked up and a false ceiling put in, which has now been partially removed.

Plate 23. Room 22, Oblique view to windows, looking east, Scales: 2m and 1m.

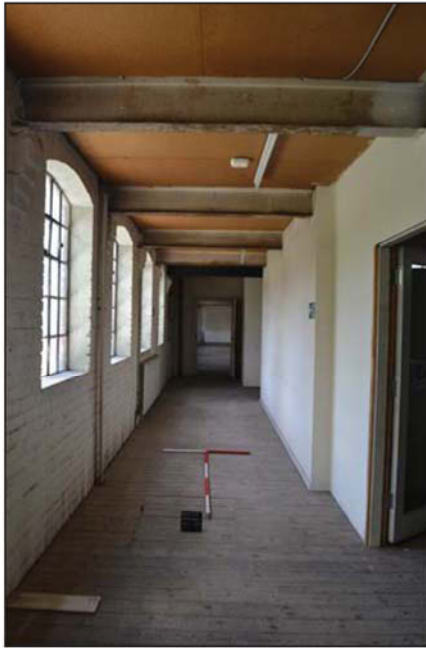
The stairwell gave access to a corridor which ran along the northeastern wall of the building (Pl. 25). The corridor in turn gave access to rooms 5-9. Room 5 was entered via a pair of doors and contained two windows in the southwest wall; both of the windows had been boarded up. Within the northwest wall was a blocked door, suggesting that the stairs were not originally in their current location (Pl. 26). A door in the southeast wall gave access to room 6, which also contained two boarded-up windows in the southwest wall. A door in the southeast wall gave access to the corridor, having turned a right angle to access a fire escape and rooms 7 and 8. Room 7 is a small kitchen area which in turn gave access to the front extension. Room 8 is a small cupboard, with no features of note. Room 9 (Pl. 27) is a large open room, nine bays long, with a window in each side of the bays, except where the front extension is present and the lift shaft in the southwest wall. In the northwest wall is a blocked door. Like the rest of the floor, the walls are of whitewashed brickwork, the floor of pine floorboards and the ceiling is constructed of steel I-beams supporting wooden joists. The lift doors were of concertina type in steel (Pl. 28). At the southeast end of the room was access to the southeast block.

Plate 25. View along corridor, looking southeast, Scales: 2m and 1m.

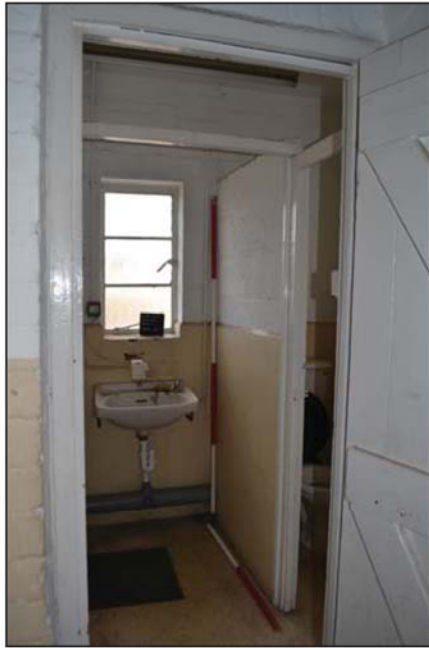
The front extension housed two sets of toilets; each contained a pair of toilet cubicles with a sink in between (Pl. 29).

Plate 29. Room 7, View to toilet and sink, looking south, Scales: 2m and 1m.

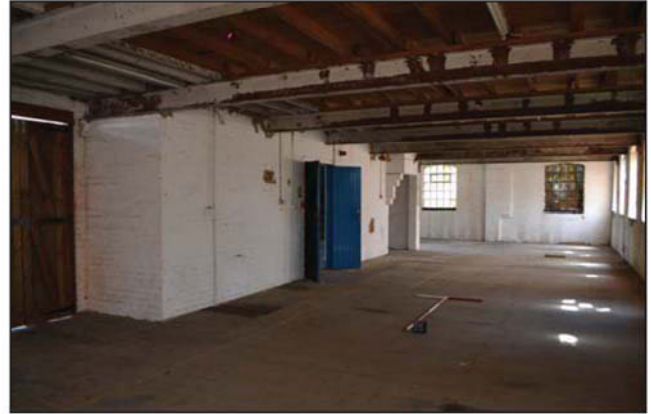
The southeast extension consisted of a single room (10) and a set of stairs giving access to the ground and second floors (Pl. 30). The room itself is divided into ten bays, including a pair of angled bays. Within each bay on an external wall is a window. The only wall not to have window is the west wall that was formerly an internal wall. Within that wall is a blocked doorway, with a second blocked doorway in the north wall at this end of the building. Adjacent to this is a double door of plank construction (Pl. 31). The floor is of pine boards, the walls of whitewashed brickwork and the ceiling constructed of I-beams overlaid with wooden joists.

Plate 30. Room 10, General view, looking northeast, Scales: 2m and 1m.

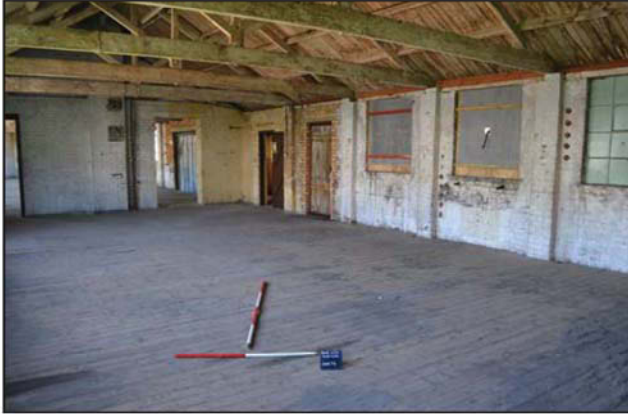
Room 24 (Pl. 33) was a little under half the building long (six bays), with a window in each bay on the northeast side and four windows and two doors on the southwest side. One door gave access to the external fire escape and the other, access to the front extension. At the far end of the room was a dividing wall with two openings giving access to room 25.

Plate 33. Room 24, Oblique view, looking southeast, Scales: 2m and 1m.

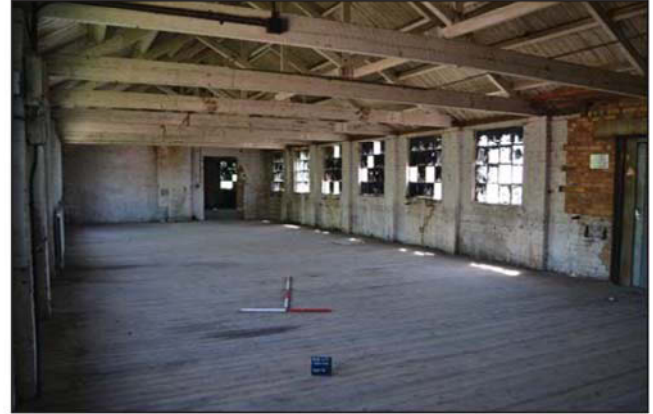
Room 25 (Pl. 34) was nine bays long with a window in each of the bays on the northeast side and six windows on the southwest side (due to the lift shaft and front extension). The lift doors were the same as those seen on the first floor - concertina style. At the far end of the room was access to the southwest extension. Within the roof space at the northwest end of the room was a pair of water tanks (Pl. 35).

Plate 34. Room 25, Oblique view, looking south, Scales: 2m and 1m.

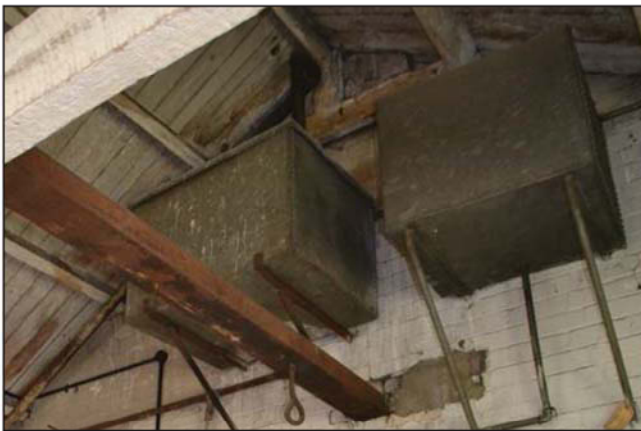
Plate 35. Room 25, Tanks within roofspace detail, looking northwest.

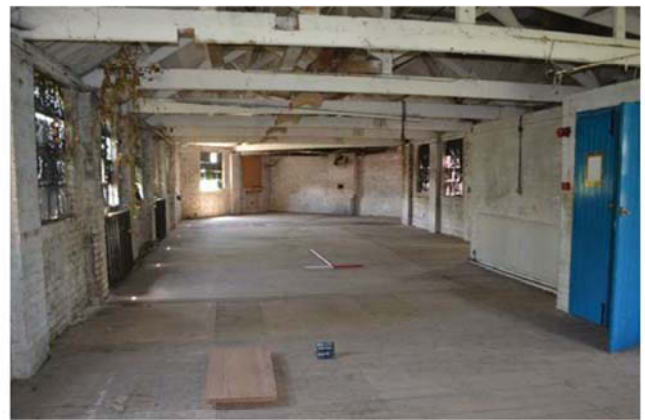
The southwest extension consisted of a single room (26) out of which a set of stairs had been taken along the former end wall of the original building (Pl. 36). These stairs were encased in a brick wall and had a window giving light, in the northeast wall. The window is metal framed, divided into eight panes (Pl. 37). The room itself is divided into nine bays, including an angled bay. Within each bay on an external wall is a window. The only wall not to have window is the west wall that was formerly an internal wall. Within that wall is a blocked doorway. At either end of the room is a chimney or buttress with stepped brickwork. In the roof space above the chimney/buttress at the west end of the room is a water tank, supported on steel beams (Pl. 38). The floor was of pine boards; a large section of which had been replaced. Within the floor are areas of round headed iron nails with a diameter of 5mm. The brick walls are painted white. The roof trusses were king post with a central ridge plank. Within the roof space is an iron pipe connected to a hopper (Pl. 39) at one end and a motorised wheel (perhaps a rotary feeder type) at the other end (Pl. 40) with vents along the length. The controls for the machine, a unit produced by 'Memota' is located on the stair wall (Pl. 37). It is possible that this apparatus distributed material along the lengths to each workstation, or possibly removed dust produced at each station by vacuum.

Plate 36. Room 26, General view, looking southwest, Scales: 2m and 1m.
