**Castle Quay Shopping Centre car parks,
Banbury, Oxfordshire**

Archaeological Evaluation

Site Code: CQB13/124

December 2016

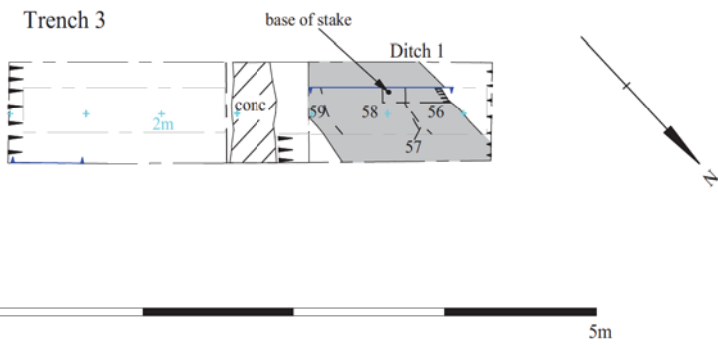
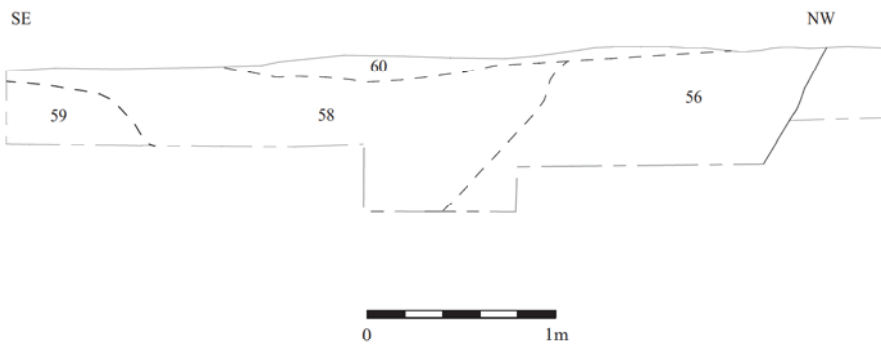
Figure 3. Detail of Trench 3 and sections.

Trench 3 was aligned NW - SE and was 12m long and 1.45m deep. This trench was dug in two halves, due to a buried service and concrete present perpendicular to the trench at 5m from the south east end of the trench. The stratigraphy of the trench was consistent on both sides to a point with 0.35m of Tarmac and hoggin (scalpins) to 0.6m, this all overlay 0.41m of firm grey blue silty clay made ground. At this level, a 0.33m of a yellowish brown silty clay deposit (60) was present, that sealed the underlying deposits. In the north eastern side of the trench, oblique to the trench, but on a roughly N-S axis, ditch 1 was recorded. This ditch (1) was c.2.5m wide and excavated to a depth of 0.45m deep though extended well beyond both the watertable and the base of the trench. It contained four upper deposits that were recorded. Under layer 60, was an upper fill (58), a yellowish blue/grey silty clay, over a thin layer of grey silty clay (57). This reached beyond the base of the trench, but represented slumped infill of the centre of the features. Under these layers, were two further fills, which could have been the same, at least stratigraphically. Both of these fills (56 and 59) were blue grey clays, and contained flecks of chalk and charcoal. Both extended well beyond the base of excavation at 1.45m. No finds were recovered.

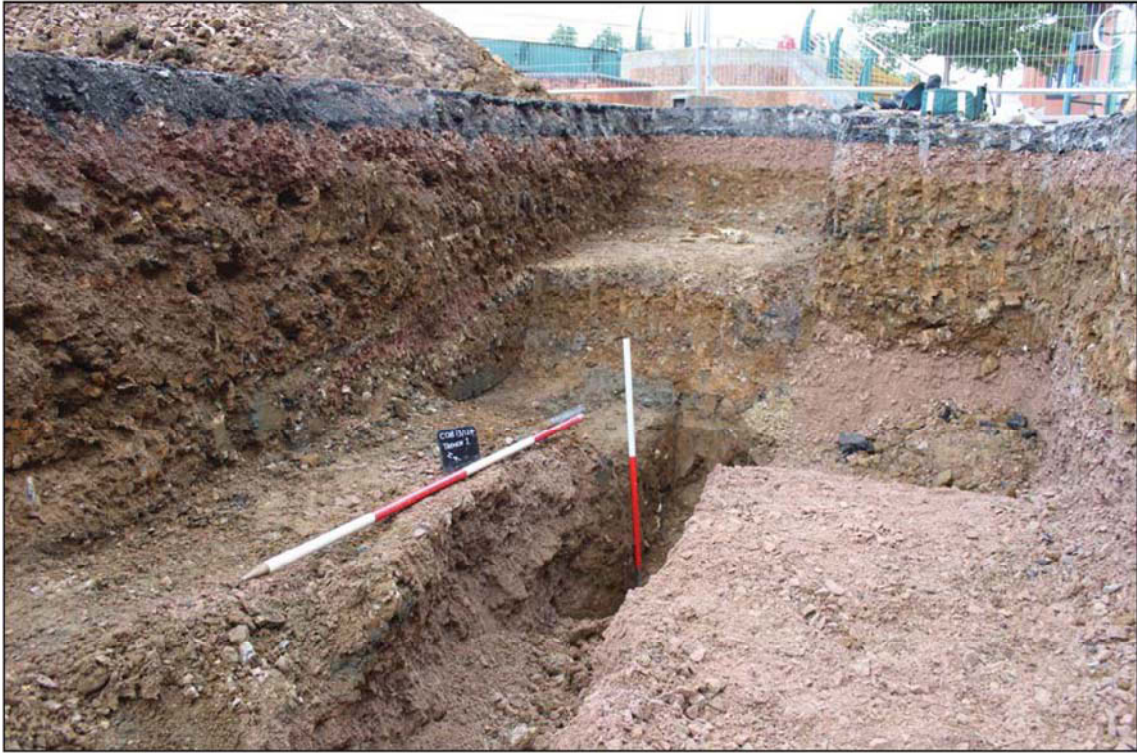
Plate 1. Trench 1, looking south east, Scales: 2m and 1m.

Trench 1 was aligned NW - SE and was 8.60m long and 0.81m deep in the SW end and 2.11m deep in the NE.

moved sideways to avoid this. The stratigraphy consisted of 0.35m of Tarmac and hoggin overlying four deposits of modern made ground consisted of 0.46m of mixed orange clay and grey sandy clay, 0.09m of hoggin, 0.20m of orange grey sandy clay and 0.35m of grey clay silt, overlying 0.45m of mid orange brown sand overlying alluvial deposits. No archaeological deposits or features were observed and no finds were recovered.

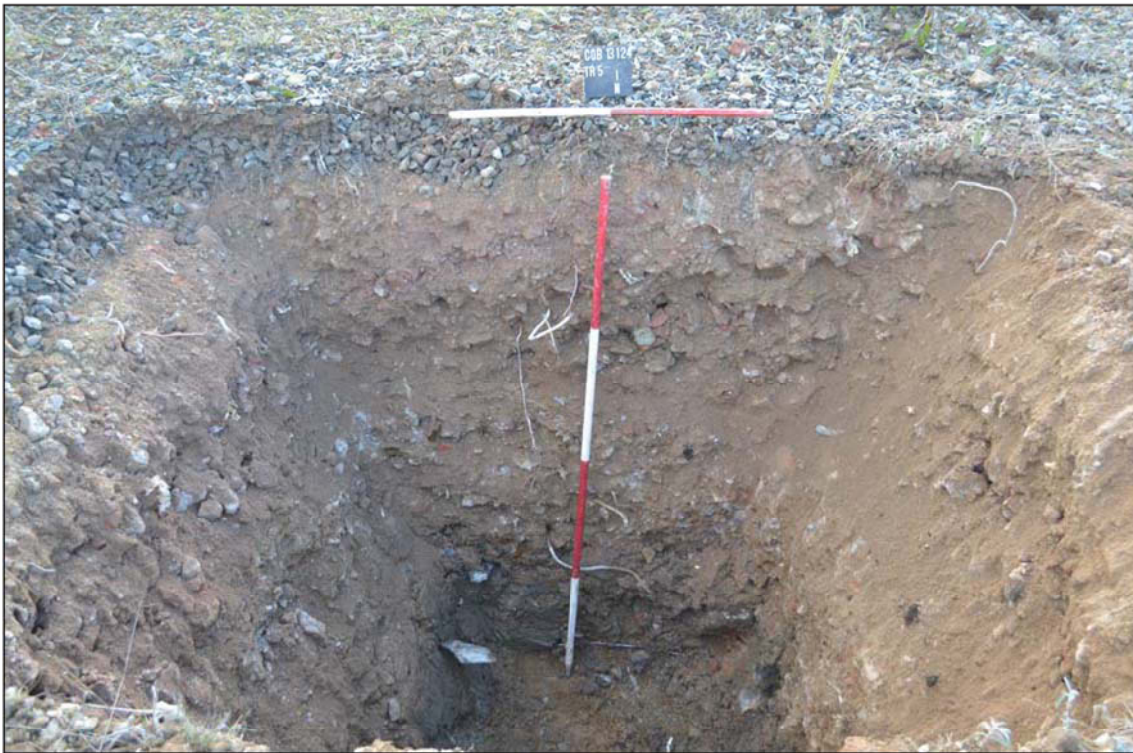
Plate 5. Trench 5, looking south, Scales: 2m and 1m.

Test pit 5 was aligned W - E and was 3.20m long and 2.20m deep. The stratigraphy consisted of 0.10m of construction gravel on top of a modern made ground. This made ground consisted of 1.10m of light reddish brown silt with frequent brick and concrete fragments, 0.70m of brick and concrete hard core and 0.30m of dark brownish grey clay with occasional brick fragments overlying mid orange brown gravel and clay natural geology. No archaeological deposits or features were observed and no finds were recovered.

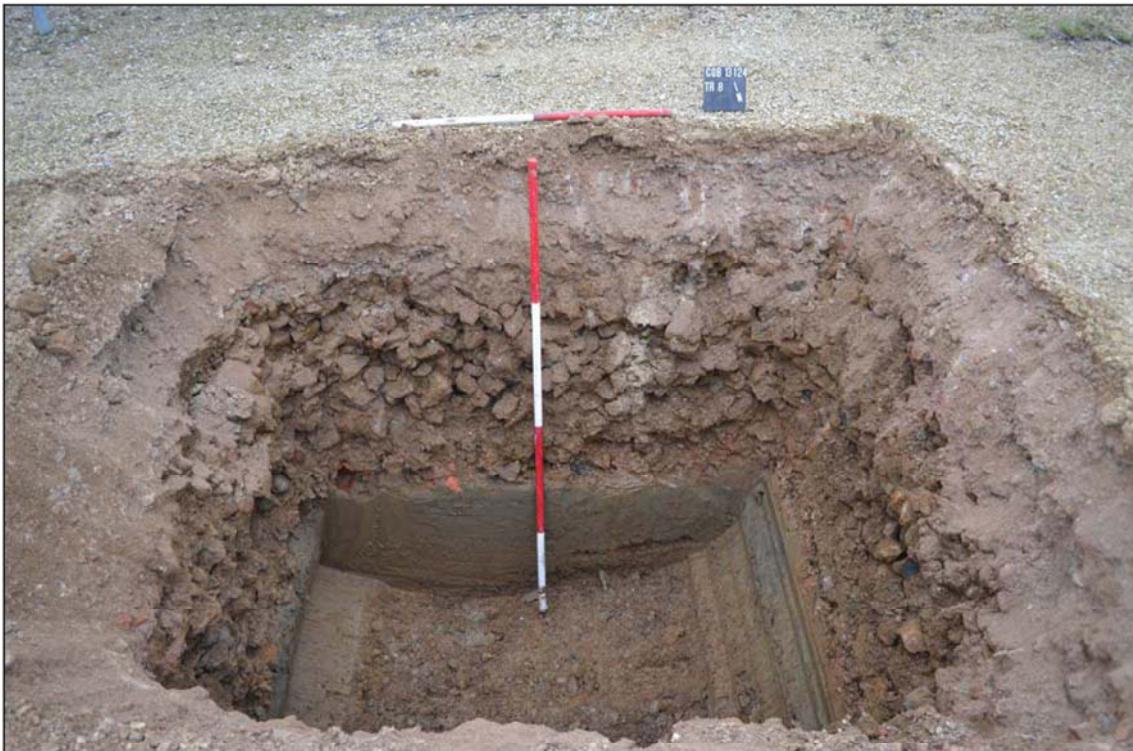
Plate 6. Trench 8, looking south west, Scales: 2m and 1m.

Test pit 8 was aligned NW - SE and was 2.80m long and 2.05m deep. The stratigraphy consisted of 0.10m of construction gravel, 0.60m of light orange brown sandy modern made ground with frequent brick and concrete fragments, 0.70m of a second made ground consisted of mid brown sand and medium size sandstones with occasional bricks, and 0.65m of light greyish brown alluvial clay overlying light brown gravel and clay natural geology. Two brick fragments were recovered from the second made ground for dating purposes showing this to be of early 20th-century date. No other archaeological features or deposits were observed.

A brick sample was recovered from made ground deposit 61, encountered in trench 8. The brick fabric was examined at x10 magnification and the brick type classified according to Harley 1974. It comprises a hard, dense fabric with groggy inclusions. It is unfrogged and the dimensions (thickness 68mm, width 110mm) and sharp finish indicate that it is of likely early 20th century date (Harley type 6).

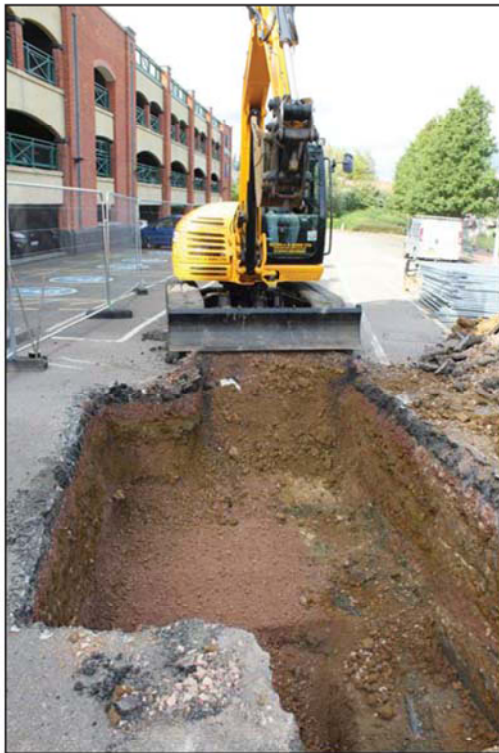
Plate 7. General setting of Trench 1, looking north.

In the event, only two trenches were excavated more-or-less as intended and four more were dug as test pits (Fig. 2). Trenches 1 and 3 were respectively 8.60m and 5m in length and 2.11m and 1.45m deep. After consultation with the Oxfordshire County Archaeological Service and considering the thickness of made ground deposits observed in Trench 5 and the presence of modern services, Trenches 5 to 8 were dug as test pits and Trenches 2, 4 and 9 to 11 were not excavated. Test pits ranged in length from 2.30 to 3.20m and in depth from 2.05 to 2.30m. A complete list of trenches and test pits giving lengths, breadths, depths and a description of sections and geology is given in Appendix 1.
