**The Cottage, Whitehouse Green,  
Sulhamstead, West Berkshire**

**Building Recording**

**Site Code: TCS17/08**

**February 2017**

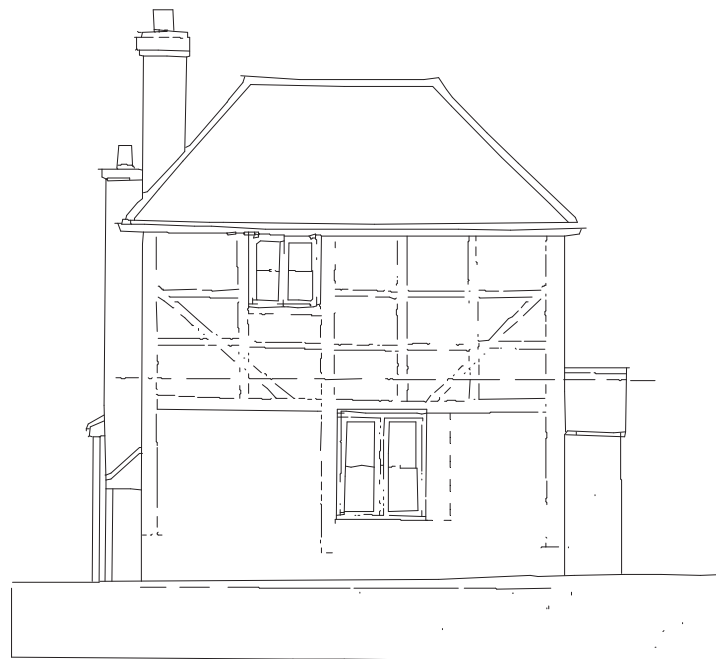
Figure 8. Elevations

**East Elevation**

**South Elevation**

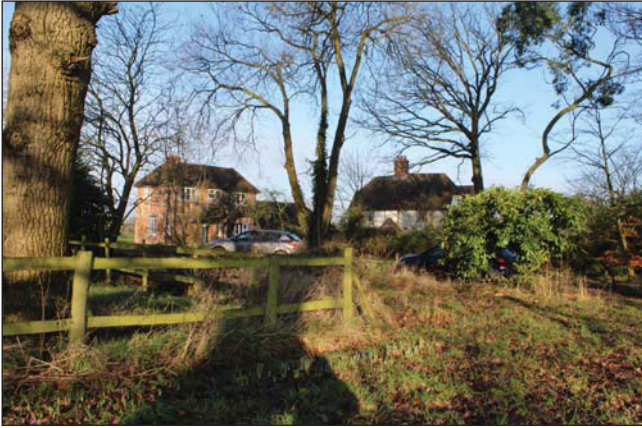
Plate 1. The Cottage and Thane Cottage, looking north west.

The Cottage is aligned north-northeast–south-southwest, approximately parallel to the private track which gives access to both the Cottage, Thane Cottage and the Old Manor. Thane Cottage is located approximately 10m away to the northeast and aligned east–west (Pl. 1).

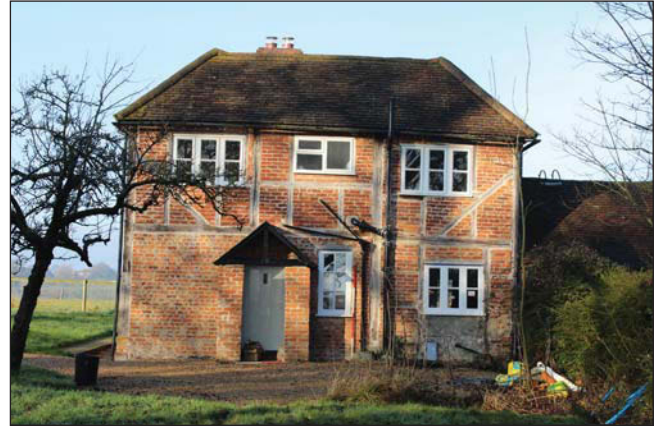
Plate 2. Front elevation, looking west-north-west, Scales: 2m and 1m.

The front (southeast facing elevation) was three bays wide with the front entrance central between bays one and two (Pl. 2). A small, open porch had been added at a later date. The porch was brick built with a slate hung gable end roof. The bricks were laid in stretcher bond, measuring 226mm x 106mm x 67mm (8 7/8" x 4 1/4" x 2 5/8") and were not keyed into the house wall. The door itself was of vertical plank construction (Pl. 3). Above the

opening was an arch created by laying the bricks on edge. Immediately to the north of the doorway was a window. A second window was present in the third bay, set within timber framing. On the first floor a window was present within each of the bays; the central window was originally taller than that present now.

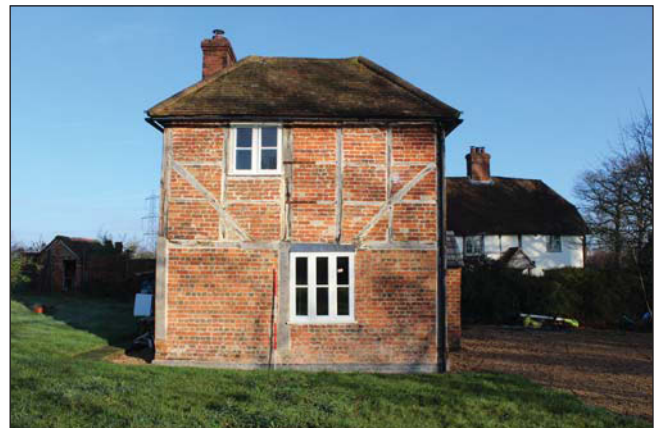
Plate 4. Side (south) elevation, looking north-north-east, Scale: 2m.

The side (southwest facing) elevation (Pl. 4) contained two windows set either side of the central principal post. The ground floor window was originally wider than that currently present.

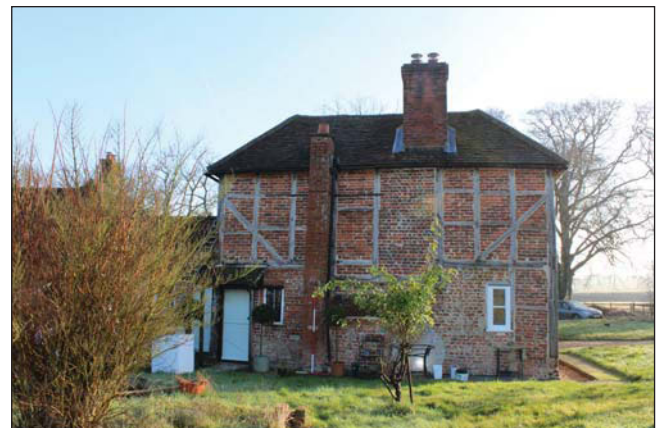
Plate 5. Rear elevation, looking east-south-east, Scales: 2m and 1m.

The rear (northwest facing) elevation (Pl. 5) was the most complex with a number of later changes apparent. At the north end of the wall was a second doorway, with a stable style door, next to which was a narrow window set beneath a brick arch. There was a scar in the brickwork between the window and door, suggesting that the window might have once been larger. This was the only window within the building that was not a recent replacement. It consisted of 10 (2x5) square leaded panes with a hood above. Internally a vertical metal bar was present. In the centre of the wall was an external chimney and a small lean-to, which formerly housed a bread oven. Neither were keyed into the main wall and the chimney, in many places did not touch the wall; both were later additions. The bricks measured 222mm x 110mm x 67-70mm (8" x 4" x 2 5/8-2 3/4"). Further to the south was a second window and a small amount of timber framing. On the first floor the timber framing was more complex to accommodate the internal chimney; the main beam within the central bay was lower than the other two and the brickwork above it was English bond rather than stretcher bond. The chimney stack above the roofline appears to have been rebuilt, and by the style of the brickwork possibly in the Victorian period.

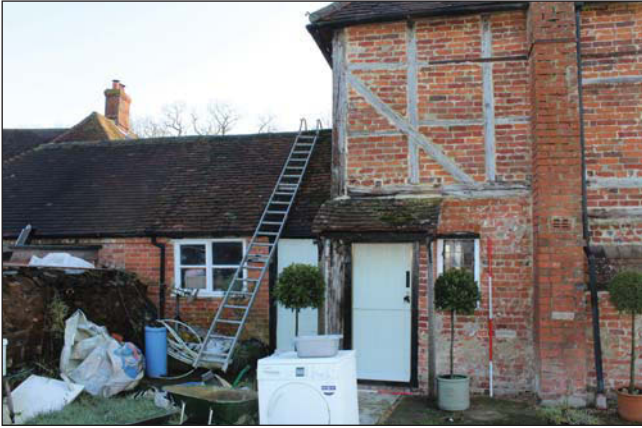
Plate 6. The extension, looking east-southeast,  
Scales: 2m and 1m.

It was only at the rear of the building that the extension to the north could be seen (Pl. 6). This consisted of a single storey extension with a hipped roof (though the hip was not present within the section of building belonging to The Cottage) and covered in red clay tiles. The building butted up against The Cottage and contained a door and a window in the section belonging to this property. A clear division was present within the brickwork, showing as a vertical scar and can also be seen in the roof where tiles have been replaced in the section belonging to Thane Cottage. The bricks are laid in Flemish Garden Wall bond and measure 228mm x 100mm x 65mm (9" x 3 7/8" x 2 1/2").

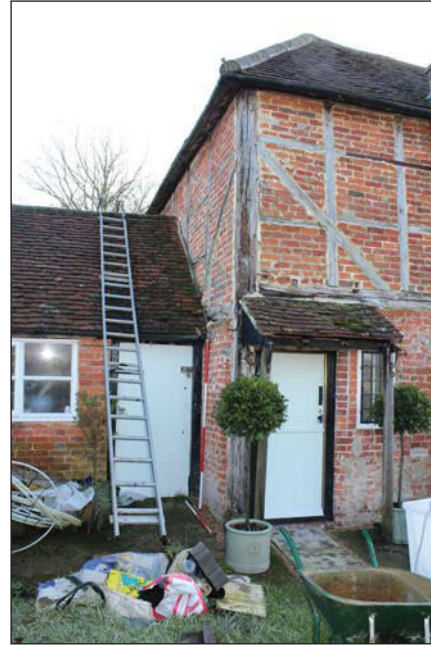
Plate 7. Side (north) elevation, looking east-southeast,  
Scales: 2m and 1m.

The side (northeast facing) elevation (Pl. 7) was largely obscured by the extension. What could be seen, however, showed it to be similar to the opposite side elevation, but without the windows.

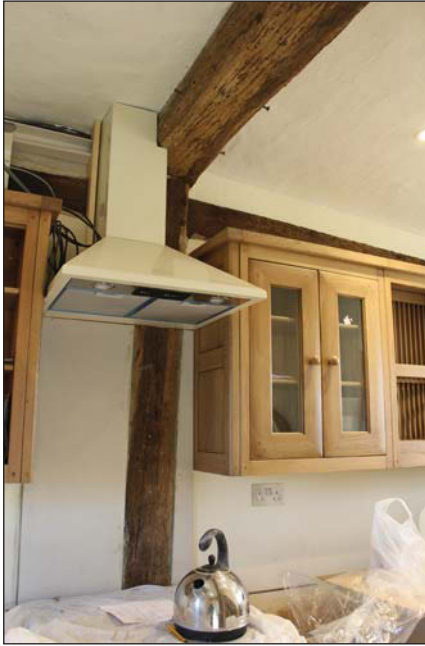
Plate 11. Timber framing within the kitchen, looking northeast.

The kitchen (room 2) was accessed via the main room (room 1) and a separate external door to the rear. The stairwell took up part of the room and a cupboard had been newly built beside the two doors. The main beam continued into this room, where it ended and a second shorter beam met the principal post in the end wall. Within the end wall it was possible to see the two girding beams tenoned into the principal post (Pl. 11). The wall dividing the stairs and kitchen is of plank construction (Pl. 12), with each plank measuring 215mm (8 1/2") wide.

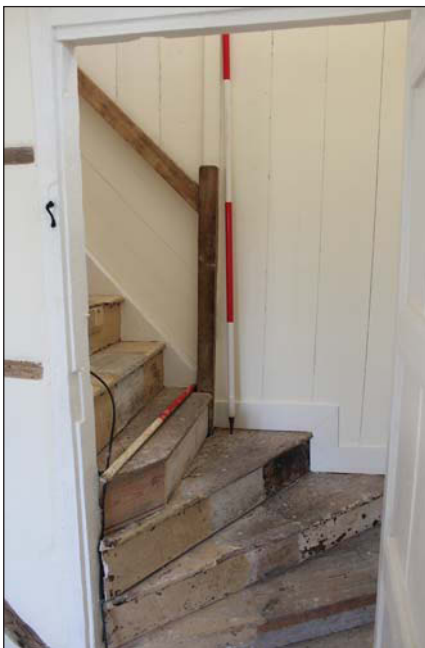
Plate 13. Bottom of the stairs and plank wall detail, looking north east, Scales: 2m and 1m.

The stairs were of winder type rising up into the centre of the house (Pl. 13). The handrail and posts were of a simple design; a square profile post with a rectangular profile handrail tenoned into the post. The plank wall could be better seen within the stair well and consisted of diagonally laid boards beneath the handrail area and vertical planks above. A cross-piece met the top stair, this in turn was supported by an additional vertical timber located behind the bottom handrail post.

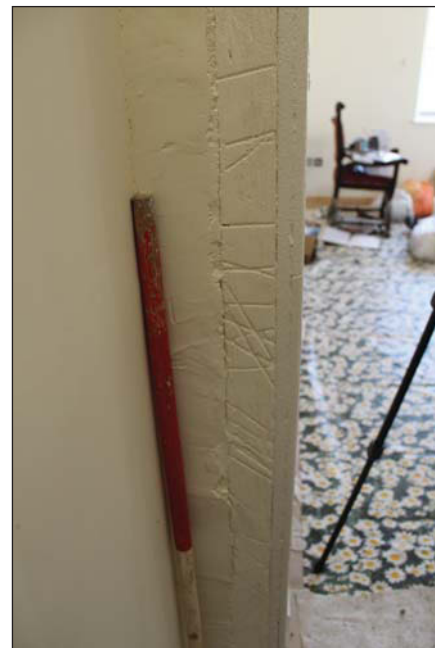
Plate 14. Apotropaic marks, looking south-south east, Scale: 1m.

On the back of the doorframe, at the bottom of the stairs, adjacent to the window were a series of apotropaic marks (Pl. 14). It is not entirely clear as to what they are; it is possible that they are a series of numbers (carpenters marks) but there are no corresponding holes for other timbers. Crude saltire crosses are another possibility or the letters V, M or double V representing the Virgin Mary, or scratched line decoration.

The presence of apotropaic marks is unusual within West Berkshire (Alex Godden pers. comm.), with no others known. These marks are most commonly found beside external doors, windows or fireplaces, though this one is beside an external wall and is located on the doorframe of the stairs, and would appear to be protecting the first floor as a kind of secondary protection. The form of the marks finds several similar examples over the border in Hampshire; Grove Place, Nursling; Mellow Farm, Headley; Goleigh Farm, Greatham and Waterditch Cottage, Poulner, Ringwood. These were all however found on fireplaces (Roberts, 2003, p101).

The date of the house is likely to fall within the mid – late 17th century based on a number of factors. Principally that it is partially brick built with the brick size indicative of this period, its move towards frontal symmetry, in particular within the upper floor and the plan of the building with its chimney located on the external wall. Fear of witches was also at its height in the 17th century (Hall, 2005, 150).

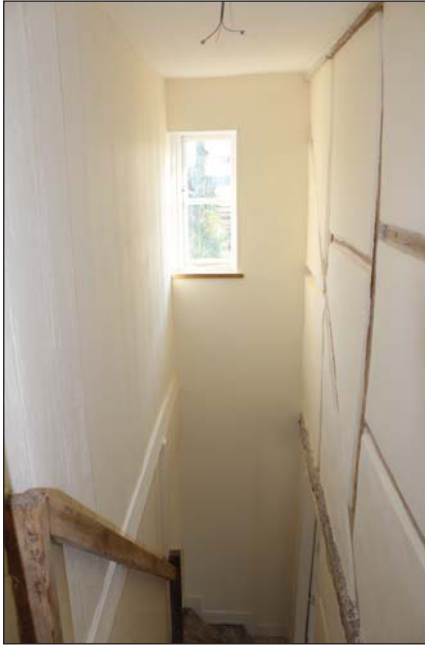
Plate 15. View to window in stairwell, looking east-southeast.

The top of the stairs opened out onto a small landing giving access to all three rooms. The stairs and landing were lit via a single window in the front wall (Pl. 15). . This window was part of a larger window within room 4, but sub-divided by the plank wall. The ceiling had been plastered over, obscuring all timbers. The floor had been replaced across the entire first floor; though it still retained its unevenness.

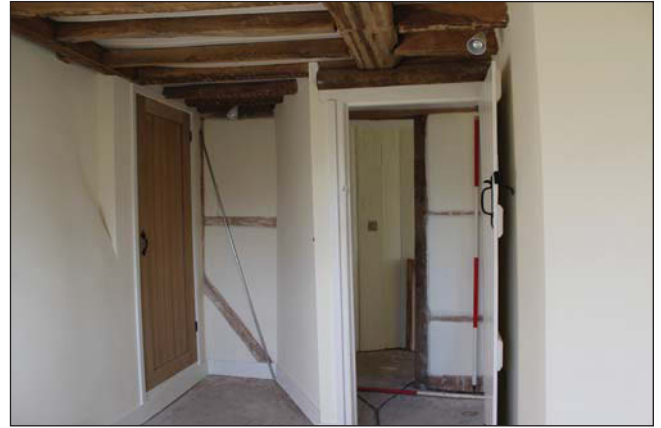
Plate 16. Internal timber framed wall, looking north-northeast, Scales: 2m and 1m.

Access to rooms 3 and 5 was through an opening in the timber framed partition wall (Pl. 16). Room 3 occupied the southern end of the building, whilst room 5 was located along the centre of the eastern (front) wall.

Room 3 was the master bedroom, it was roughly 'L-shaped' in plan form with a window in both the east and west walls. The wall between the landing and the room was angled; it was newly plastered with no apparent timber framing and is likely to be a later addition to allow access to the bathroom (room 5) (Pl. 16). The chimney breast rose up through the room in the centre of the western wall (Pl. 17). The alcoves either side of the chimney breast had been infilled with modern cupboards. Within the ceiling it was possible to see all the timbers (Pl. 31). These consisted of the main north-south beam; which appeared to be a single piece of oak spanning the entire length of the house measuring 9 ¾" wide with no chamfer. The division between bays one and two was clearly identified by the presence of a pair of binder beams and a change in direction of the joists. In bay one the joists ran approximately north-south, whilst in bay two they ran east-west. A number of these joists bore carpenters marks; in bay one it was possible to see numbers II-VII (Pl. 19), presumably I was present on the joist within the cupboard. The carpenters marks within bay two were not as apparent; however the joists either side of the main beam were numbered differently, VIII was present on the east side whilst numbers XX, XXI and XXII were present on the west side.

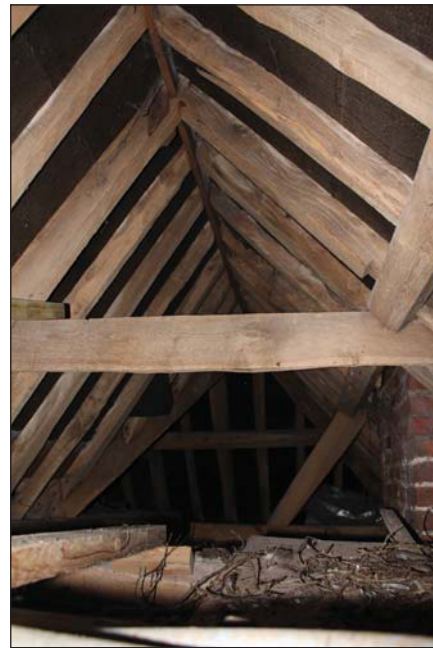
Plate 22. Roof detail, looking east.

The roof was of typical hipped roof construction (Pl. 22), but without a single apex. The dragon beam and tie were visible in each corner of the building in the rooms below. The roof itself was of common rafter type, meeting at a ridge plank. The occasional raised collar was present between the rafters. The purlin was clasped by the rafters and further supported by the occasional strut. Where the chimney stack was located the rafters do not continue below the purlin.

Structurally the building is interesting with a number of unexpected building techniques as compared to a more traditional timber-framed building. Most notable is the form of the roof and the length of some of the timbers used. The design of the roof means it avoids having the steep pitch and height like that found on the adjacent Thane Cottage, but instead has a central valley from which water needs to be drained. Such a design could have the potential to span a wider area; however this is not the case here. The presence of a single beam the length of the house (8.2m / 27ft) within the ceiling of the first floor is unexpected since it may have been easier to span the width of the building instead with smaller binder beams running the length of the house. This beam is also off-centre, located towards the rear of the building, making the front hip slightly larger than the rear hip. The only explanation would appear to be that the location of this beam accommodates the height of the stairs. Incidentally bay 3 is slightly wider than bays 1 and 2 by 0.45m / 1ft 5".
