Pond Farm, Godstone Road, Lingfield, Surrey

Archaeological Evaluation

Site Code: PFL17/30

March 2017

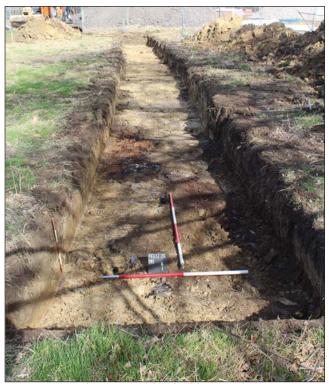
Plate 1. Trench 1 looking North. Scales: 2m, 1m and 0.50m.

This trench was orientated approximately N-S, and was 30.40m long and up to 0.63m deep. Along most of the trench the natural clay geology was revealed beneath 0.21m of topsoil (50) and 0.30m of mid greyish brown silty

clay subsoil (51). However, a large modern pit was observed in the southern end of the trench, measuring at least

7m in length. No archaeological finds or features were recorded in the trench.

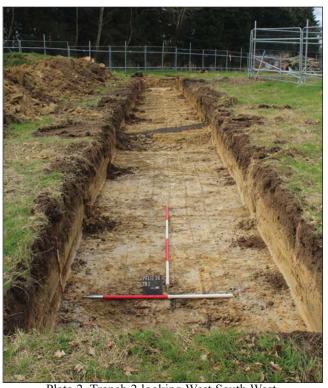
Plate 2. Trench 2 looking West South West. Scales: 2m, 1m and 0.50m.

This trench was orientated approximately WSW-ENE, and was 21.00m long and up to 0.56m deep. The natural

clay geology was revealed beneath 0.15m of topsoil (50) and 0.21m of mid greyish brown silty clay subsoil (51).

No archaeological finds or features were recorded in the trench, although two services were noted, along with a

clearly modern pit.

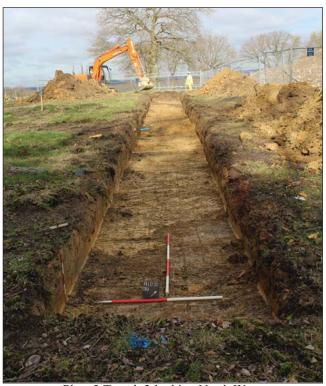
Plate 3.Trench 3 looking North West. Scales: 2m, 1m and 0.50m.

This trench was orientated approximately SE-NW, and was 30.20m long and up to 0.63m deep. The natural clay

geology was revealed beneath 0.20m of topsoil (50) and 0.32m of mid greyish brown silty clay subsoil (51). Six

modern services were noted within the trench, but no archaeological finds or features were recorded.
